## **Project**

**Project Name:** Greenfield School, Merthyr Tydfil

**Project Date:** 09/04/2021

**Inspection Standard:** MSCC5 Sewers & Drainage GB (SRM5 Scoring)

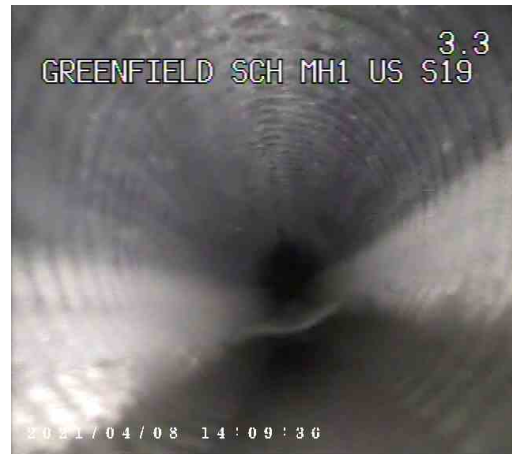
S19X\_2070d7b8-d2cf-4c01-9172-b5b239d22960\_20210409\_112421\_670.jpg, 00:00:12, 2.70 m  
Shape changes to oval, new size(s), 130mm high, 180mm wide, Pipe been squashed at bottom on the joint

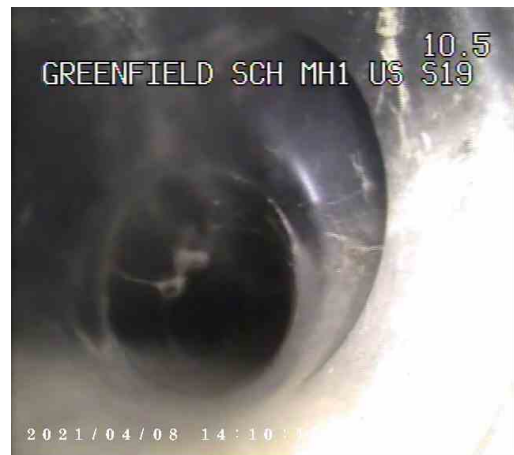
S19X\_19c7ea18-c9f5-4cb1-8efc-64b29e25f29c\_20210409\_113031\_413.jpg, 00:00:37, 8.00 m  
Settled deposits, coarse, 10% cross-sectional area loss, start

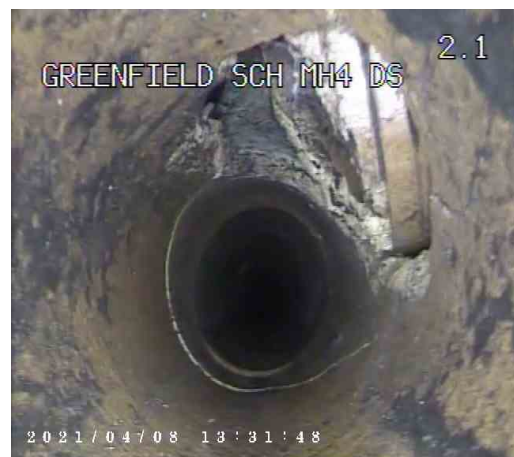
| Section | PLR | Grade | Description |
|---|---|---|---|
| 7 | MH4X | 4 | Hole in drain or sewer at joint at 12 o'clock |

MH4X\_888a0a1b-f5d6-4178-8084-9966d7f5f239\_20210409\_15543\_842.jpg, 00:00:27, 2.20 m  
Hole in drain or sewer at joint at 12 o'clock, Hole above connecting pipe.

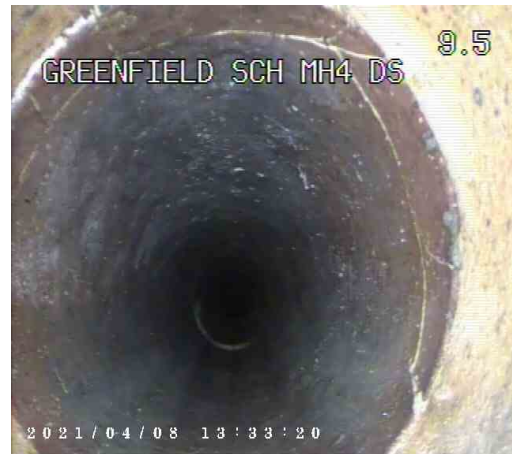
| Scale: 1:99 | Position [m] | Code | Observation | MPEG | Photo | Grade |
|---|---|---|---|---|---|---|
| | 8.90 | CC | Crack, circumferential from 12 o'clock to 12 o'clock | 00:01:54 | MH4X_739ae0a7-c8ac-4b7b-9 | 2 / 2 |

MH4X\_739ae0a7-c8ac-4b7b-9a3c-6cac798f8d48\_20210409\_115924\_634.jpg, 00:01:54, 8.90 m  
Crack, circumferential from 12 o'clock to 12 o'clock

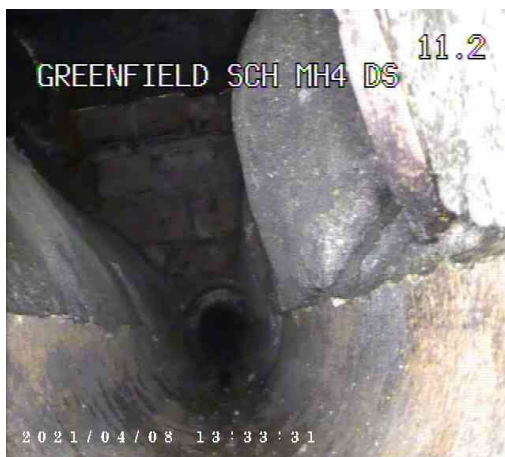
| Scale: 1:99 | Position [m] | Code | Observation | MPEG | Photo | Grade |
|---|---|---|---|---|---|---|
| | 9.70 | CCJ | Crack, circumferential at joint from 9 o'clock to 4 o'clock | 00:01:58 | MH4X_5489f68a-388c-47fa-81 | 2 / 2 |

MH4X\_5489f68a-388c-47fa-8197-1a58b960e300\_20210409\_115957\_561.jpg, 00:01:58, 9.70 m  
Crack, circumferential at joint from 9 o'clock to 4 o'clock

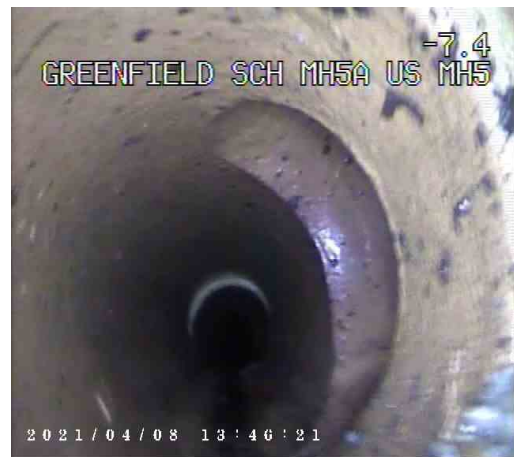
MH5X\_66ca5f3c-a5ba-4cae-84ed-91cc88a78fdc\_20210409\_120404\_401.jpg, 00:00:49, 7.00 m  
Joint displaced, medium

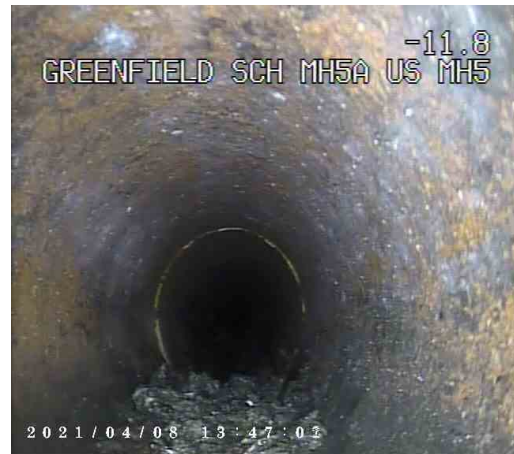
MH5X\_ed2a13a7-1ff5-4519-9d26-d6a8b7d03c89\_20210409\_121031\_657.jpg, 00:00:56, 8.00 m  
Joint displaced, medium

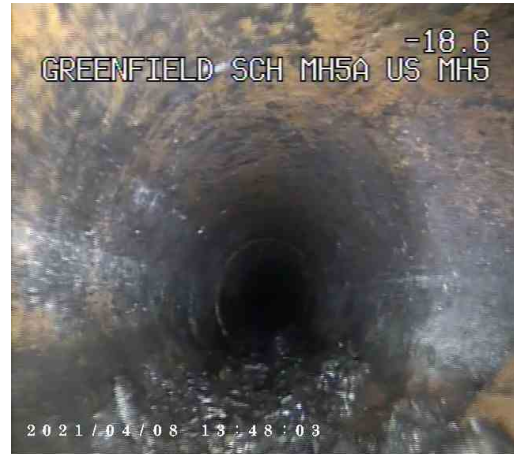
MH5X\_7f03486a-89f9-4ab3-bba0-de8f049f1135\_20210409\_1  
21840\_128.jpg, 00:02:21, 16.10 m  
Joint displaced, medium

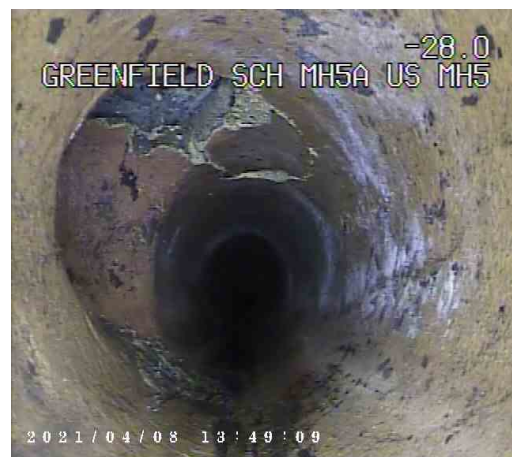
| Scale: | 1:237 | Position [m] | Code | Observation | MPEG | Photo | Grade |
|---|---|---|---|---|---|---|---|
| | | 27.80 | JXD | Junction, damaged at 9 o'clock, diameter: 100mm: cracks around junction and surface has broken away at roof of junction. | 00:03:40 | MH5X_3e<br>04c64e-b1<br>fe-4b77-90 | |

MH5X\_3e04c64e-b1fe-4b77-907c-be5f65923622\_20210409\_124842\_293.jpg, 00:03:40, 27.80 m  
Junction, damaged at 9 o'clock, diameter: 100mm, cracks around junction and surface has broken away at roof of junction.

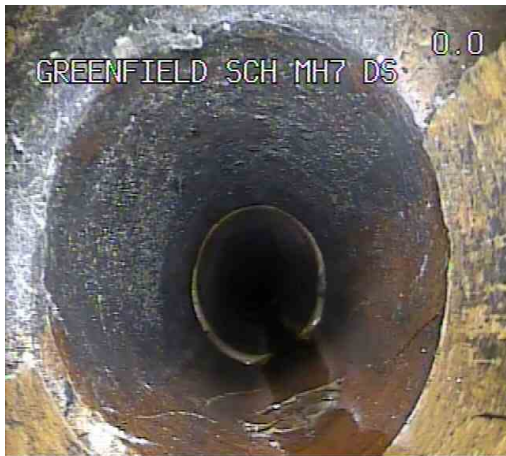
| Section | PLR | Grade | Description |
|---|---|---|---|
| 13 | MH7X | 3 | Cracks, multiple from 3 o'clock to 9 o'clock |

| Scale: 1:50 | Position [m] | Code | Observation | MPEG | Photo | Grade |
|---|---|---|---|---|---|---|
| | 0.00 | CM | Cracks, multiple from 3 o'clock to 9 o'clock | 00:00:00 | MH7X_b3<br>d17391-9a<br>c9-4437-a | 3 / 2 |

MH7X\_b3d17391-9ac9-4437-ad4c-0bd7297b8cd9\_20210409\_131057\_843.jpg, 00:00:00, 0.00 m  
Cracks, multiple from 3 o'clock to 9 o'clock

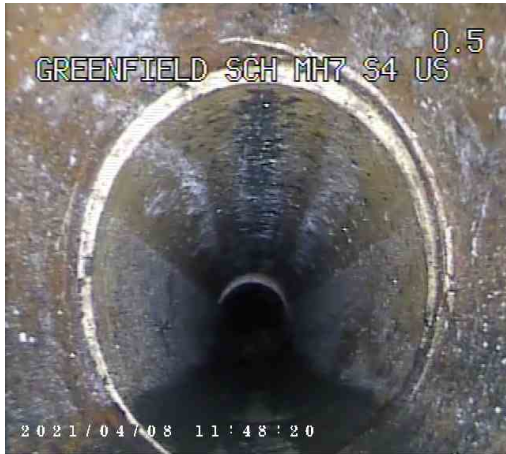
| Scale: 1:50 | Position [m] | Code | Observation | MPEG | Photo | Grade |
|---|---|---|---|---|---|---|
| 0.67 | CCJ | Crack, circumferential at joint from 12 o'clock to 12 o'clock | 00:00:05 | S4X_6331-30cf-93ca-4fc3-9c14- | 2 / 2 | |

S4X\_633130cf-93ca-4fc3-9c14-b2304613b7c7\_20210409\_13  
1515\_171.jpg, 00:00:05, 0.67 m  
Crack, circumferential at joint from 12 o'clock to 12 o'clock

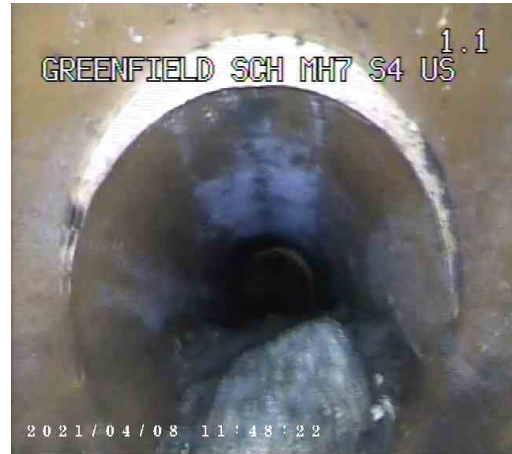
S4X\_5506ed63-ef6f-458f-85c2-470b96b1d029\_20210409\_13  
1550\_066.jpg, 00:00:08, 1.10 m  
Settled deposits, coarse, 10% cross-sectional area loss, start

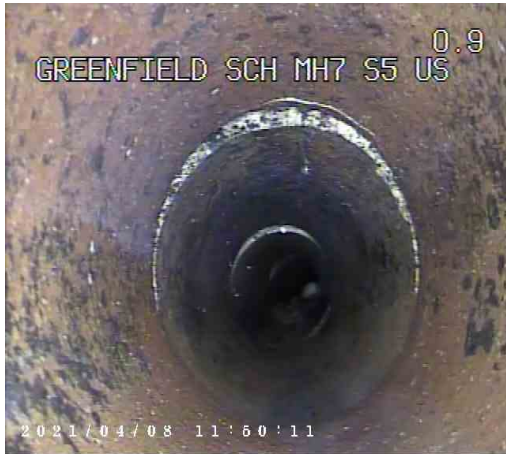
| Scale: 1:50 | Position [m] | Code | Observation | MPEG | Photo | Grade |
|---|---|---|---|---|---|---|
| | 0.90 | CCJ | Crack, circumferential at joint from 11 o'clock to 2 o'clock | 00:00:07 | S5X_1c40c8f5-375d-4011-b65b | 2 / 2 |

S5X\_1c40c8f5-375d-4011-b65b-048b5e0933bf\_20210409\_13  
2324\_234.jpg, 00:00:07, 0.90 m  
Crack, circumferential at joint from 11 o'clock to 2 o'clock

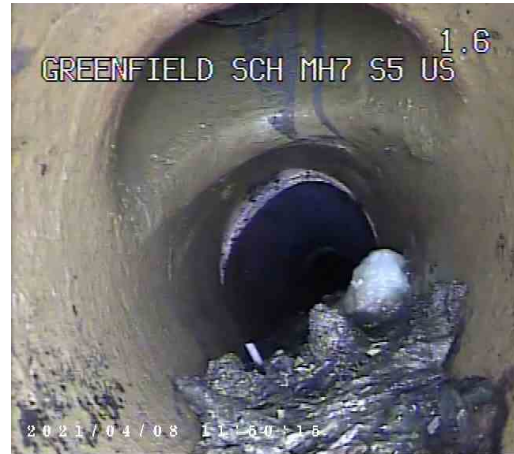
S5X\_990815f3-9e2d-435f-86be-476a1ba6b88a\_20210409\_13  
2429\_553.jpg, 00:00:11, 1.60 m  
Settled deposits, coarse, 10% cross-sectional area loss, start

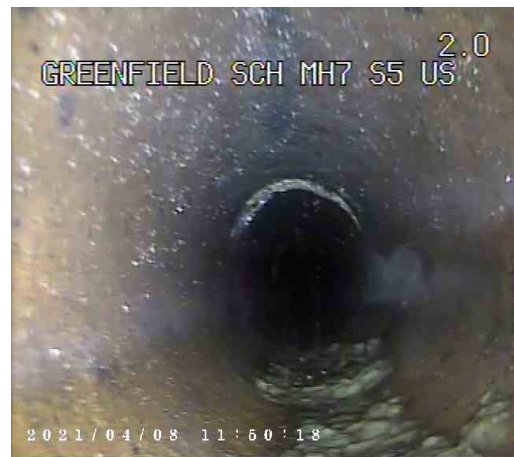
S5X\_2d45addb-b2ca-400e-8ee0-89f7a52ac2d0\_20210409\_1  
32450\_858.jpg, 00:00:13, 2.00 m  
Settled deposits, coarse, 10% cross-sectional area loss, finish

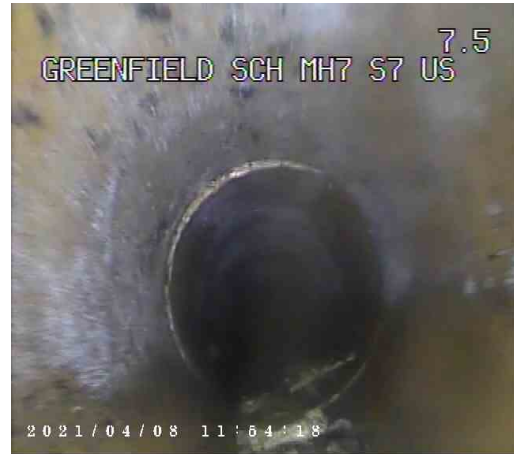
S7X\_95626faf-779e-457a-8c7d-22ee80fa5031\_20210409\_133340\_128.jpg, 00:00:30, 7.50 m  
Settled deposits, coarse, 5% cross-sectional area loss, start

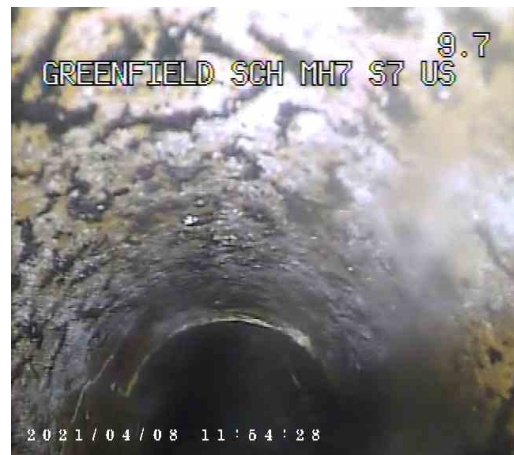
S7X\_86844c6d-d3c3-4dae-ae76-a470b62a408f\_20210409\_133525\_000.jpg, 00:00:39, 9.60 m  
Settled deposits, coarse, 5% cross-sectional area loss, start

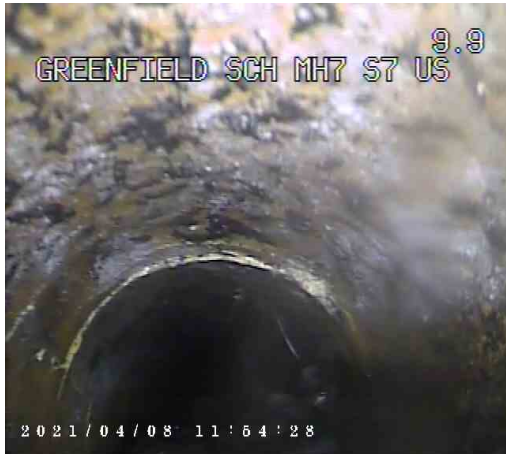
| Section | PLR | Grade | Description |
|---|---|---|---|
| 18 | S7X | 3 | Cracks, multiple at joint from 12 o'clock to 12 o'clock |

| Scale: 1:87 | Position [m] | Code | Observation | MPEG | Photo | Grade |
|---|---|---|---|---|---|---|
| | 10.00 | CMJ | Cracks, multiple at joint from 12 o'clock to 12 o'clock | 00:00:40 | S7X_31a2<br>0647-ef4e-<br>4f80-a3ed- | 3 / 2 |

S7X\_31a20647-ef4e-4f80-a3ed-62e373c3424a\_20210409\_13  
3520\_746.jpg, 00:00:40, 10.00 m  
Cracks, multiple at joint from 12 o'clock to 12 o'clock

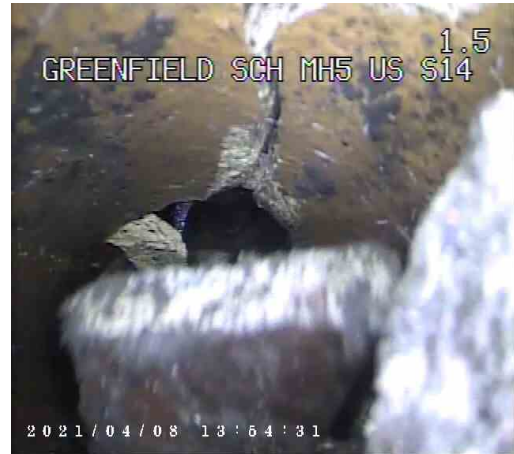
| Section | PLR | Grade | Description |
|---|---|---|---|
| 23 | S14X | 4 | Hole in drain or sewer from 11 o'clock to 1 o'clock |

S14X\_8eb29e50-fc94-4eee-95f4-6c47882edeb4\_20210409\_151906\_833.jpg, 00:00:17, 1.70 m  
Hole in drain or sewer from 11 o'clock to 1 o'clock

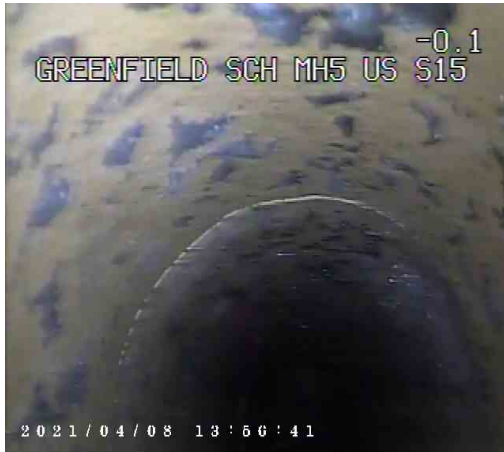
| Section | PLR | Grade | Description |
|---|---|---|---|
| 24 | S15X | 2 | Crack, circumferential from 9 o'clock to 2 o'clock |

| Scale: 1:50 | Position [m] | Code | Observation | MPEG | Photo | Grade |
|---|---|---|---|---|---|---|
| | 0.30 | CC | Crack, circumferential from 9 o'clock to 2 o'clock | 00:00:11 | S15X_c11<br>3b6bd-6e6<br>c-495a-98 | 2 / 2 |

S15X\_c113b6bd-6e6c-495a-9882-878ab48ba0b2\_20210409\_152006\_206.jpg, 00:00:11, 0.30 m  
Crack, circumferential from 9 o'clock to 2 o'clock
