Primrose Hill, Merthyr Tydfil

RECORD OF BUILDING AND CONDITION ASSESSMENT REPORT, WITH REPAIR PROPOSALS

.....(449)2503-GVWP-A-HIS-P01

Date: 05.03.25

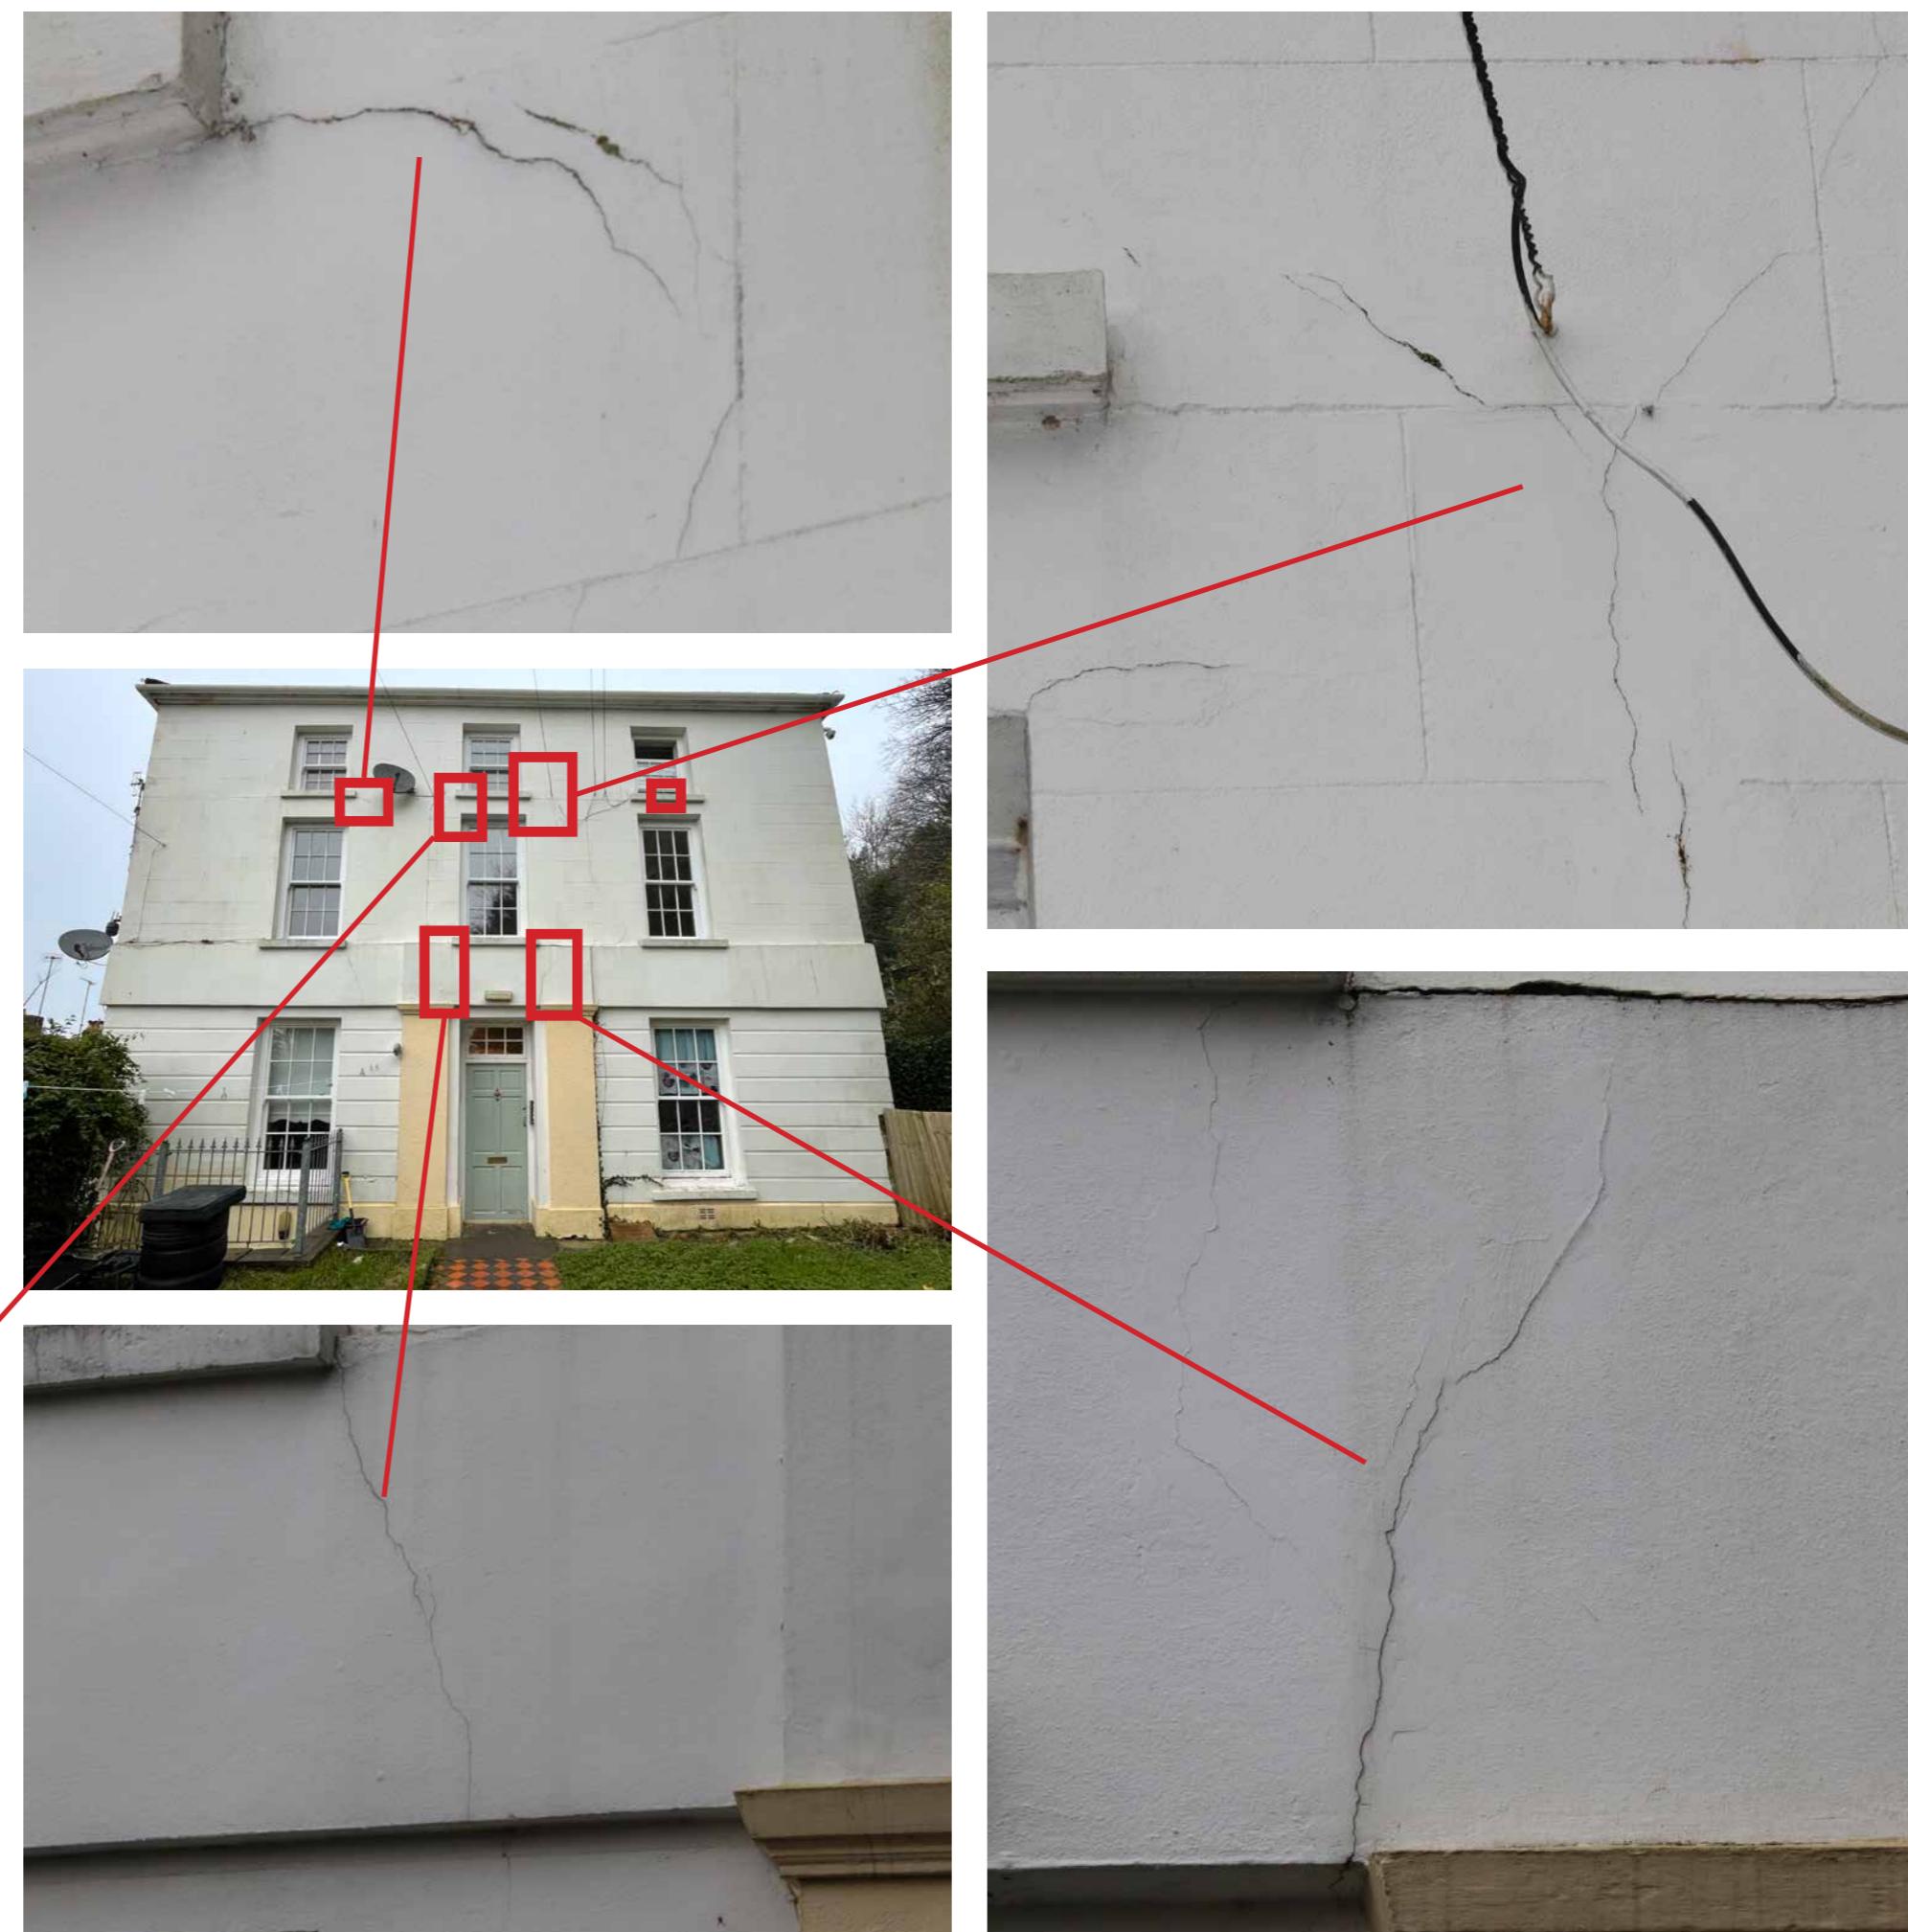
2.1 Front Elevation - Cementitious Render

The front elevation has been applied with a cementitious render, sometimes known as 'stucco'. To the upper two floors, the render has been incised to emulate coursed finished stone. Below the flat deep band underneath the first floor window cills, the render has been rusticated. The substrate behind the render (i.e. the masonry with which the walls were built) appears to be red brick (as suggested by the one view in the bottom right photo on the next page); however, there could also be stone. Given the age of the building, this render would initially have been a lime and sand render, not cementitious.

Clearly apparent across the elevation are cracks in the render - see photos on this page and the next page. This is a problematic issue. Traditional buildings made of solid masonry walls are designed to be slightly flexible. Lime mortar and render provides that flexibility, which allows the walls to expand and contract nominally without cracking. Cement render is not flexible, and so any expansion or contraction in the walls cannot be absorbed by the coating. The result is often the appearance of cracks within the cement render. Once cracks occur, water enters the wall through the cracks, and is held between the render and the masonry. Lime render is vapour-permeable, whilst cement render is impermeable. So, if the render was lime, not only would there be many fewer, if any, cracks; but also the moisture absorbed into the wall fabric would be drawn out of the wall (hygroscopically) through the joints and render, would sit on the surface of the wall, and be evaporated by the sun and wind. With cement render, it is not possible for the moisture to escape through the coating, and hence to evaporate on the surface. As such, a cement rendered wall, once cracks occur, holds onto the moisture. This can result in various defects – the breaking down of the masonry itself; the widening of cracks (as moisture held, freezes and expands); saturation of the masonry, which could cause damp or mould internally (especially if the internal plaster is gypsum, not lime, as it is here); saturation of timber in contact with the masonry, which could cause mould, rot or infestation; and a generally unhealthy building.

A quick response would be to repair the cracks; but this would not address the problems. More cracks will appear in time, and more water will get behind the render. In addition to this, we are aware of significant issues with water ingress to the fabric causing problematic mould growth to the internal face of the walls. The walls are, of course, not insulated (which they cannot be, being solid masonry); however, damp walls perform very badly as insulators, whilst dry walls are good insulators. The most important thing for the building is to dry out the walls and ensure they do not, again, become saturated. The only way to do this is to remove the water ingress causes (i.e. cracks in render, poor rainwater goods, lack in internal ventilation and heating) and then to ensure that the walls are vapour-permeable from both the outside face and the inside face.

To that end, we recommend very carefully hacking off the cementitious render to the external face (as well as the cementitious / gypsum plaster to the internal face), allowing as long a time as possible for the external walls to dry out, by exposing both external and internal faces of the masonry to evaporation), and then re-applying a 3-coat lime render to the outside face of the walls (and a 3-coat lime plaster to the inside faces). The external render will need to be smooth-finished with the top coat, rusticated at ground floor and incised at upper floors, to emulate coursed finished stone, to match the design of the existing stucco.

Trying to remove cementitious render, which usually bonds extremely well to masonry, can cause damage to the stone. However, sometimes it can be removed fairly easily with little damage; with the work in the right hands. This is a risk; however, given the damp condition internally, this may be a risk which needs to be taken.

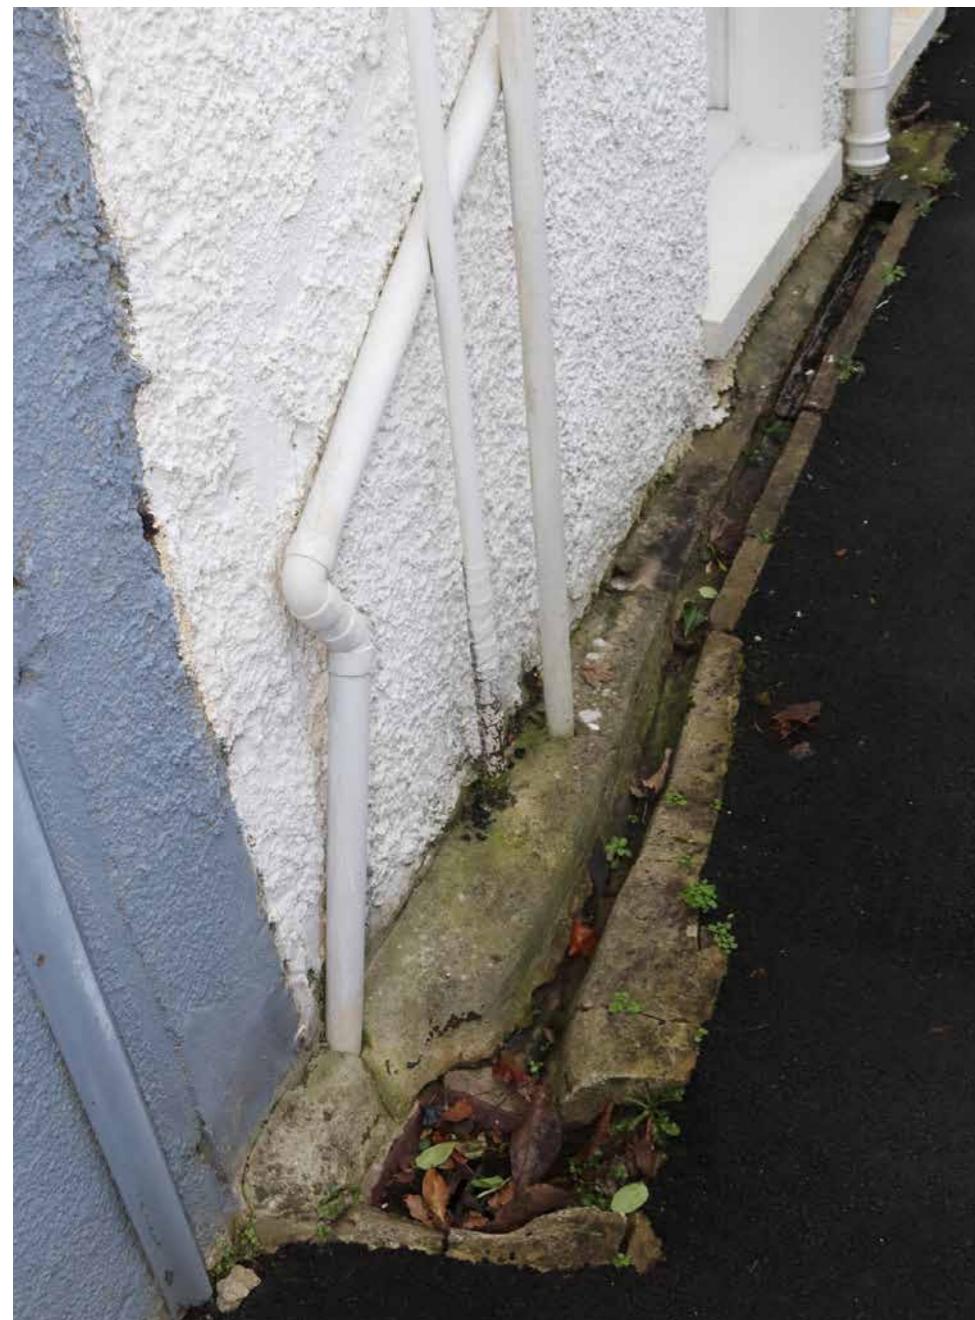
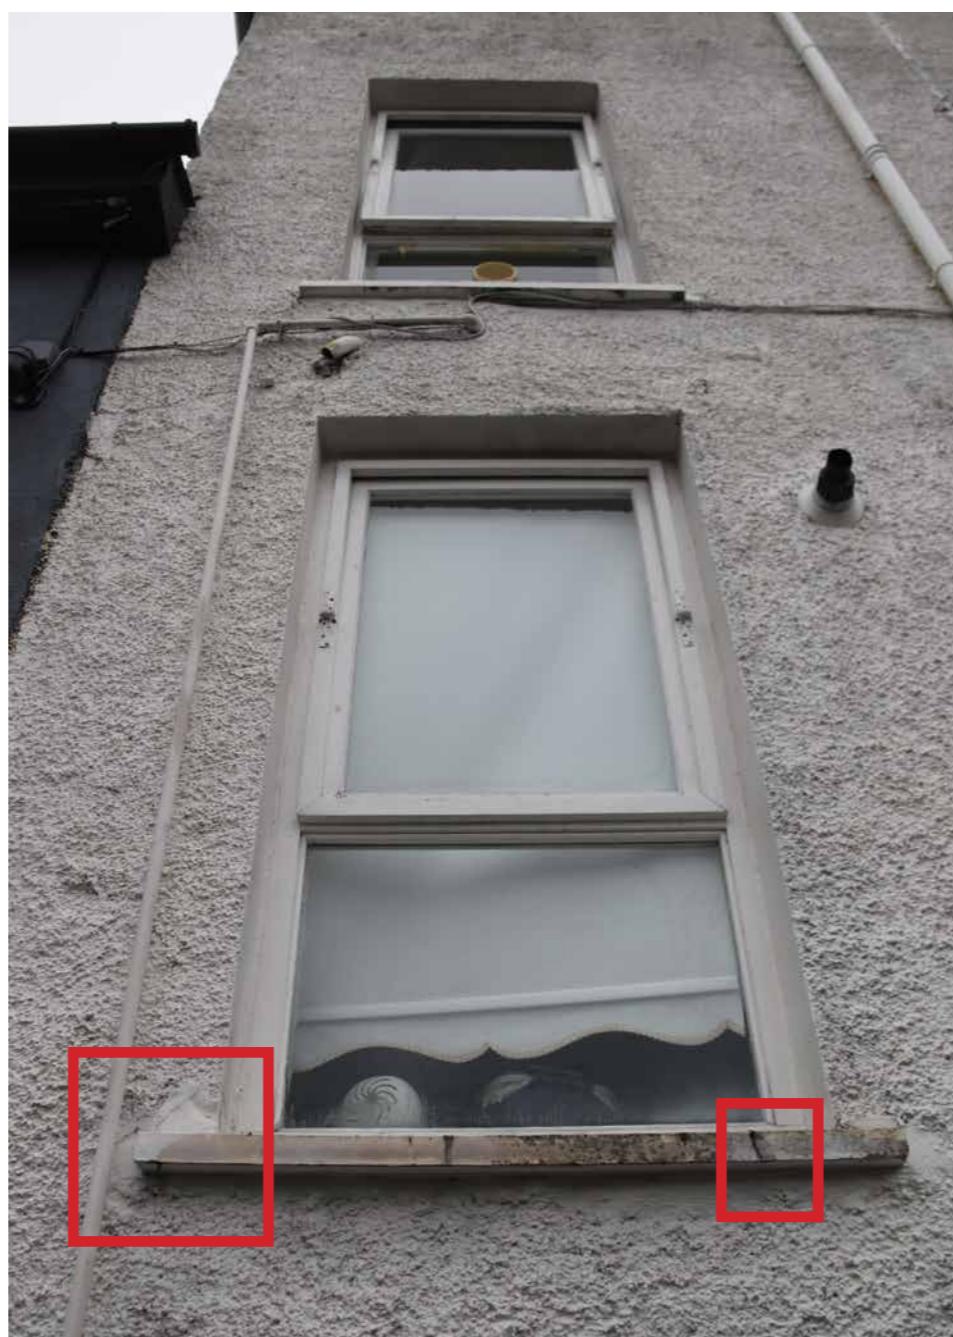
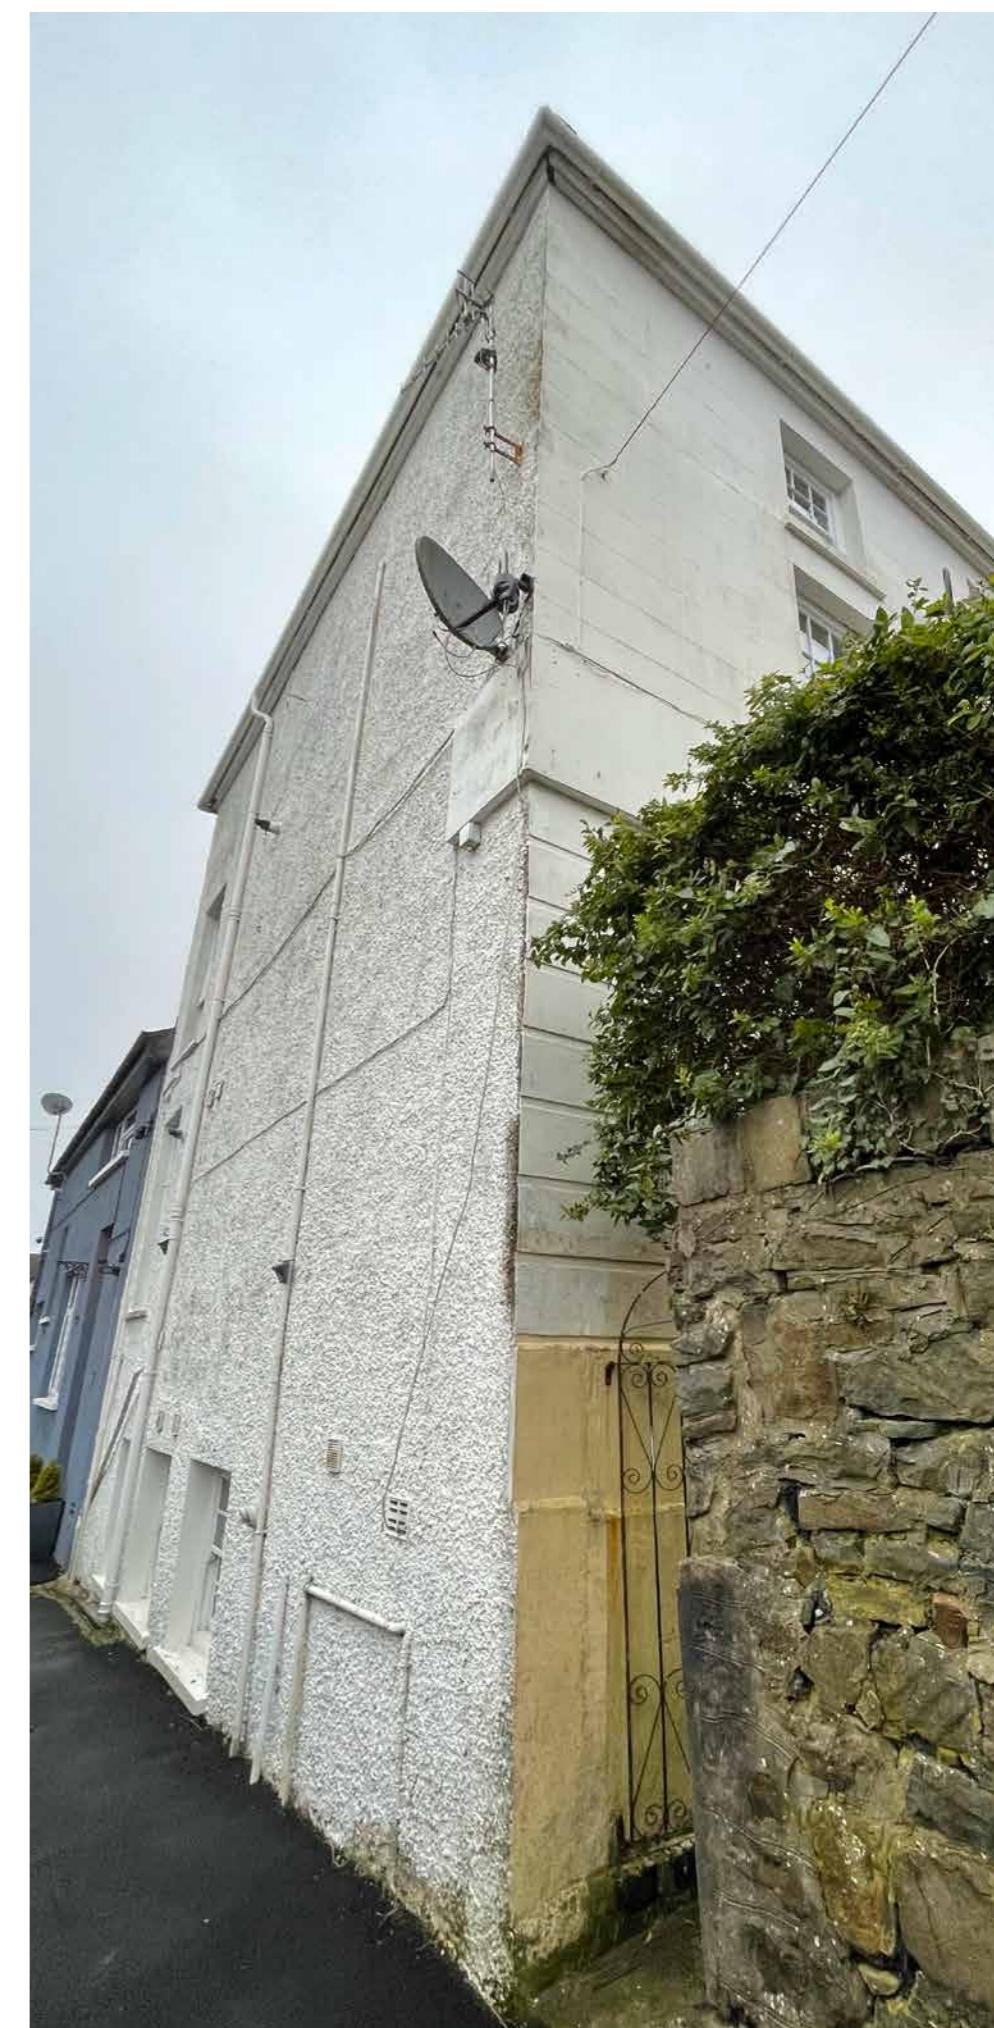
3.0 Side (West) Elevation

The 3no. 6-over-6 timber sash windows at the base of this elevation, and the 2no. central-pivoted windows down the side, at ground and first floor, are all timber windows, painted off-white. The panes to all 5no. windows are single-glazed. In the main, they appear to be in a reasonable condition, some having recently been re-painted; however, the timber cill to the middle low window has suffered from water ingress and is showing signs of loss of body. This should be rubbed back and, if any of the wood is soft, or 'gives' to the penetration of a sharp object, then the soft central should be cut out and a new section of timber spliced in, and the cill painted.

It is also proposed that the glazing to all 5no. of these windows are replaced with 'Slimline' double-glazed units with white spacers.

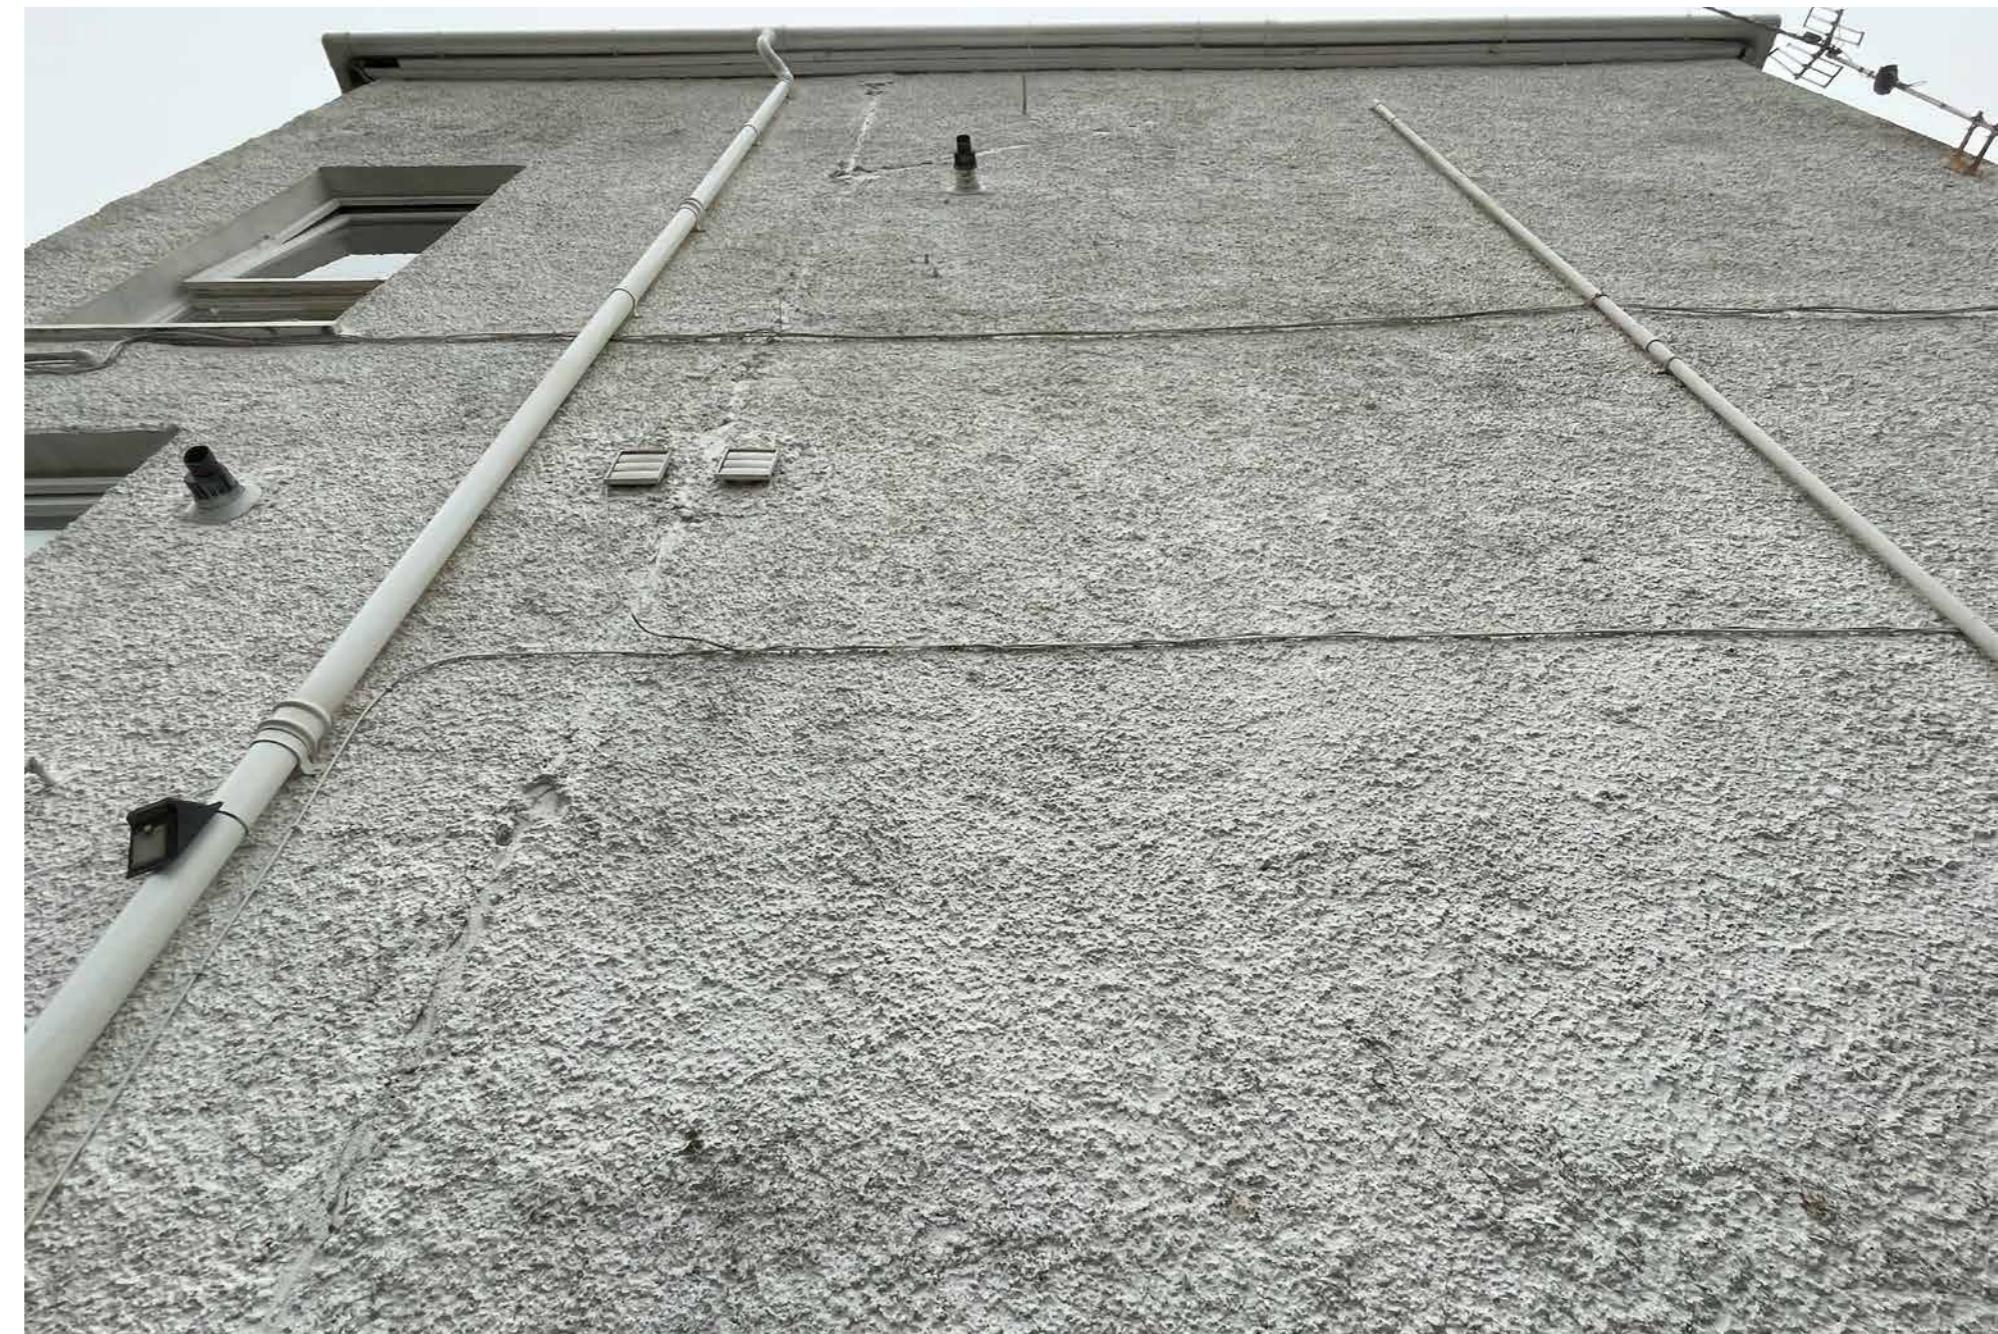
4.0 Side (East) Elevation

To this side elevation, the render is also roughcast; however, here it is a mixture of off-white and light grey with dark grey and green environmental and organic staining. It is not known whether this is a cementitious; however, it is assumed to be. This elevation comprises a number of soil drainage pipes, surface water drainage pipes and condensate pipes. It is assumed that, over time, leaks from one of more of these pipes has stained the render. It is also of concern that the rainwater pipe spills out onto concrete, which then runs into a gully. This means that the water splashes off the concrete and probably splashed back onto the wall.

We recommend that the internal plaster is removed and the masonry investigated from inside. This may remove the need to expose the masonry from the outside; however, it may not. So, for now, we also recommend that the render is also removed from the outside face and, once the wall has dried out, and any defects in the masonry addressed, then the walls should be re-rendered with a roughcast lime render. We also propose that the drain is provided with a shoe which dresses into the gully cover to stop the chance of splashback.

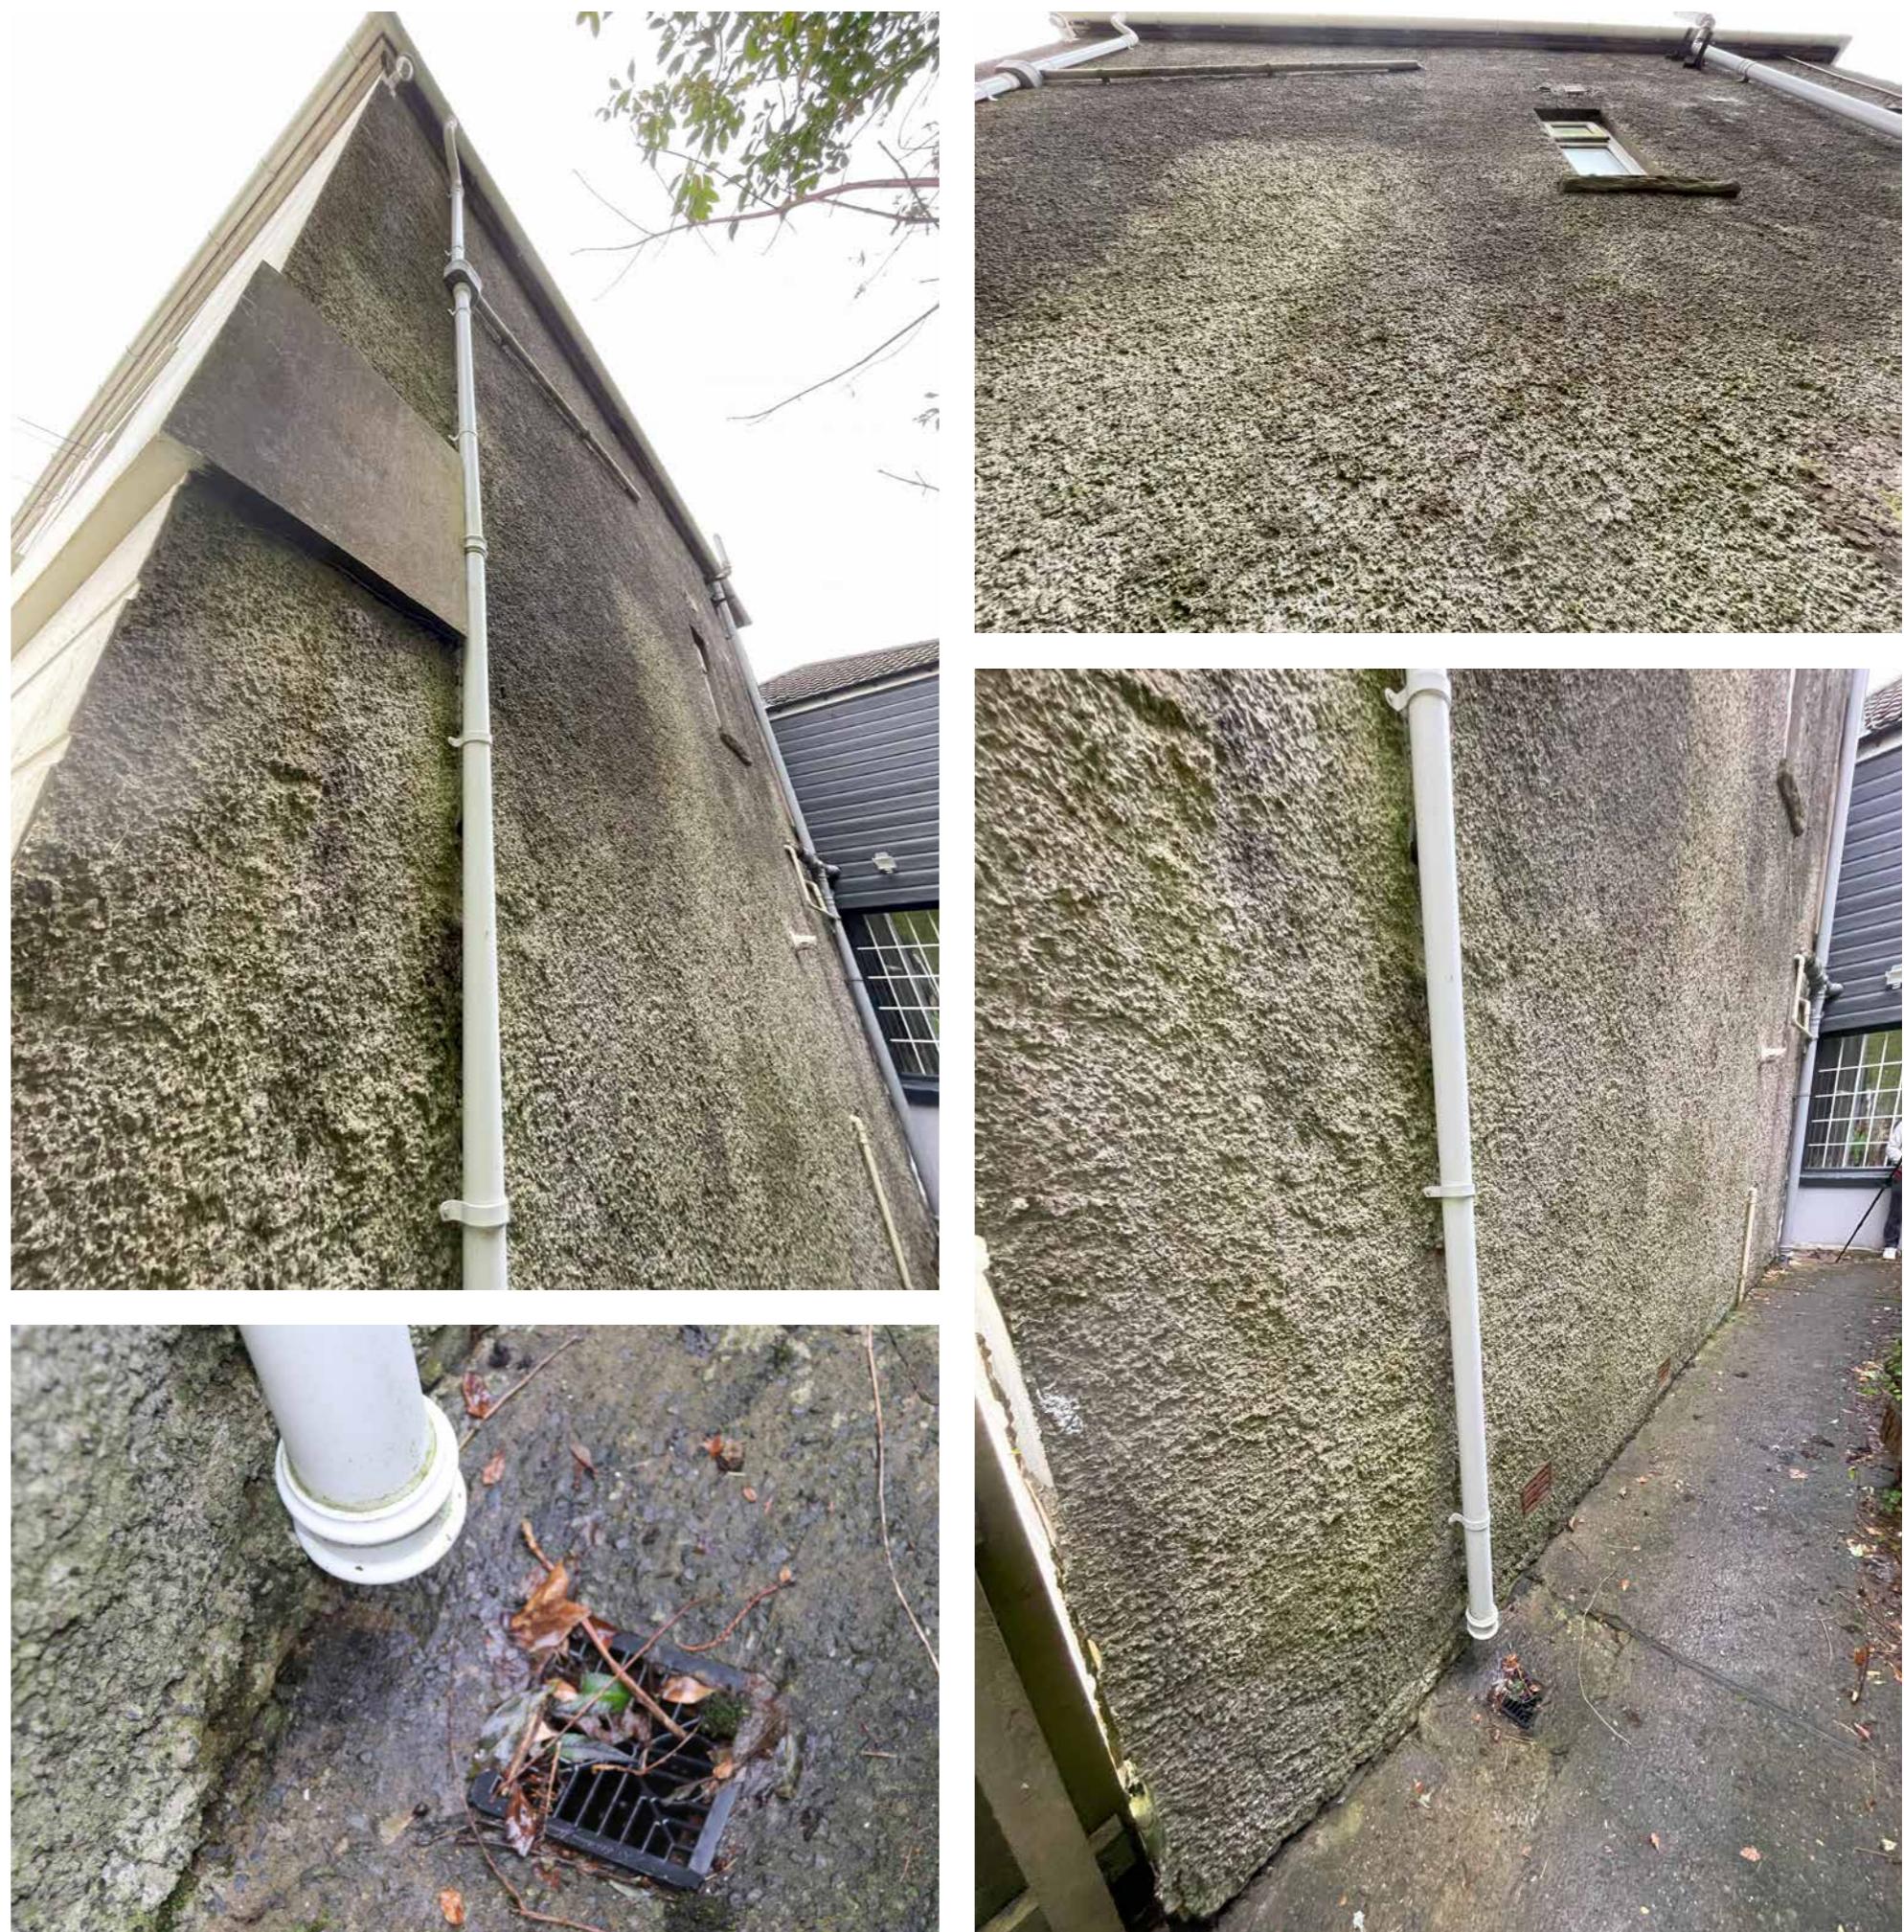
4.0 Side (East) Elevation

The 3no. windows on this elevation are timber-framed and all incorporate double-glazed panes. There is a sash window to the ground floor and two part-top-hung casements part-fixed windows to the first floor. All would benefit from a light rub back and re-coat.

It is recommended that all joints in all pipework is checked and any issues with either pipes or joints addressed.

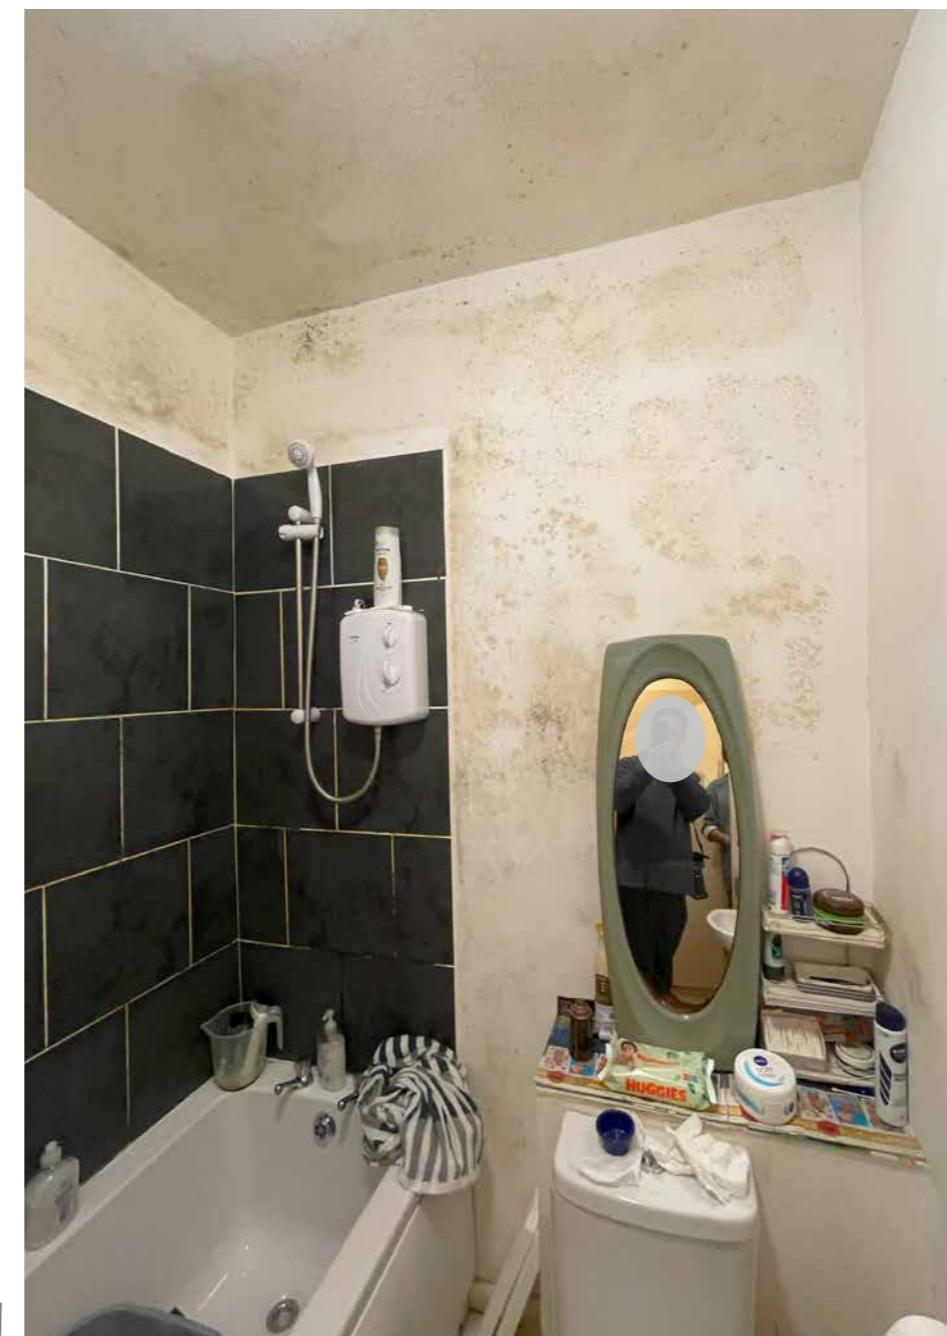
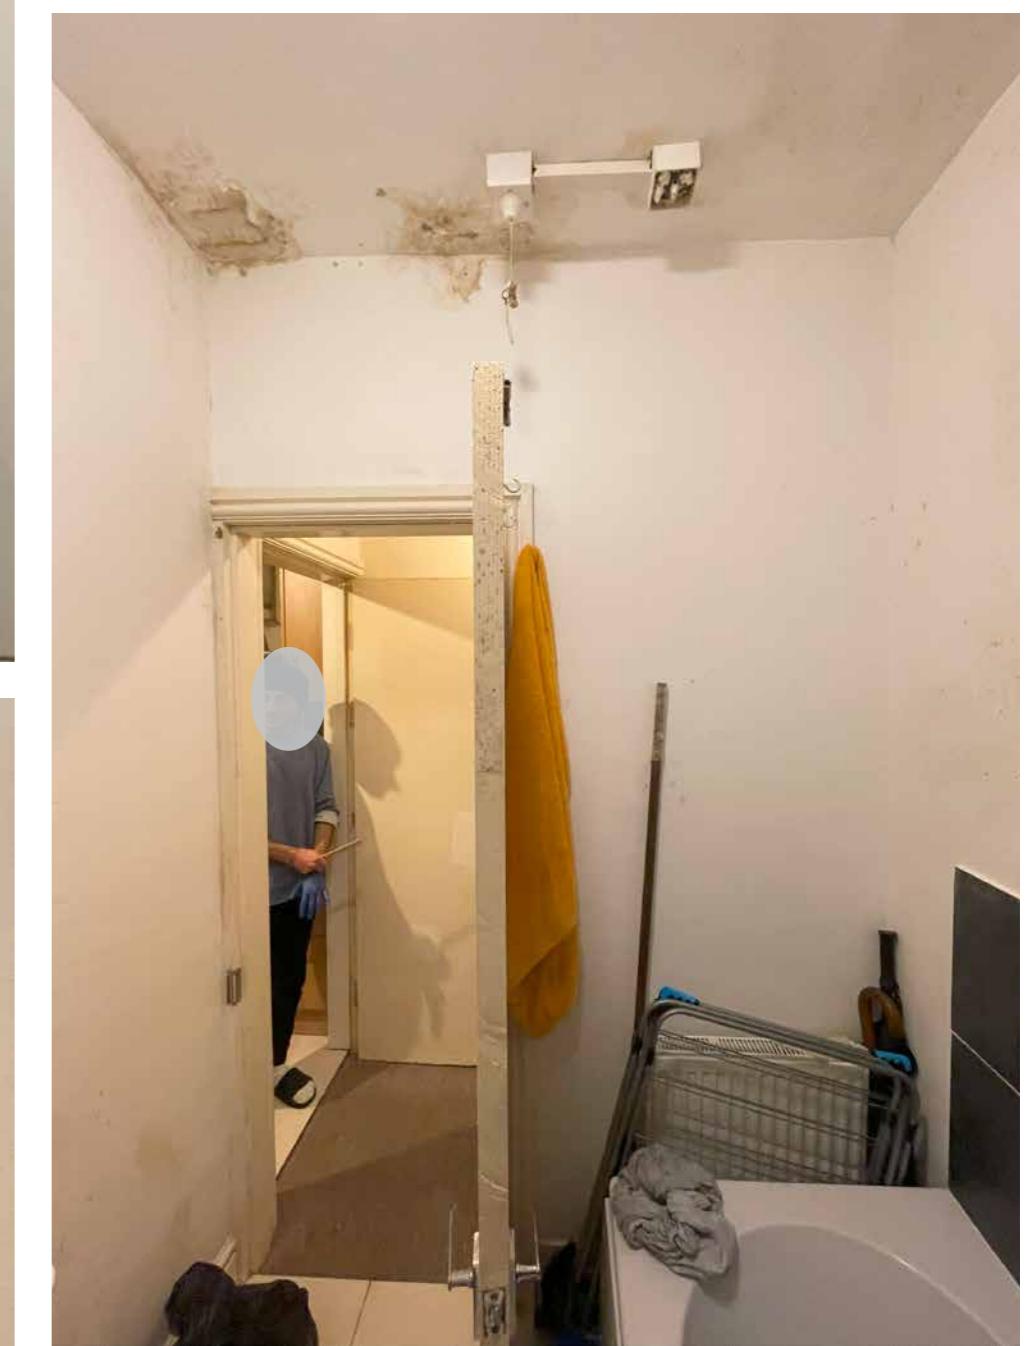
10.0 Interior - Ground Floor - East Flat Lobby

There is no obvious sign of significant staining and mould on the plastered walls to the lobby; however, it is very bad at the plastered ceiling. There is no means of ventilation in this space (which collects moisture from the bathroom, kitchen and bedroom) and no apparent means of heating. As a result condensation is not controlled.

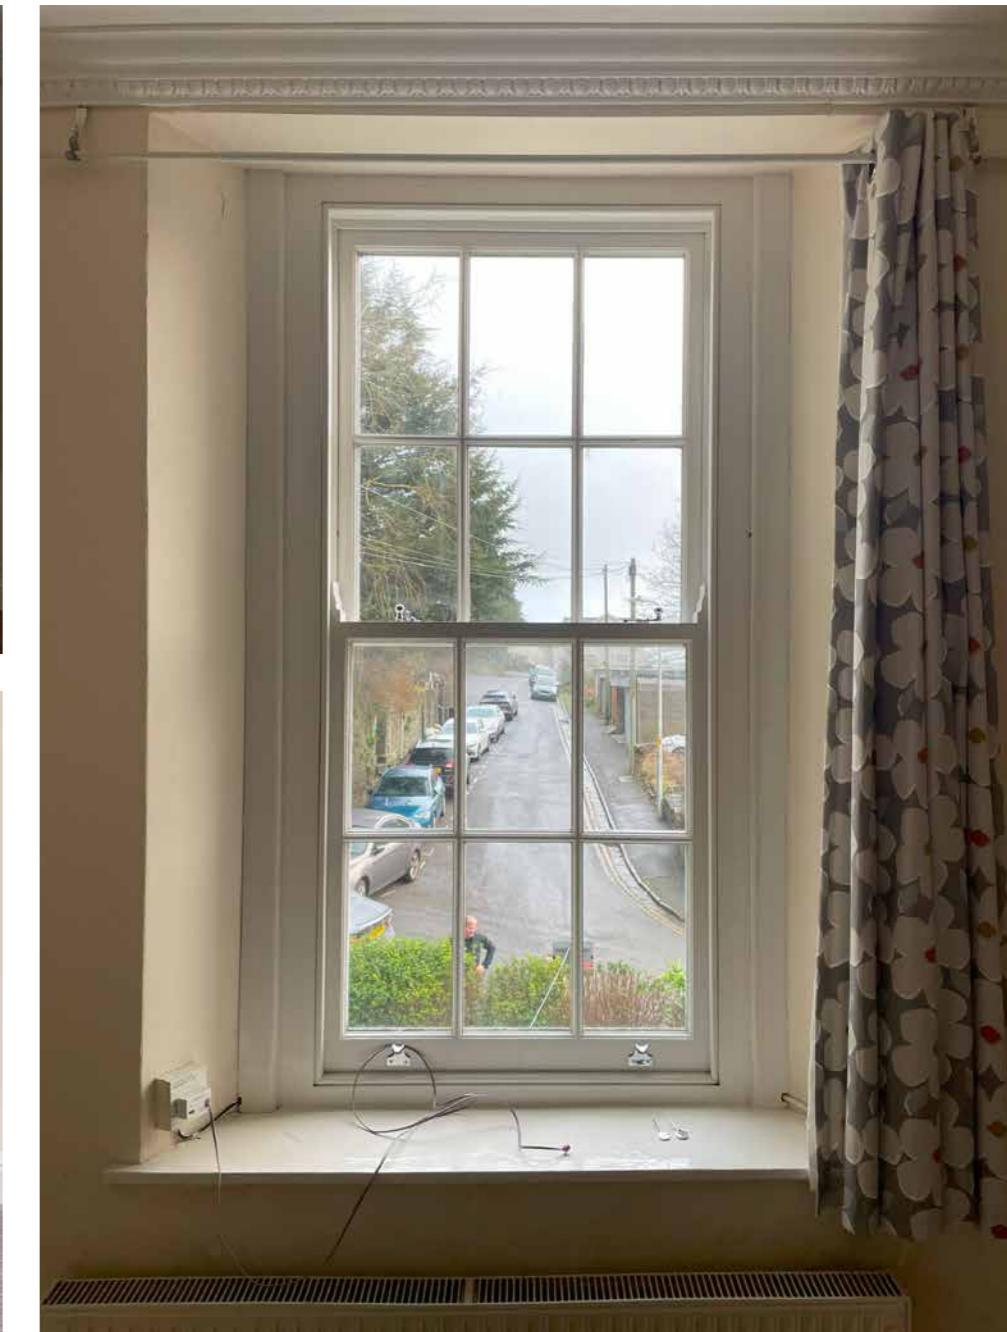
11.0 Interior - First Floor - Central Room

There is water-staining, dampness, spalled plaster and crystallised salts on the external front wall to the left of the window (see photo below). There is a significant amount of cracking render on the outside just above this point. This might explain how the inside face of the wall is damp - water has been getting behind the render, cannot evaporate externally and so is finding its way to the inside face of the wall, and drying, leaving salt crystals. The plaster needs removal and a new lime plaster applied.
