Primrose Hill, Merthyr Tydfil

RECORD OF BUILDING AND CONDITION ASSESSMENT REPORT, WITH REPAIR PROPOSALS

.....(449)2503-GVWP-A-HIS-P01

Date: 05.03.25

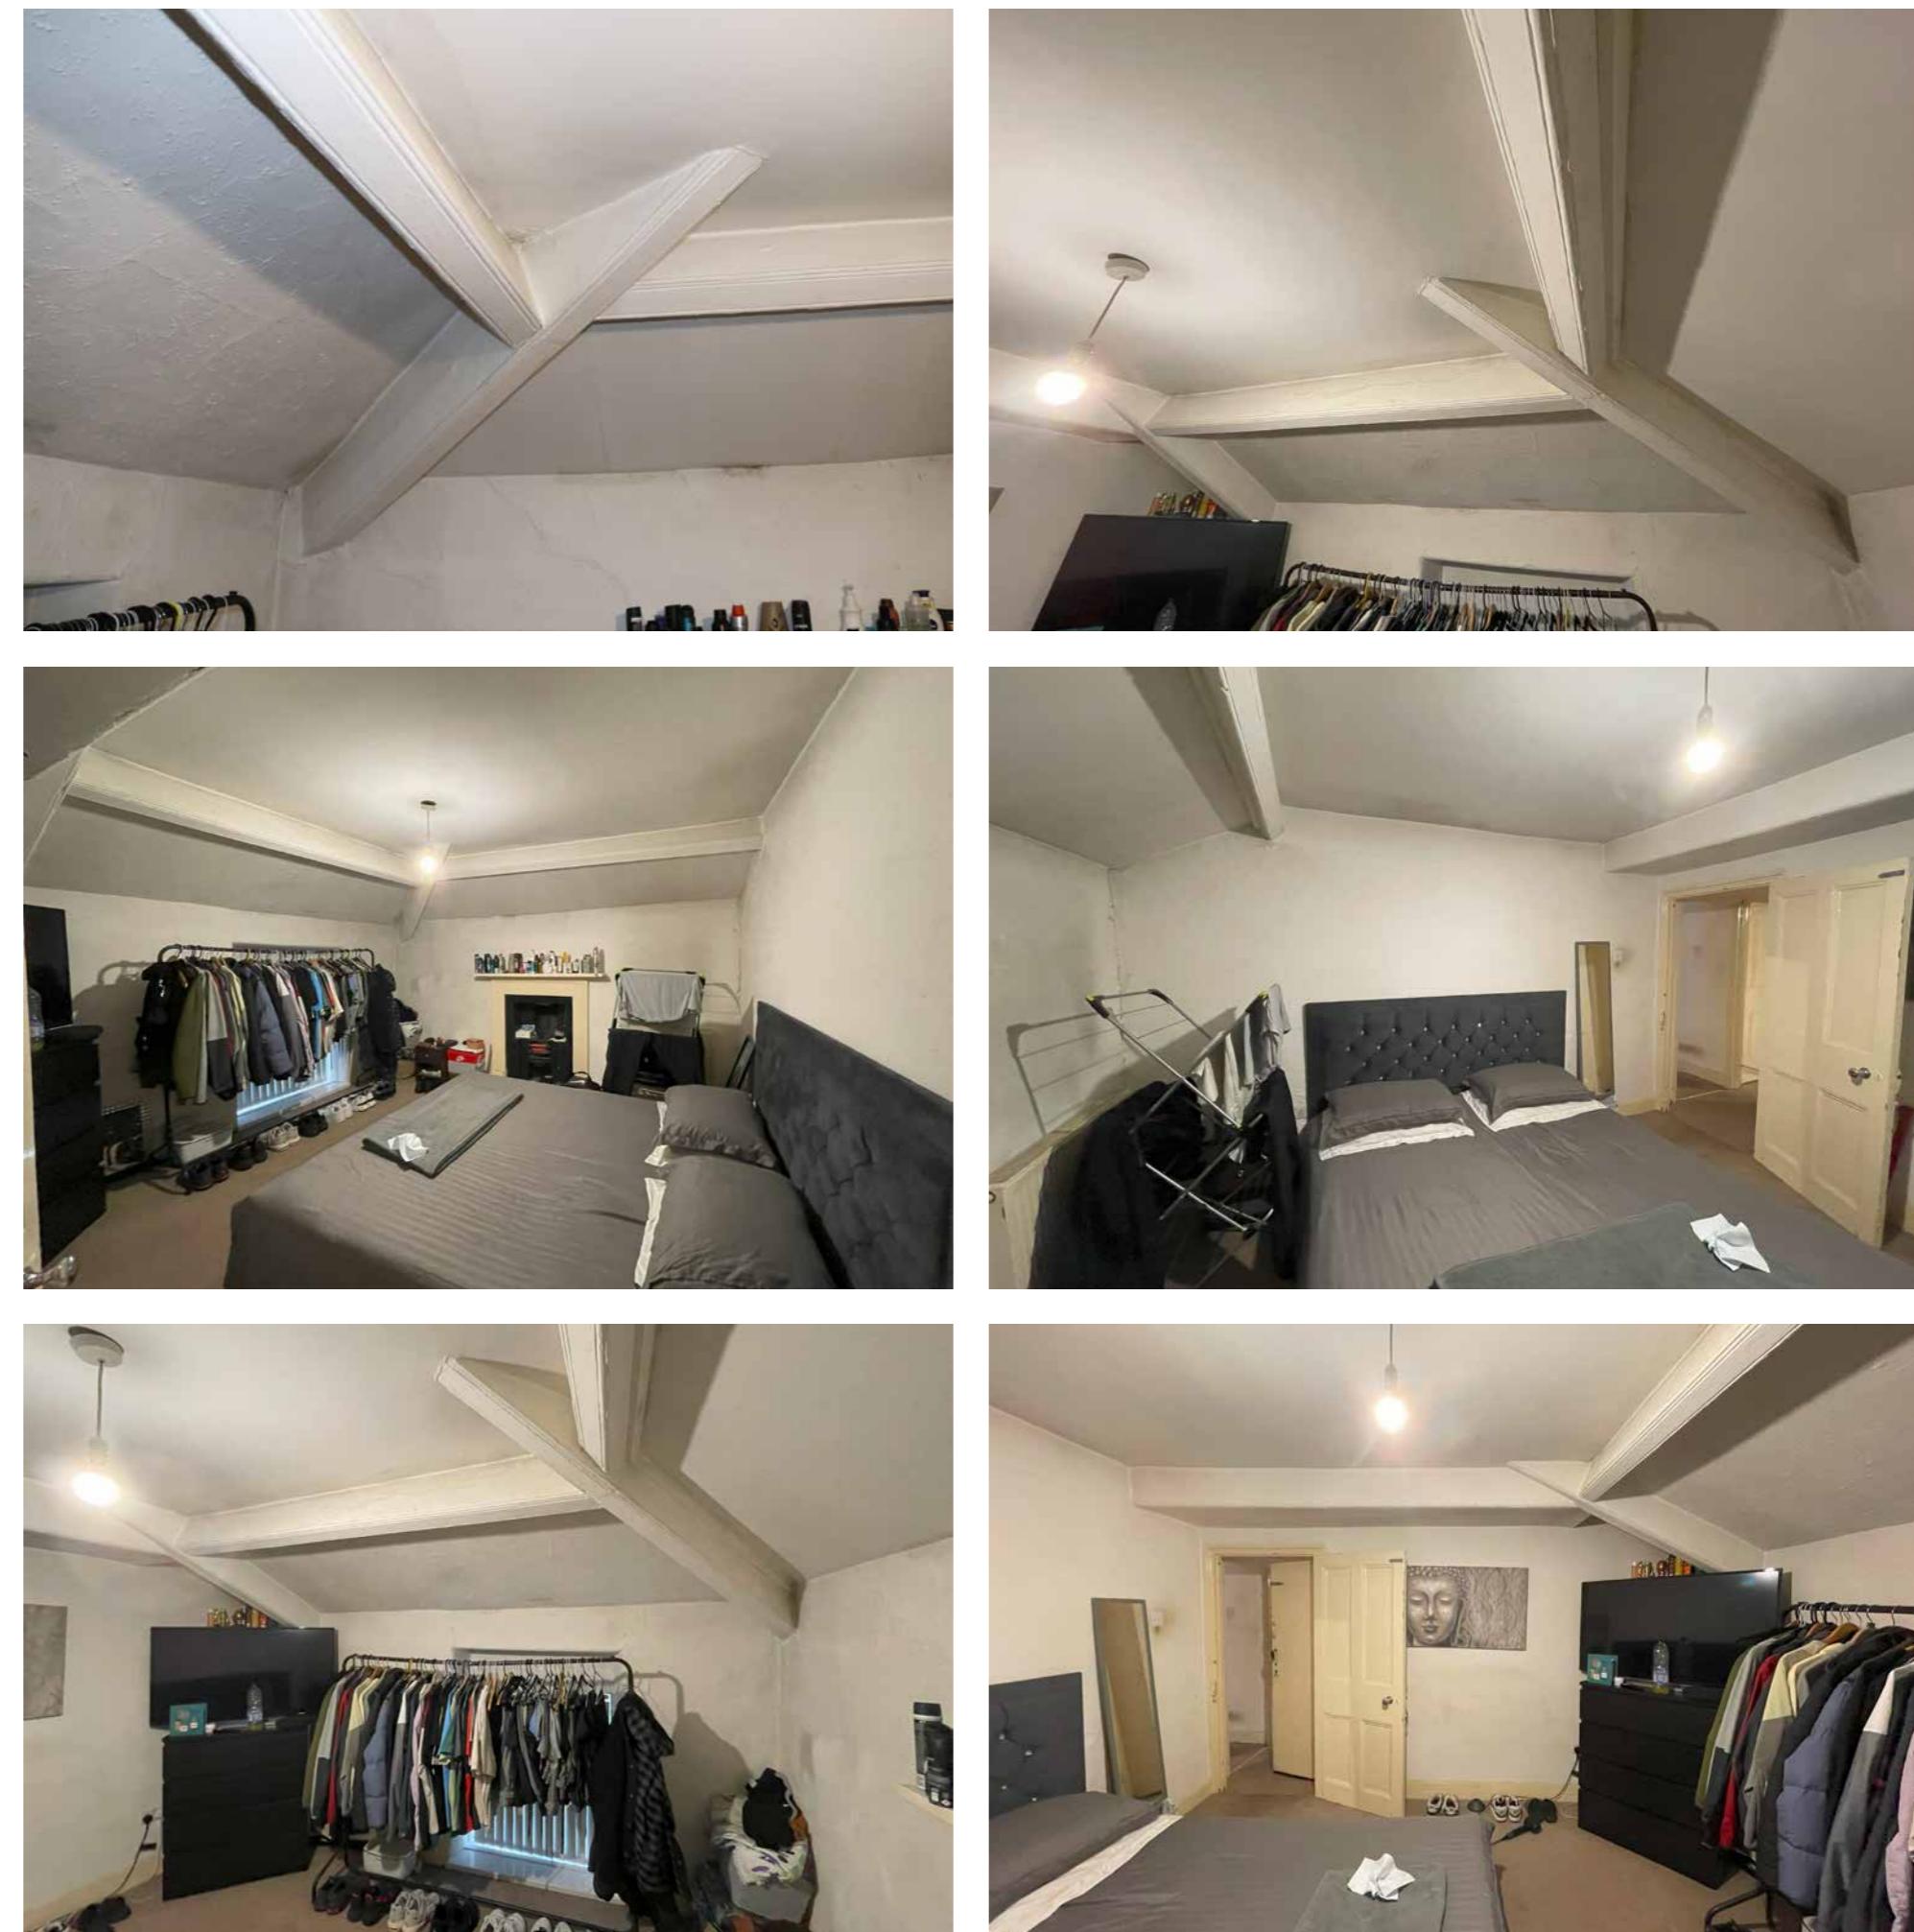
12.0 Interior - Second Floor - Rear North West Room

There is some staining on the walls and ceiling; and there appears to have been some areas of crack repair, fairly recently, to some of the plasterwork on the walls. The worst area of staining is to the external north west corner. This will require the plaster to be removed to see what is causing this.

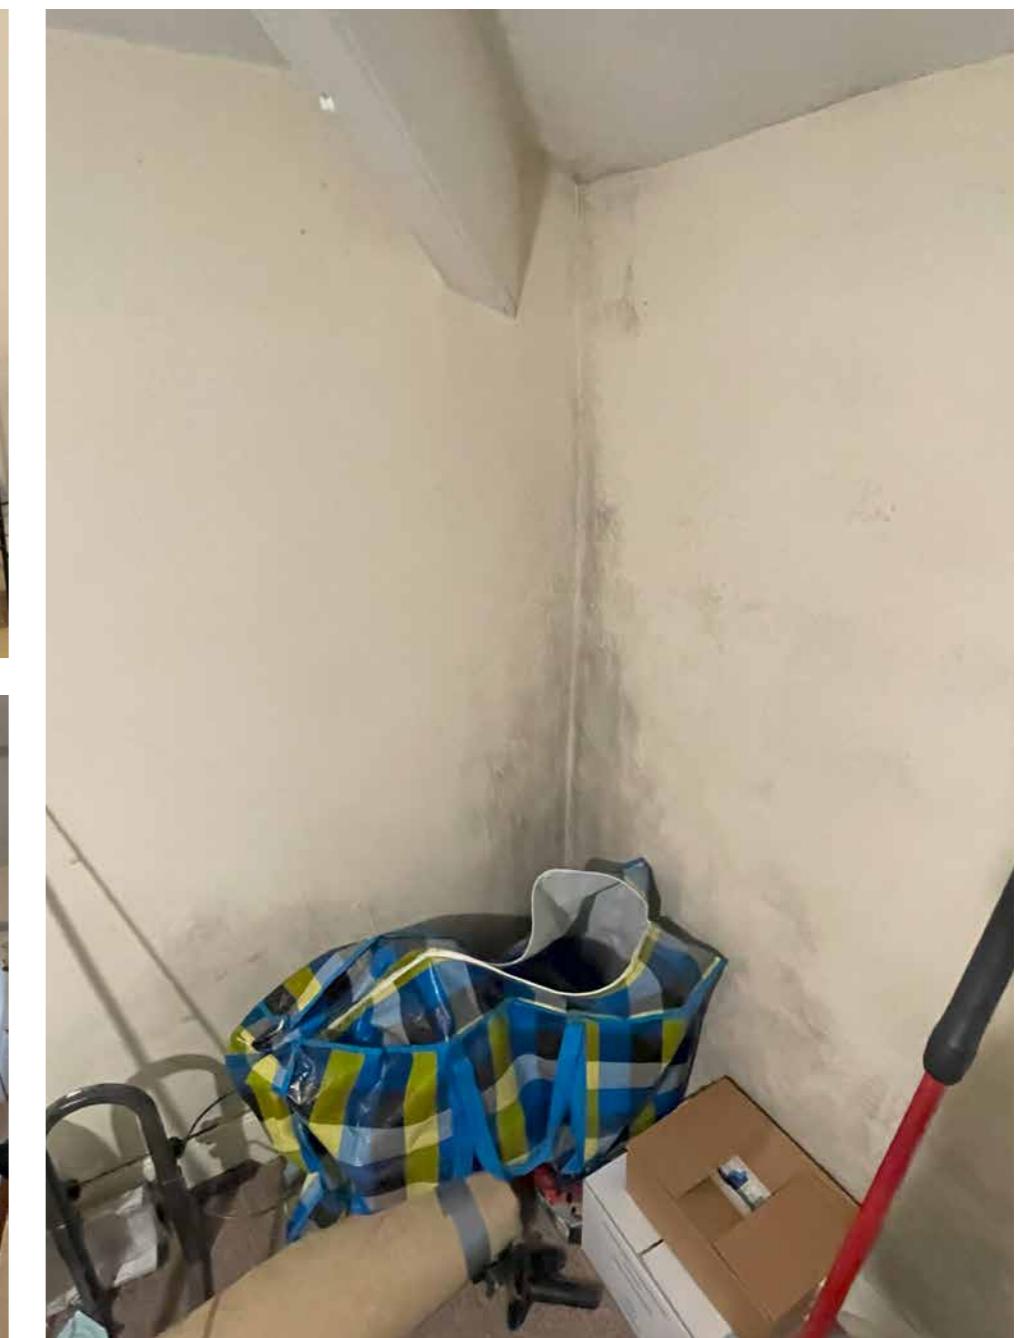
12.0 Interior - Second Floor - Bathroom

There is mould on one part of an internal wall; however, this is likely to be a case of moisture build-up and insufficient ventilation.

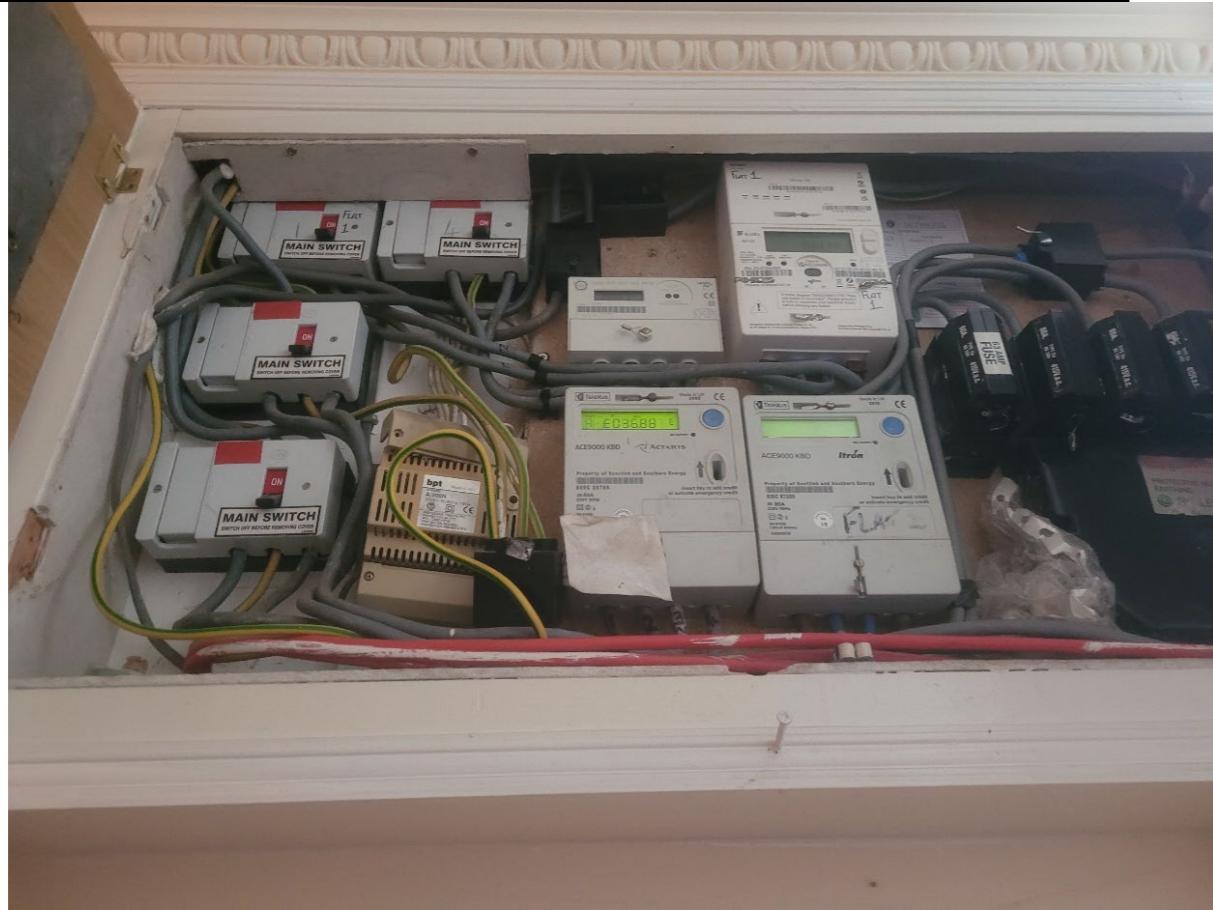
The electrical supply is a 60 Ampere three phase 4-wire TN-S 400/230-volt 50Hz. PME (TN-C-S) and although installed in an untidy ad-hoc method there are no visual signs of any thermal damage or stress to the conductors.
