# Synagogue, Merthyr Tydfil

## RECORD OF BUILDING AND CONDITION ASSESSMENT REPORT

.....  
(449)2503-GWP-A-HIS-P00

Date: 17.03.25

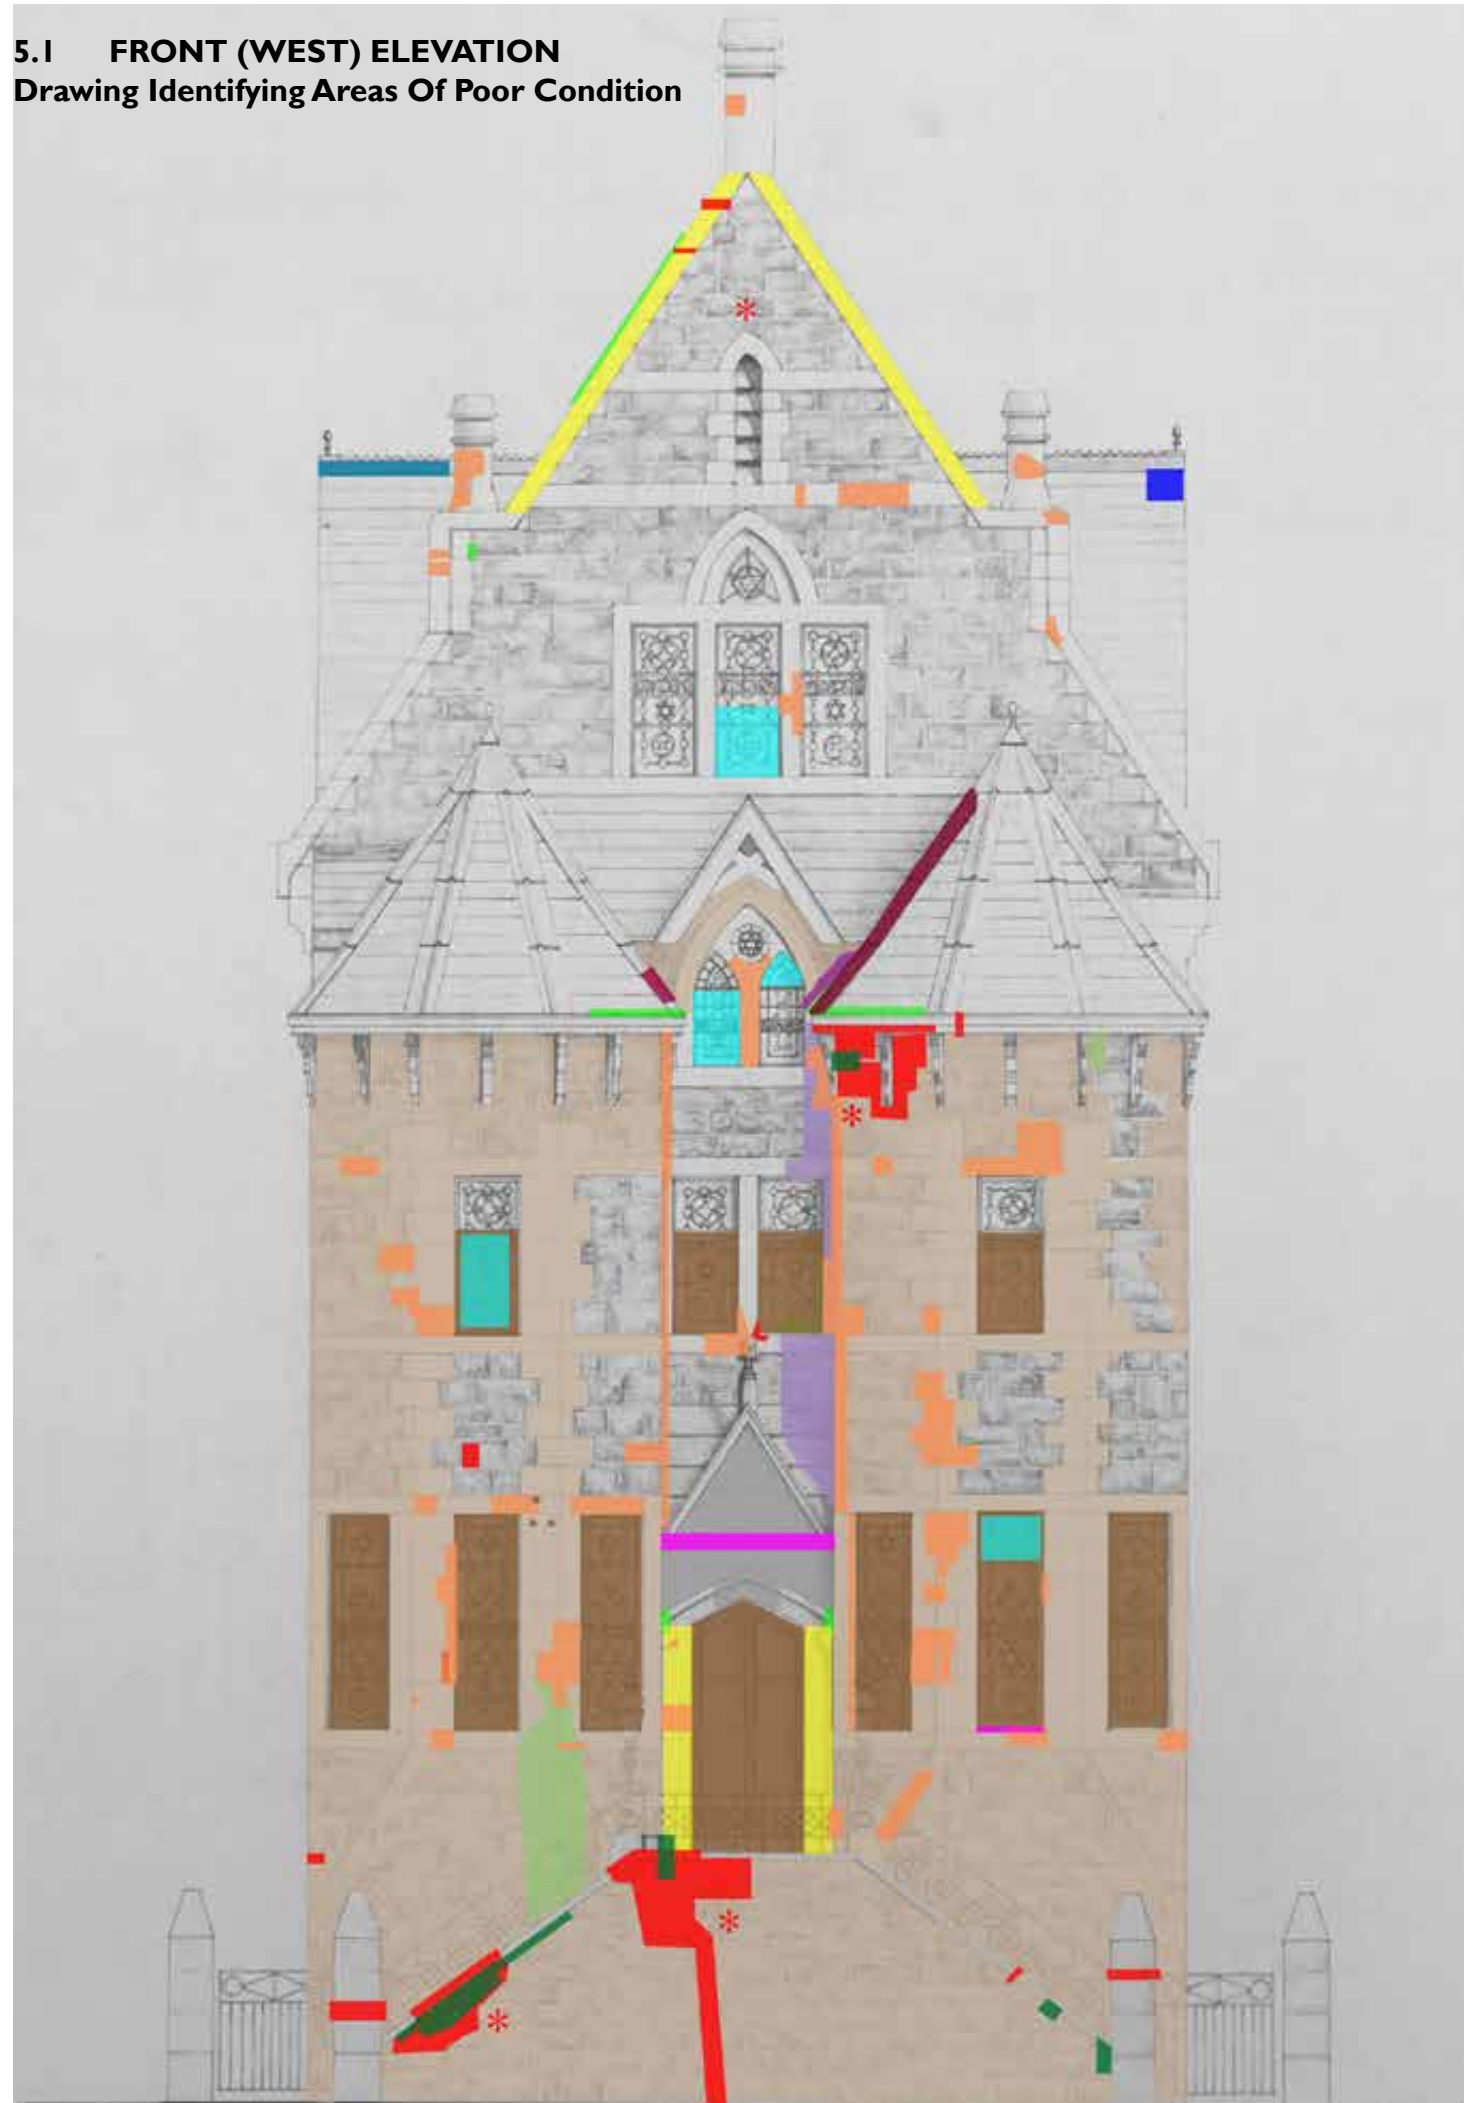
## 5.1 FRONT (WEST) ELEVATION

It is, however, apparent that the top section of the stone gable wall to the front elevation, within the upper half of the roof and above into the finial, is leaning quite considerably into the building. Some of the mortar joints at the top of the wall and to the finial have opened up a fair bit as a result. An inspection was made in the roof space, in 2020, to see if purlin ends had failed and encouraged the wall to lean into the pockets left by the failed purlin ends. There was no suggestion that this was the case.

It is noted that this cement re-pointing has been applied to the whole of the front (west) elevation and the whole of the side (south) elevation, it has not been applied to the rear (north) elevation and it has only been applied to part of the side (north) elevation. The fact that some of the walling still shows the original lime mortar pointing, confirms that this is original.

It is always preferable that any cement mortar is removed, allowing the fabric to 'breathe' again. However, if the cement mortar is still firmly bonded to the stones and the backing mortar, removing it can result in damage to the stones, and so it may be counter-productive trying to remove it. Conversely, if it is possible to remove it without damaging the stones, then this should be done. Because it is projected, it appears that it may not be too difficult to remove it without damaging the surrounding stonework or the lime bedding mortar behind it. It is therefore recommended that all of the cement pointing is removed.
