**DRAINAGE CHANNEL, DRAGON PARC,  
MERTHYR TYDFIL**

**Coal Mining Risk Assessment**

12392/LW/21/CMRA

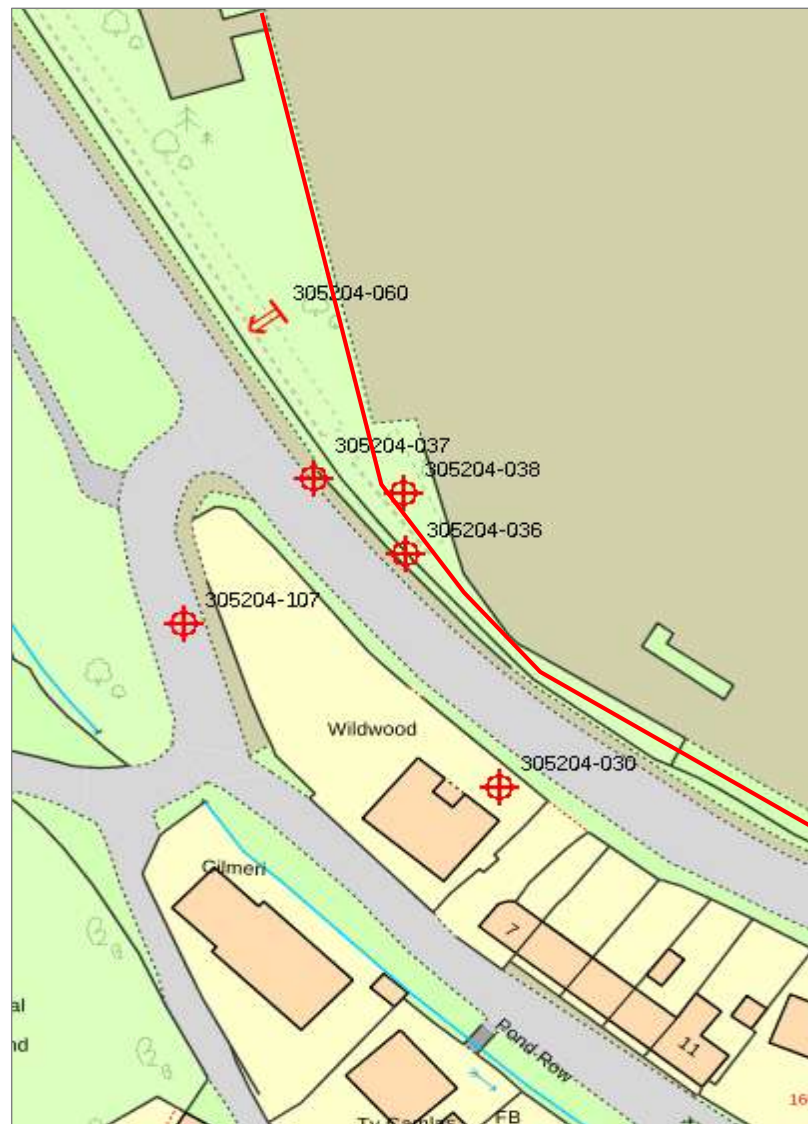
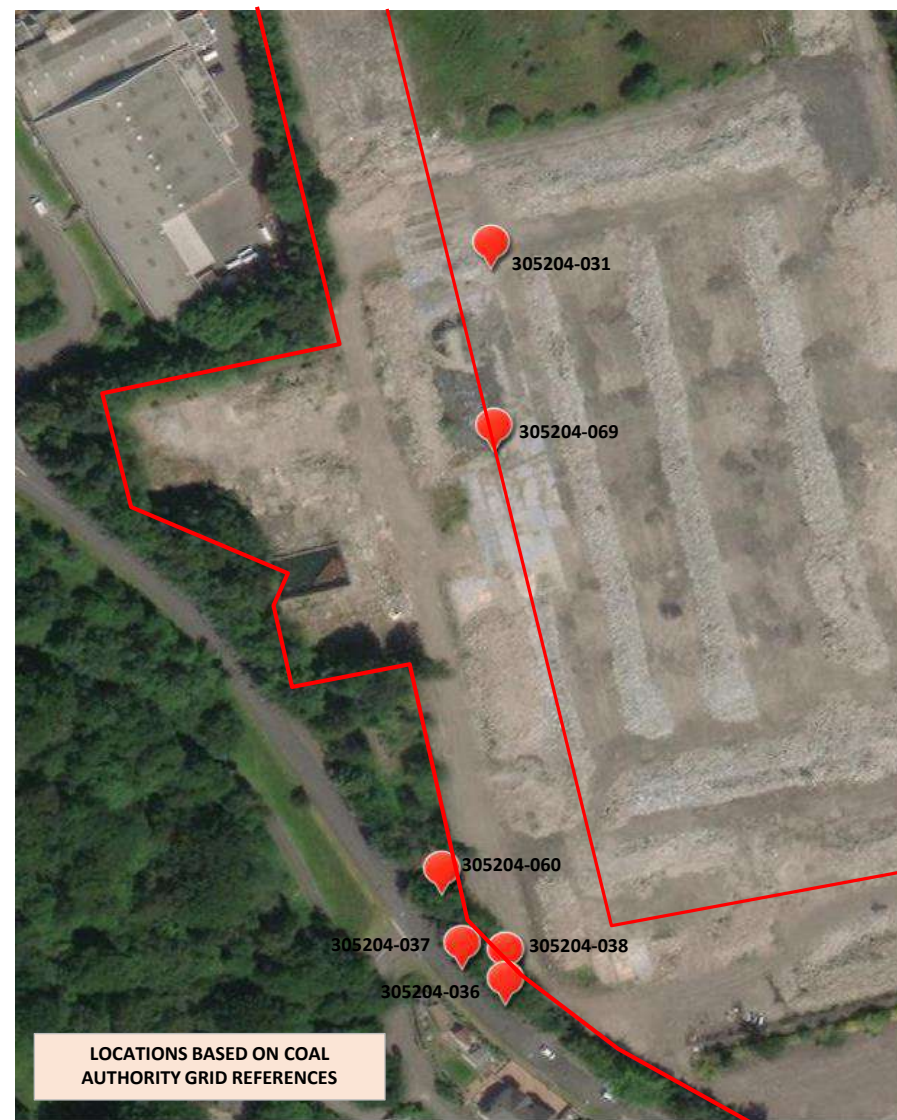
**FIGURE 4: MINE ENTRY LOCATION PLAN**

One shaft (coal authority reference 305204-038) is located on site in the south western corner as indicated on Figure 4. A further cluster of shafts are indicated off site to the southwest and one shaft is indicated off site to the south. An additional shaft is located off site to the east of the channel in the central area of the site. The presence of the mine entries recorded by the Coal Authority may have the potential to cause localised instability.

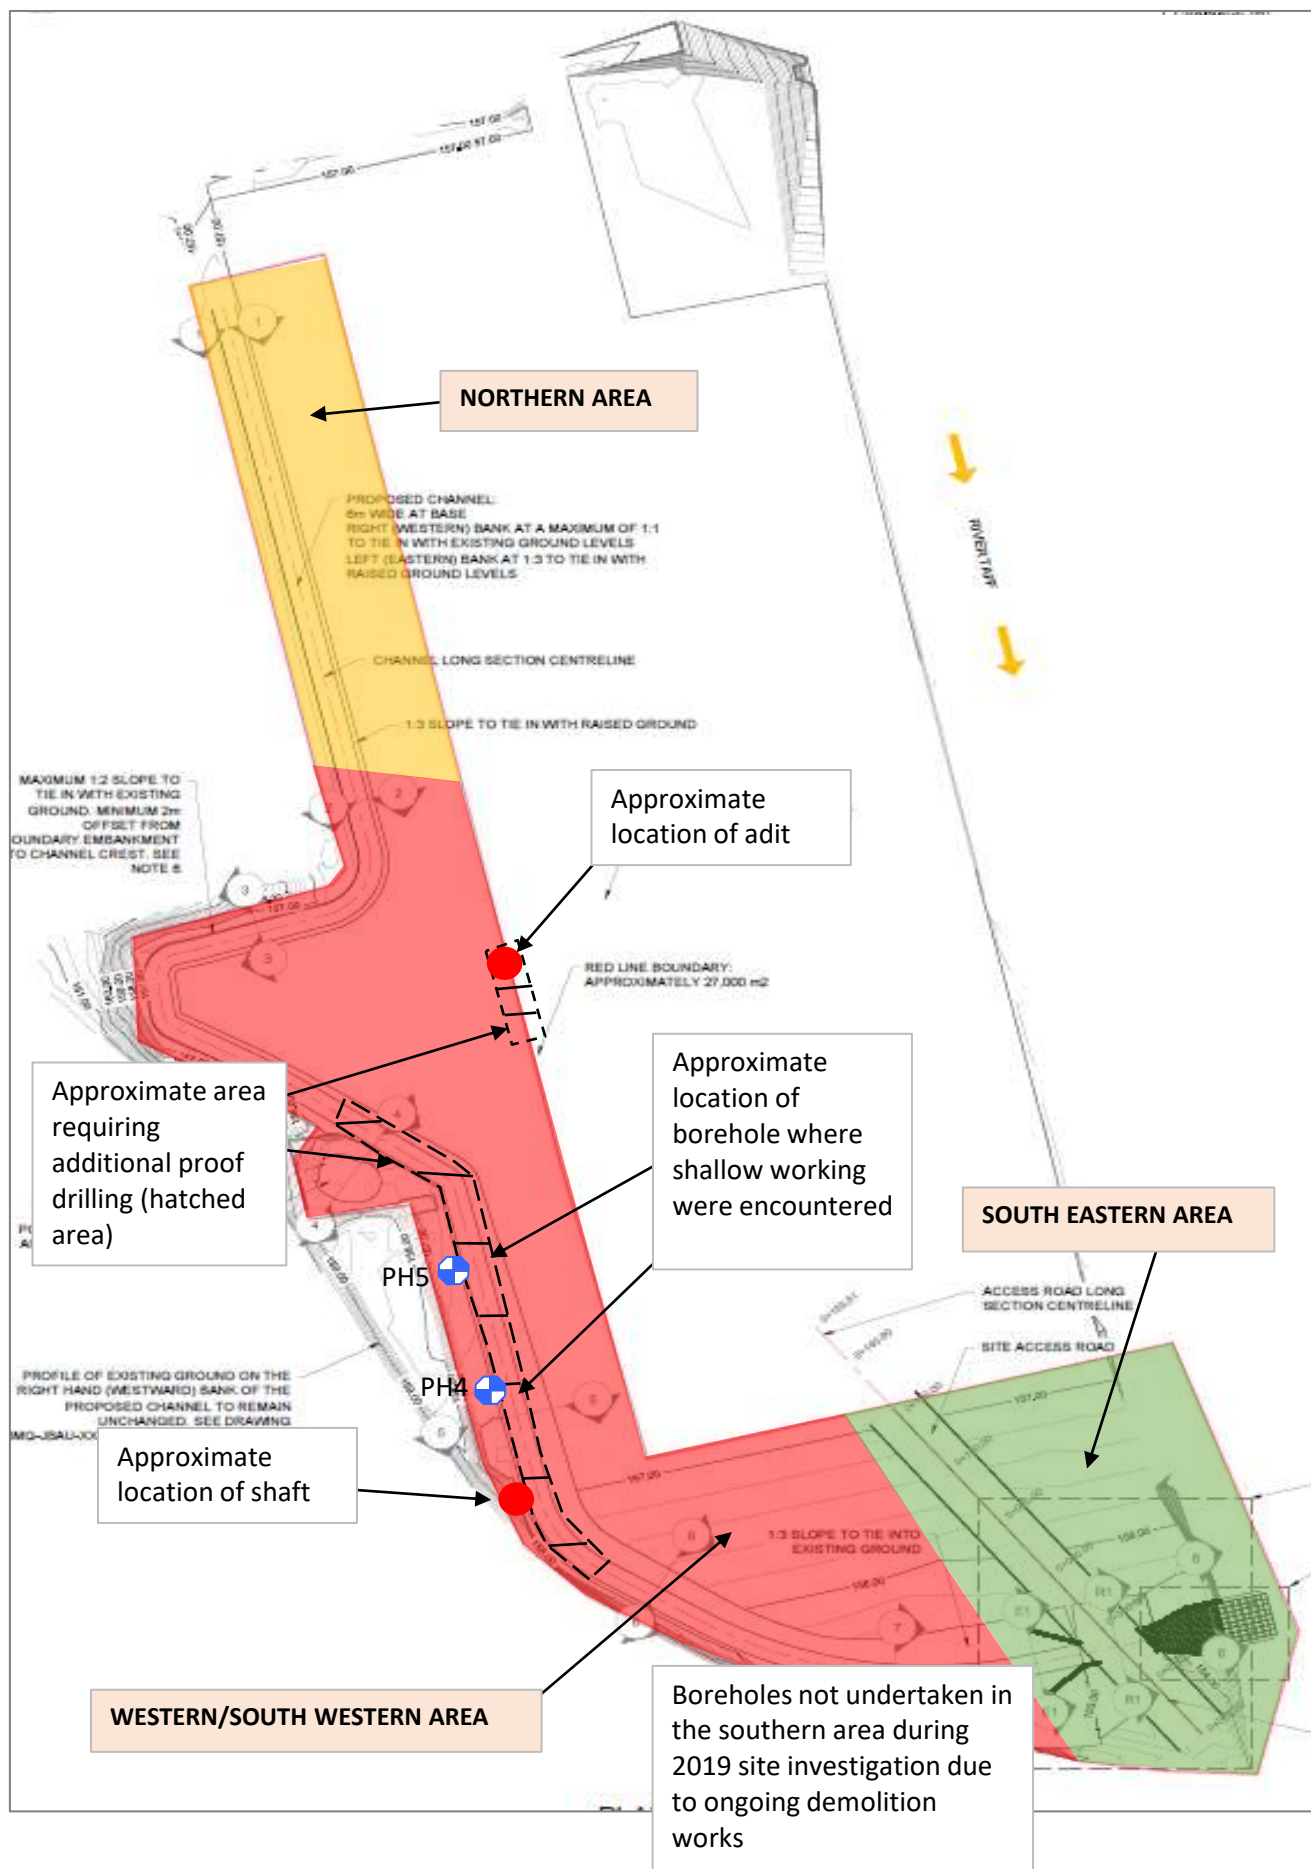
**FIGURE 8: MINING RISK ZONES**

Given the presence of shallow coal seams, shallow coal mine workings and insufficient rock cover identified, it is recommended that mitigation measures are required along the route of the channel.

However, within the areas of probehole PH4 and PH5, where workings have been encountered and within the area of potential roadways associated with the adit located on the eastern boundary of the site, it is recommended specific proof drilling is undertaken along the line of the proposed drainage channel to full understand the degree of shallow mining workings and the rock cover present. Based upon these results, a further assessment should be undertaken to determine if an installation of a reinforced geomattress is sufficient or if a specific drilling and grouting exercise is required to stabilise the mine workings identified.

Bearing in mind the earthworks nature of the proposed development, the most likely ground remediation/stabilisation strategy would be the installation of a reinforced geo-mattress along the route of the proposed channel and over the line of the adit tunnel if found to be open and shallow.
