Former St. Tydfil's  
Hospital

Listed Building Room Data &  
Photographic Record

Project Ref: 2447

21 September 2020

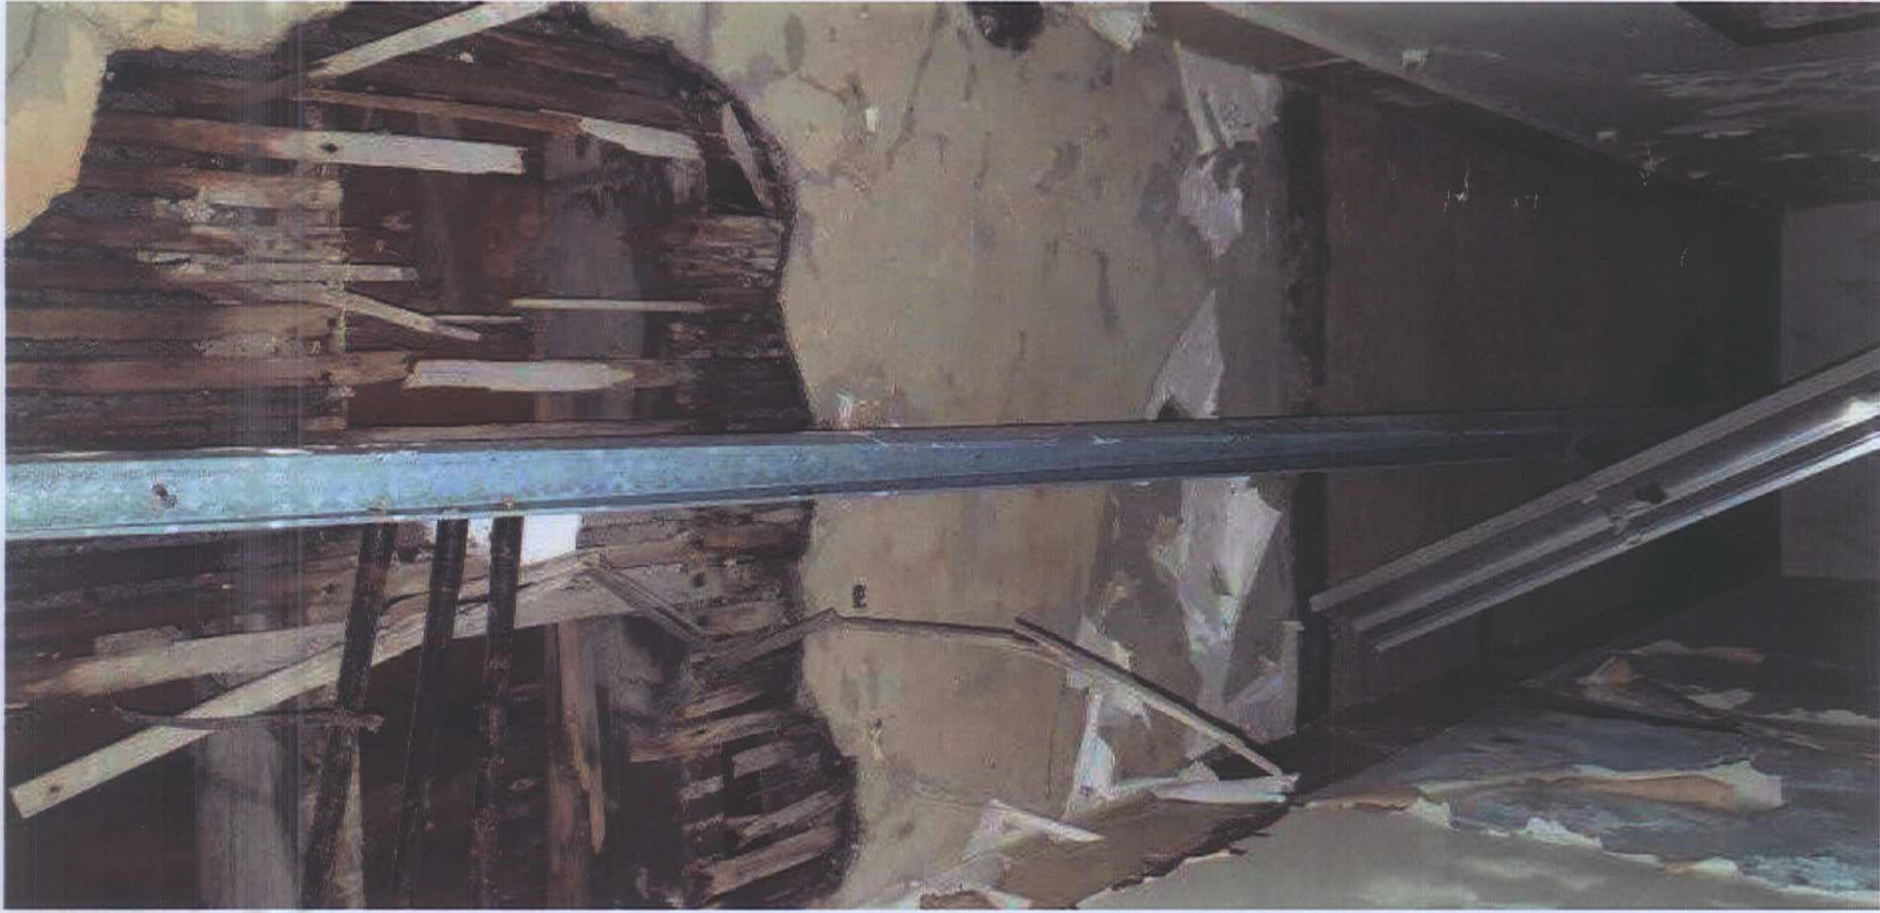
Ceiling

| Element | Condition (G/F/P) | Comments |
|---|---|---|
| Ceiling/Roof | P | Lath and plaster remnants above remnants of modern suspended ceiling |

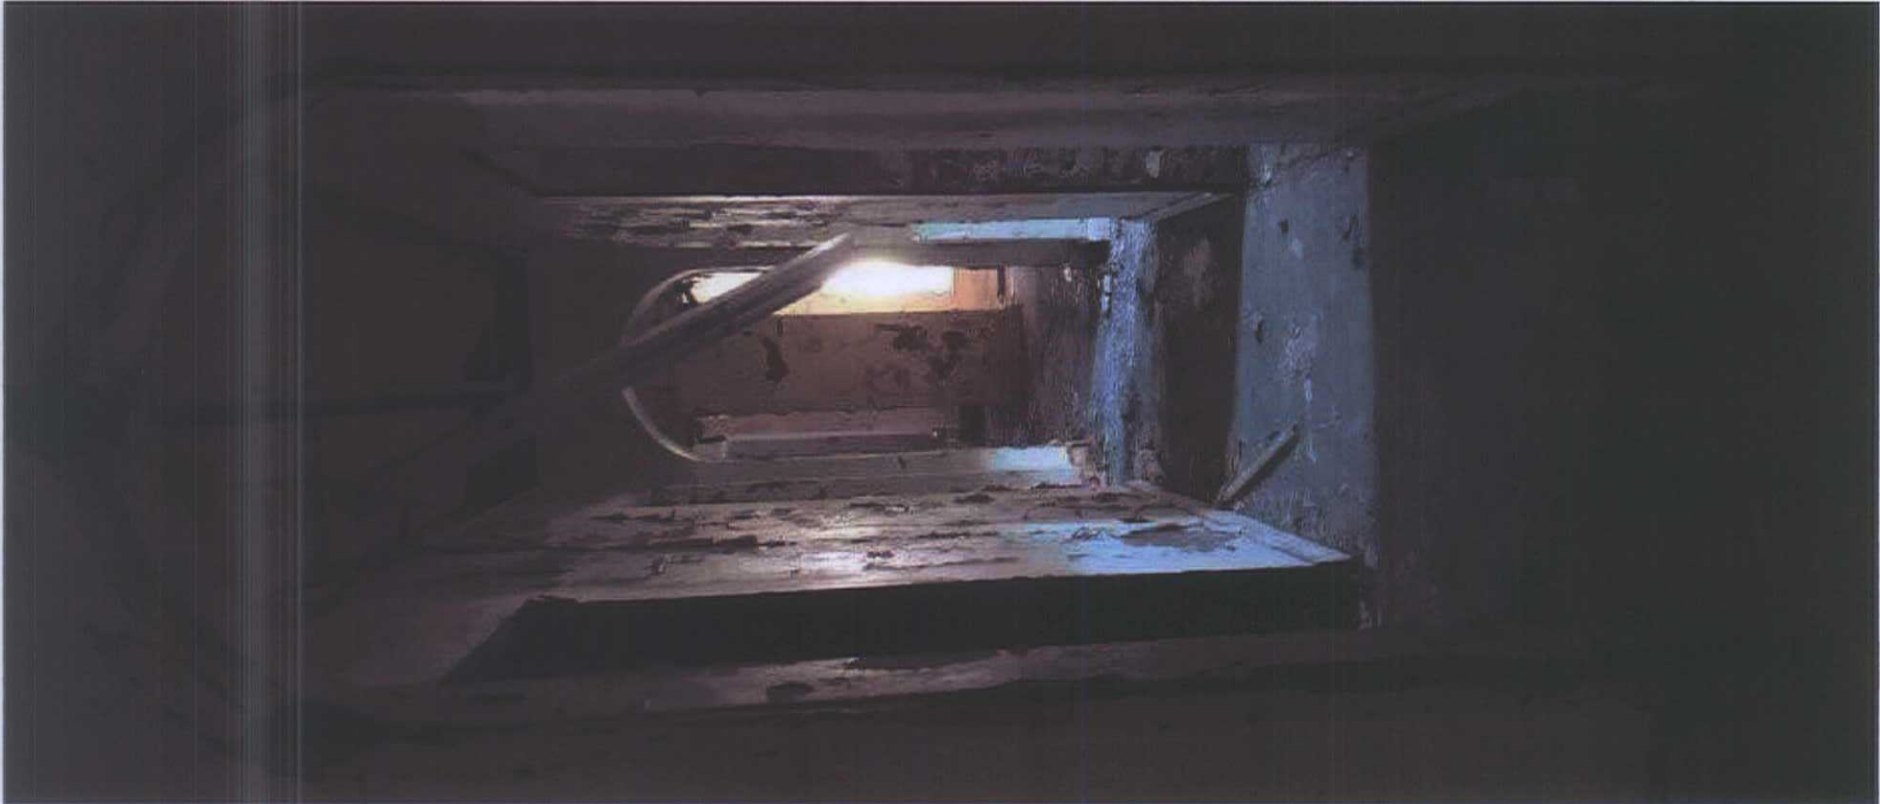
View north along corridor

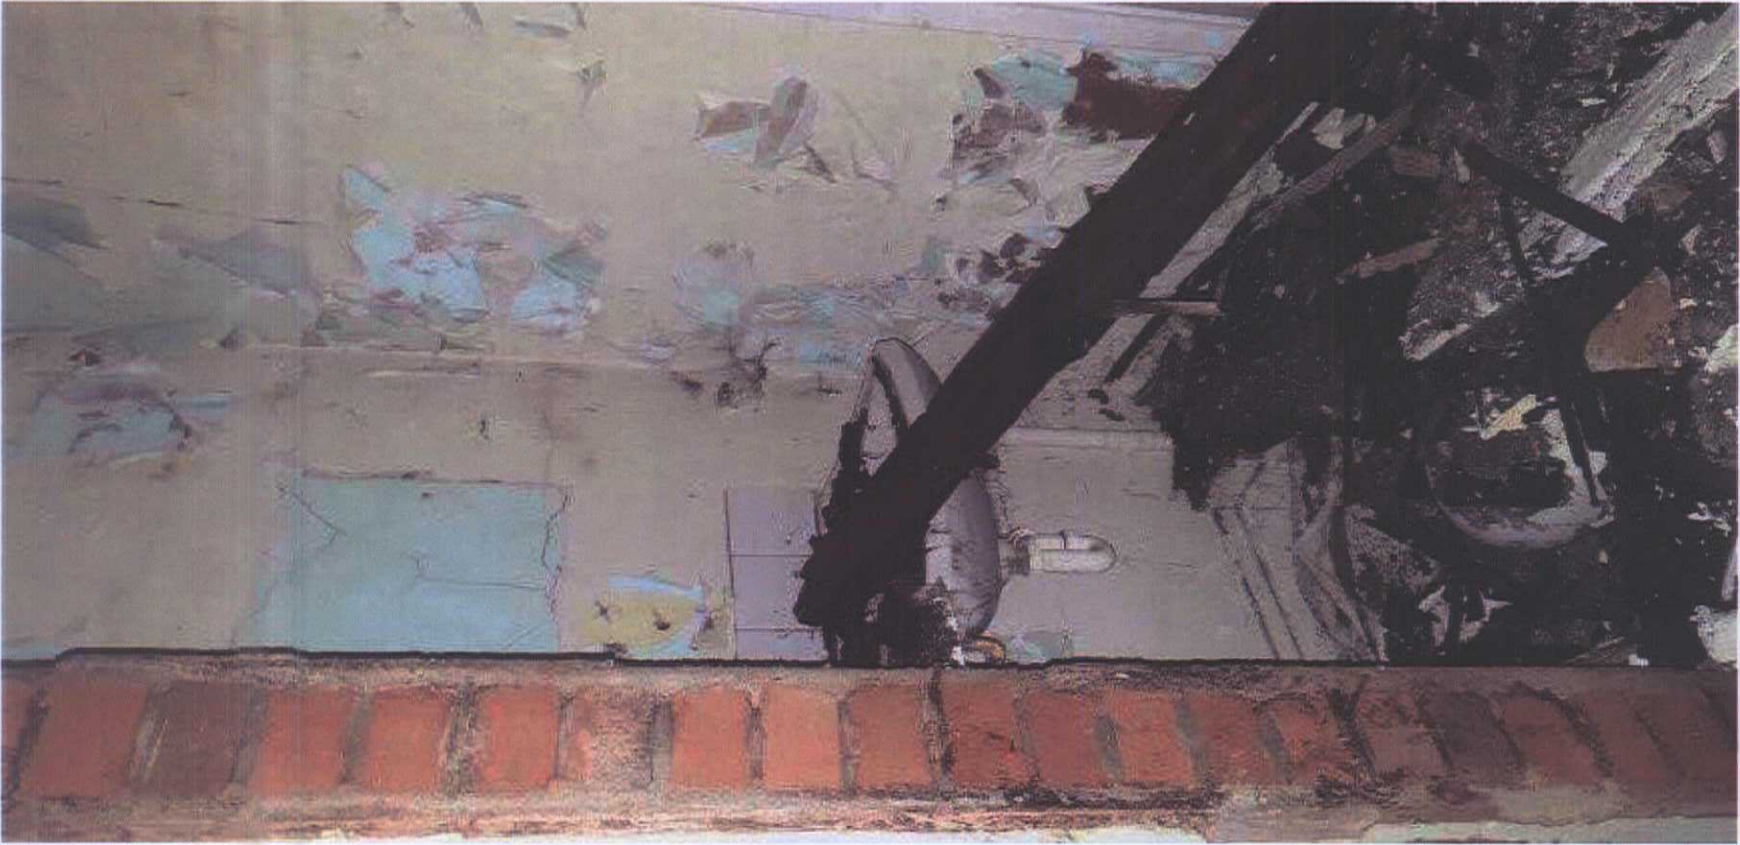
Looking south into WC

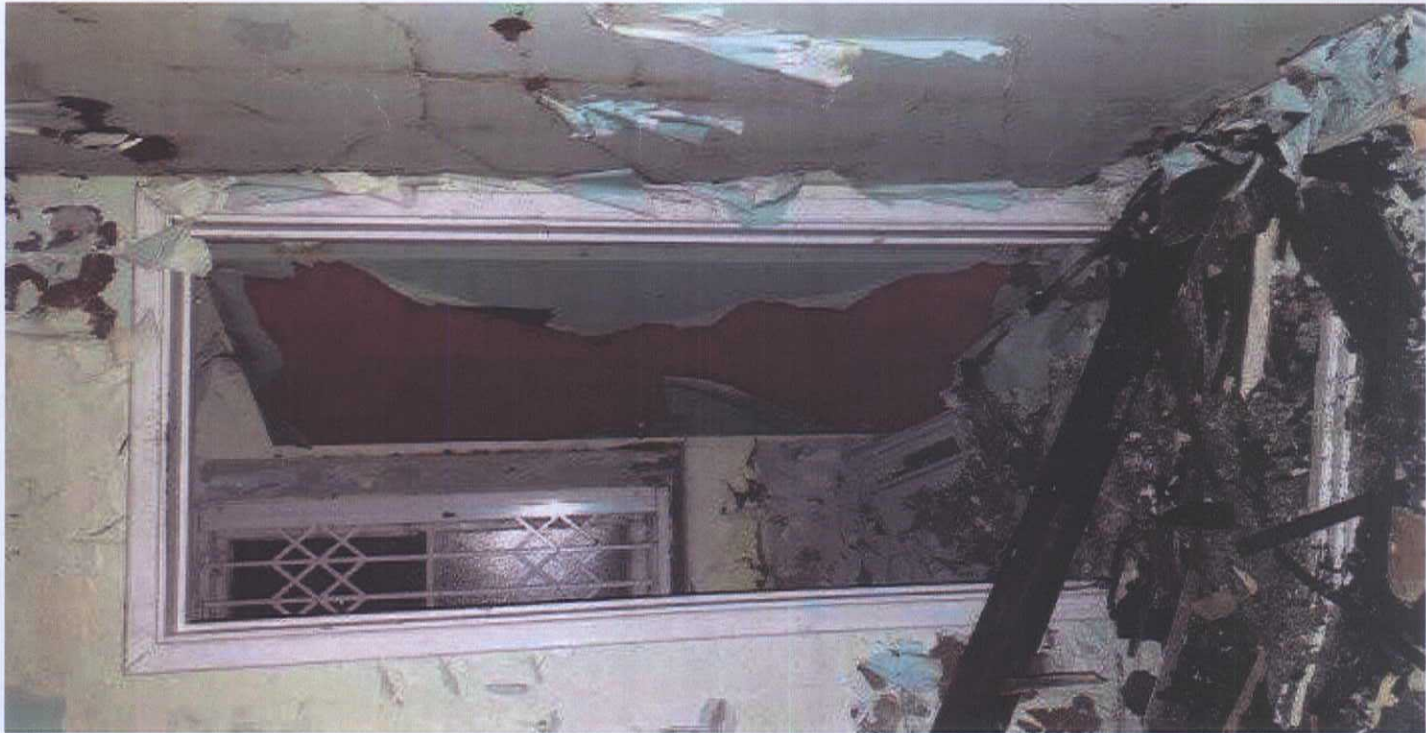
Looking west into WC

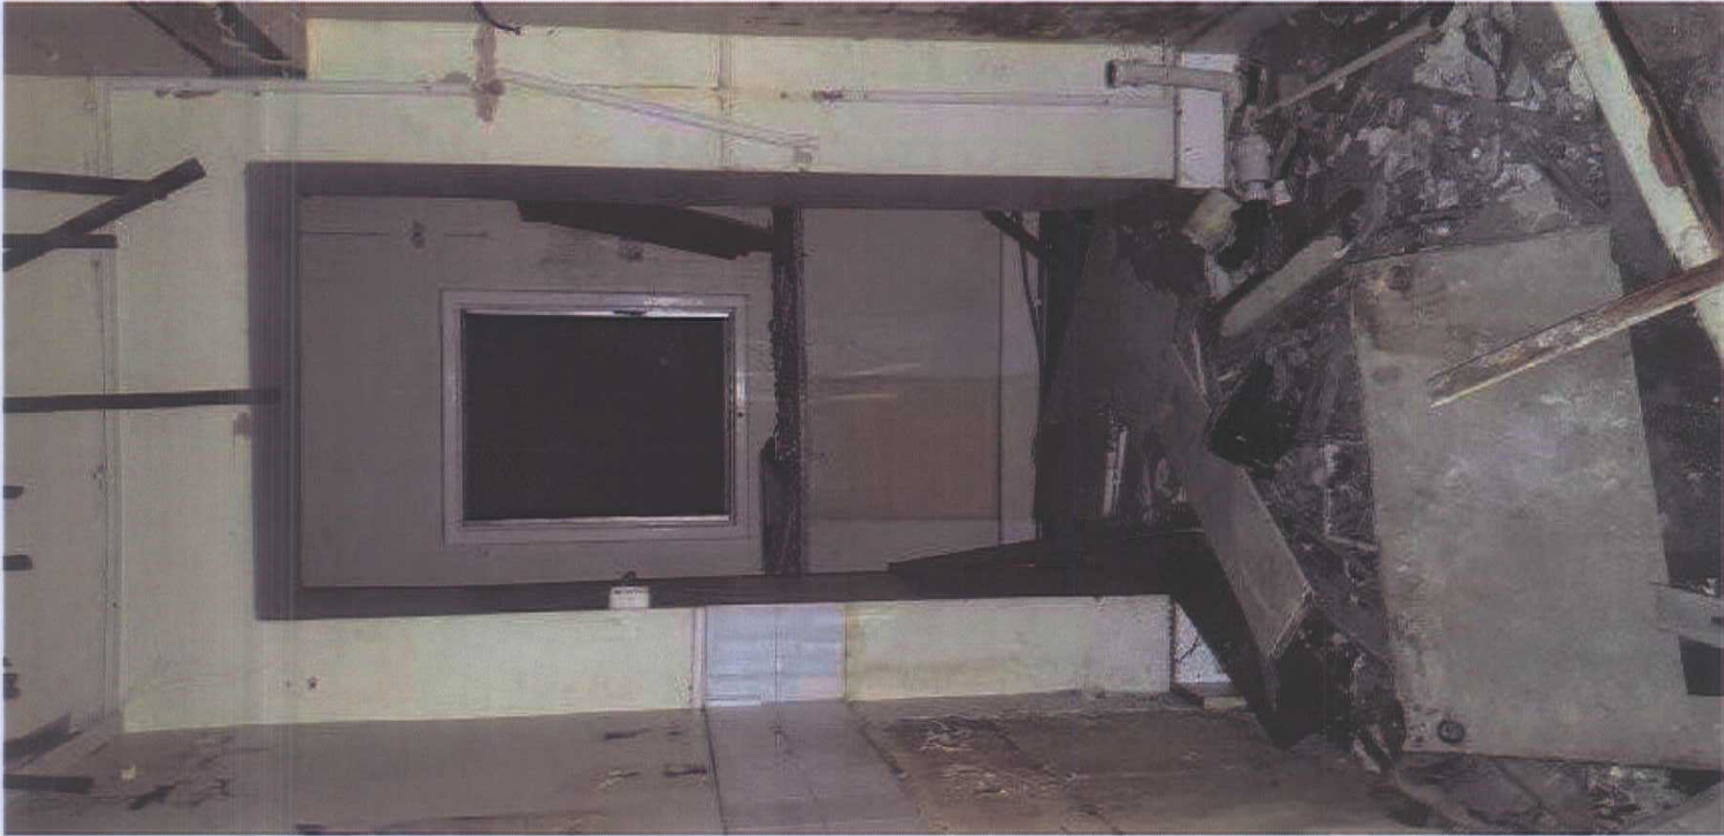
| Room Data | | |
|---|---|---|
| Floor | P | Not visible due to rubble but a collapsed drainage inspection chamber is visible |

Collapsed drainage inspection chamber in floor

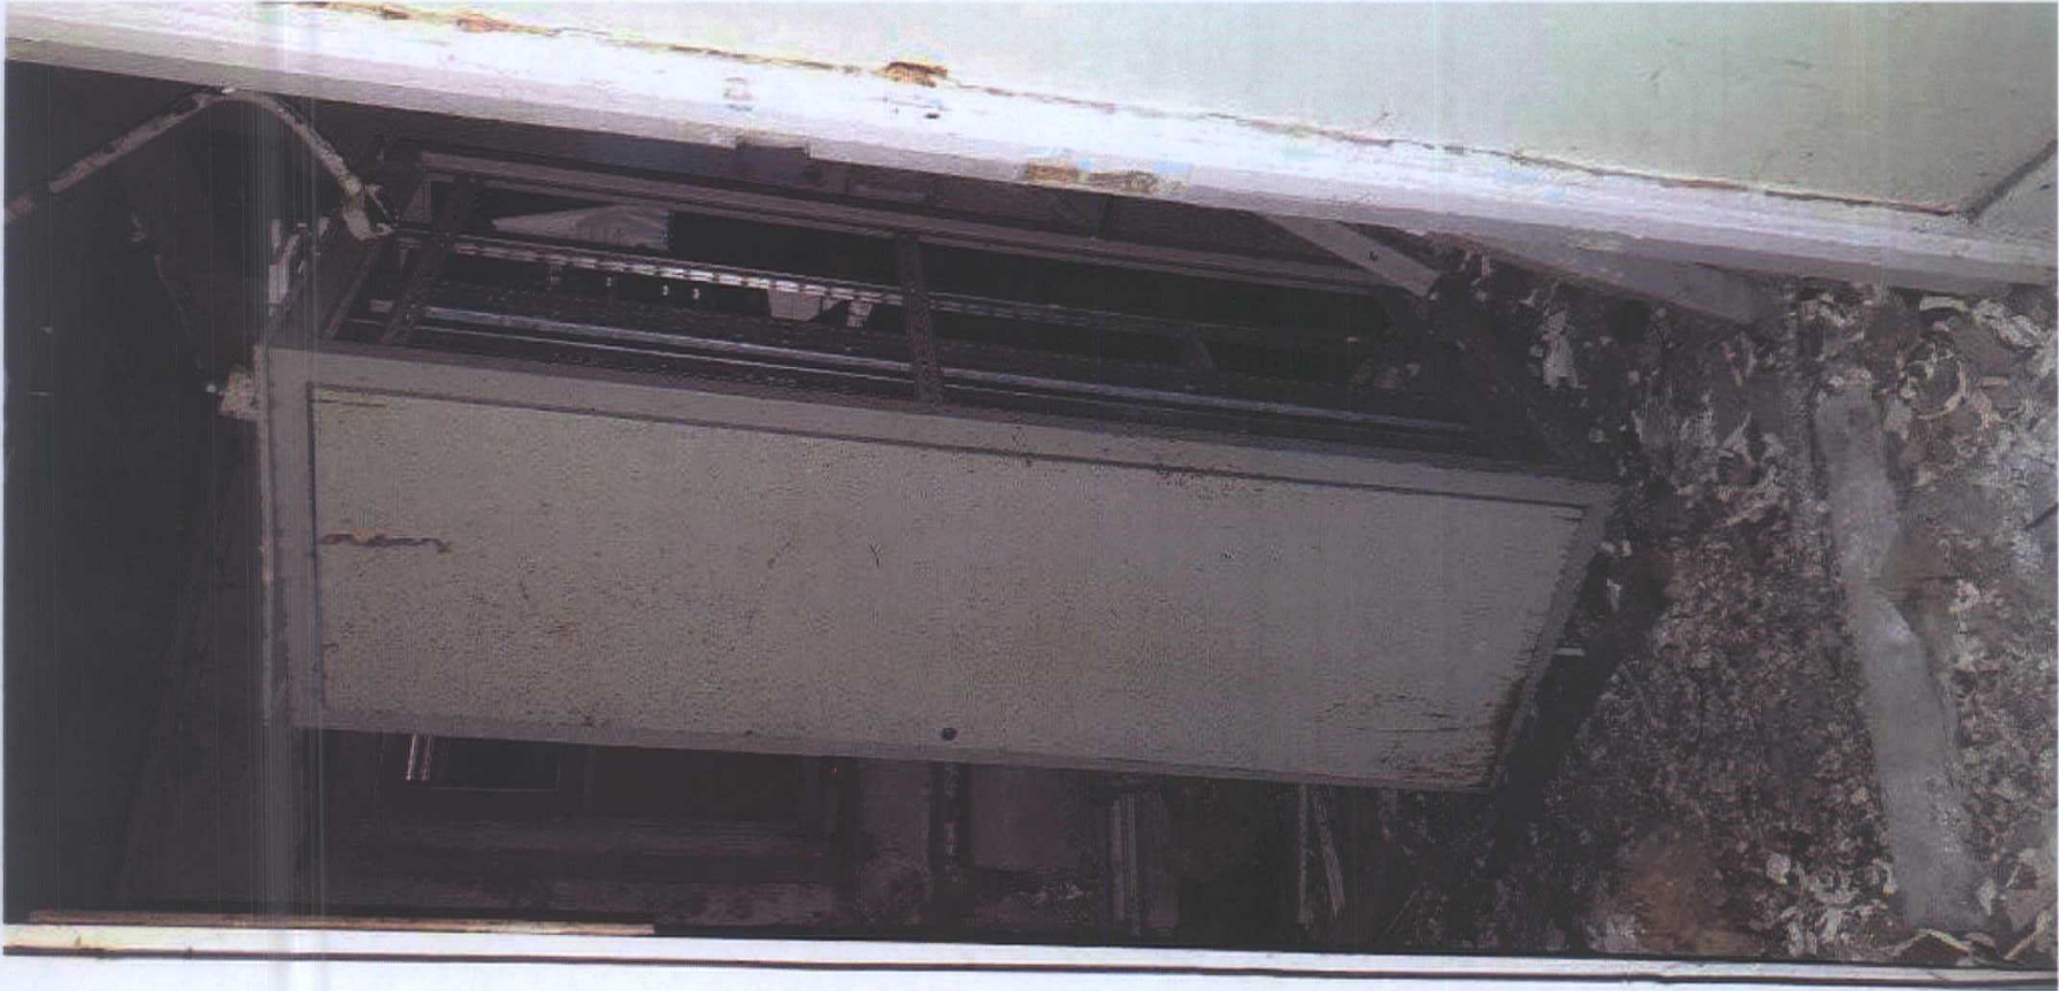
Looking east into GF13

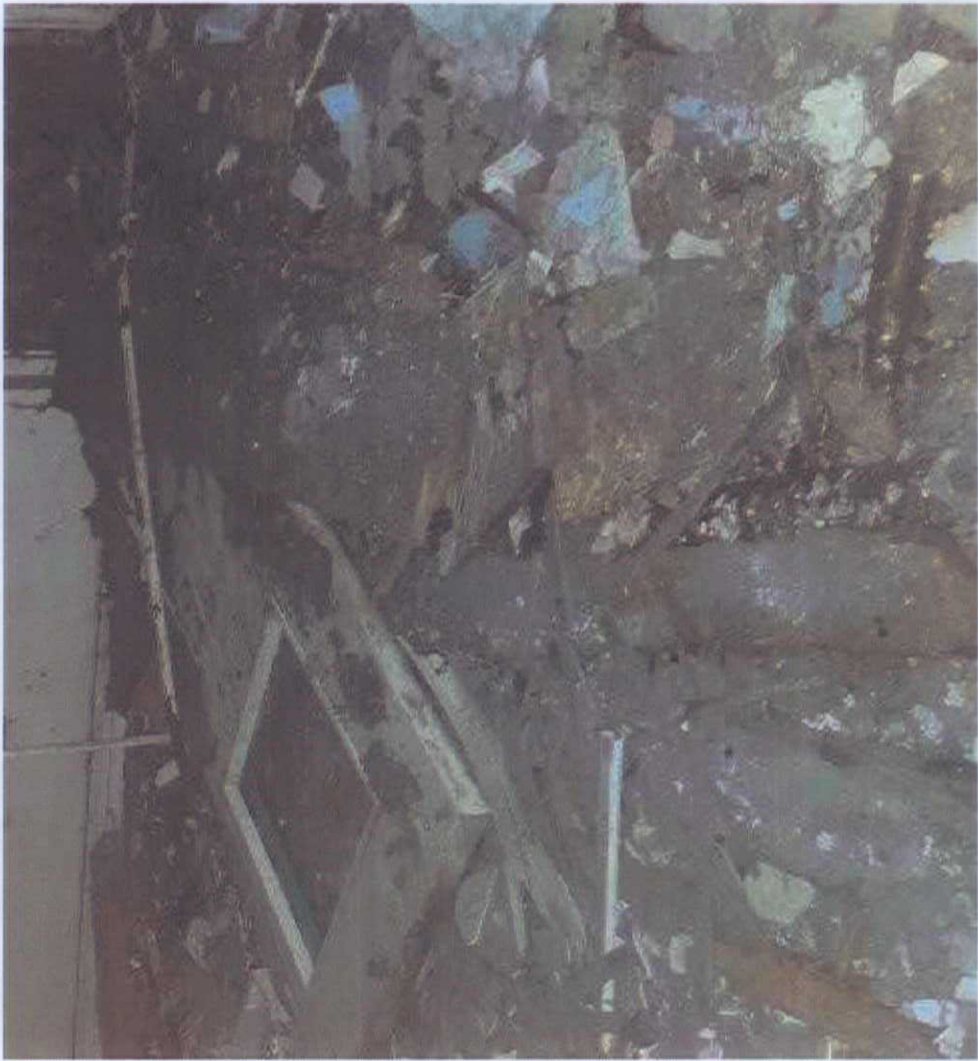
| Element | Condition (G/F/P) | Comments |
|---|---|---|
| Ceiling/<br>Roof | P | Not visible but seemingly mostly collapsed |

Collapsed ceiling & floor above

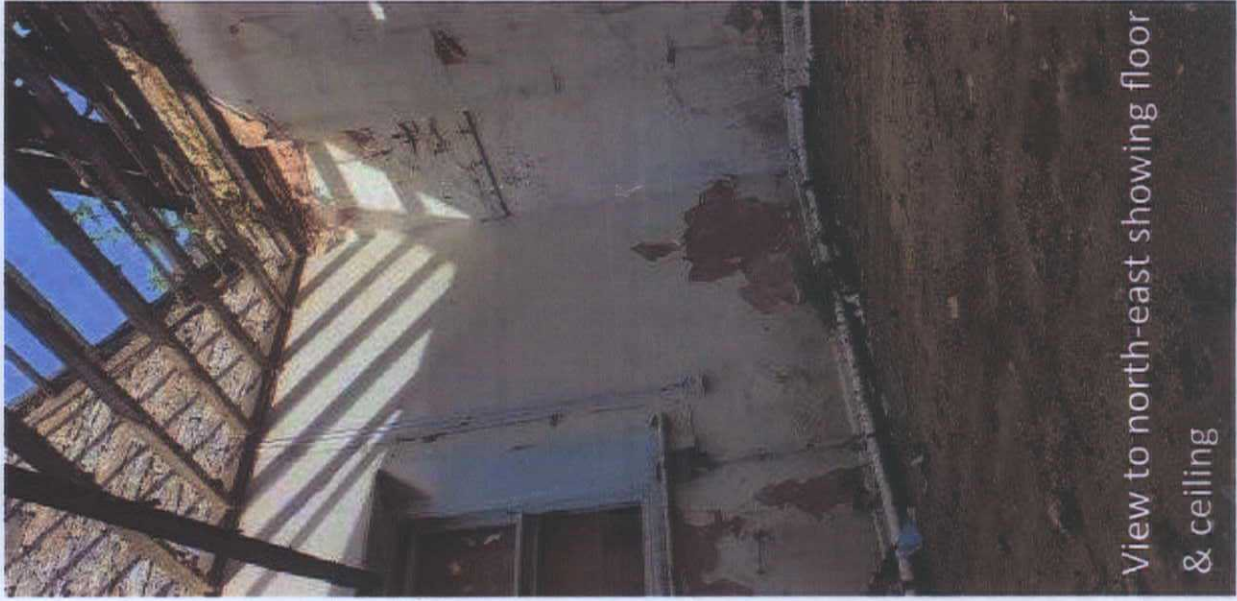
View to north-east showing floor & ceiling

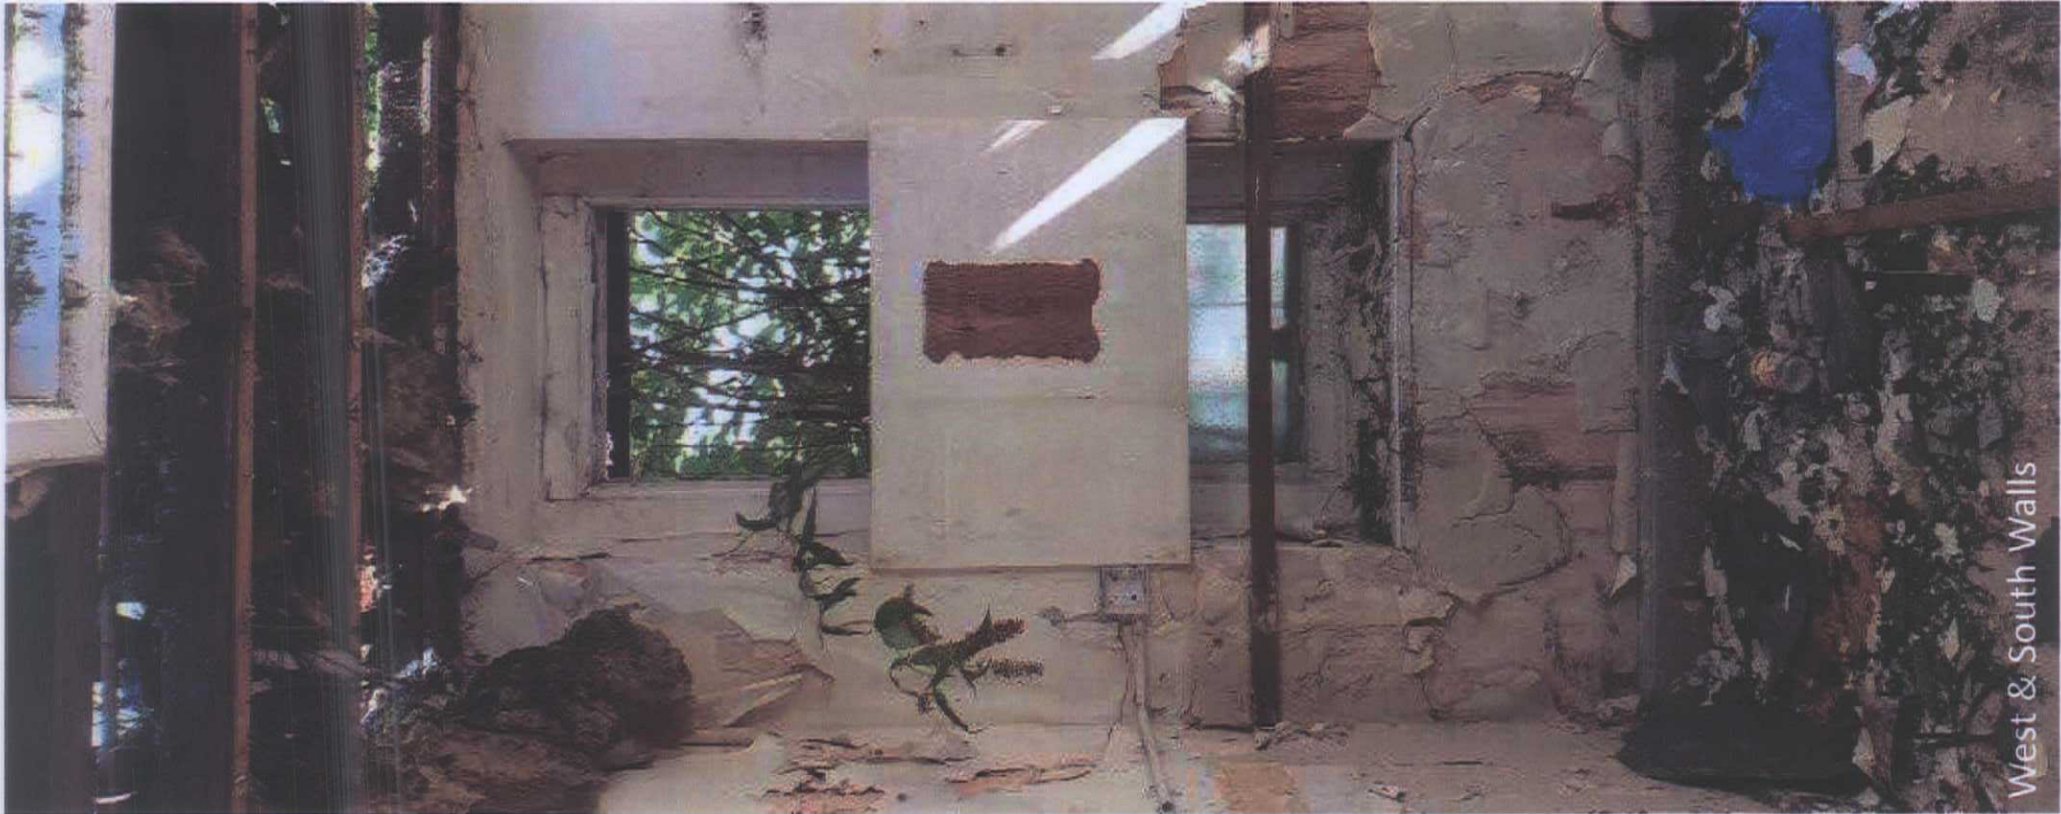
West & South Walls

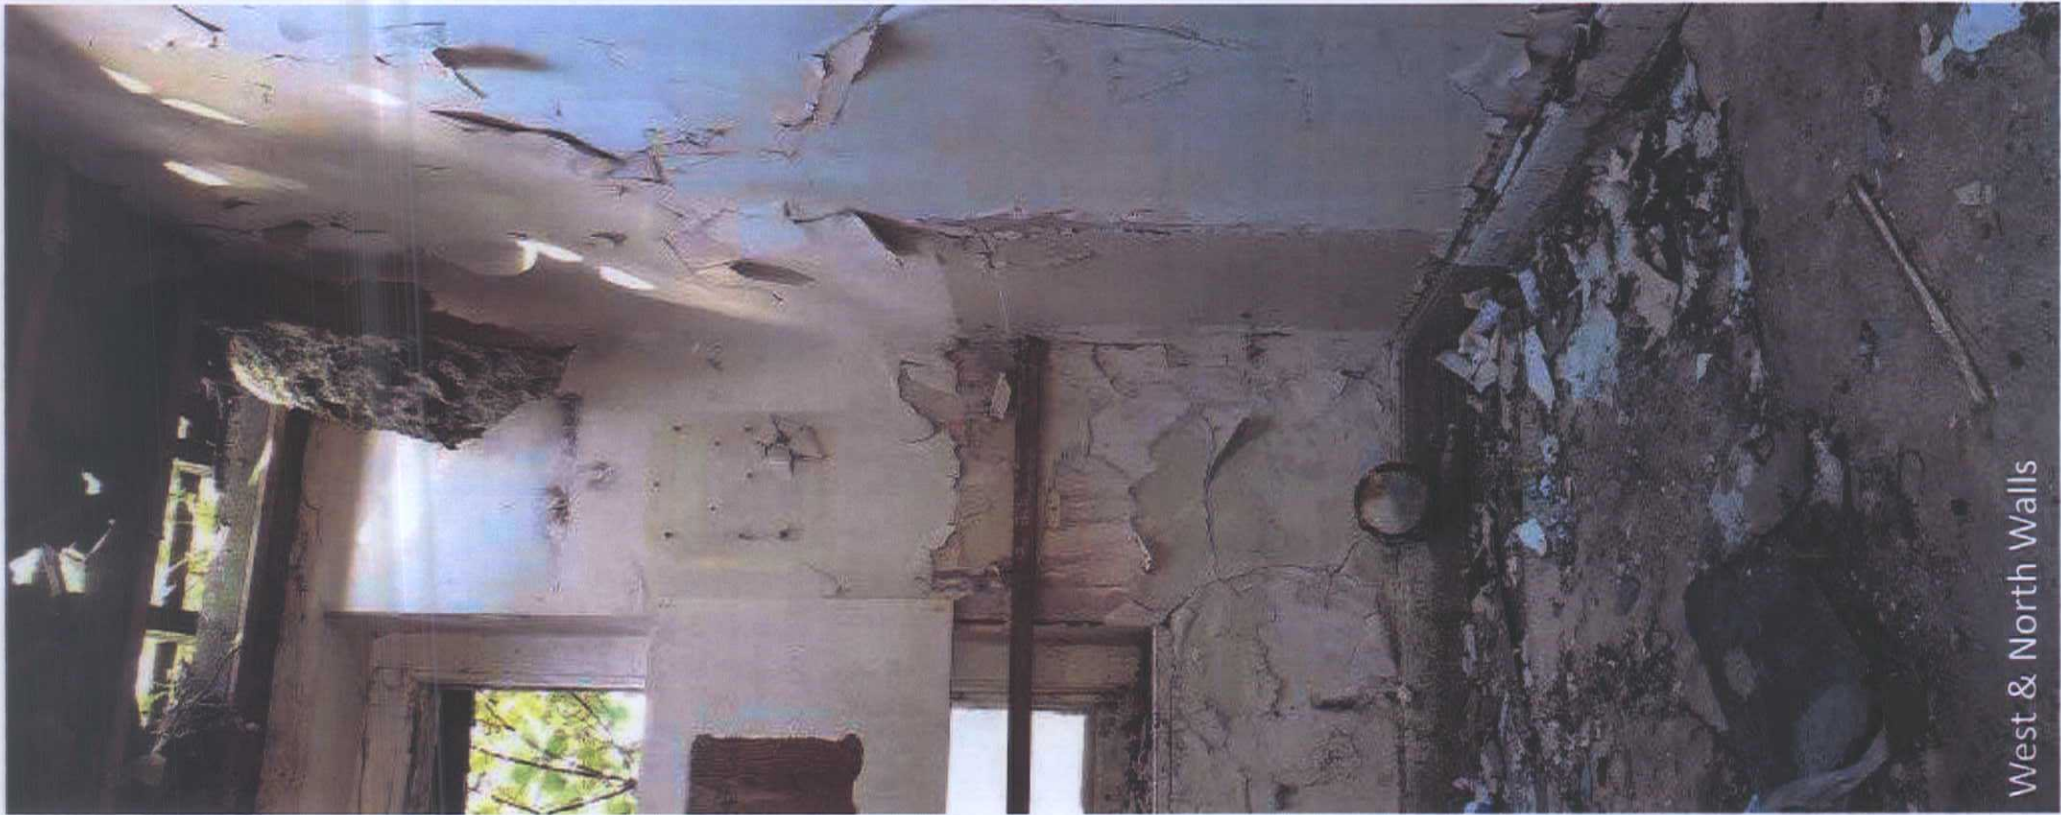
West & North Walls

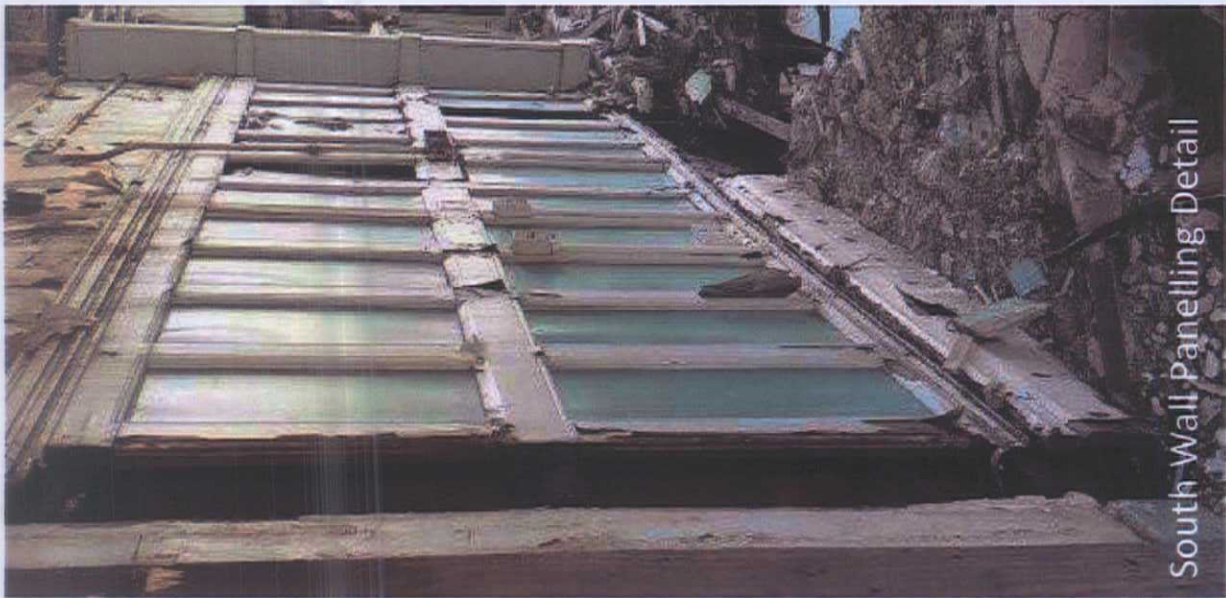
South Wall Panelling Detail

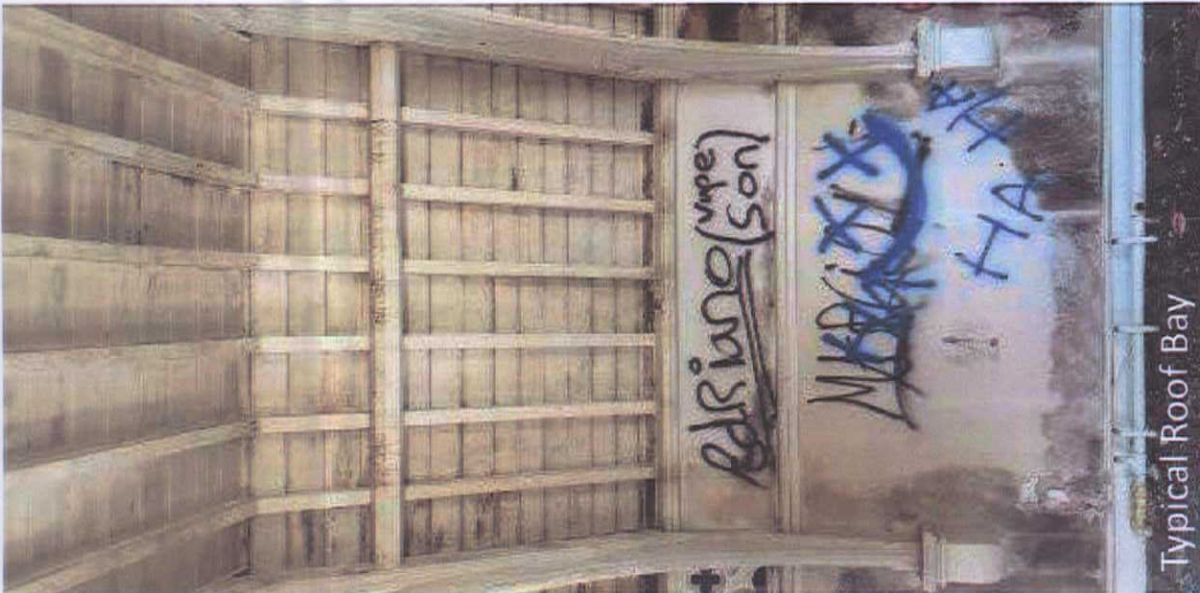
Typical Roof Bay

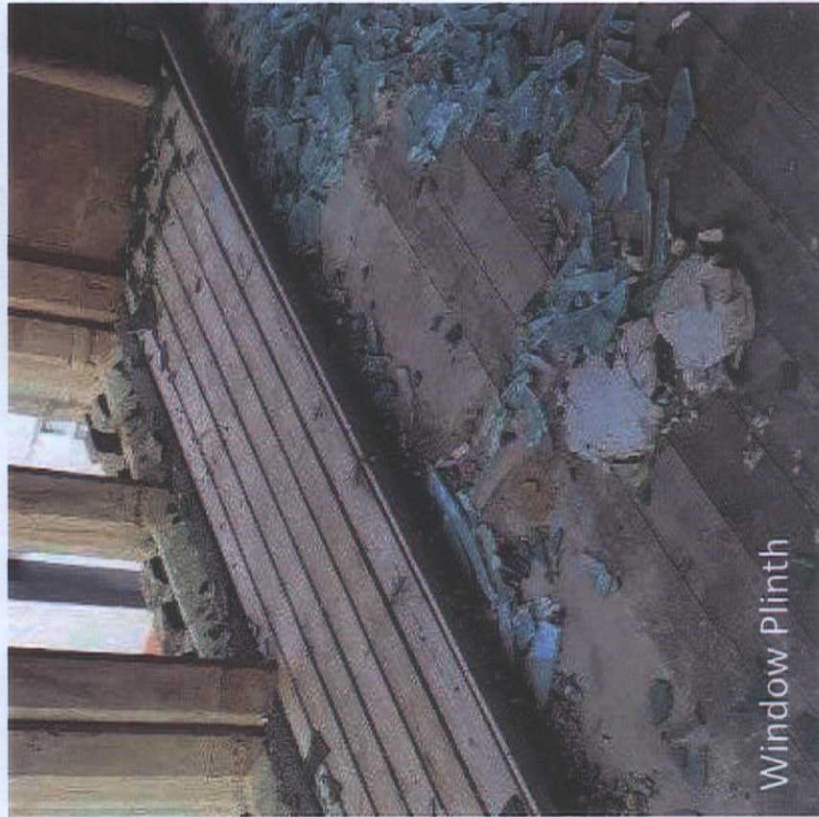
Window Plinth
