Dear David,  
Re: Proposed Remodelling of Chapel Hall.

**Long Rafter Length - Rear Roof over Toilets.**

### **Rear Roof over Toilets - Short Term Problem.**

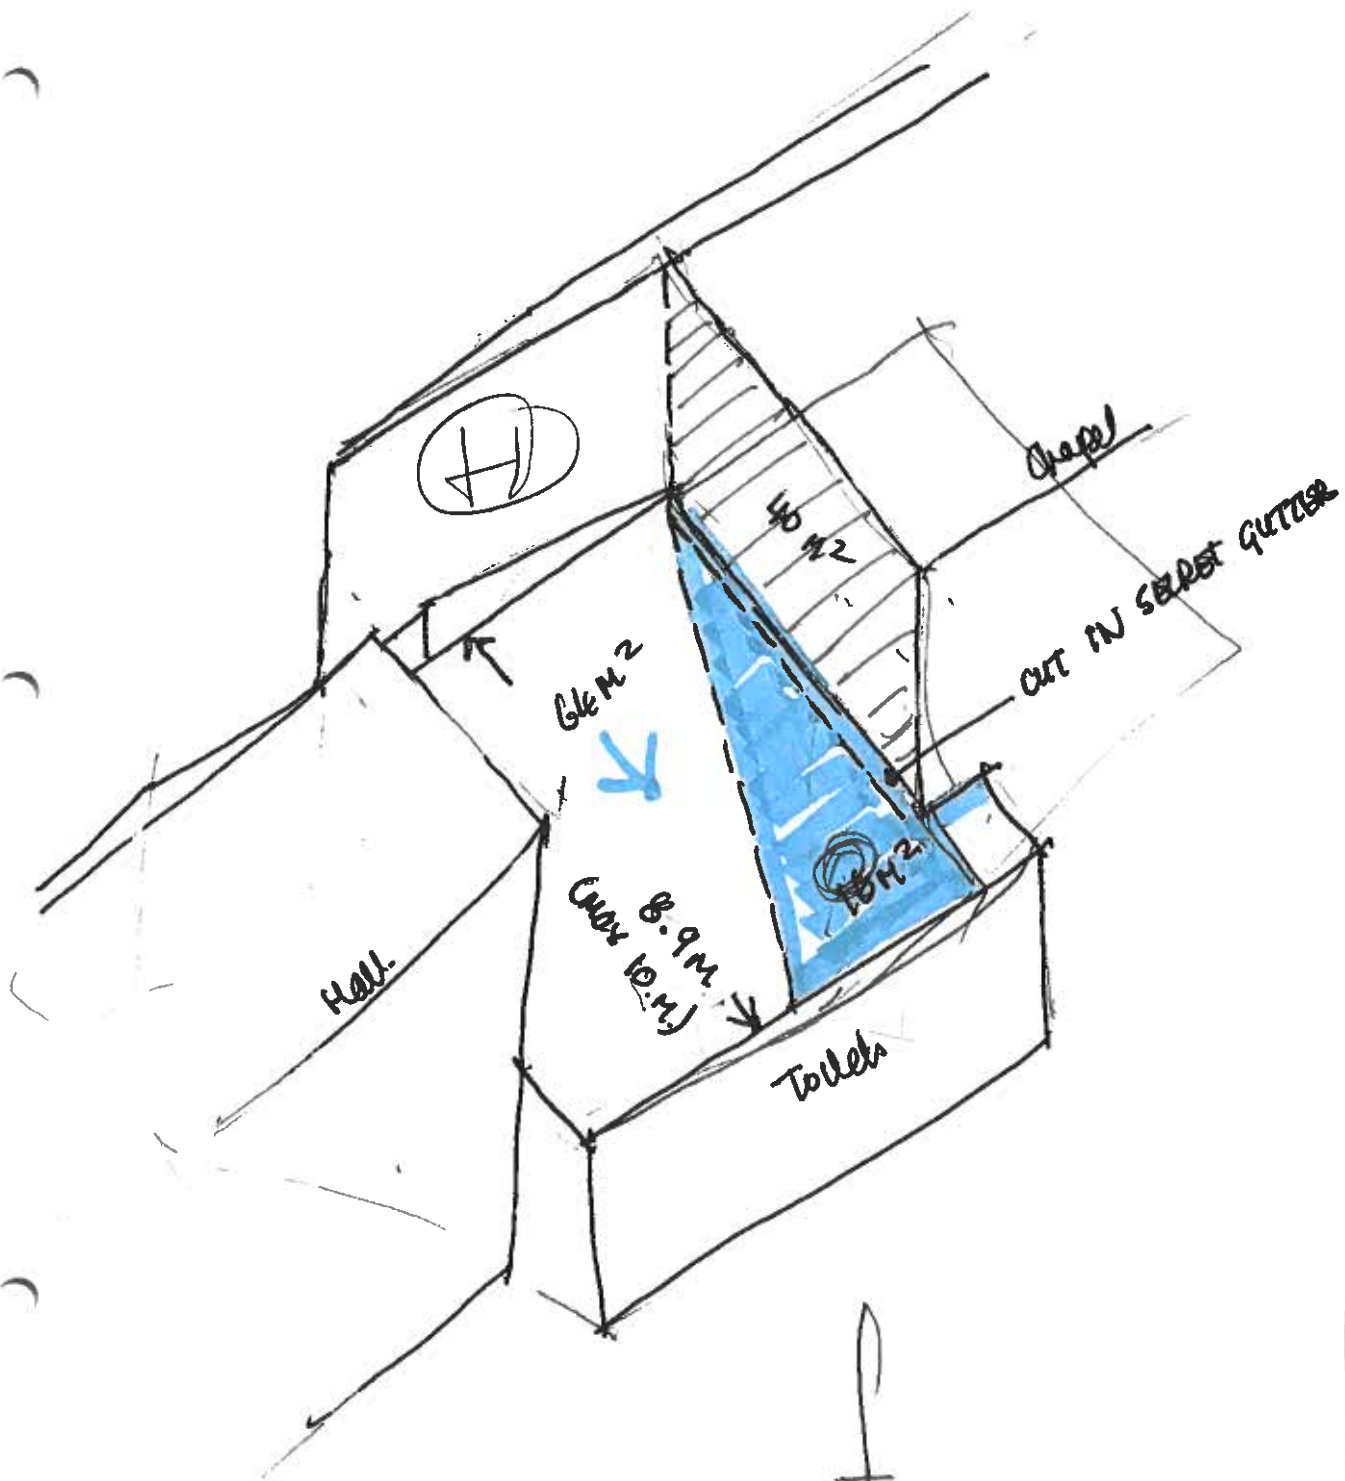
See attached sketch.

In a storm rainwater is hitting the high gable wall of the chapel which acts as a vertical roof throwing water back onto the main roof. The rear toilet roof is an area of some 64 m<sup>2</sup> the adjacent wall above this roof is 40 m<sup>2</sup>. The roof is thus asked to drain 104 m<sup>2</sup> which would greatly extend a theoretical rafter length. The problem is compounded as the wall water is then concentrated onto a triangular quarter of the roof. Thus, water from 40 m<sup>2</sup> runs over 16 m<sup>2</sup> of roof already carrying its own storm water.
