## Arboricultural Evaluation

**Trees at Queens Road, Merthyr Tydfil, CF47 0HE**

**Location:** Front garden, The Mount, CF47 0HE

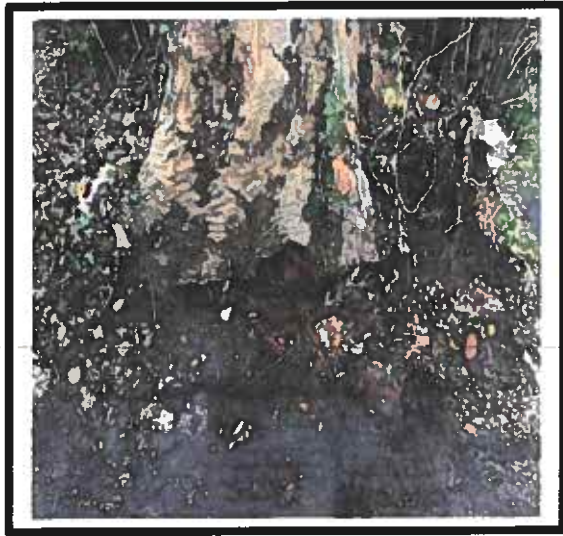
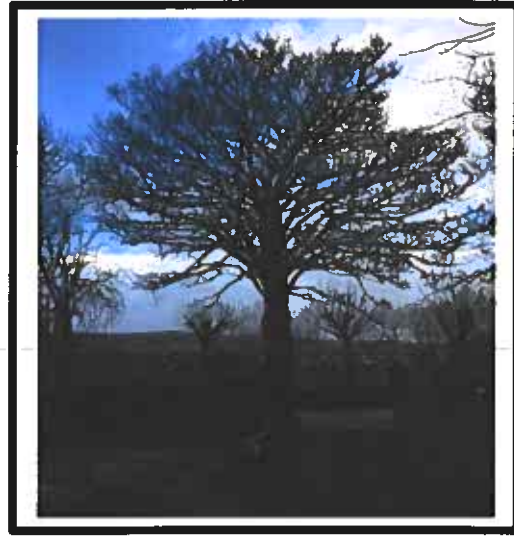
**Species:** T1(Tag 1999) Sycamore

This large mature tree has severe root damage. The roots have been severed and there is severe decay. (See photo above).

A probe into the decay extended further than 480mm and a sounding mallet also revealed further internal decay.

The tree is bifurcated at approximately 3 metres and there is some included bark although it is difficult to confirm structural integrity of the fork due to ivy on the main stem.

There is minor and major dead wood throughout the crown.

Annual increment root growth may cause more damage to built structures, drive, public footpath, etc.

The tree is potentially unstable and given its location is potentially unsafe.

High

Given this trees location and the targets/hazards when it fails it is recommended the tree is removed. Replant more suitable species for location.

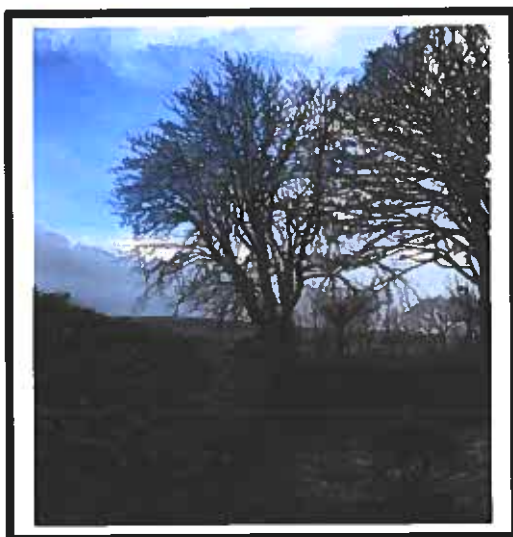
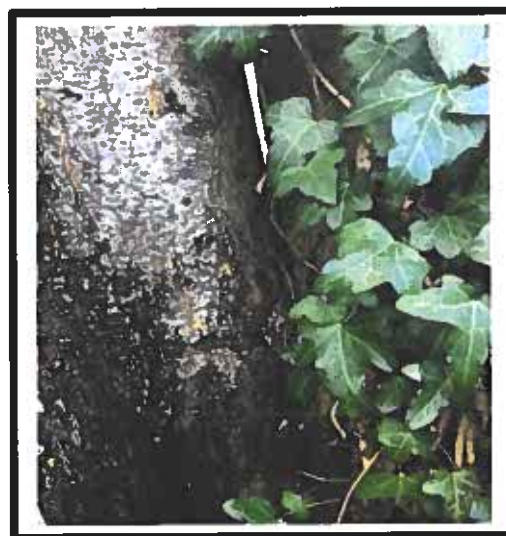
**Species:** T2(Tag 2000) Sorbus    **Age Class:** Mature    **Height:** 10/12 Metres

This tree is heavily suppressed by the neighbouring Sycamore.

Main stem is bifurcated from the base and there is a minor shear crack forming and extending up the stem. This has high potential to fail.

There is some minor dead wood in the upper crown and Ivy on the lower main stem.

Medium/High

Given this tree's location and the targets/hazards when it fails it is recommended the tree is removed.
