## INSTALLATION OF NEW SKYLIGHTS/VELUX WINDOWS

JAH-JIREH CARE HOME, A465 MERTHYR

### BUILDING INSPECTION REPORT

Document Ref: E25136001 Doc 01 September 2025

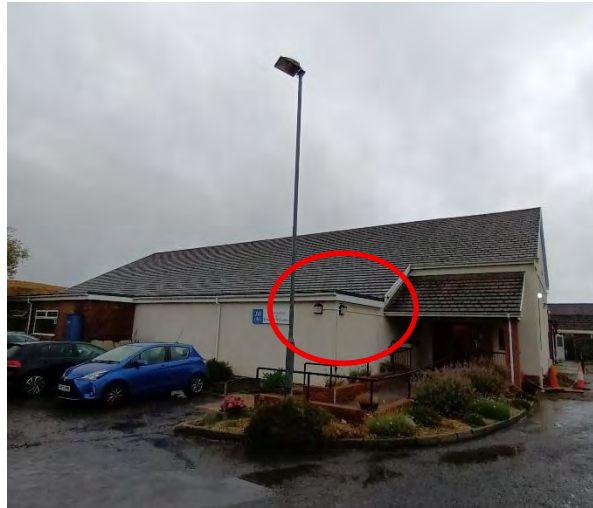
**Plate 1- View Looking Towards The North Eastern Side Of The Building.**

- 3.6 The walls are a combination of red brick and render and are in a good state of repair i.e. no obvious cracks damage (with the exception of the one area identified in TN 5). The roof is well sealed and new fascia's and bargeboards have been installed recently (within last 12 months<sup>4</sup>). (Plate 1 and TN 10, 11, 12& 13).

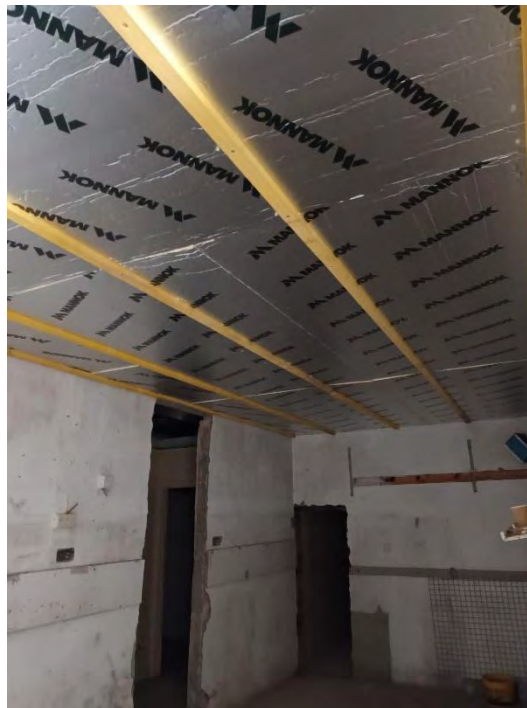
**Plate 3-Room B-View of Recently Installed Ceiling Insulation Boards**

3.10 The door was locked upon entry and the window located in room B was open. Rooms A-C are largely located within the flat roof area and no accessible roof space is present (Room C is partially located in the pitched roof section of the building). Recent works include the installation of ceiling insulation boards in room A,B and C. There were no signs of bat droppings on any surfaces within these rooms.

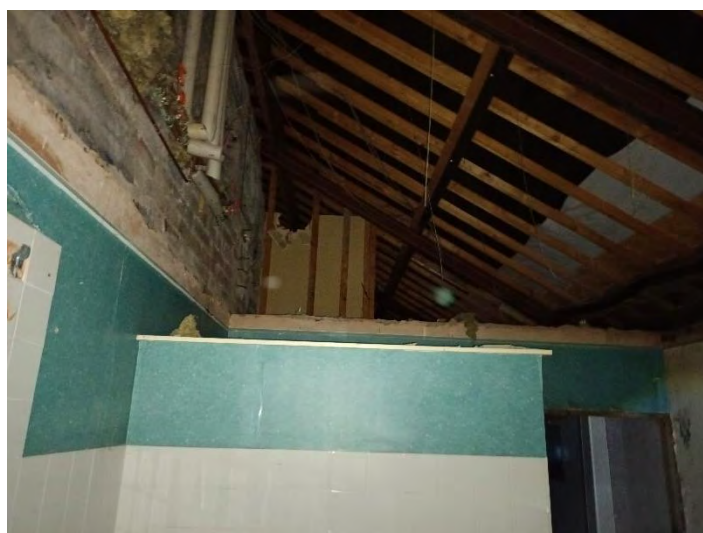
**Plate 4-View Looking Up at Ceiling From Room G-Exposed Roofing Felt/ Battens and Joists**

3.11 The remaining rooms (E-G) are located within the pitched roof section and where the proposed Velux window/skylights are to be installed. The ceiling has largely been removed and the roofing felt, battens and joists visible from most of the rooms. There is a brick wall present separating the roof space from the remainder of the building/roof. There is a small section of roof that was boarded up and inaccessible (Plate 4)

- 3.12 The roofing felt appeared to be Bitumen 1F and was in a good state of repair i.e. no rips/tears. Rooms D-G were completely dark with no external light ingress noted. There was a small area of light ingress noted in room C (TN5) which corresponds with the damaged render noted in the north eastern corner. This was the only potential entry point observed during the daytime inspection.

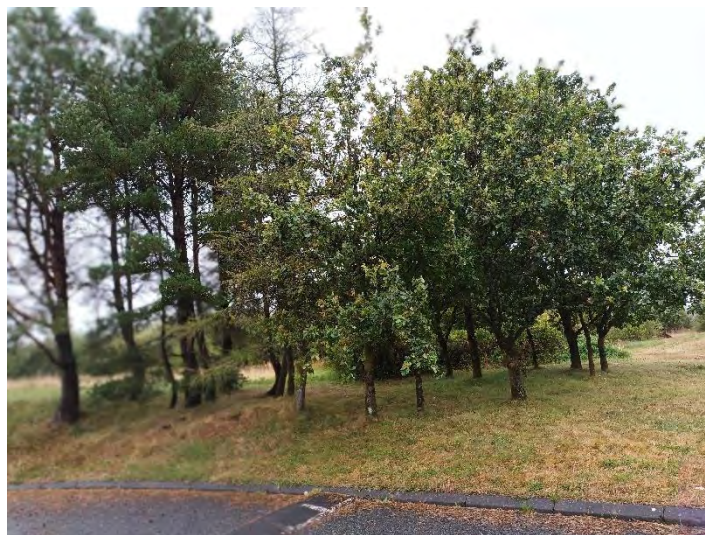
**Plate 5-View Looking North Eastwards Towards Boundary Vegetation**

- 3.13 There is a car park immediately adjacent to the building with some ornamental planting present and a single Willow *Salix sp.* noted. There is a small area of grassland with trees bordering the north/eastern part of the site. Species include Oak *Quercus robur*, Scots Pine *Pinus sylvestris*, Alder *Alder glutinosa* and Willow *Salix*. (Plate 5).

- 3.14 The habitats contained within the care home grounds would be suitable for common reptiles and amphibians - although these areas would not be directly impacted by the roofing works consideration of site compound or storage areas would be appropriate to minimise any risk to these groups.

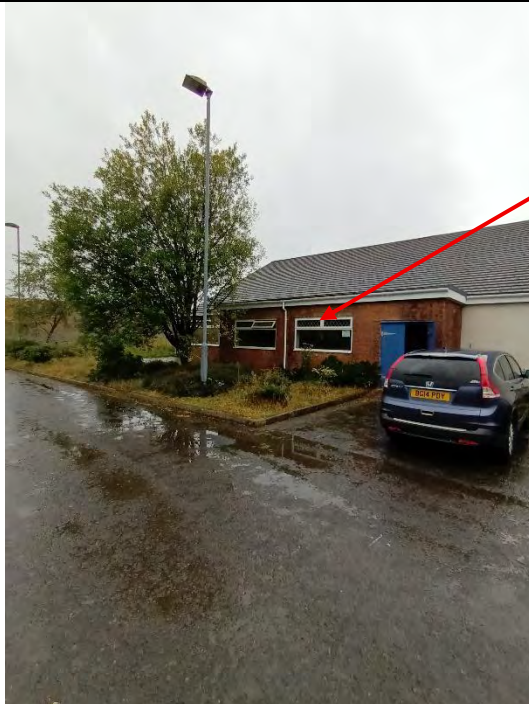
TN1

2 windows (one open) present in the single story extension to the right of the entrance door.

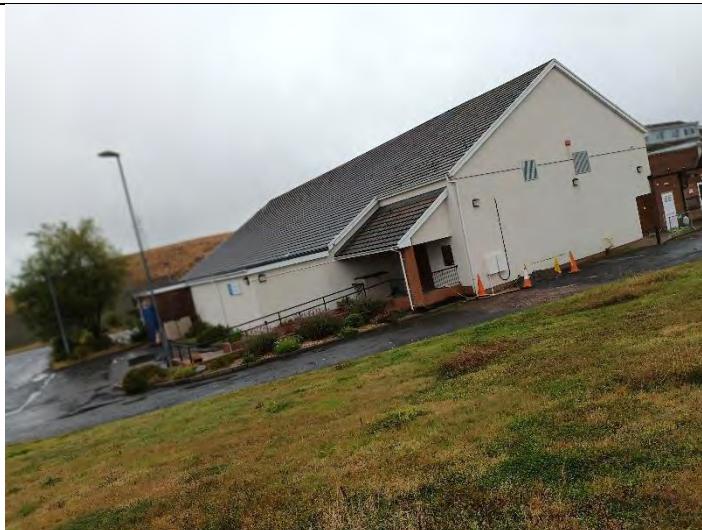
TN2

View looking south towards the proposed location of works where the section of flat roof meets the pitched roof.

Car parking and hardstanding present around the site building.

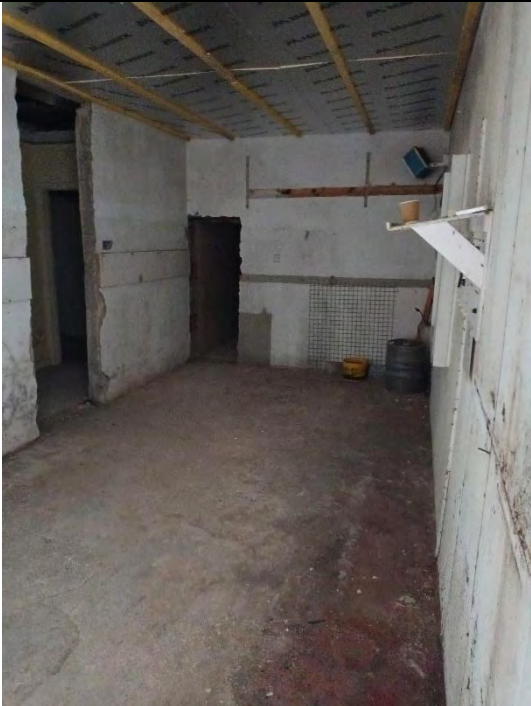
| TN3 | | <p>Room A-within flat roof section of the building.</p> <p>Insulation boards on ceiling.</p> <p>No evidence of bat use e.g. droppings on surfaces etc.</p> |

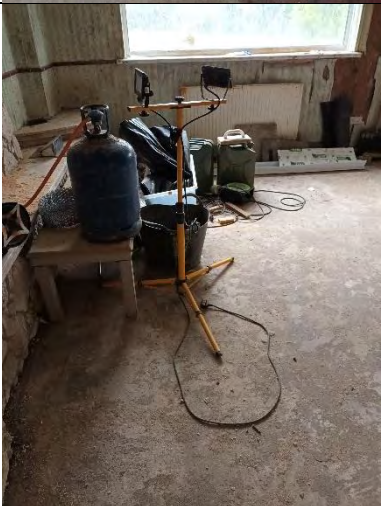
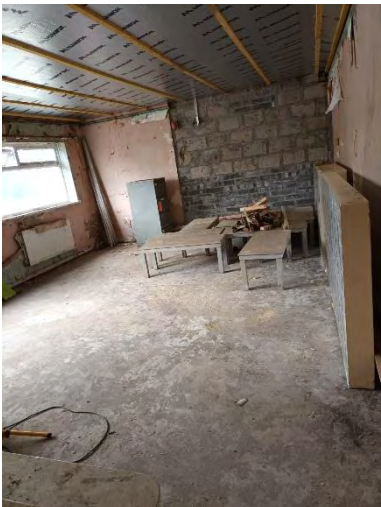
| TN4 | <br> | <p>Room B-within flat roof section of the building. Insultation boards on ceiling.</p> <p>No evidence of bat use e.g. droppings on windowsill/surfaces etc.</p> |

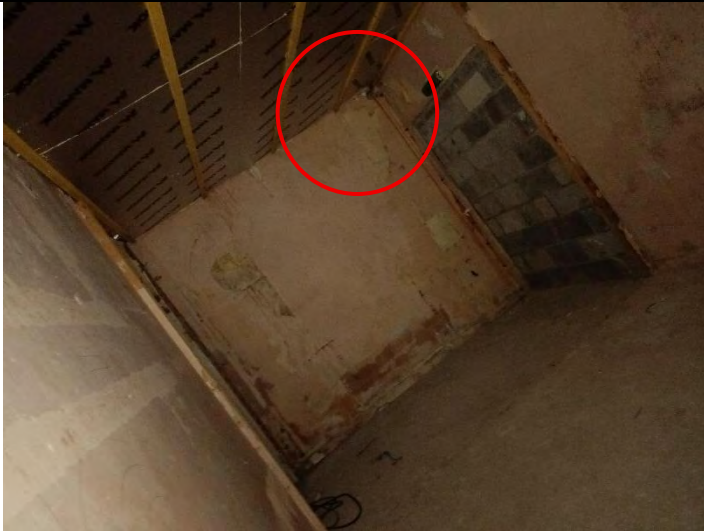
TN5

Roof C-partially within flat roof section of the building.

Insulation boards on ceiling.  
Previous doorway has been blocked up.

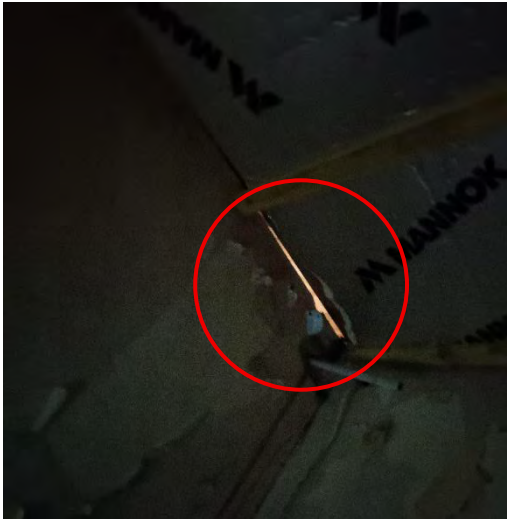
Small area of light ingress in the corner.

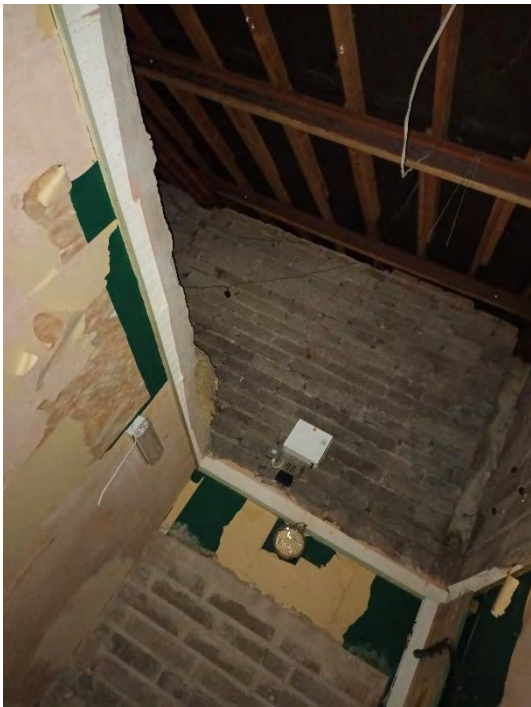
Roofing felt and battens etc visible.

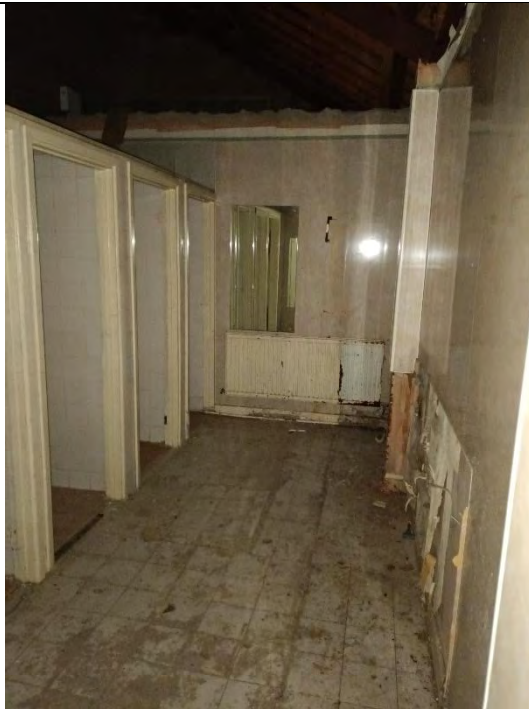
TN6

Room D-disused  
toilets.

No signs of bat use e.g.  
droppings noted on the  
floor.

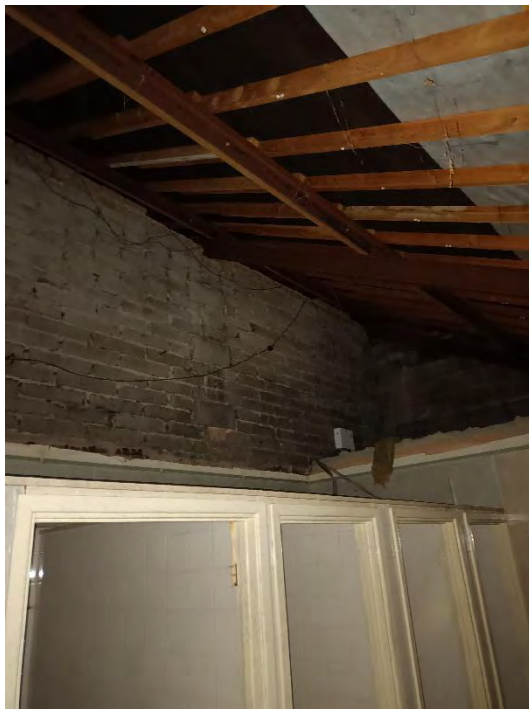
Roofing felt and batten  
exposed with no  
external light ingress  
noted.

Roofing felt appears to  
be bitumen 1f and  
good condition.

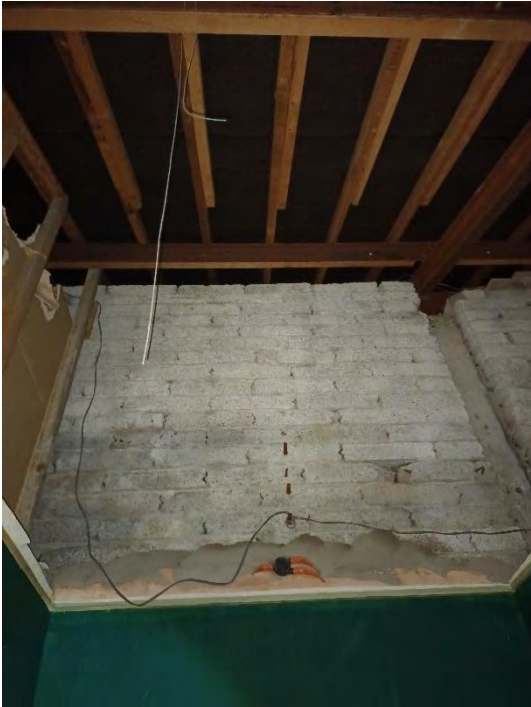
| TN7 | | <p>Room E- Roofing felt and battens exposed with no external light ingress noted.</p> <p>Roofing felt appears to be bitumen 1f and good condition.</p> |

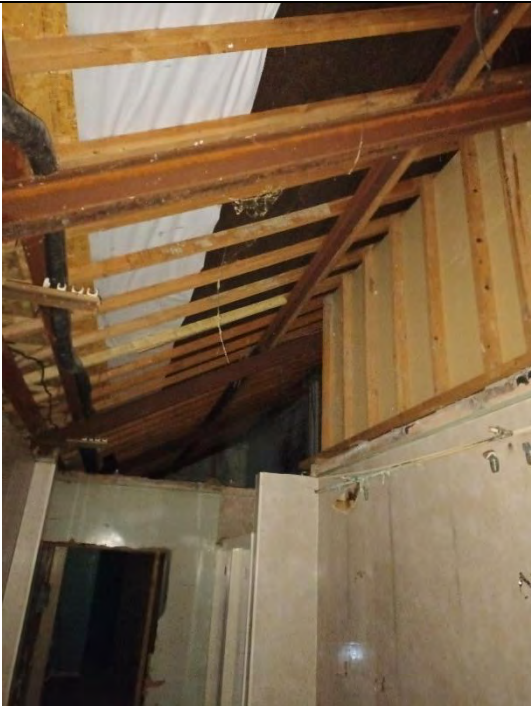
| TN8 | | <p>Room F-former toilet.</p> <p>Boarded section of roof space(right hand side of photograph)</p> <p>Roofing felt and batten exposed with no external light ingress noted.</p> <p>Roofing felt appears to be bitumen 1f and good condition.</p> |

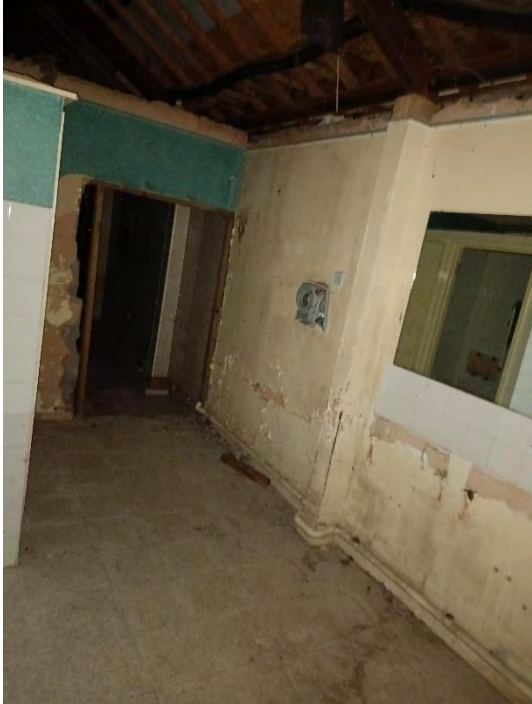
| TN9 | | <p>Room G-former toilets.</p> <p>Roofing felt and batten exposed with no external light ingress noted.</p> <p>Roofing felt appears to be bitumen 1f and good condition.</p> |

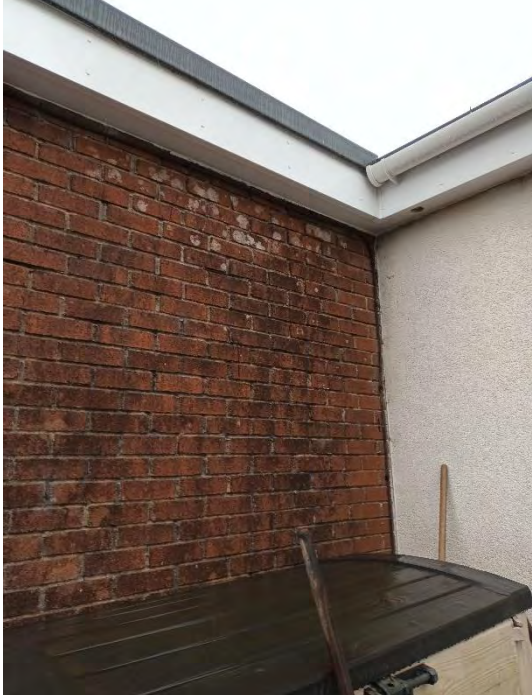
| TN10 | | <p>Red bricked wall. Flat roof.</p> <p>Facias/barge boards appear relatively new and intact. No obvious entry points.</p> |

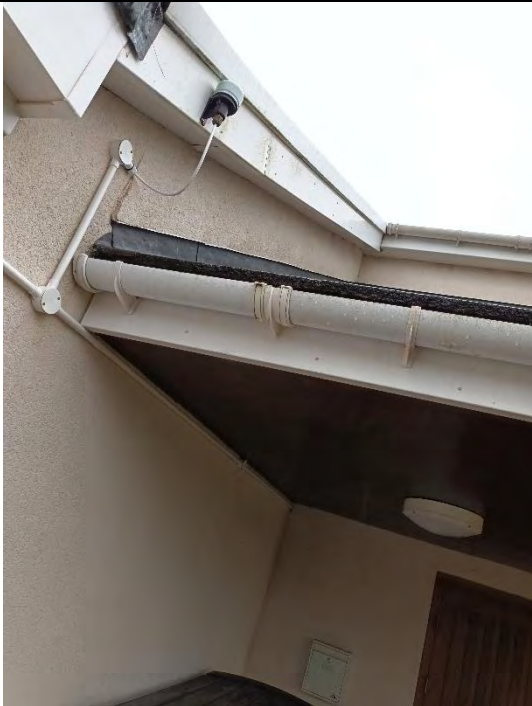
| TN11 | | <p>Entrance to the rear of the building.<br/>Lead flashing intact.<br/>No obvious entry points.</p> |

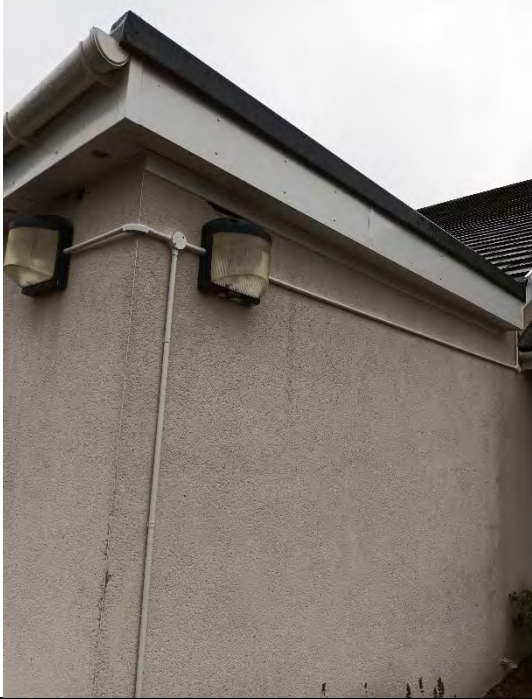
| TN12 | | <p>Small gap in masonry above the security light corresponding to the light ingress noted from within the building.</p> |

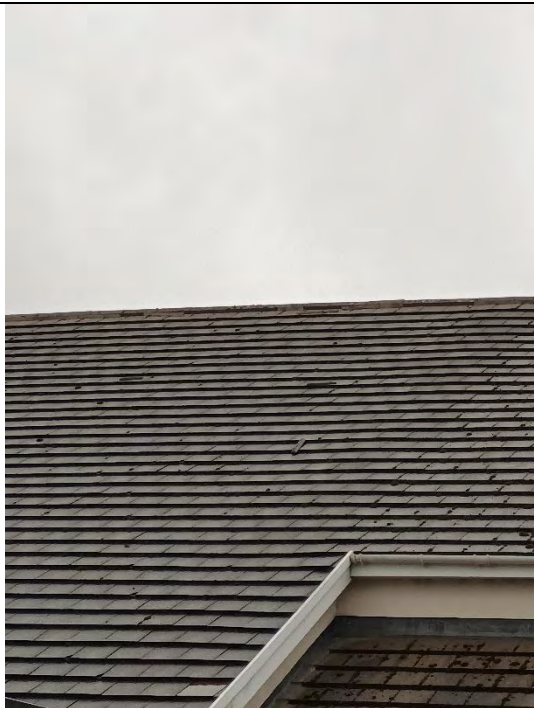
TN13

- 3.7 There appeared to be some missing cement along the ridge of the main roof away from the proposed development area although it was not clear (from ground view with binoculars) if this created any access points(TN13).
- 3.8 There are two security lights and a street light present in the location with the damaged render was noted (red circle).

Some raised/loose bit  
of cement present  
along the ridge of the  
roof.

No obvious  
raised/damaged tiles.
