CANOLFAN SOAR, MERTHYR TYDFIL  
CURRENT CONDITION  
FEBRUARY 2026

## CURRENT CONDITION & FABRIC ISSUES

This section outlines the observations obtained from the assessment of the fabric to the lower ground floor of the Canolfan Soar building undertaken on Friday 3rd February and Friday 17th February 2023.

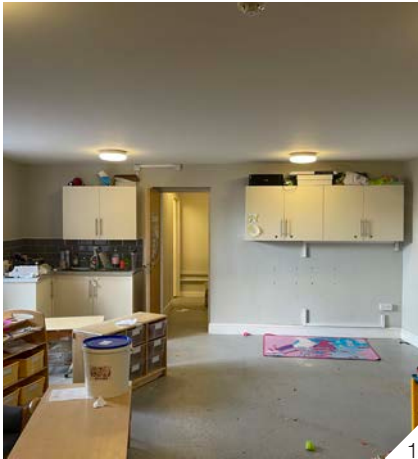
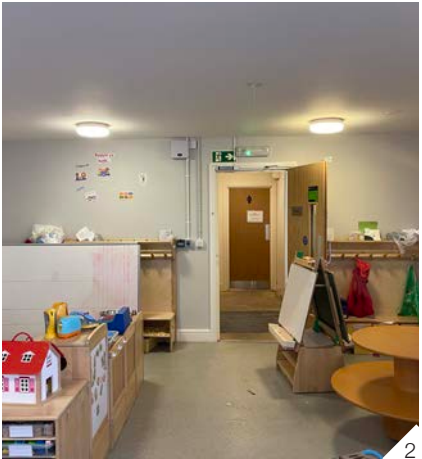
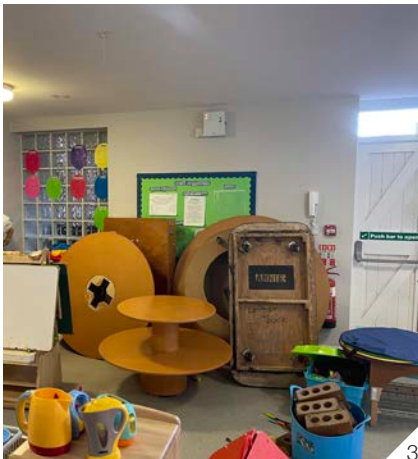
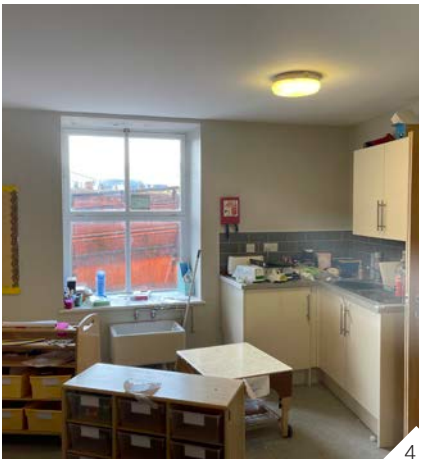
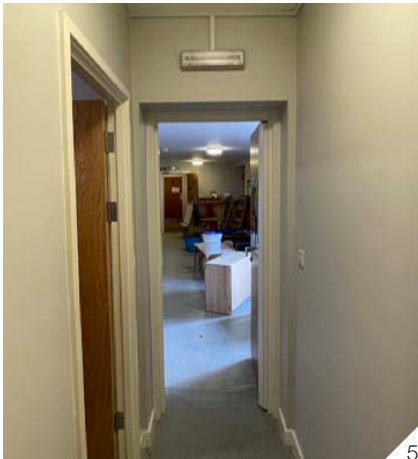
1. The Meithrin looking west towards the door opening that provides access into the corridor leading to the toilets, baby-change, and store. Kitchen type facilities are located to the SW corner of the space.
2. The Meithrin looking east towards the main central corridor.
3. The Meithrin looking south to the glazed blocks adjacent to the main Canolfan Soar stair and the external door which leads on to the south terrace.
4. The Meithrin has 1 no window located on the south wall.
5. The corridor that provides access to the ancillary spaces with the Meithrin beyond.

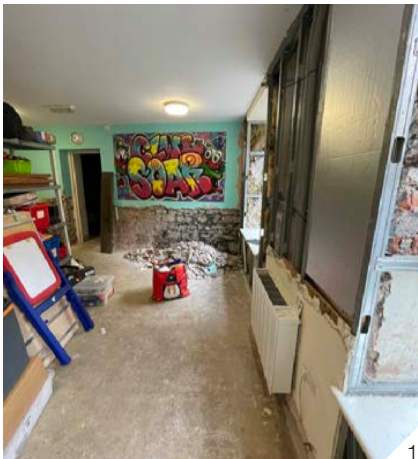
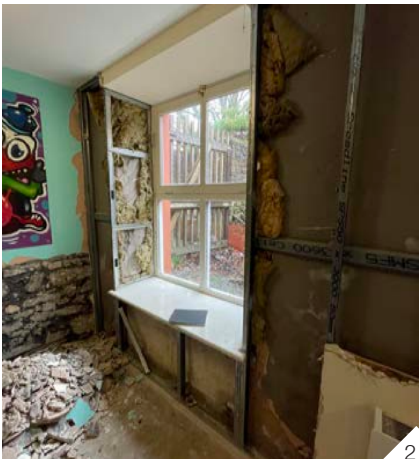
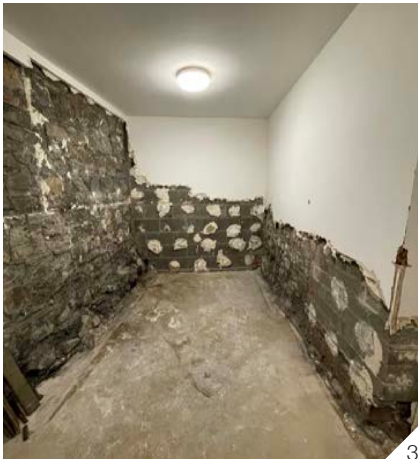
1. The Youth Room looking west where investigations have revealed that the walling is rubble stone wall, suggesting that the interior wall between the Youth Room and Storeroom is original. There is evidence of a modern block which suggests that the door opening location has been changed.

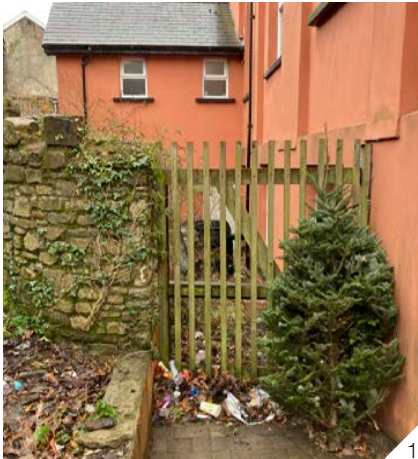
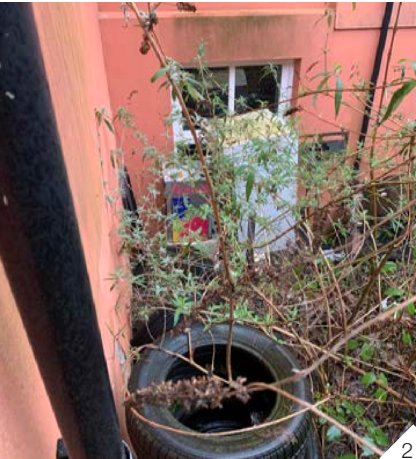
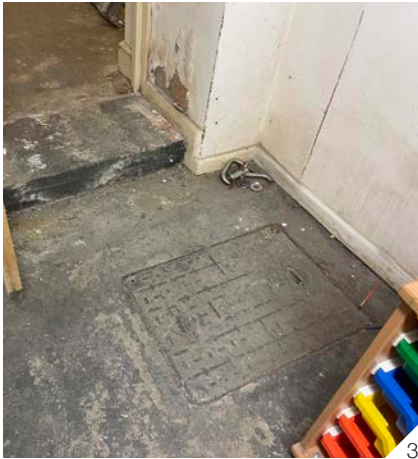
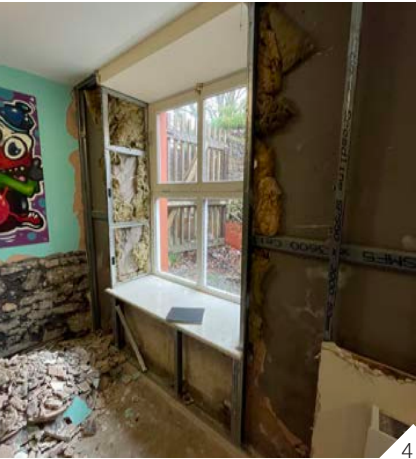
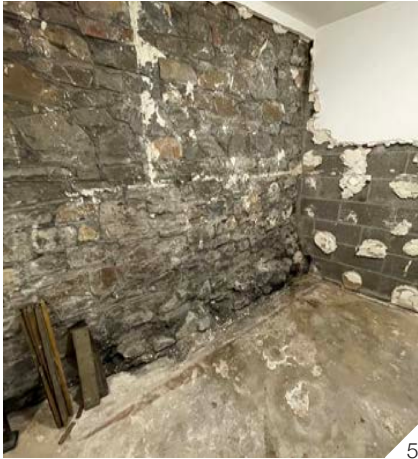
The original wall construction of the school building was a solid masonry wall built with local random rubble stone. Evidence suggests that the internal finishes were plastered surfaces and decorated. Most recently within the 2010 campaign of building works, the north wall of the Youth room has been remodelled to form a contemporary aesthetic and assumed desire to reduce thermal loss. The works appear to have included the interior face of the walls being over-cladded with metal studs which were then friction fitted with insulation and overlaid with plasterboard and skim. Prior to the investigations, these walls presented a small level of moisture transfer. From this initial assessment, it is believed that the north walls of the Youth room had been subject to the process of wetting at low level due to the raised ground conditions, with the transfer of moisture moving to the drier and warmer environment, the interior space. As the moisture connects with the modern impermeable materials, a process of evaporation and condensation occurs which presented as damp to the interior walls/floors.

1. North landscaped area to the north of the Youth Room.
2. View of the north landscaped area from the boundary wall.
3. Manhole located within the boiler room.
4. Investigations to the exterior north wall to the Youth room.
5. Investigation to the exterior north and west wall of the Storeroom.

Whilst the application of modern surface treatments to modern substrates is accepted, where there are raised ground conditions there should be an expectation that damp will migrate from the wet ground and through into the interior surfaces. However, where there is the application of modern impermeable materials on to solid stone masonry walls which are either partially submerged by the adjacent ground, or not, other defects will begin to arise as the solid masonry wall will not perform as originally intended.

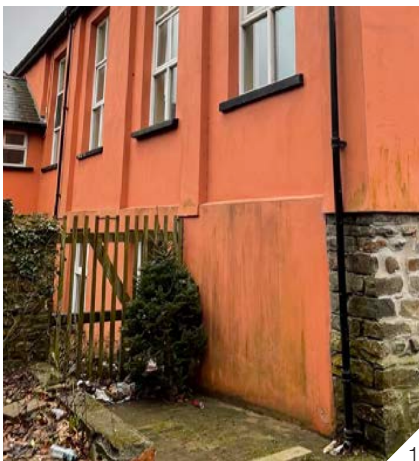
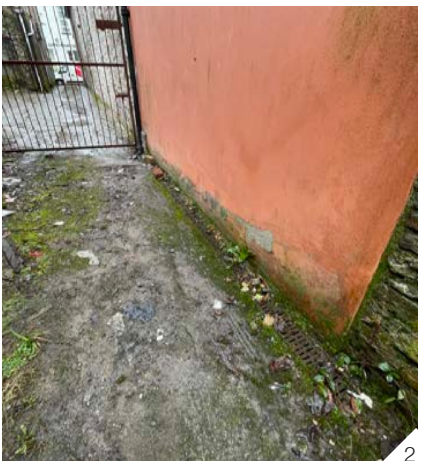
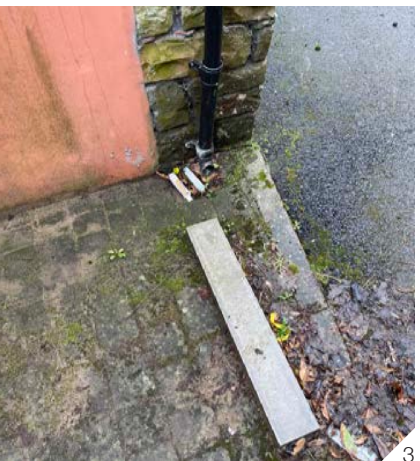
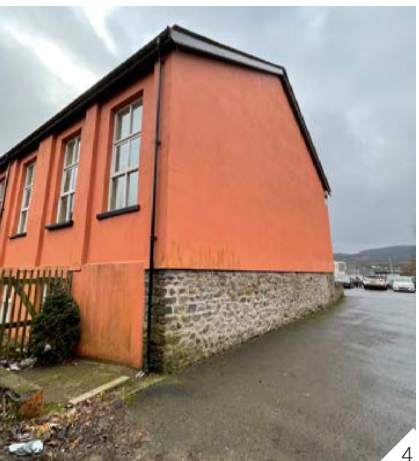
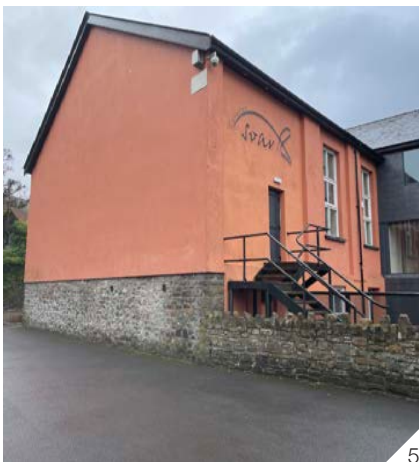
1. North elevation of the building with the lower ground floor featuring an offset projection to the external walls. The projection also appears to the south elevation.
2. Drain-slot located to the north wall of the boiler room/ladies toilets.
3. Downpipe to the NW corner of the building discharges into a gulley.
4. Exposed rubble stone to the base of the west wall.
5. Exposed rubble stone to the base of the west wall with the offset projection to the lower ground floor as seen on the north wall mirrored on the south wall.

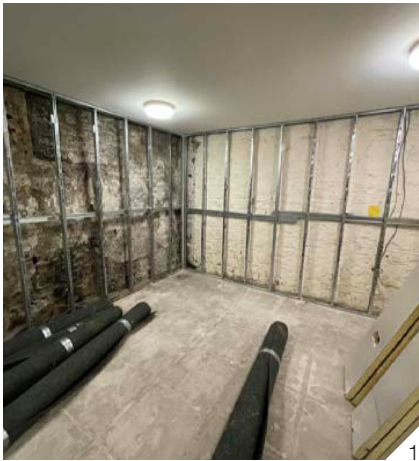
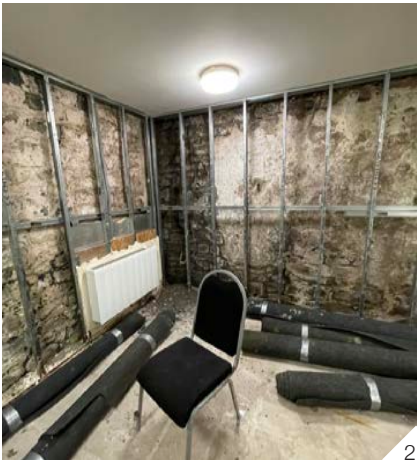
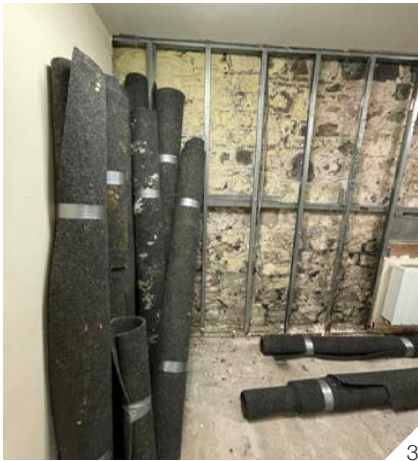
The removal of contemporary materials exposes several areas of hollows/ voids within the surface of the east wall and there is friable material within the northeast corner. There are also several cracks within the surface of the wall which should be investigated by a structural engineer.

The ventilation to this space is neither natural or mechanical and given that the space is below ground and is deep within the footprint of the building the lack of ventilation needs to be addressed.

Previous visits to the lower ground floor indicated that this room was in very poor environmental condition with a build-up of moisture ingress and condensation. Modern materials have been removed from this space to allow the historic structure to breathe which has greatly benefited this space, which now appears to be drier.

1. Meeting Room looking towards the SE corner of the space with exposed metal stud frame with original rubble stone wall behind. The south internal wall appears to be treated different in construction which may suggest a different date range. The east wall is a ground retaining wall and is below ground.
2. Meeting Room looking towards the NE corner of the room, There is a small amount of mortar/stone dust on the floor which is suggestive that the mortar is friable which may be related to the process of condensation/evaporation and general moist conditions.
3. Meeting Room looking towards the north wall which is in-between the boiler room and meeting room.

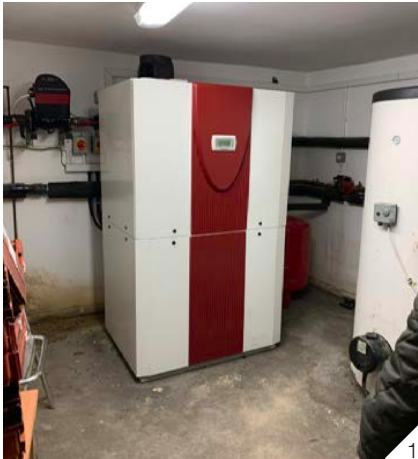
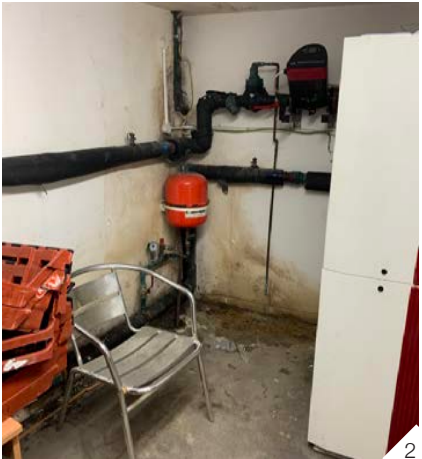
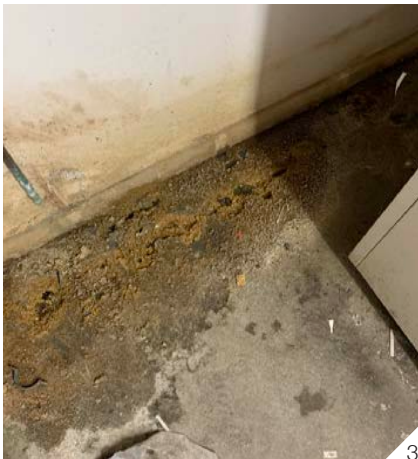
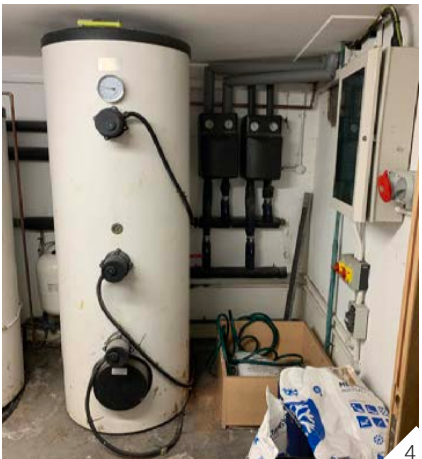
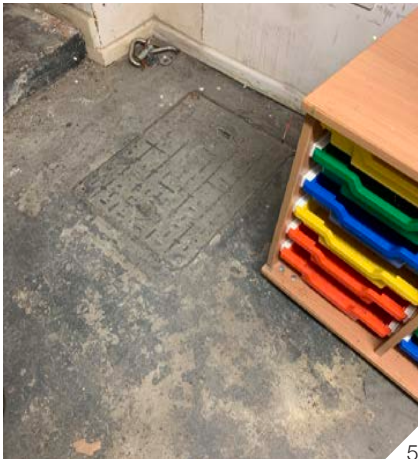
The internal finish to the boiler room appears to be a wet plaster system, which is indicating the presence of damp with the surface of the plaster and decorated finish spoiling, particularly on the north wall.

1. View of the equipment within the boiler room with the north wall to the background of the photograph. There is wet plaster applied over the stone and is showing minimal signs of disrepair.
2. Looking towards the NW corner of the boiler room with evidence of a dusting of debris to the floor slab.
3. Close-up image of the debris on the floor slab - it is not clear what this is caused by. It is assumed that there has been a leak within the system.
4. View of the equipment within the boiler room with the east wall to the background of the photograph. There is wet plaster applied over the stone and is showing minimal signs of disrepair.
5. Manhole cover in the slab.

The internal space of the boiler room is a small space (3.5 x 4m) which contains the equipment in connection with the ground heat recovery boiler system. It is recommended that a services engineer is appointed to inspect the existing services and how these connect with the upper floors and bore holes within the car park.
