*Report No. BC/MB/09.19.04.*

# **Coal Minig Risk Assessment: Land at the Top of Heolgerrig, Merthyr Tydfil.**

***Mr Alan James***

# **Coal Mining Risk Assessment: Land at The Top of Heolgerrig, Merthyr Tydfil.**

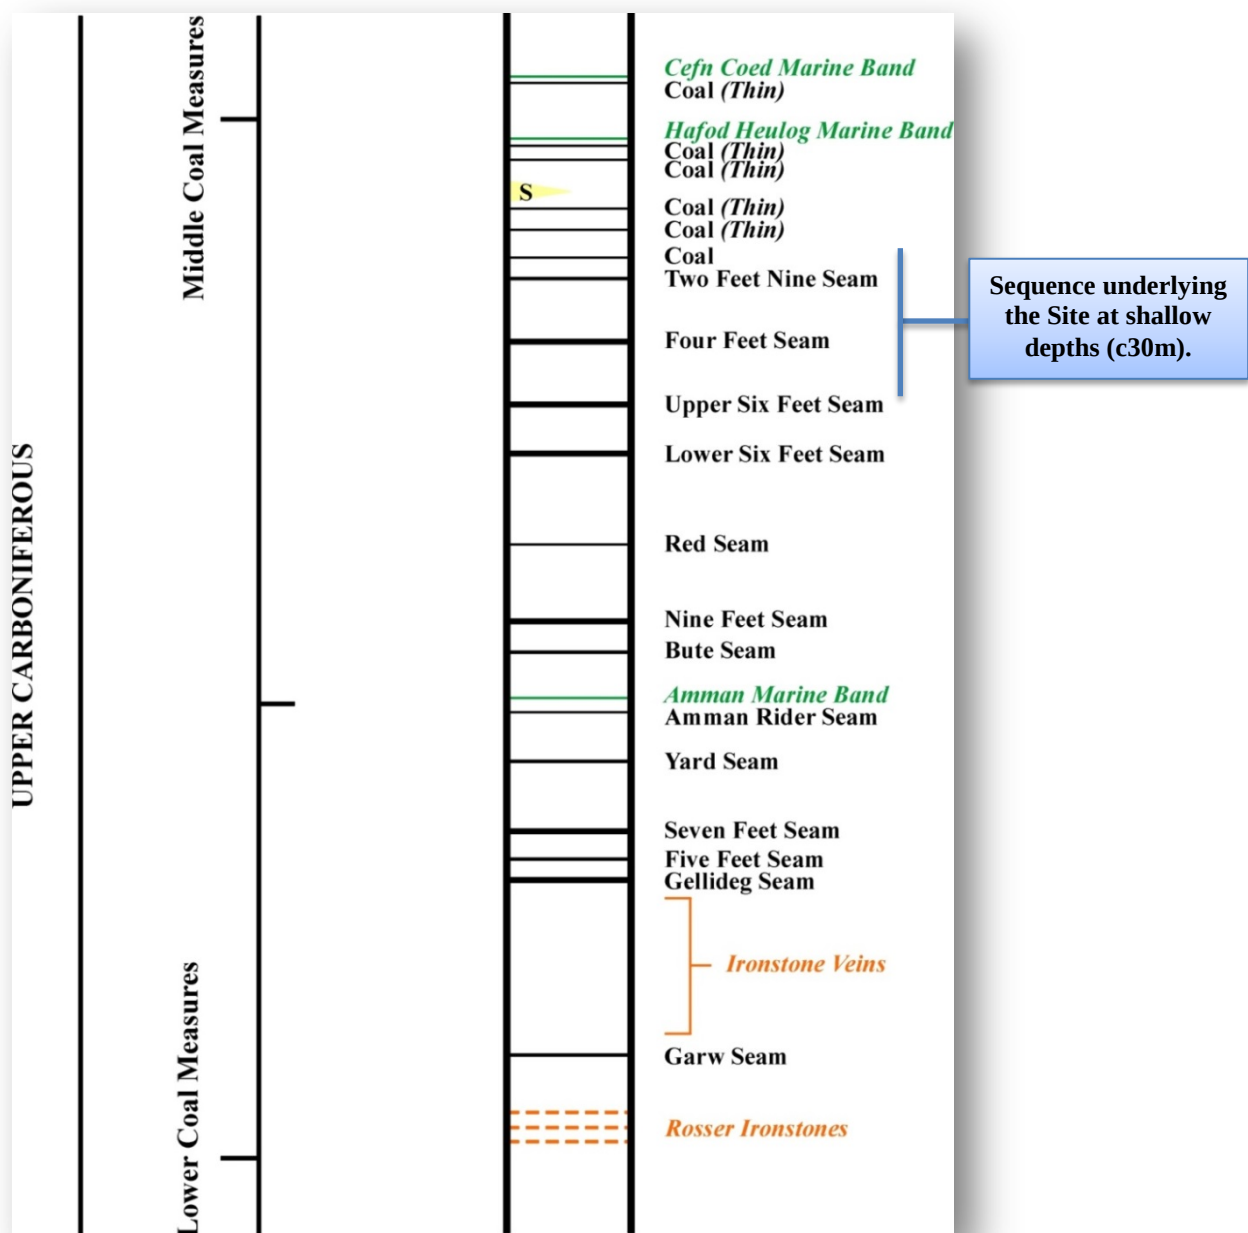
**Figure 2**  
**Part of the Stratigraphic Column.**  
 Scale: Not to Scale.

geological sheet (SO 00 NW at 1:10,560 scale) shows the outcrops of several coal seams crossing the district with a generally north-westerly trend. The inferred positions of the outcrops of the Two Feet Nine, Four Feet and Upper and Lower Six Feet Seams are shown to be present in close proximity to the Site with the inferred position of the outcrop of the Two Feet Nine Seam passing through the Site (see *Geology Plan*, drawing no. BC/MB/09.19.04.02).

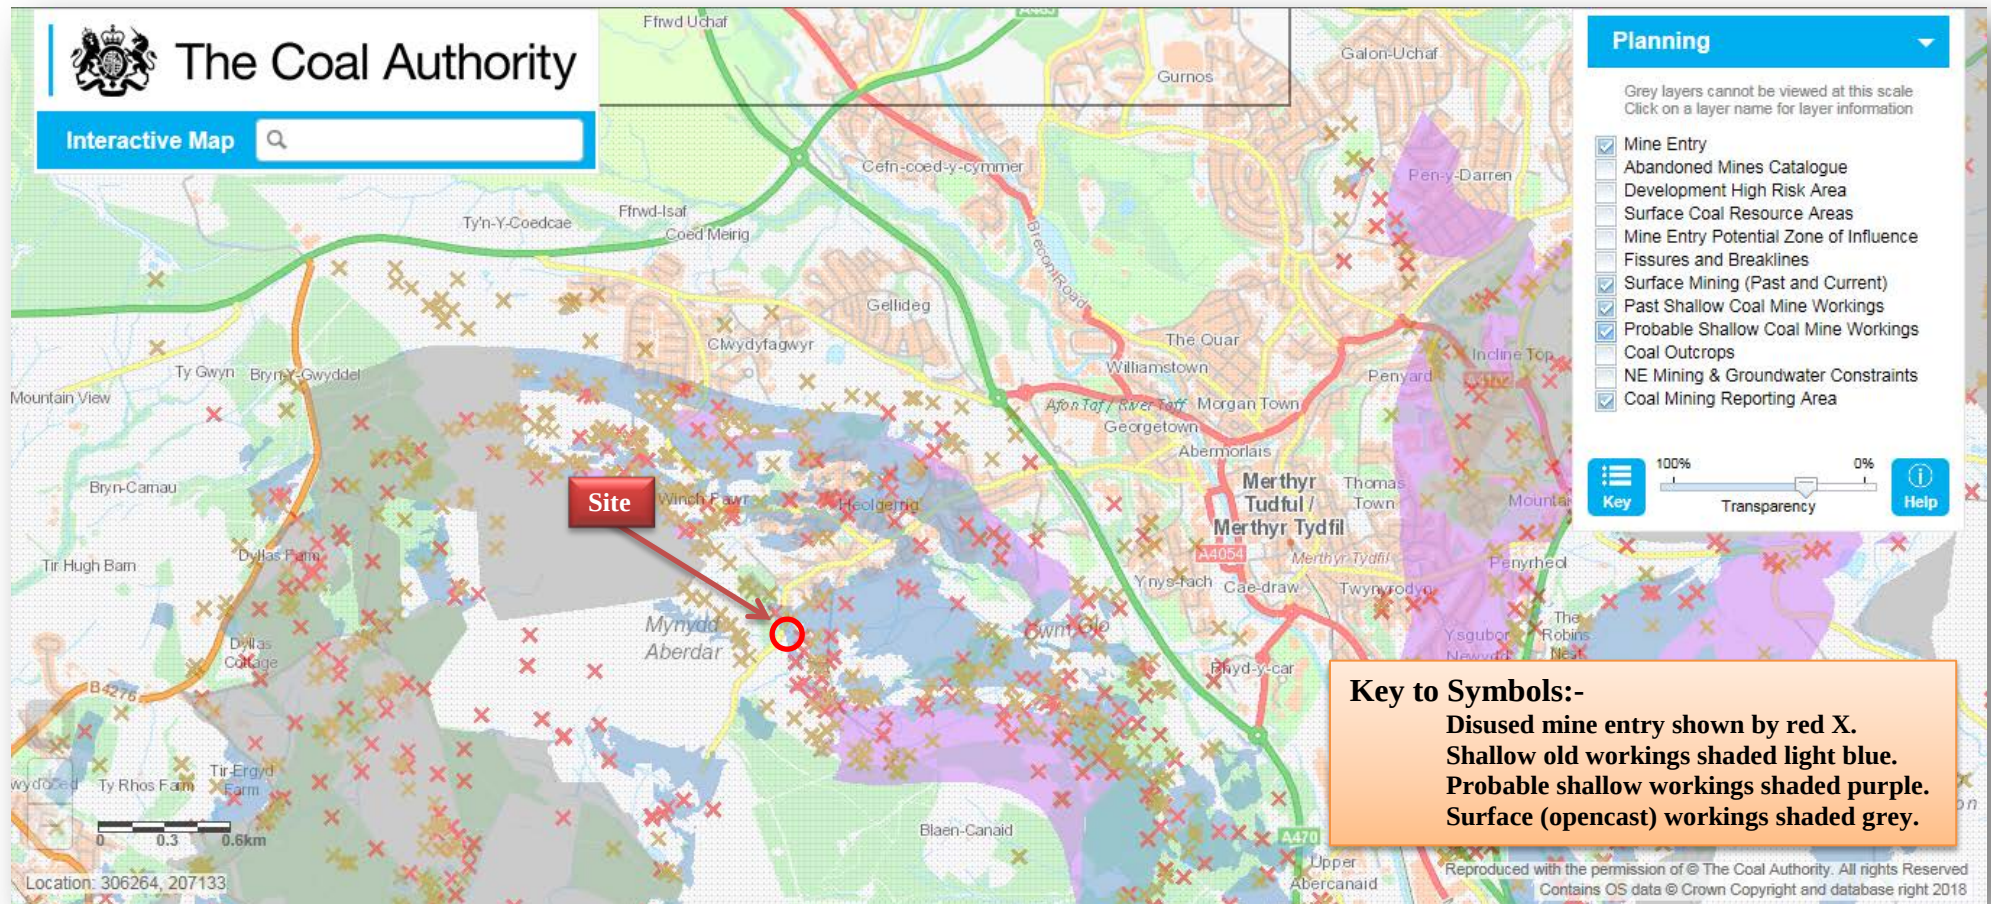
**Figure 3**  
**Copy of The Coal Authority's Interactive Map**  
 (accessed 16<sup>th</sup> September 2019)

The general area has experienced extensive underground operations for both coal and ironstone dating back to the early nineteenth century. Our searches identified old coal workings in the vicinity of the Site at depths ranging from shallow (less than 30m) to 200m; the last mining operations were in 1939. Mining records indicate that shallow old workings may be present beneath the Site in the Four Feet Seam. The Coal Authority's mining report refers to the presence of shallow mine workings and The Coal Authority's interactive map shows shallow mine workings to be present beneath the Site (see Figure 3).

The locality has experienced extensive mining operations for both coal and ironstone, most of which are of an age and/or are at depths such that they will not affect the structural integrity of the proposed dwelling. The Four Feet Seam has been extensively mined across the area and the Seam, and any old workings in it, are at shallow depths beneath the Site. It is recommended that exploratory boreholes are drilled on the Site in order to determine the details of any old workings that may be found to be present in order to assess in greater detail the risk from shallow mine workings.

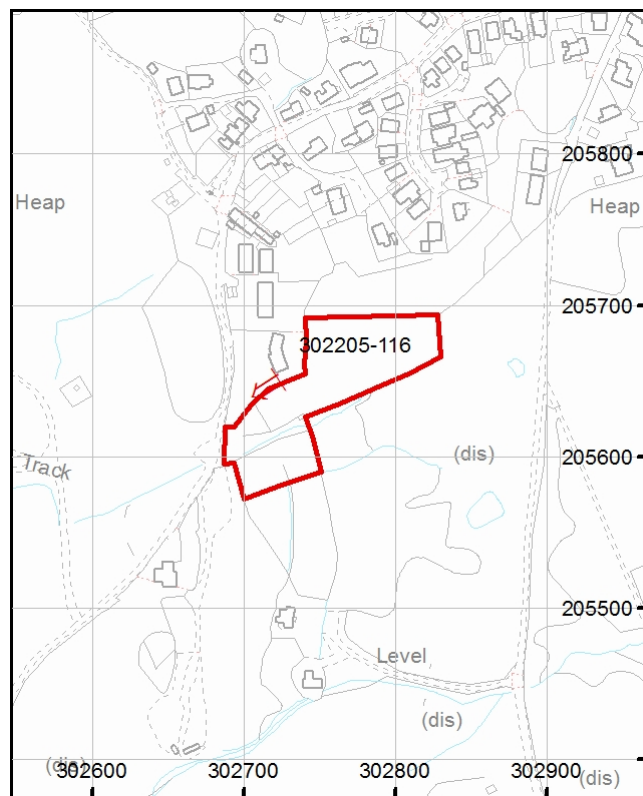
# Enquiry boundary

Within, or within 20 metres of, the boundary of the property there is 1 mine entry, the approximate position of which is shown on the enquiry boundary plot. For reasons of clarity, mine entry symbols may not be drawn to the same scale as the plan.

There is no record of what steps, if any, have been taken to treat the mine entry.
