Purcell & Mann Williams  
on behalf of MTCBC

## 1.0 Roof

### *Opening Up*

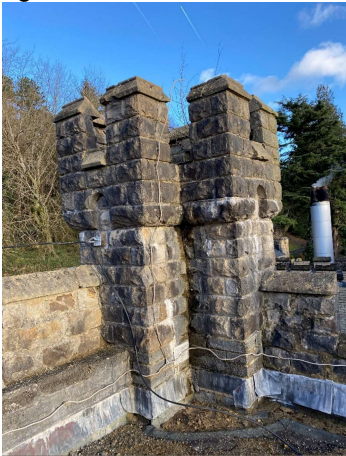
#### 1.1 Roof R2.23. Tower/Merlon & Parapet

Ascertain extent of water penetration to mortar flaunching detail and whether lead apron/flashing is continuous through masonry.

Remove vegetation and break out cementitious/bituminous roof covering to tower/merlon (c.1sqm)

Dismantle roof covering of tower/merlon and section of parapet (c.1lin.m)

The structure will need to be rebuilt to match the existing appearance. However the exact method of rebuilding will require discussion and agreement with Cadw following the investigation works. As the current detailing is failing, it is likely that some improvements to the detailing will be required in order to shed water from the structure more effectively. It is suggested that a condition be attached to the LBC to require detailed drawings and a specification for the reinstatement works, within an agreed time scale.

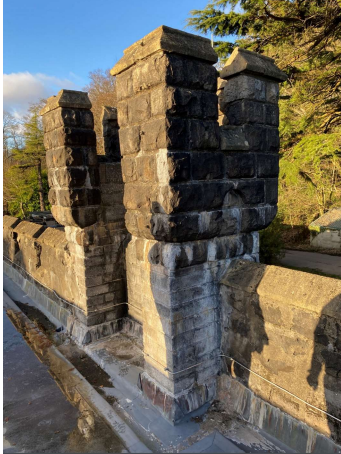
#### 1.2 Roof R1.3. Tower/Merlon

Ascertain cause of water penetration through tower to lower levels and whether lead apron/flashing is continuous through masonry.

Dismantle centre of tower/merlon and open up roof (c.1sqm)

The structure will need to be rebuilt to match the existing appearance. However the exact method of rebuilding will require discussion and agreement with Cadw following the investigation works. As the current detailing is failing, it is likely that some improvements to the detailing will be required in order to shed water from the structure more effectively. It is suggested that a condition be attached

to the LBC to require detailed drawings and a specification for the reinstatement works, within an agreed time scale.

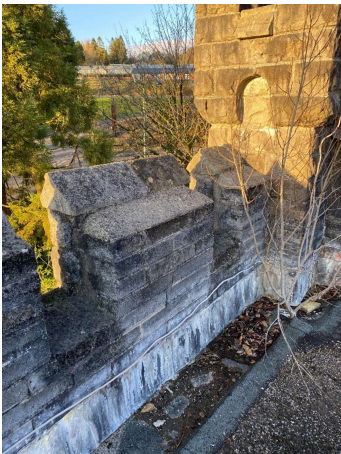
### 1.3 Roof R2.20. Parapet

Ascertain extent of water penetration and whether lead apron/flashing is continuous through masonry.

Dismantle section of concrete blockwork to parapet (c. 1lin.m) to

The structure will need to be rebuilt to match the existing appearance. However the exact method of rebuilding will require discussion and agreement with Cadw following the investigation works. As the current detailing is failing, it is likely that some improvements to the detailing will be required in order to shed water from the structure more effectively. It is suggested that a condition be attached to the LBC to require detailed drawings and a specification for the reinstatement works, within an agreed time scale.

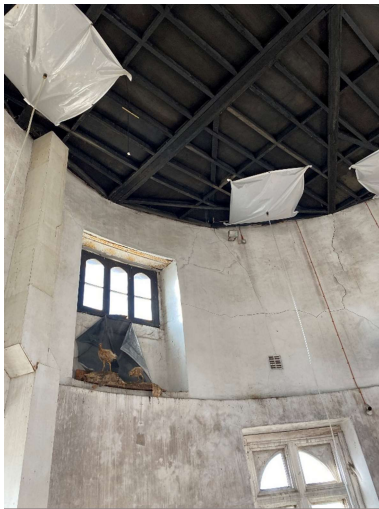
### **2.1 Ceiling**

To allow inspection of rafter ends

Remove plaster at high level (c.2sqm)

If exposed timbers are found to be in good repair, the plaster finish will be reinstated to match the existing materials and finish. If they are not in good condition, a repair strategy will need to be agreed with Cadw. It is suggested that a condition be attached to the LBC to require a detailed specification for the reinstatement works, within an agreed time scale.

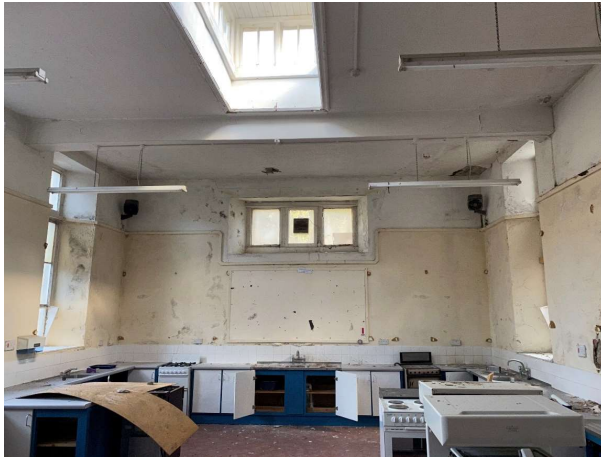
### **3.1 Room 1.09A. Wall**

Ascertain water penetration to, and condition of, tower

Remove plaster from wall (c.4sqm)

If exposed area is subject to ongoing water saturation, a repair strategy will need to be agreed with Cadw. It is suggested that a condition be attached to the LBC to require a detailed specification for the reinstatement works, within an agreed time scale.

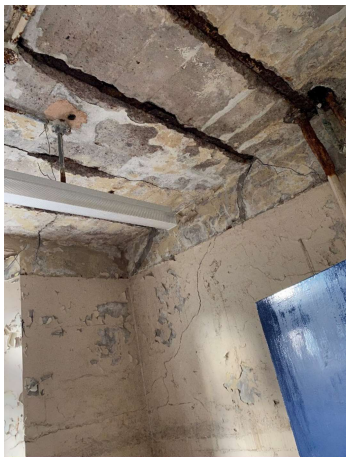
### 3.2 Room 1.59. Wall

Remove plaster (c.2sqm) to expose fracture in wall from service outlet to 150 past filler joist

Inspect condition of structural steelwork

A repair strategy will need to be agreed with Cadw. It is suggested that a condition be attached to the LBC to require a detailed specification for the reinstatement works, within an agreed time scale.

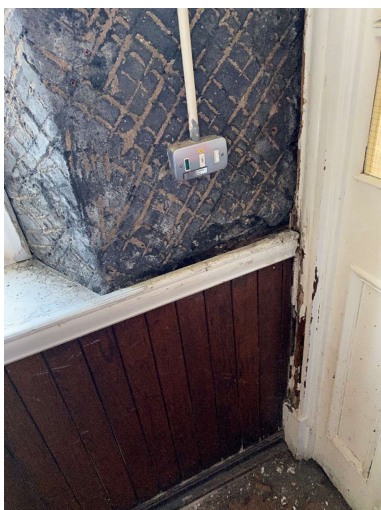
### 3.3 Room 1.31D. Wall

Ascertain extent of dry rot

Remove timber wainscoting to expose timber grounds (c.2sqm)

A repair strategy will need to be agreed with Cadw. If dry rot is found, it may be necessary to leave this area exposed. It is suggested that a condition be attached to the LBC to require a detailed specification for the reinstatement works, within an agreed time scale.

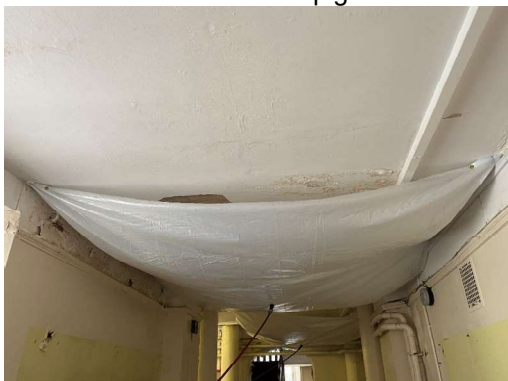
**3.4 Room 1.31B. Ceiling****Task**

Inspect condition of structural steelwork

Remove pig sacks and hardboard/Masonite ceiling panels (c.5sqm) to

Reinstatement of ceiling finish could be subject to LBC condition (unlikely to be matching hardboard/masonite ceiling panels).

Need for reinstatement of pig sacks to be determined on site, in discussion with Cadw.

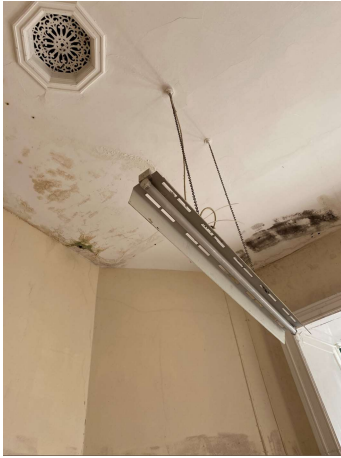
**3.5 Room 1.50. Ceiling****Task**

Remove plaster (c.1sqm) to corner where damp evident

Inspect condition of timber structure over

Reinstate pig sacks following inspection

Reinstatement of ceiling finish could be subject to LBC condition. Need for reinstatement of pig sacks to be determined on site, in discussion with Cadw.

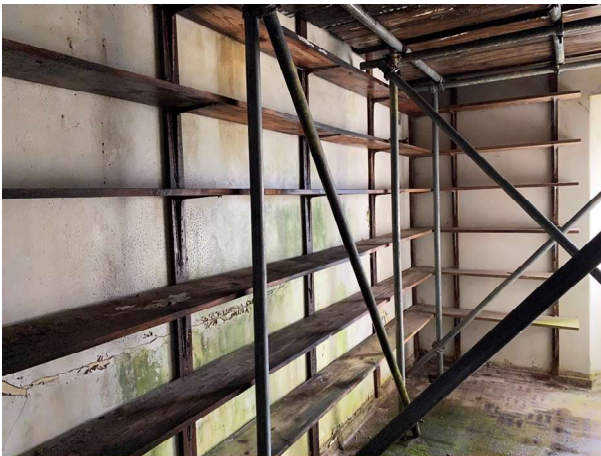
### 3.6 Room 1.24. Wall

Ascertain extent of horizontal crack

Remove plaster (c.6sqm) to wall

A repair strategy will need to be agreed with Cadw. It is suggested that a condition be attached to the LBC to require a detailed specification for the reinstatement works, within an agreed time scale.

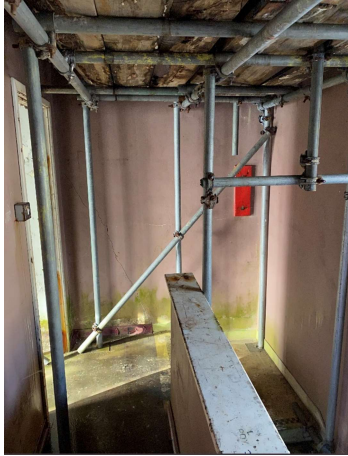
### 3.7 Room 1.22. Wall

To inspect steel bearing

Remove plaster (c.1sqm)

A repair strategy will need to be agreed with Cadw. It is suggested that a condition be attached to the LBC to require a detailed specification for the reinstatement works, within an agreed time scale.

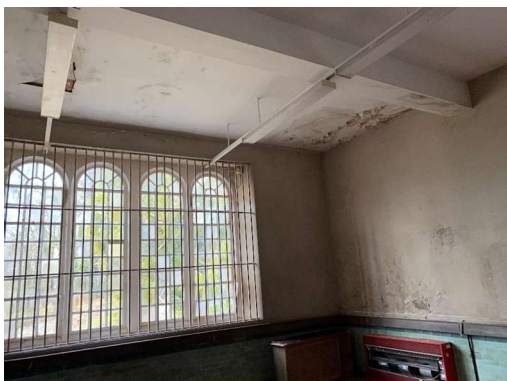
### 3.9 Room. 1.07 Wall

Ascertain extent of horizontal crack adjacent to lintel

Remove plaster (c.1sqm) to lintel end right of window

A repair strategy will need to be agreed with Cadw. It is suggested that a condition be attached to the LBC to require a detailed specification for the reinstatement works, within an agreed time scale.

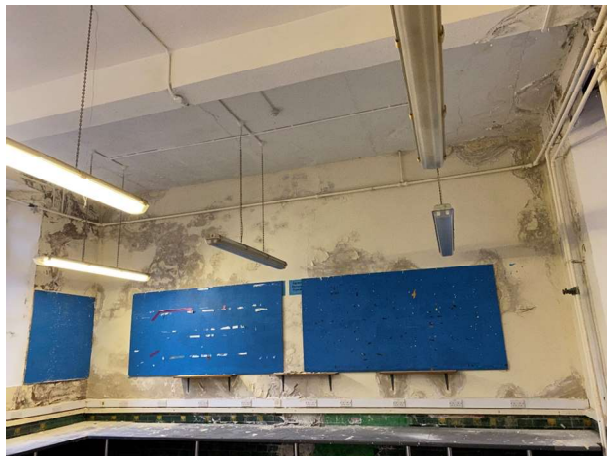
#### 4.1 Room 0.09. Ceiling

To inspect filler joist structure

Remove plaster (c.1sqm)

A repair strategy will need to be agreed with Cadw. It is suggested that a condition be attached to the LBC to require a detailed specification for the reinstatement works, within an agreed time scale.

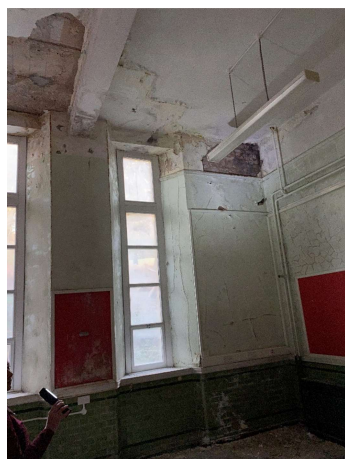
#### 4.2 Room 0.17. Wall

Ascertain water penetration to tower base

Remove faience/tiled wainscoting (c.2sqm) and take-down masonry to allow inspection of tower core.

Install temporary works to facilitate as required (TBC)

A repair strategy will need to be agreed with Cadw. It is suggested that a condition be attached to the LBC to require a detailed specification for the reinstatement works, within an agreed time scale.

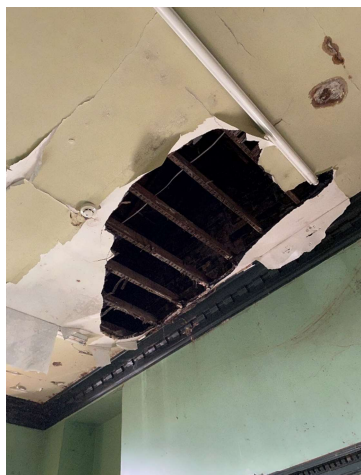
#### 4.3 Room 0.58. Ceiling

To inspect for dry rot – note most plaster in this room has failed

Remove plaster (c.2sqm)

A repair strategy will need to be agreed with Cadw. It is suggested that a condition be attached to the LBC to require a detailed specification for the reinstatement works, within an agreed time scale.

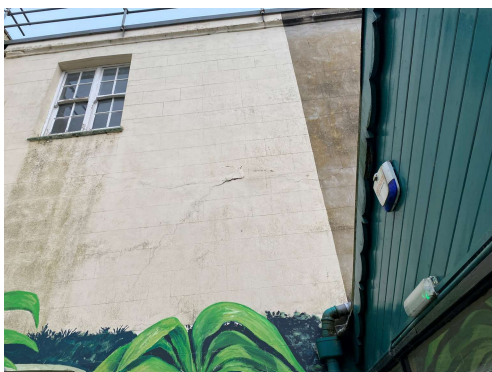
#### 4.4 Courtyard 0.68. Wall

Remove render to horizontal crack (c.2sqm)

To ascertain extent of damage to structure

A repair strategy will need to be agreed with Cadw. It is suggested that a condition be attached to the LBC to require a detailed specification for the reinstatement works, within an agreed time scale.
