*Report No. BC/MB/09.17.02/2.*

# **Site Investigation Report: Land at Goatmill Road, Dowlais, Merthyr Tydfil.**

**M. DeLacey and Sons (Holdings) Ltd.**

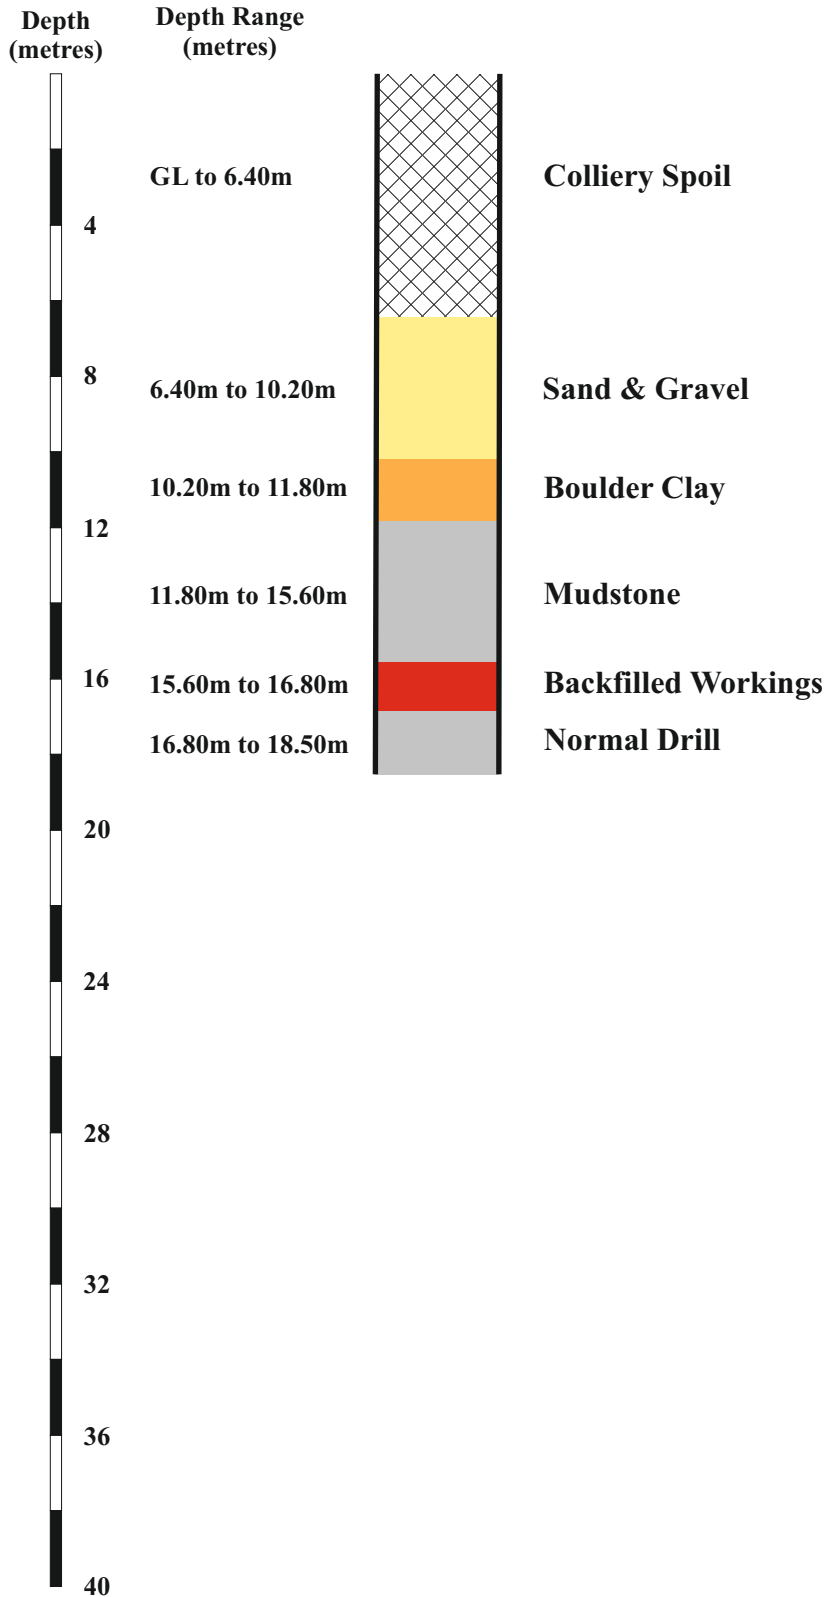
### *Borehole No. 3*

The middle coal seam horizon was encountered with its base at depths of between 16.80m and 21.60m, the coal seam was variously found to be a single leaf of coal and elsewhere was found to be made up of two leaves of coal. The seam was found to have been partially or completely worked in Borehole 3, 5, 6 and 7.

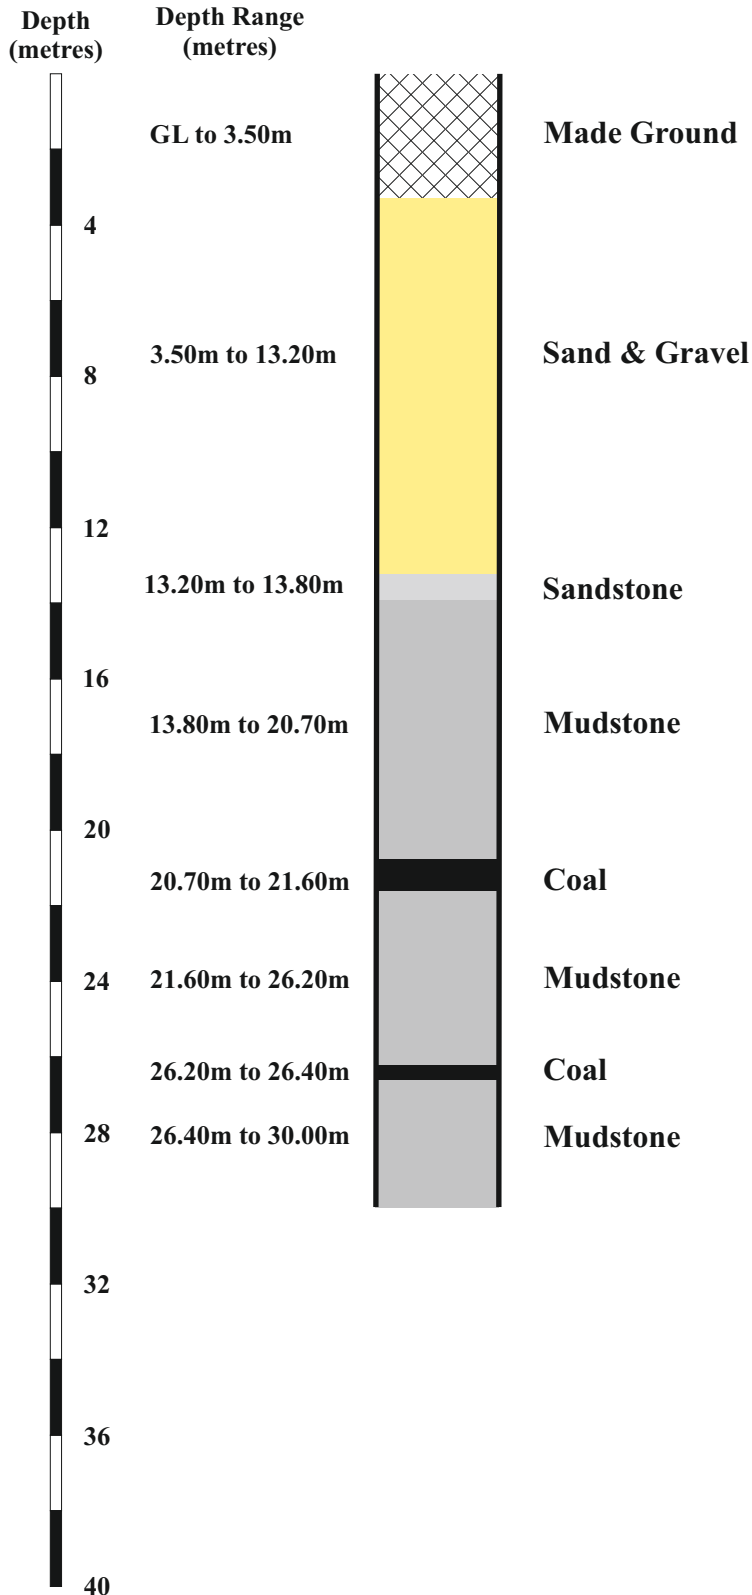
### *Borehole No. 4*

The lowest of the three coal seam horizons was encountered only in Borehole 4, 1.20m of coal at 26.40m. The seam was not encountered in other boreholes that were deep enough to have intersected it, the seam may be subject to washout conditions.

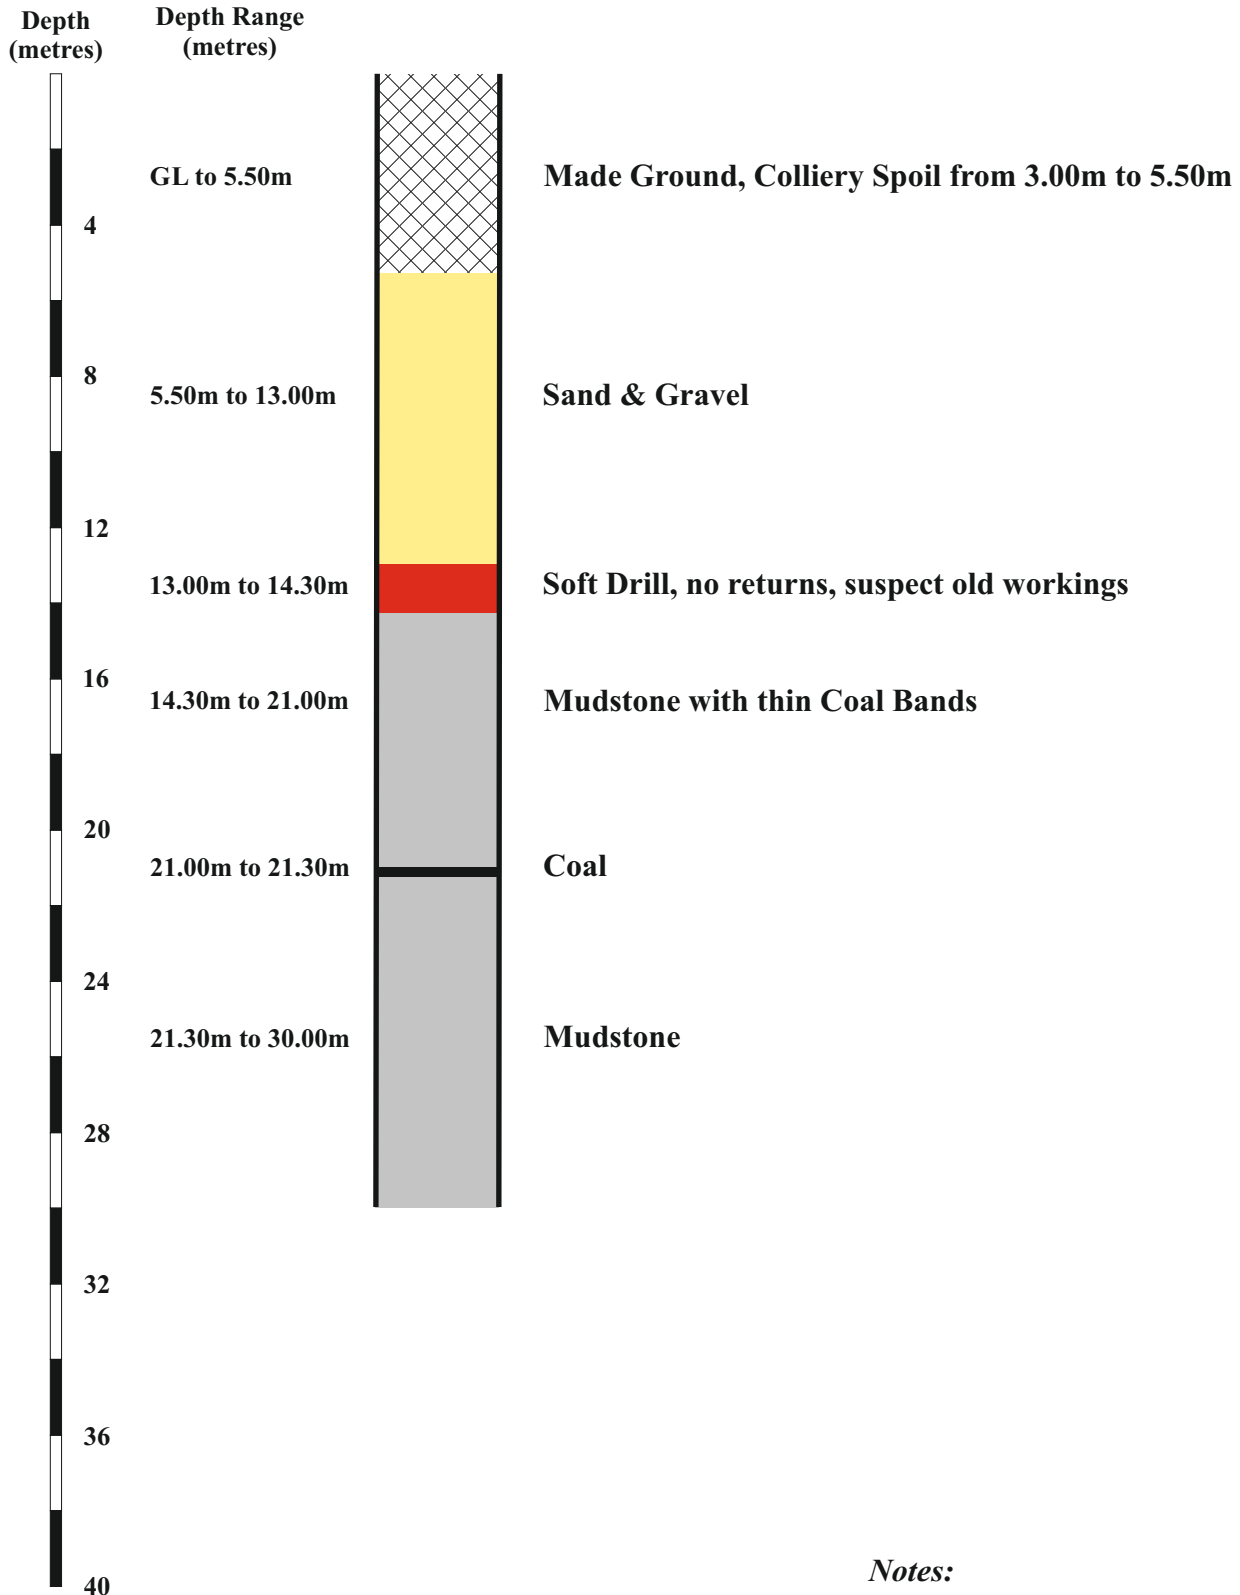
### Borehole No. 8

Three coal seam horizons were encountered in the boreholes. The upper horizon was encountered only in Borehole 8, where 1.30m of soft drilling with no air returns was encountered immediately beneath the base of the Sand and Gravel deposit. It would have been exceptionally difficult to have mined coal up to the base of the Sand and Gravel deposits and the finding is not conclusively backfilled old workings.

In the upper coal seam horizon suspected old workings were encountered only in Borehole 8, where 1.30m of soft drilling with no air returns was encountered immediately beneath the base of the Sand and Gravel. It is not clear that the soft drilling indicates the presence of backfilled old workings because it would have been exceptionally difficult to have mined coal up to the base of the Sand and Gravel deposits. The horizon was encountered only in Borehole 8, so that the seam would be at outcrop within the Site. Any old workings at this horizon would carry an extremely high risk of them collapsing to the base of the sand and gravel deposits and inducing subsidence at the surface.
