TREE REPORT (For application for works) DATE: 17/01/2025

SITE : TREDERWEN (OFF BRONDEG) HEOLGERRIG MERTHYR TYDFIL CF48 1TR

TREE SPECIES : Oak (*Quercus robur*)

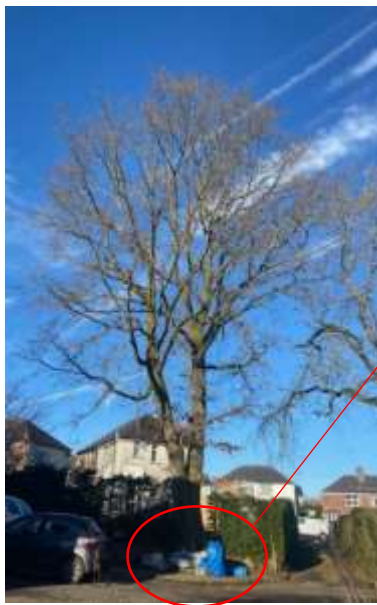
Description ;; Single main stem that forks at 2.8m . Some evidence of historical damage to surface **roots** and some compaction within rooting area although no apparent diseased or dying roots as evidenced by firmly attached live bark at root/stem zone. Building materials stored within root zone that could lead to sand and fines being washed into ground affecting soil structure and gaseous exchange properties.

Building materials stored within rooting area (Photo 1)

Remove building materials from rooting area and de compact soils around base of tree and define edge of driveway/parking area to reduce compaction. Add 40-50mm composted bark mulch to soils within defined area

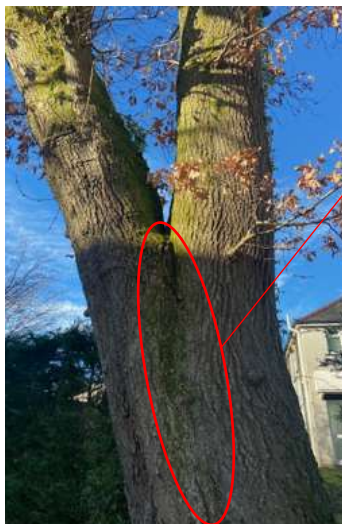
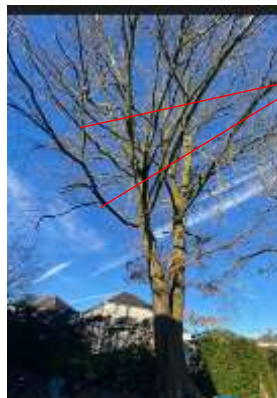
**Main stem** appears sound at base some ridging associated with fork at 2.8m which may indicate some weakness and movement between the two stems and potential weakness (Photo 2)

Reduce overall tree by 3 – 4 m to reduce weight loading on forK in stem

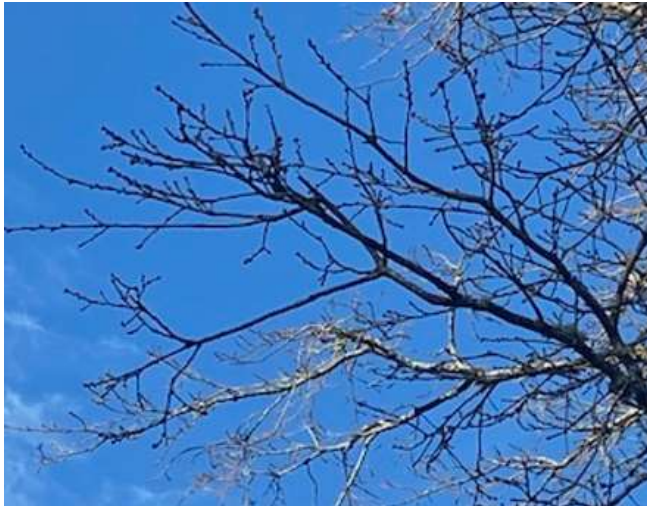
End loaded limbs developing over property (Photo 3)

Shorten or remove vulnerable damage or overly end loaded limbs

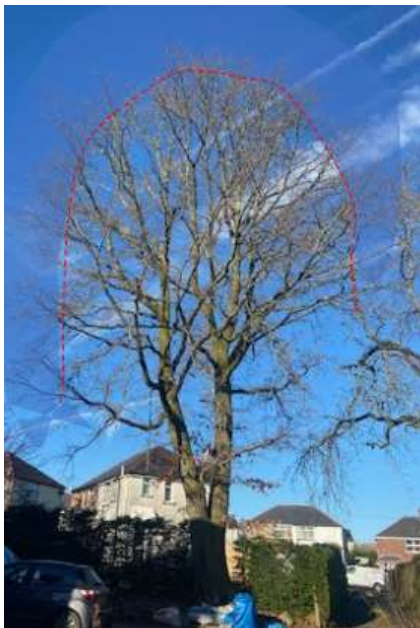
Illustration of Approximate extent of reduction proposed
