**Goitre Coed Fach Farm, Goitre Coed Road, TREHARRIS, CF46 5BB**

**Agricultural Barn**

**Structural Inspection Report**

## **Steve Morgan Associates**

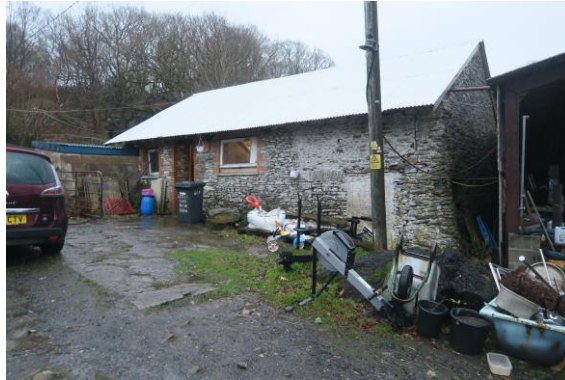
There are several existing doors and windows in this elevation that are framed in brickwork and have timber lintels that support the wall and / or roof over depending on the location. There are other, infilled openings, towards the south end, and a crack towards the upper section of the wall adjacent to the corner; this is possibly associated with the former openings and there is a straight, un-bonded joint internally at the corner.

**EAST ELEVATION: NOTE BRICK SURROUND TO OPENINGS AND  
INFILLED OPENINGS AT SOUTH END:**

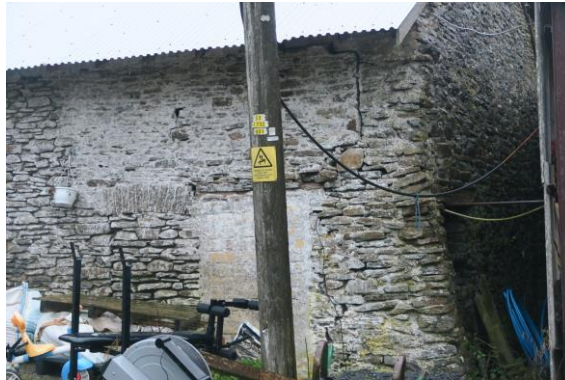
**EAST ELEVATION / SOUTH END: NOTE INFILLED  
OPENINGS AND CRACK IN UPPER SECTION:**

- (h) Internally and externally, the stonework will require careful raking out and re-pointing. There are a number of areas that will require more intensive work. Areas may require to be re-built with stones tied across the cracks or bonding by the insertion of specialist sock anchor ties from the outside.

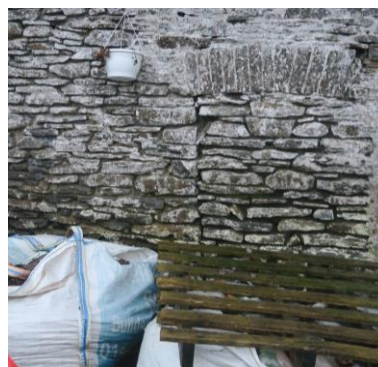
**EAST ELEVATION / SOUTH END: NOTE INFILLED  
OPENINGS WITH STRAIGHT JOINT:**

- (v) There are a number of areas of existing infill that have straight joints that are not adequately bonded to the walls at the side, this also applies at corners. It is important that walls have structural continuity, and this can be achieved by cutting out and re-bonding or introducing mechanical or resin ties across the joints. Where walls are to be exposed the former proposal is most applicable whilst at corners where two walls meet, a form of tie bars would be preferred.

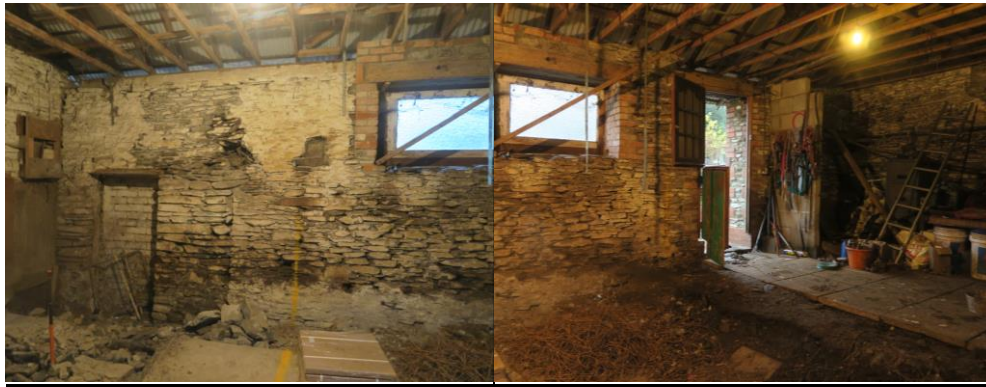
**EAST ELEVATION INTERNAL: NOTE INFILLED OPENINGS WITH STRAIGHT JOINT AND STRAIGHT JOINT AT CORNER:**

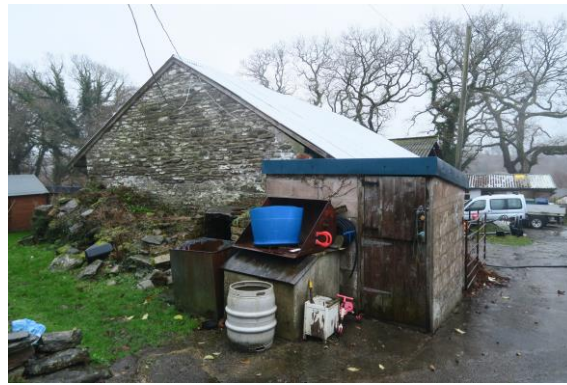
This elevation is a gable wall at the higher level and is partially concealed externally by stone rubble along the lower level. There is some banding of a paler coloured stone that maybe associated with a previous structure. Internally the wall shows evidence of a possible redundant fireplace. There are no other obvious openings and the bonding to the side walls appears to be in the form of intermittent tie stones as opposed to continuous bonding along the full height.

**NORTH ELEVATION: NOTE RUBBLE AGAINST WALL AND PALER BAND OF STONE – STRUCTURE AT CORNER TO BE REMOVED:**

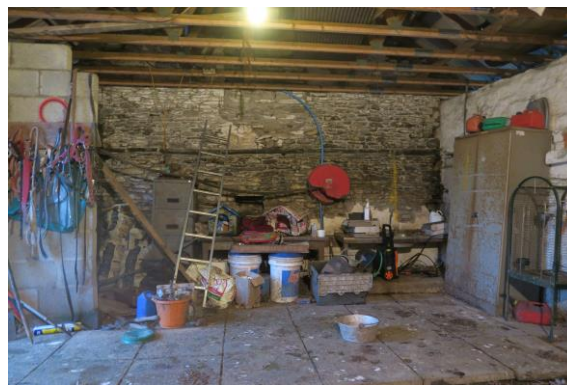
**NORTH ELEVATION INTERNAL: NOTE POSSIBLE FIRE PLACE WITH STRAIGHT JOINT AT CORNER:**

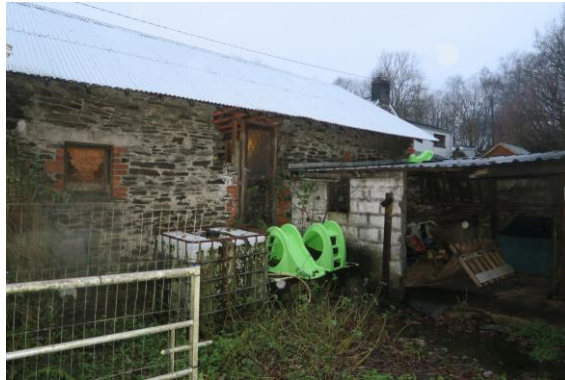
**PART OF EAST ELEVATION WITH LOWER BARN:**

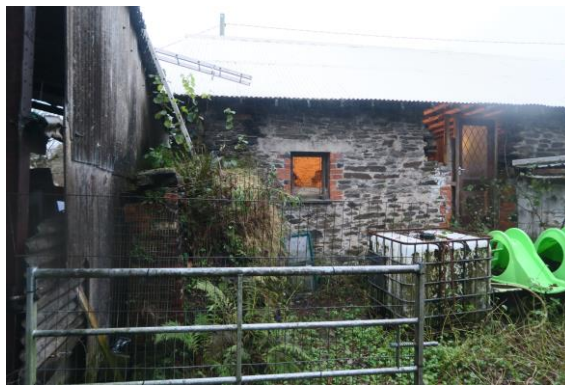
There are two openings in this elevation, an original brick framed window and a modern door that appears to have been set into an existing opening that has been modified and as a result the upper section of stone either side has “run” back away from the frame. Internally the wall is undisturbed apart from the door and window.

**PART OF EAST ELEVATION: NOTE WALL TO SIDES OF DOOR:**

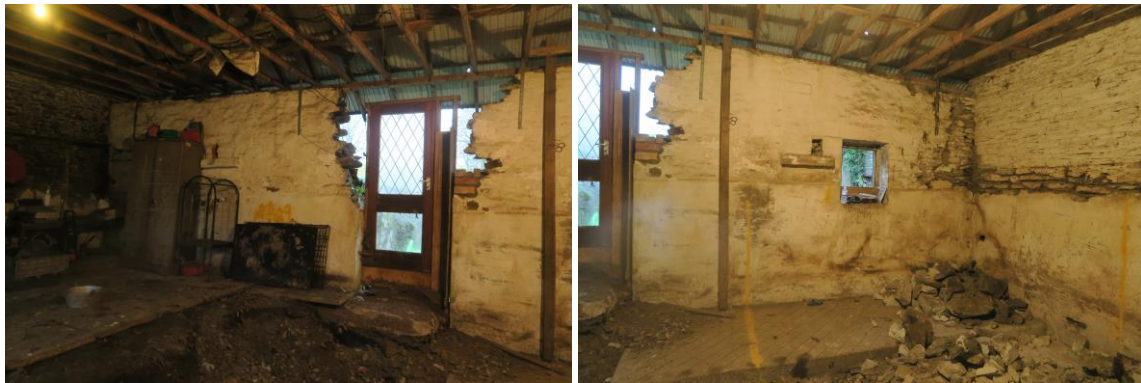
**EAST ELEVATION - INTERNAL: NOTE WALL TO SIDES OF DOOR AND LEVEL DIFFERENCES:**

- (ii) The barn will require a new floor slab with the necessary insulation to adjust the floor levels and comply with current regulations. The relevant levels are not detailed on the Planning Drawings, but the access is shown to be at the lower level with no indication of any changes in level internally. It is therefore assumed that the existing floor level in the north end of the main area will need to be lowered. It is not known, within the scope of this report, what is the form or level at which the walls are founded. It is often the case in older agricultural buildings that the walls simply terminate at a relatively shallow depth and no, or minimal, thickening of the wall to spread the loads. The form of the wall below ground will need to be established and a suitable course of action considered. If the north end of the floor is lowered, then the levels may be below the external ground level and suitable tanking required.

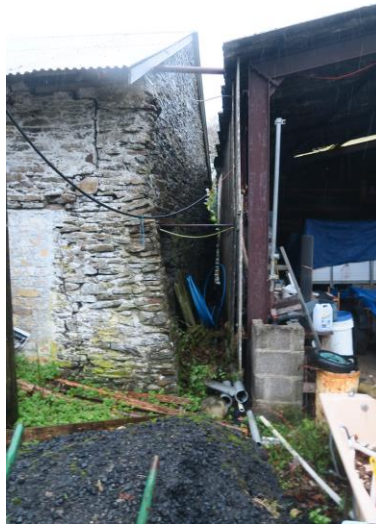
Externally this gable could only be viewed obliquely as a result of the proximity of the steel structure; the general plane of the wall appears good, but the south-west corner seems to form a slight buttress and this section of wall may have once continued along, what is now, the line of the newer barn. There is evidence of a former doorway towards the west end, and this is boarded over internally.

**VIEW ALONG SOUTH ELEVATION: NOTE POSSIBLE  
FORMER WALL EXTENSION AT CORNER:**

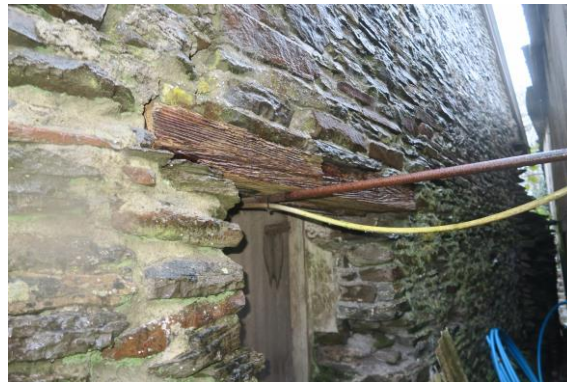
**VIEW ALONG SOUTH ELEVATION: NOTE OPENING AT WEST SIDE –  
SECTION BOARDED OFF INSIDE:**

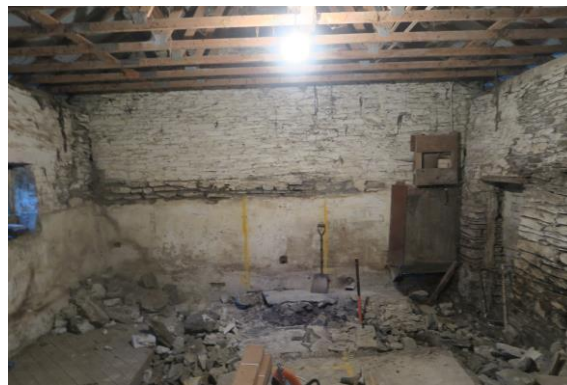
**SOUTH ELEVATION INTERNAL: NOTE BOARDED OVER OPENING  
AND WITH STRAIGHT JOINTS AT CORNERS:**

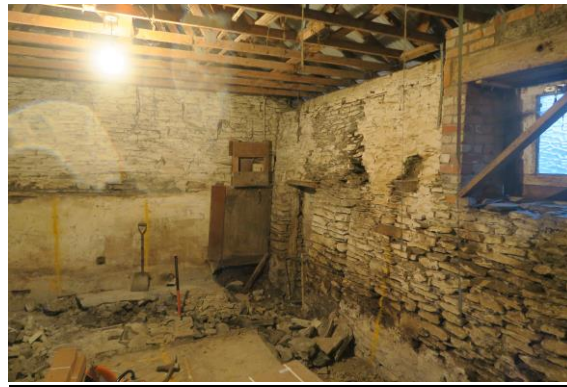
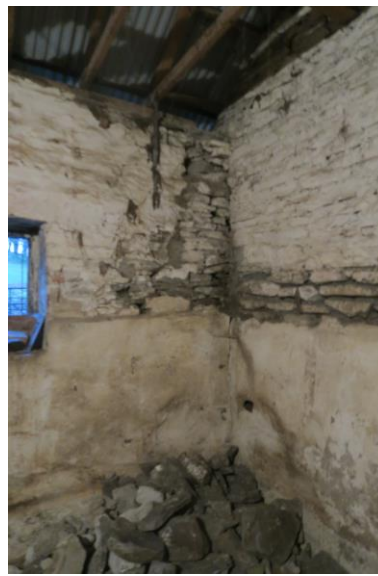
**SOUTH ELEVATION INTERNAL - DETAILS: NOTE BOARDED  
OVER OPENING AND WITH STRAIGHT JOINTS AT CORNERS:**
