# MERTHYR VALLEY HOMES

## DEMOLITION OF 6 GARAGES AT PINE CLOSE, GURNOS ,MERTHYR TYDFIL

### BUILDING INSPECTION REPORT (PROTECTED SPECIES)

October 2023

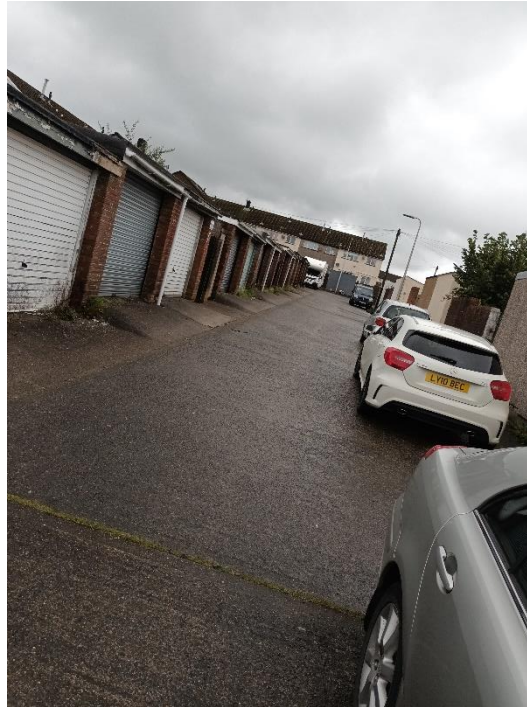
**Plate 1-Lighting columns on the front elevation of the garages.**

3.4 Immediately adjacent to the frontage of the garages are two lighting columns (Plate 1) and to the rear there is a communal garden which consists of short amenity grass (Plate 2).

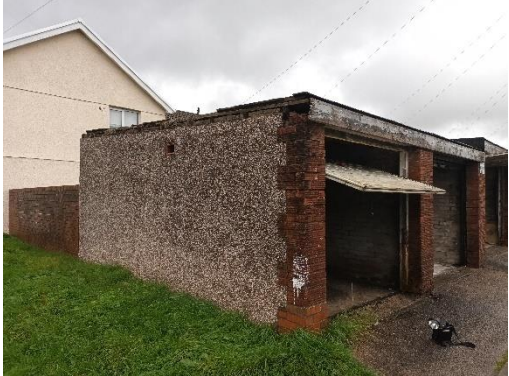
| Description | Photograph |
|---|---|
| <b>Garage 1</b> | |

| Description | Photograph |
|---|---|
| Missing fascia covering on southern elevation exposing wooden beams/plyboard.<br>Large gap in SE corner. | |

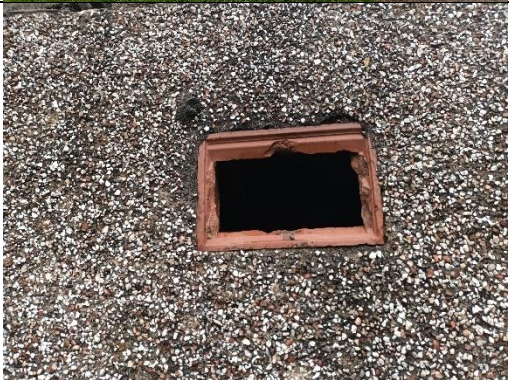
| Description | Photograph |
|---|---|
| Uncovered vent leading into the garage-these vents connect all 6 garage's. | |

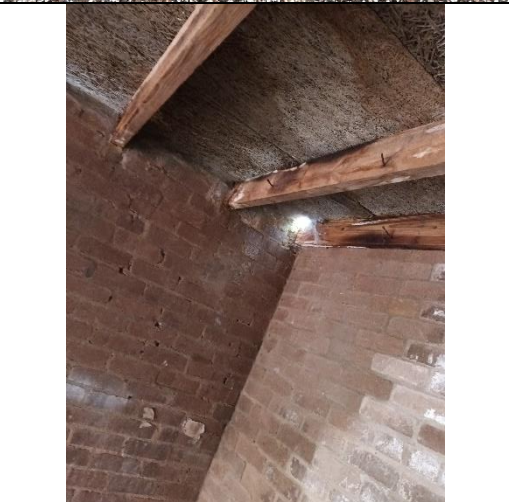
| Description | Photograph |
|---|---|
| Gap south western corner of the garage-light ingress noted internally. | |

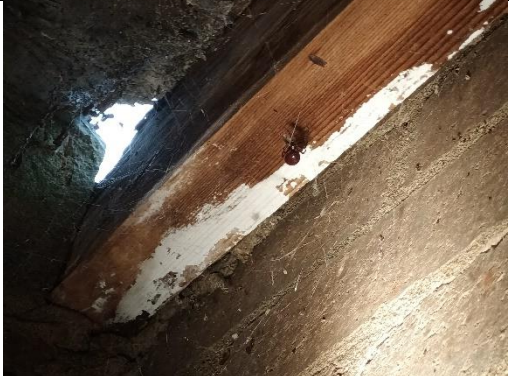
3.5 There were no signs of nesting material identified within the garages. However, there were suitable nesting opportunities/access points. A False widow spider *Steatoda nobilis* was noted in the corner of garage 1.

| <p>False widow spider <i>Steatoda nobilis</i> noted.</p> | |

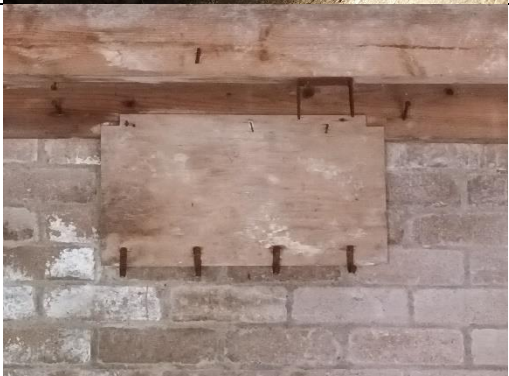
| <p>Wooden board attached to the internal wall. This was checked using a high powered torch and endoscope.</p> | |

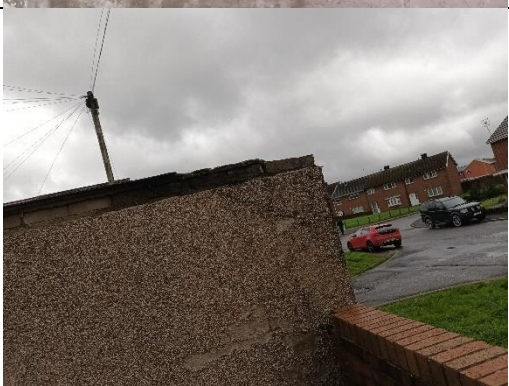
| <p>No fascia covering to the rear of the property exposing brickwork. Location of damaged roof consistent with area of light ingress observed internally..</p> | |

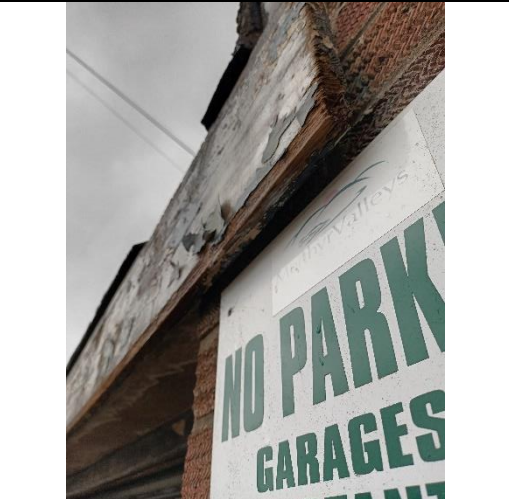
| <p><b>Garage 2</b></p> | |

| <p>Gap &gt;5cm between wooden facias covering and wall.</p> | |

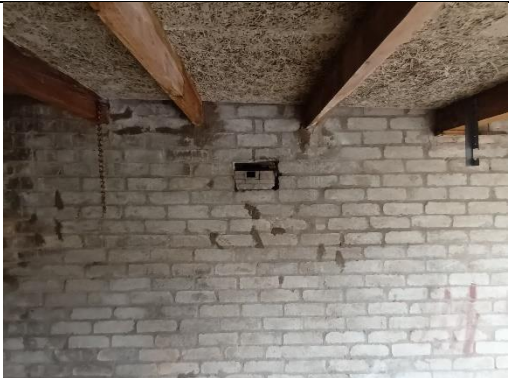
| <p>Open/uncovered internal vent between the adjacent garages.</p> | |

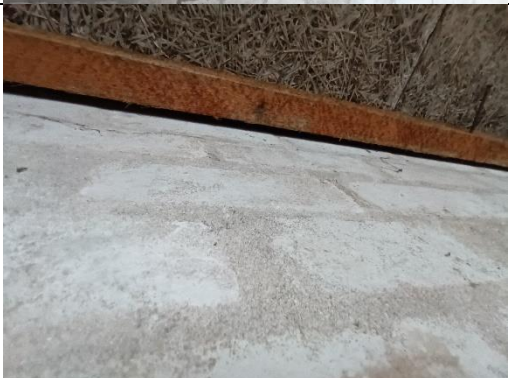
| <p>Small gap &lt;5cm between 1oodend beam and rear internal wall of the garage. This was checked using a high powered torch and endoscope.</p> | |

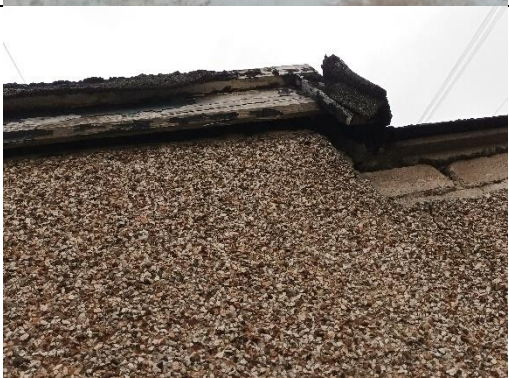
| <p>Gap between wooden fascia to the rear of the garage (western elevation) and the wall.</p> | |

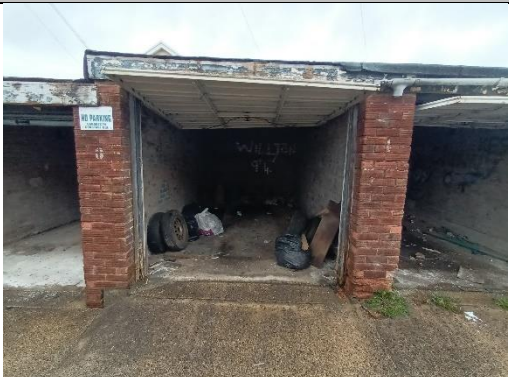
| <p>Debris present in this garage. No signs of droppings on any of the surfaces noted.</p> <p>Gap between wooded fascia covering and wall above garage doors.</p> <p>Area of raised felt adjoining the next garage.</p> | |

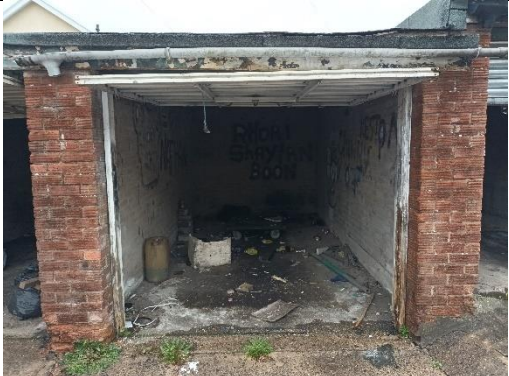
| <p>Debris present in this garage. No signs of droppings on any of the surfaces noted. Gap between wooded fascia covering and wall above garage doors.</p> | |

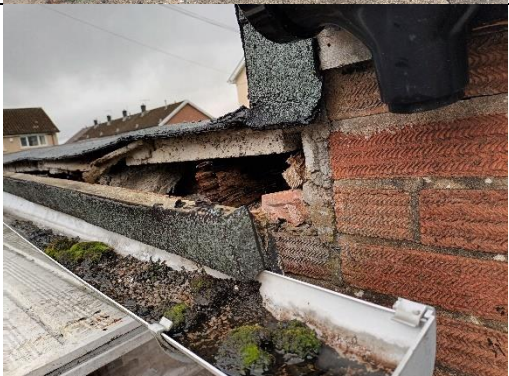
| <p>Felt and wooden batten has come away from the brickwork leaving a large gap.</p> <p>Gaps in roofing felt present along the length of the front of the garage.</p> | |

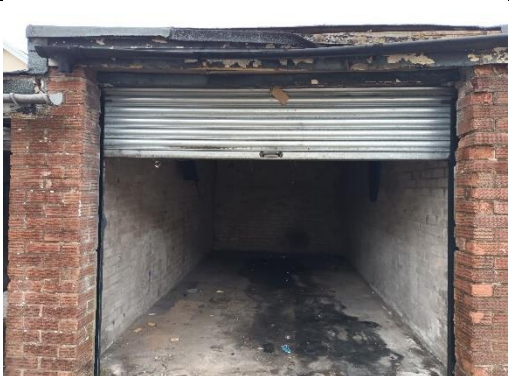
| <p><b>Garage 5</b></p> | |

| <p>Clean garage. Guttering and felt has dropped on the from of the garage exposing the plyboard ceiling.</p> | |

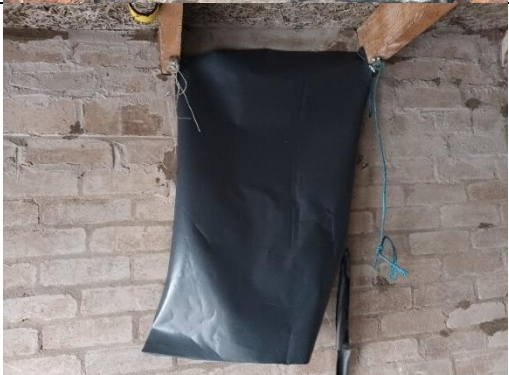
| <p>Internal vents have been covered with plastic sheet.</p> | |

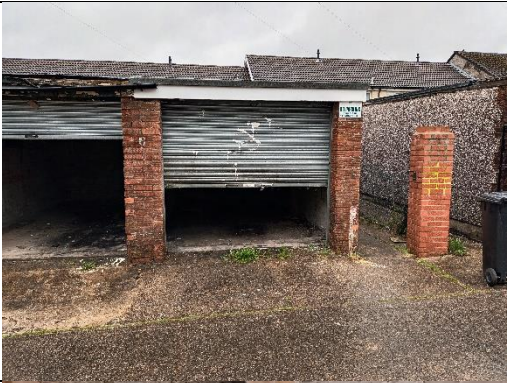
| <p><b>Garage 6</b></p> | |

| <p>Plastic fascia covering intact on the front/side and rear of the garage.</p> | |

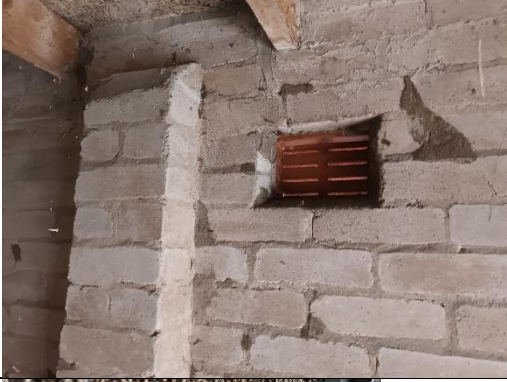
| <p>Vent covering present,</p> | |

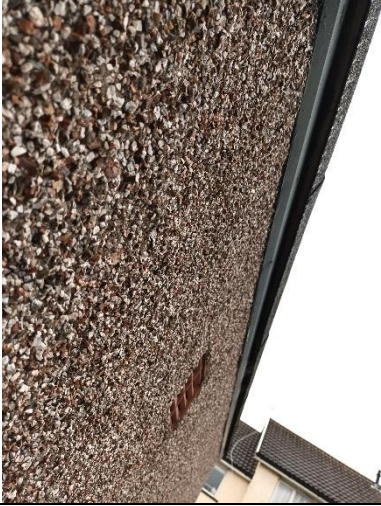
| <p>Very few gaps present between plastic fasci and wall.</p> | |
