# **HOPE CHURCH HIGH STREET MERTHYR TYDFIL ROOF SURVEY**

**AUGUST 2022**

**HOPE CHURCH, HIGH ST. MERTHYR TYDFIL.  
Main Roof North Pitch**

**Project:704**

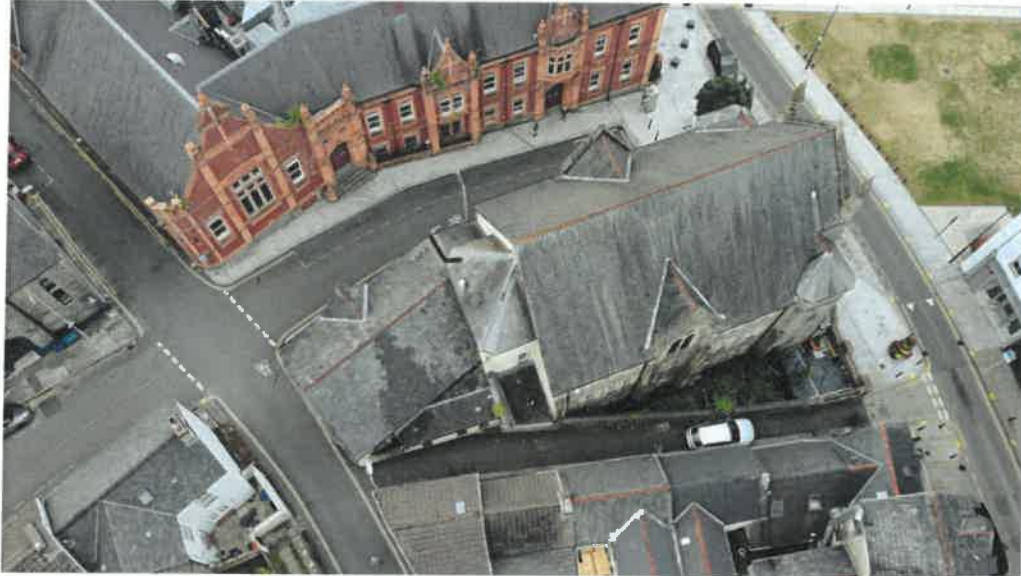
**Overview of the roof.**

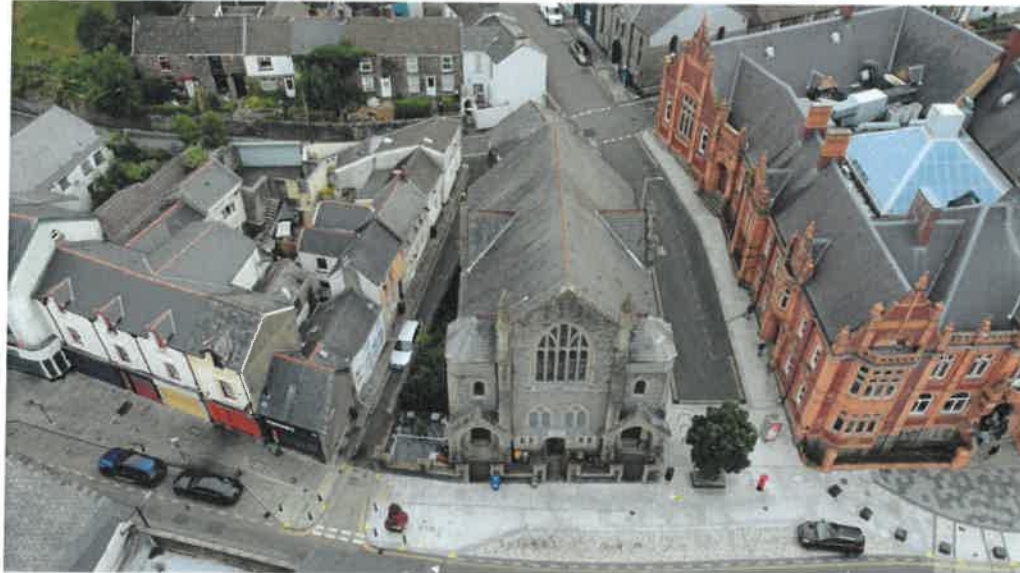
**View from the front.**

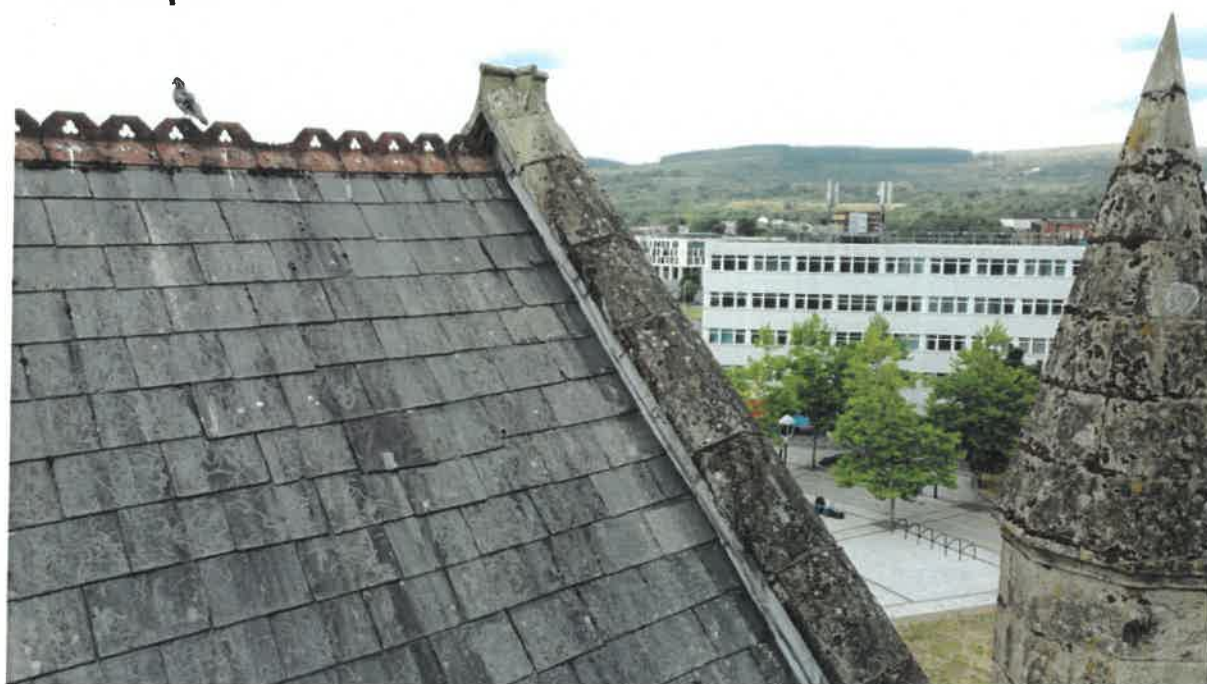
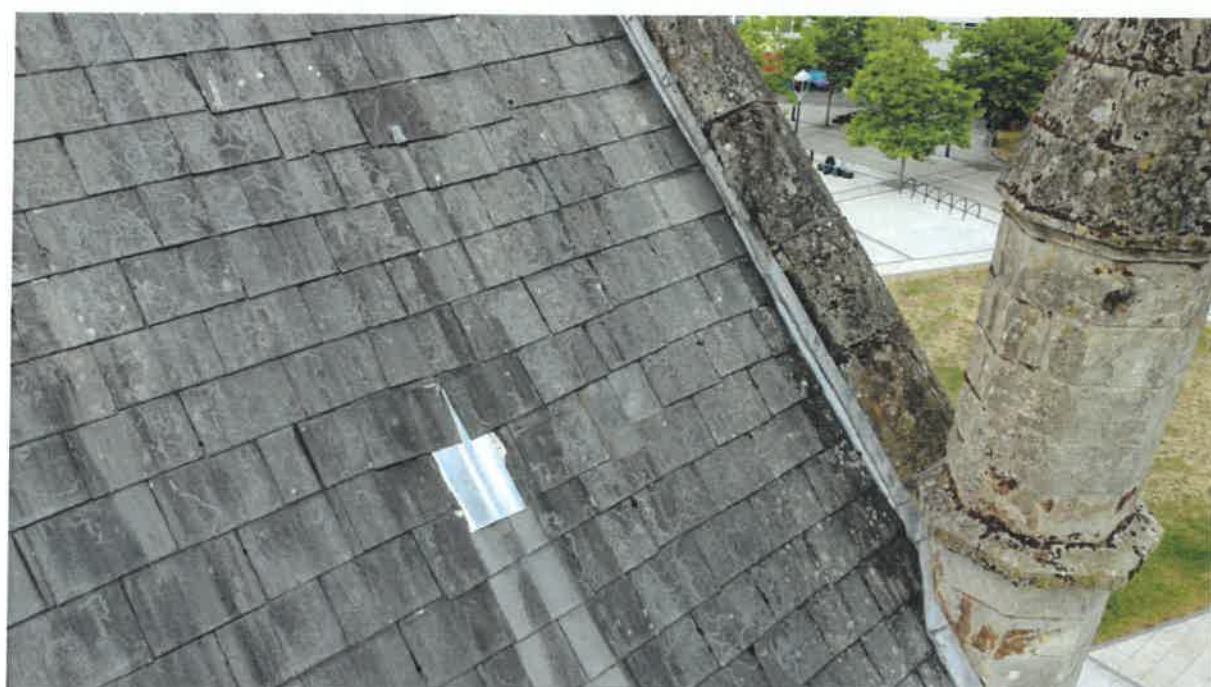
**Front Parapet.**

The stone parapet capping was covered with moss and lichen so was difficult to see the surface of the parapet stones. I could detect small defects in some of the stones and also, that some of the pointing between the stones was showing signs of weathering. However, it was not currently considered to be in a poor condition, but these are items that will require attention in the future.

There appeared to be hairline type cracks in some of the stones, these were small and were not leading to any significant loss of stability or strength, however, these cracks can become worse over a long period of severe weathering and should be checked in the future when roof repairs are being carried out.

The feature stone spires have lichen in various locations and the surface of the stone is weathered. The level of lichen suggests that the stone surface is deteriorating sufficiently to allow the lichen to become established. There is some delamination of the surface of some of the stones making up the spires, but it is not serious but indicates an ongoing deterioration of the stonework.

The pointing is generally in a reasonably good condition however some areas are now showing signs of decay and will require repointing at some time in the future.

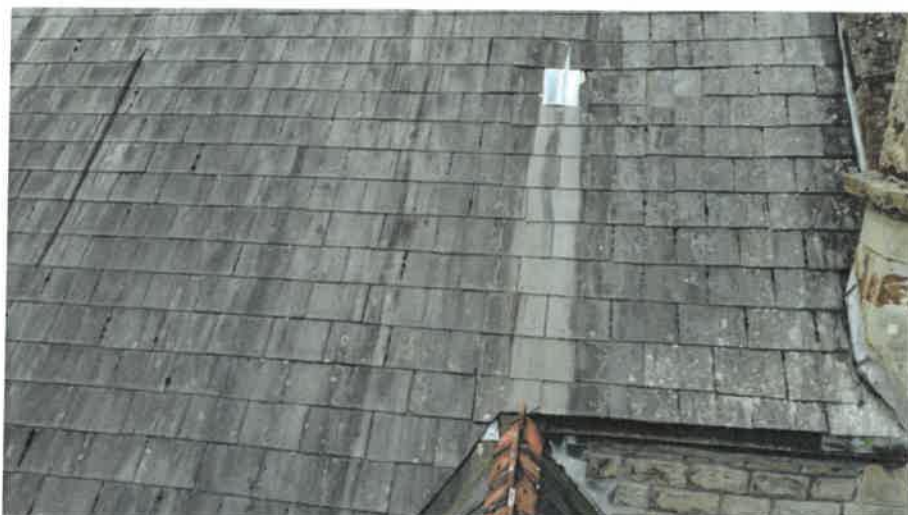
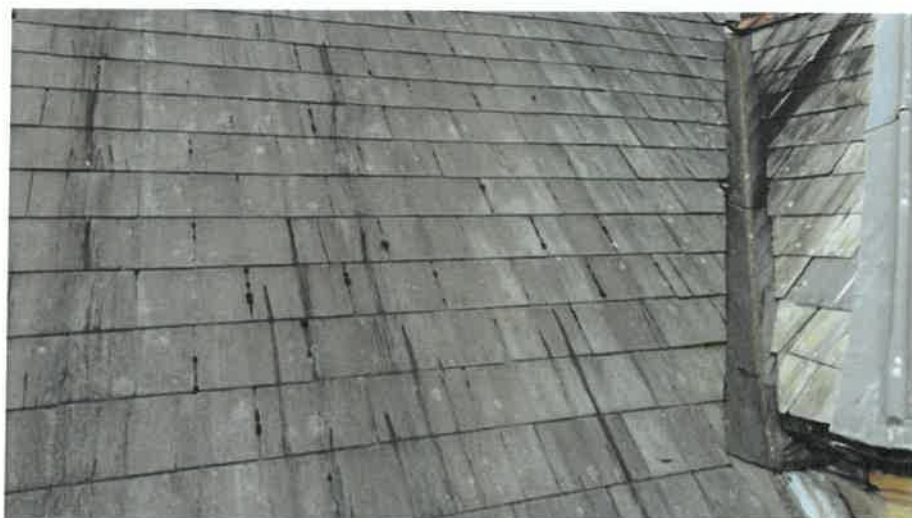
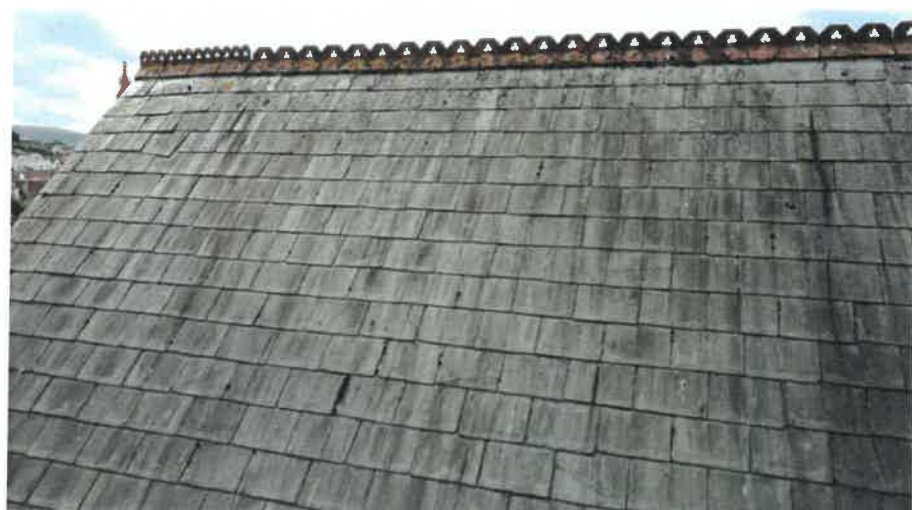
The roof was covered in natural slates, there were however quite a few broken slates, some slates had slipped, and a few were missing.

Although the roof generally provided adequate cover it would require attention in the future as some of the nails holding the slates on were seen to be forming holes in slates on top of them. This occurs when the nails holding the slates onto the roof structure become rusted, and the holes in the slates through which the nails pierce become larger, the slates start to move slightly and then, when they vibrate in high winds the slates above hit the nails holding on the slates below, which can eventually form small holes in the slates above. Regular marks on the slates provide evidence that this deterioration is starting to happen. Some of the slates have had sealant placed over the nail positions.

The ridge tiles all required to be re-bedded and re-pointed. Four had previously been replaced and one was broken.

The roof gutters were made of cast iron and required attention as much rust was visible, and the joints should be checked and resealed.

The eastern eaves have a timber barge board and soffit. These were both in need of replacing or redecorating before they start to decay.

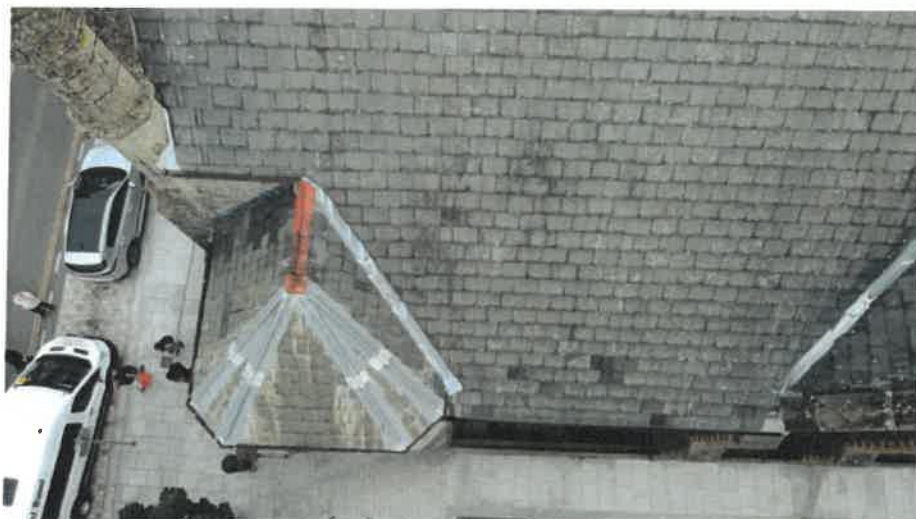
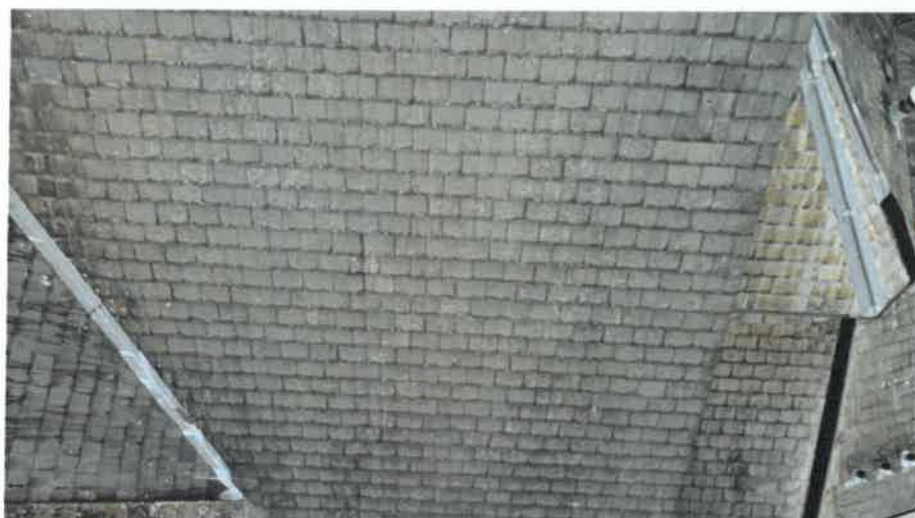
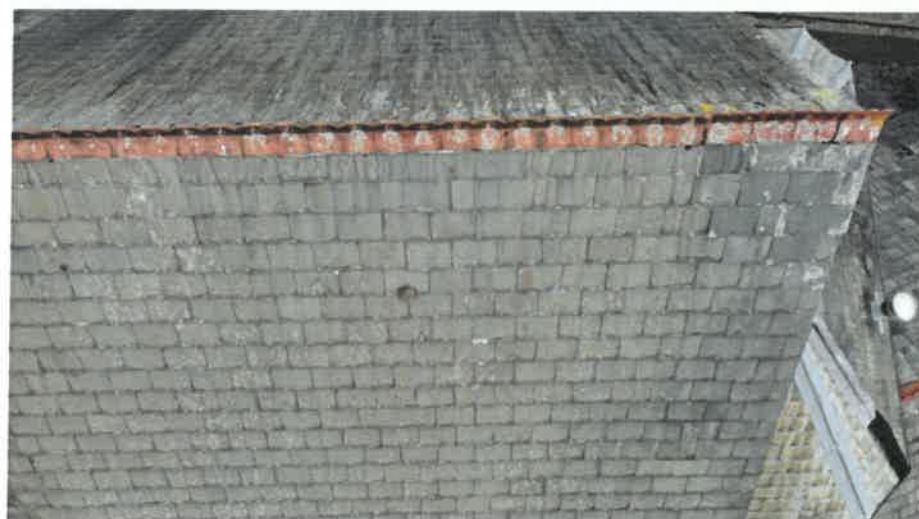
**Main Roof South Pitch**

The roof was covered in natural slates, there were however quite a few broken slates, some slates had slipped, and a few were missing. Although the roof generally provided adequate cover it would require attention in the future as many of the nails holding the slates on were seen to be forming holes in slates on top of them. This occurs when the nails holding the slates onto the roof structure become rusted and the holes in the slates through which the nails pierce become large, the slates start to move slightly and then, when they vibrate in high winds the slates above hit the nails holding on the slates below, which can eventually form small holes in the slates above. Regular marks on the slates provide evidence that this deterioration is starting to happen. Some of the slates have had sealant placed over the nail positions.

It would appear this roof has been repaired in the past as there are areas of different shades of slates that do not match the others. It appears that the south side of the roof has in the past been subject to a higher level of weathering due to its orientation and being close to another high building.

The roof gutters were made of plastic and looked acceptable.

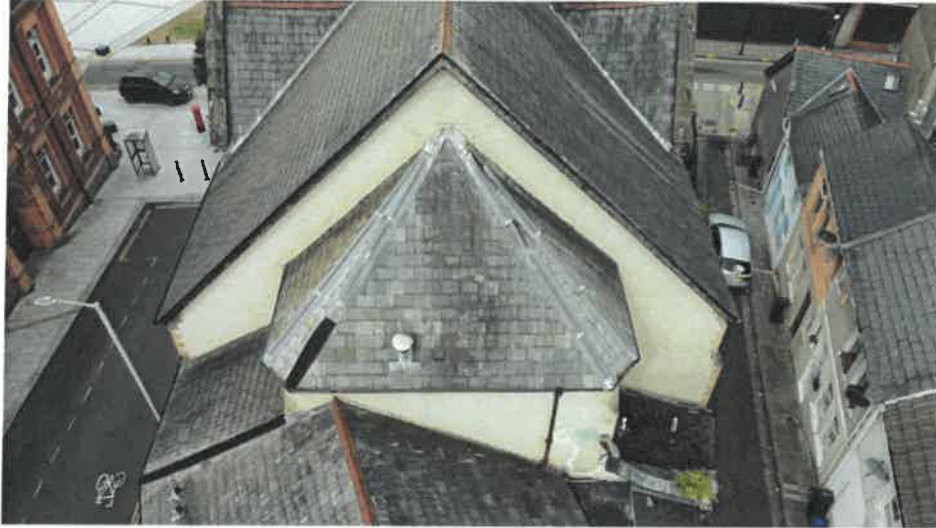
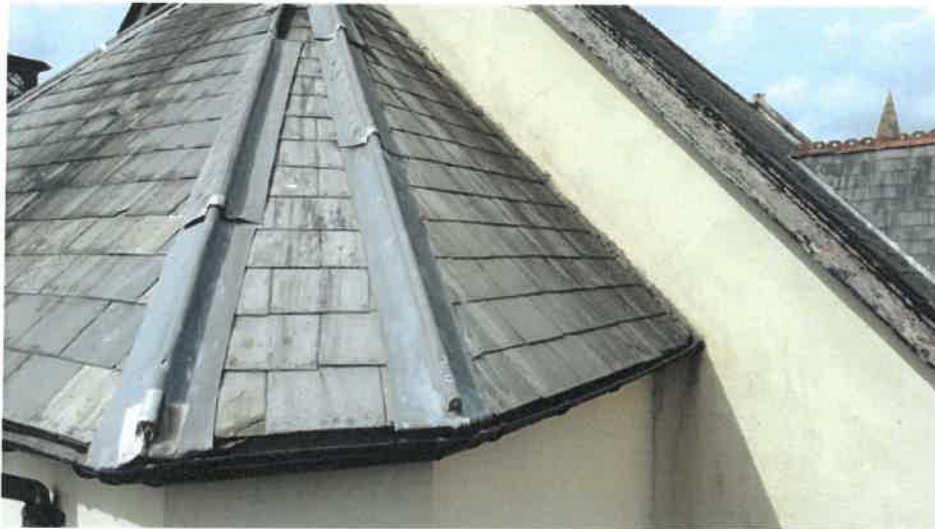
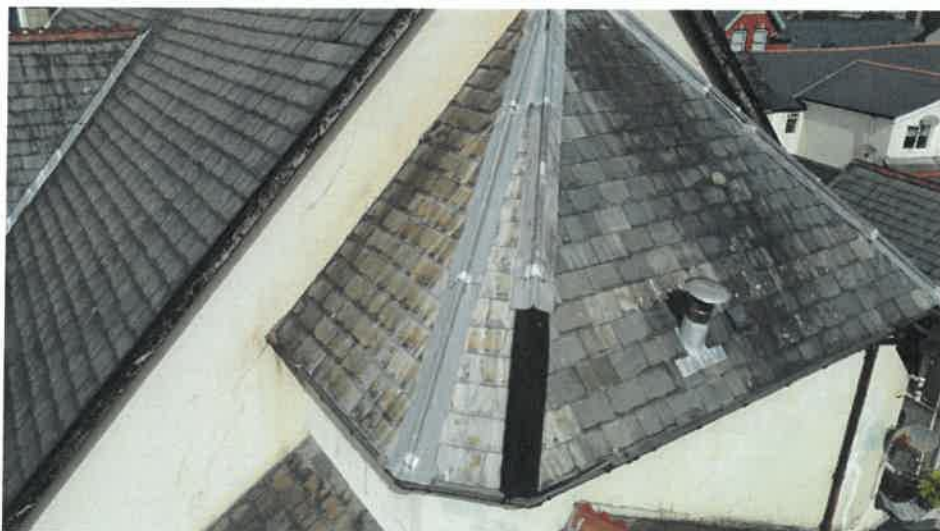
**Rear Lower Roof Over Extension**

The roof is covered in natural slates which all looked generally acceptable. They were covered with lichen and weather stained but acceptable. Although the roof generally provided adequate cover it would require attention in the future as a few of the nails holding the slates on were seen to be forming holes in slates on top of them. This occurs when the nails holding the slates onto the roof structure become rusted and the holes in the slates through which the nails pierce become large, the slates start to move slightly and then, when they vibrate in high winds the slates above hit the nails holding on the slates below, which can eventually form small holes in the slates above. Regular marks on the slates provide evidence that this deterioration is starting to happen. Some of the slates have had sealant placed over the nail positions.

The hip detailing however was generally in a poor condition. Some of the lead flashings covering the hips had slipped, some of the supporting timbers were visible and much use of grey flashing tape had previously been used to make temporary repairs.

At the abutment of the slates and the gable wall there was no lead flashing visible, however a small cement fillet could be seen. If the roof is repaired and the roof coverings replaced new stepped flashings should be introduced.

The rear gable wall exposed between the extension roof and the main roof had several small distinctive cracks and required re-rendering and re-decorating.
