# CANOLFAN SOAR

MERTHYR TYDFIL

Internal Environmental Monitoring Report (Nr.1)

## Taliesin Conservation

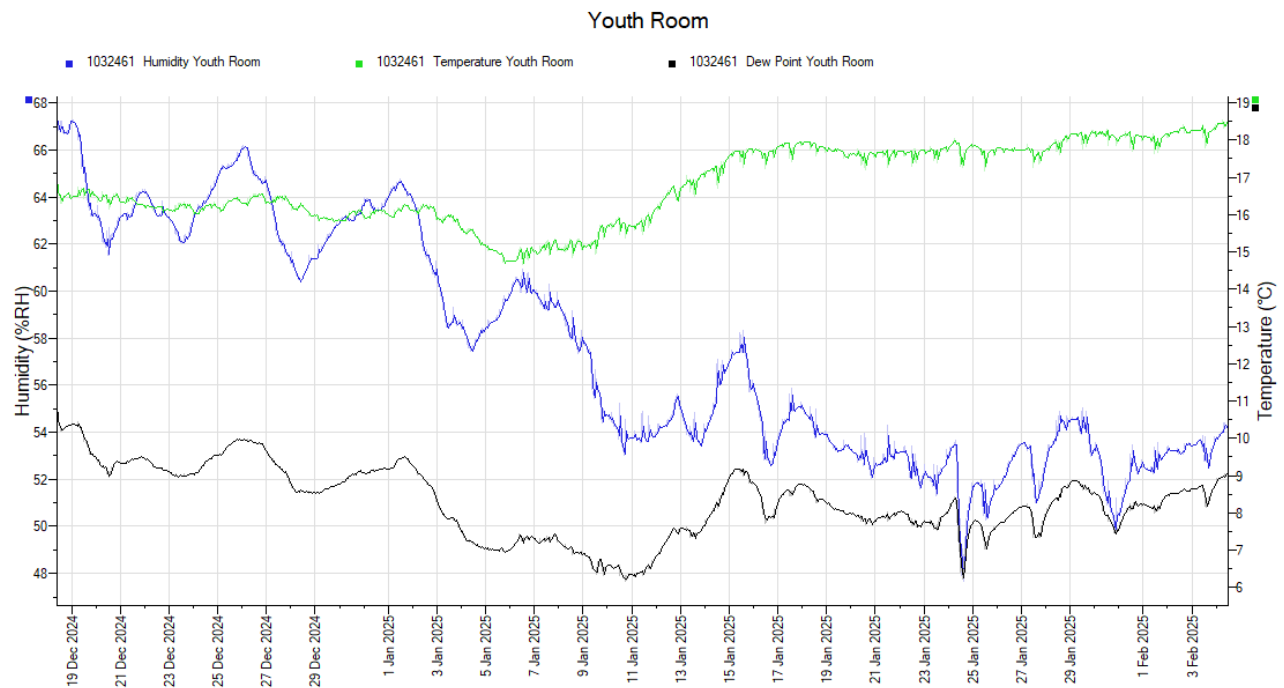
Fig.2 – Internal Environment Graph (Youth Room)

The Youth Room, given its current unoccupied state, remains relatively stable in terms of internal environmental conditions. However, this data is expected to change once the space is in use and background heating is introduced. With its existing windows, internal conditions can likely be managed effectively, either through proper user guidance or the installation of an automated control system.

One key concern worth highlighting is the humidity levels, which show spikes that mirror external conditions. This pattern suggests potential moisture infiltration, indicating that the space is not fully sealed from external influences. Any ingress of moisture should be thoroughly assessed, mitigated, and monitored before re-occupancy to prevent long-term issues such as damp and mould growth.

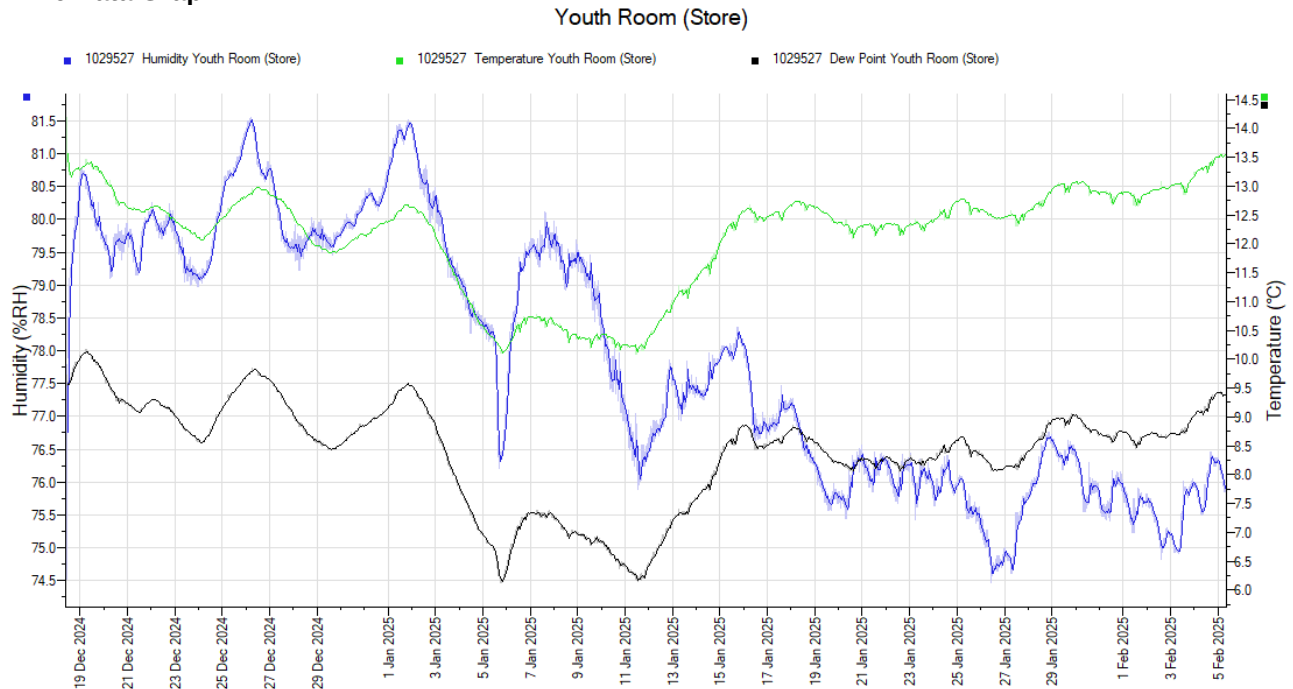
Fig.3 – Internal Environment Graph (Youth Room Store)

The Youth Room Store, in its current unoccupied state, exhibits consistently low internal temperatures and persistently high humidity levels. Unlike the main Youth Room, this space cannot benefit from natural ventilation from windows which has led to internal conditions that are inherently unsuitable for occupancy. Given the consistently high relative humidity and low temperatures, the risk of condensation, damp accumulation, and mould growth is significantly elevated.

A key concern is the fact that humidity levels remain critically high at all times, exceeding 65% throughout the monitoring period. This suggests a lack of adequate air exchange and possible moisture ingress from external sources. The correlation with external conditions indicates that the space is highly susceptible to environmental fluctuations, reinforcing the need for environmental control. Before considering re-occupancy or storage use, thorough moisture mitigation measures must be implemented to prevent long-term structural degradation and health risks.

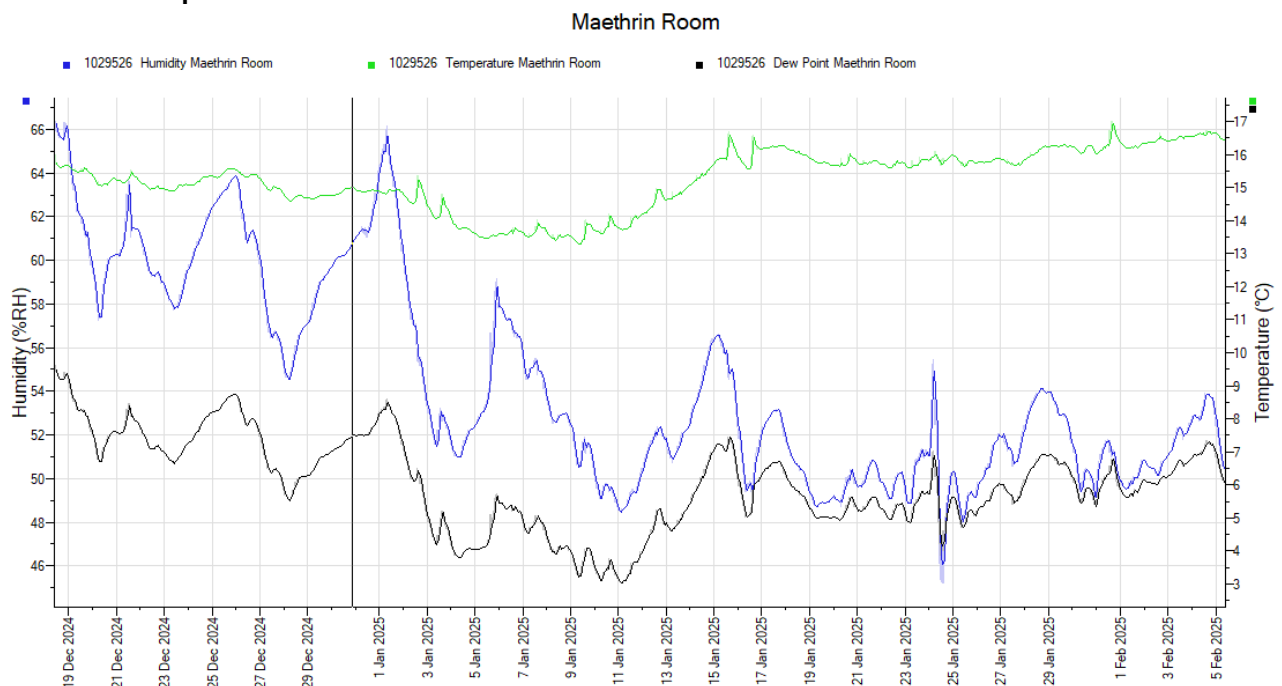
Fig.4 – Internal Environment Graph (Maethrin Room)

The environmental data collected for the Maethrin Room indicates that the space is consistently below the recommended comfort temperature and never exceeding the 18°C lower comfort threshold. This data suggests heat retention issues, particularly during nighttime. Given the room's lack of active use and lack of assumed background heating, such temperature trends are expected.

Humidity levels averaged within acceptable limits for indoor environments. However, occasional spikes above 65% RH indicate moments where moisture levels could contribute to mould growth. The average dew point of 6.04°C, combined with recorded lows down to 3.01°C, suggests that condensation may form on colder surfaces, potentially increasing the risk of dampness-related issues.

Overall, while humidity levels remain largely within a safe range, the persistent low temperatures and occasional high dew points suggest that condensation risks should be closely monitored. Addressing heat retention and improving ventilation will be key in preventing long-term damp and mould issues within the Maethrin Room.

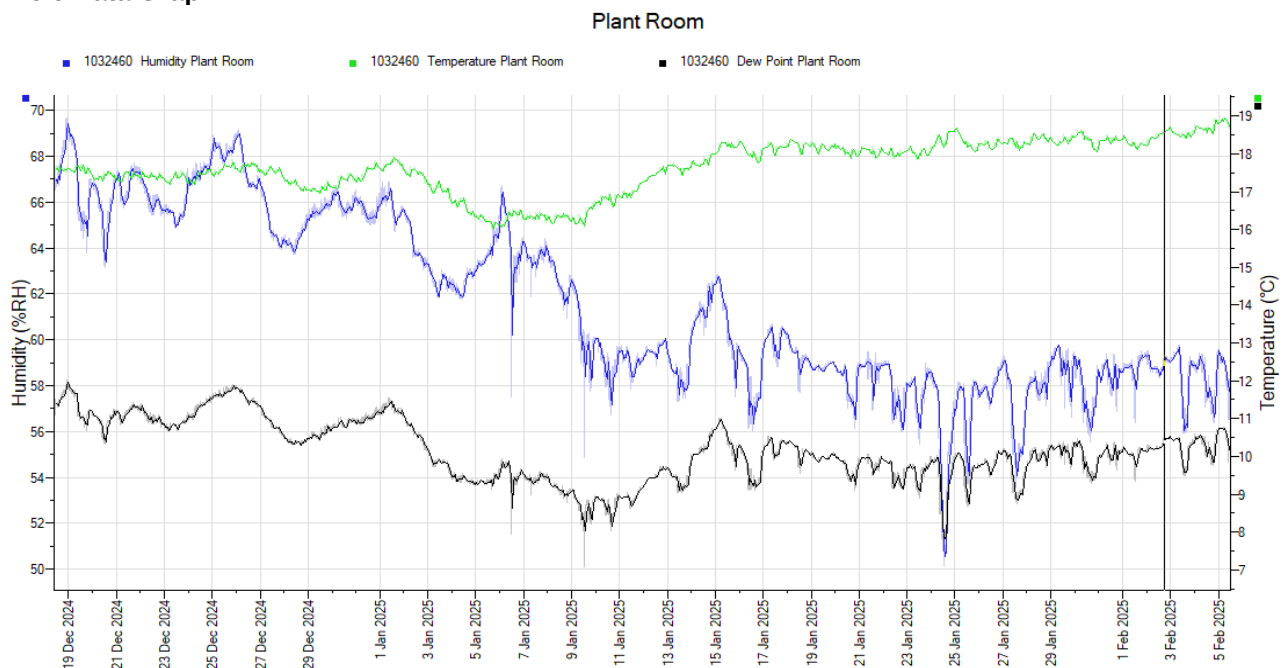
Fig.5 – Internal Environment Graph (Plant Room)

The environmental data for the plant room, indicates that temperatures remain relatively stable, with an average of 17.66°C. While the temperature fell below 18°C for 60.22% of the recorded period, comfort is not a primary concern in this space. Instead, maintaining stable conditions to protect mechanical equipment is the key priority.

Humidity levels averaged 61.53% RH, generally within an acceptable range. However, readings exceeded 65% RH for 27.03% of the time, increasing the risk of condensation and potential corrosion of equipment. Given the enclosed nature of the space and limited ventilation, moisture retention is a concern.

The average dew point of 10.14°C, with peaks reaching 12.01°C, suggests a heightened risk of condensation on cooler surfaces, which could contribute to dampness and long-term deterioration of plant equipment. To mitigate these risks, maintaining controlled ventilation and humidity management strategies is essential to ensure the longevity and efficiency of the mechanical systems housed within the room.

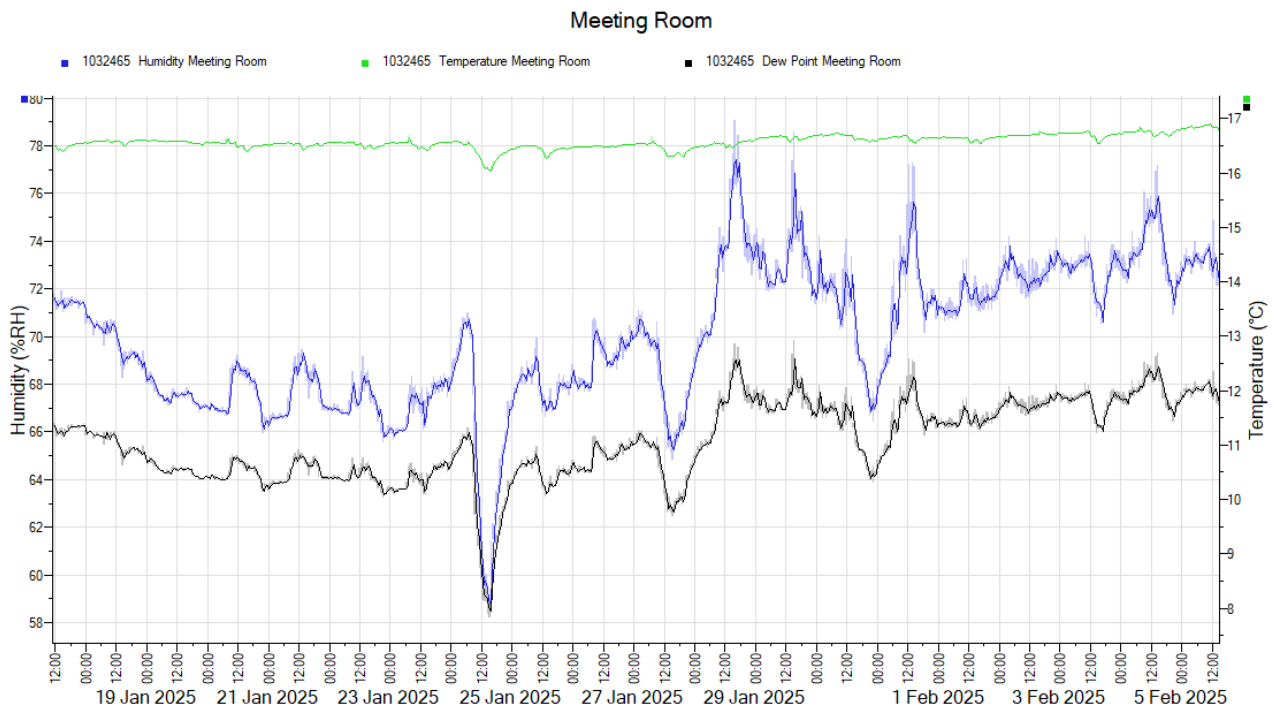
Fig.6 – Internal Environment Graph (Meeting Room)

The Meeting Room, despite being consistently cool, remains relatively stable in terms of temperature. However, with an average of 69.93% RH and all readings exceeding 65% RH, humidity is a significant concern. These conditions indicate persistent moisture retention, increasing the risk of condensation and mould growth. Additionally, the fluctuations consistent with external conditions indicate possible moisture ingress.

The high dew point values further highlight potential condensation risks, particularly on cooler surfaces. Given these factors, improving ventilation and moisture control will be essential to maintaining a healthier internal environment and preventing long-term damp issues.

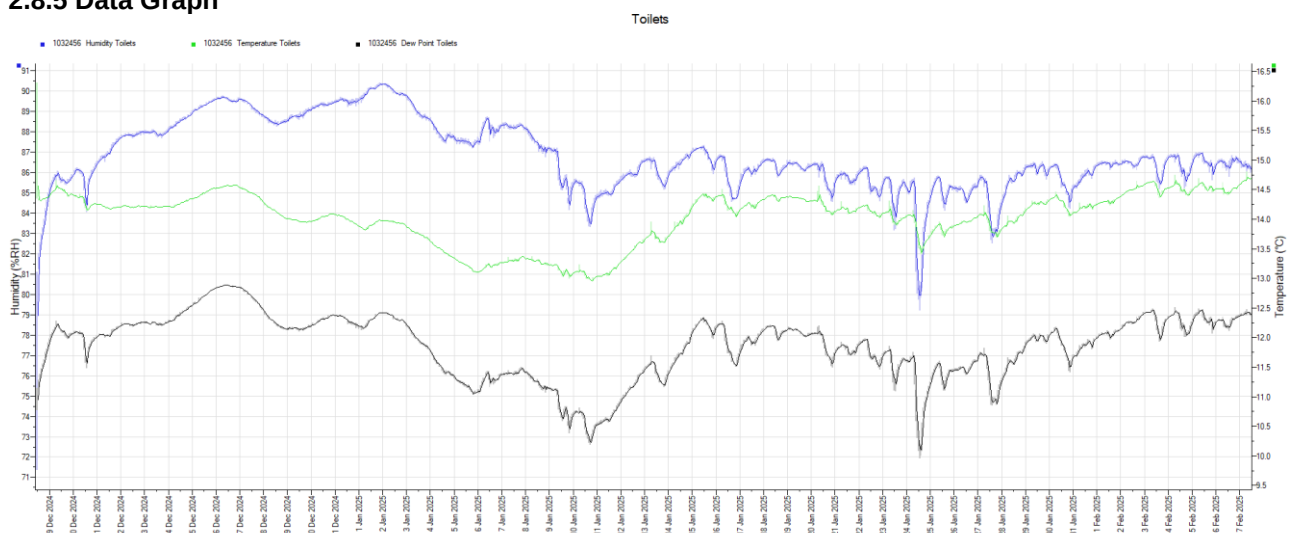
Fig.7 – Internal Environment Graph (Toilets)

The toilet area exhibits persistently high humidity levels with all recorded RH values exceeding 65% and an average of 86.82% RH. Moisture retention is a major issue, increasing the likelihood of condensation and mould growth. The highest recorded temperature and lowest humidity occurred during installation when

people were present, likely due to the heat generated by occupants and increased air movement. However, once the space was left unused, temperatures dropped, and humidity levels rose again, creating a persistently damp environment.

Additionally, suspected water ingress is likely exacerbating the humidity problem. The presence of excess water entering the space adds to the moisture load, making it more difficult to control humidity levels. An unused toilet is particularly prone to high humidity due to a lack of ventilation, moisture retention from residual water and damp surfaces, and the absence of heat sources. Without regular air circulation, condensation can form on cooler surfaces, and porous materials may absorb and retain moisture. These conditions create an environment that encourages mould growth and structural deterioration. The consistently high dew point values further emphasise the risk of condensation, particularly on cold surfaces. Without adequate ventilation or temperature regulation, damp conditions will persist, highlighting the urgent need for improved moisture control to prevent long-term damage.

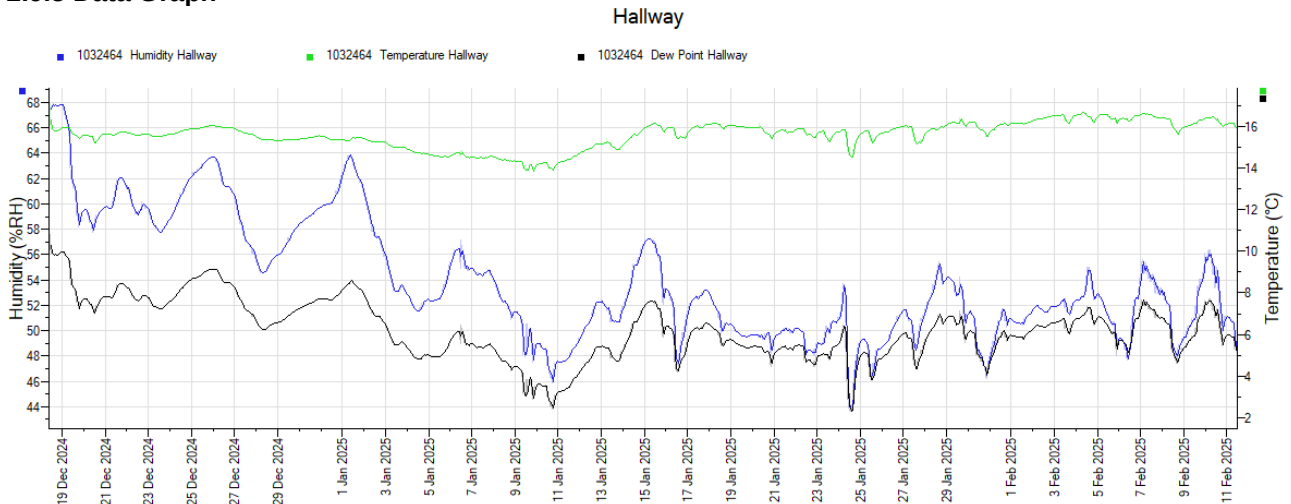
Fig.8 – Internal Environment Graph (Hallway)

The environmental conditions in the hallway indicate a relatively stable and moderate climate, with an average temperature of 15.59°C and consistent temperatures below 18°C throughout the monitoring period. While this is not optimal for occupancy, no background heating is present. The relative humidity (RH) averaged 53.84%, with only 1.73% of readings exceeding 65% RH, suggesting that overall moisture levels in the space are under

Overall, the hallway appears to have a balanced internal environment, with no significant moisture issues or risks of condensation. The relatively low humidity and controlled dew point levels indicate that the space is adequately ventilated and that there is little concern for mould growth or damp conditions. Maintaining proper airflow and temperature regulation will help sustain these favourable conditions.
