**PROTECTAHOME LTD**

**Re: LOWER GROUND FLOOR, CANOLFAN SOAR, PONTMORLAIS, MERTHYR TYDFIL CF47 8UB**

Further to instructions received, please find detailed below our summary report following an inspection of the property on Tuesday 25 November 2025.

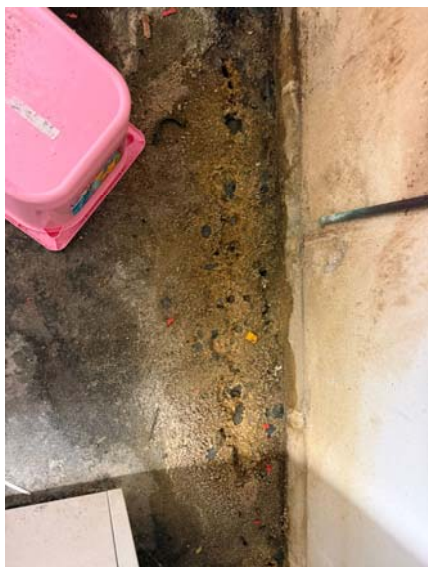
Upon entering the substructure, it became apparent that the blockwork was of updated construction and not part of the original construction, with a form of bitumen paint applied directly to the blockwork, which appeared not to be flush jointed. When observing the wall it seems to be letting free lime through the joints in the blockwork. It was not possible to determine if the blockwork walls are tied back to the original walls of the basement, if a cavity exists between the two, or if any other form of waterproofing has been applied behind the blockwork wall. The blockwork walls terminate against the wall of the existing structure. Upon a second visit during wet weather it was shown to be damp with water ingress from unknown sources present on the wall.

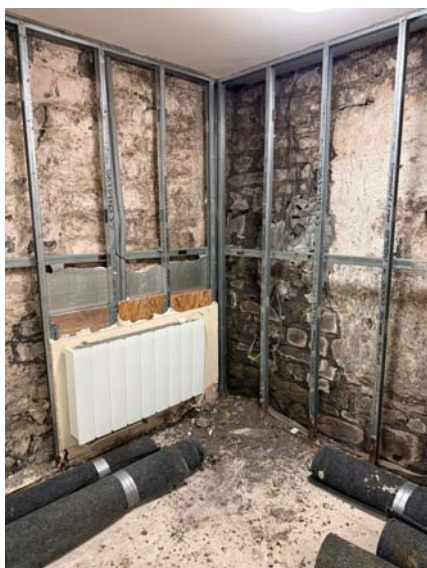
When entering the substructure and proceeding to turn towards the east wall, towards the male WC's, some opening up works have already commenced. Upon inspection, it was noted that the metal track along the wall floor junction has started to rust, along with the fixings that are installed into the original construction wall. The stone work wall is penetrable when probed and will require surface preparation work.

The same problems were apparent upon entering the meeting room, along with a damp odour. A destructive slab investigation has been conducted and reported "appeared to be a 150mm thick screed possibly on a sand layer with potential fragments of a DPC visible. There was no insulation and the material from the base of the hole appeared slightly damp but there was no standing water". Upon a second site visit after the investigation was completed, a probe into the cored hole was shown to go directly to soil.

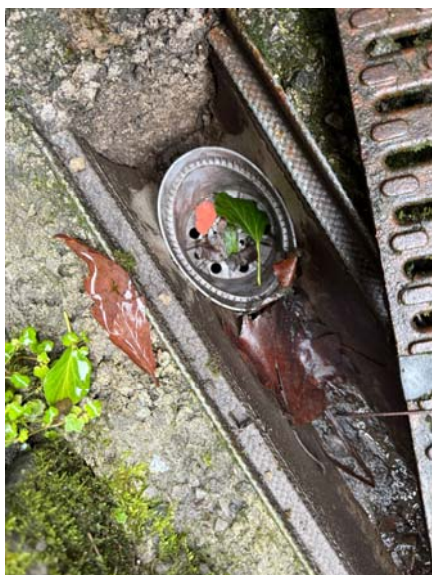
Work has since taken place in the plant room with modern block work closing off a doorway. The blocked off doorway is situated against another disabled access ramp, which is effectively pushing water against the blockwork. This is shown by the growth of mould and staining around the door outline.

It is worth noting that there is also a gully in the centre of the plant room, however the water ingress is sat along the perimeter of the plant room. When the grating was lifted it was around 16 cm's deep with water. The occupier was unsure where the gully was discharging.

The floor slab in the plant room has experienced damage to it from prolonged exposure to water actively dripping onto it from the pipes which are linked to the boilers and heat pump. After a second site visit I was able to look further into the make-up of the plant room. It appears to be a sandy gravel base with a thin screed laid upon it and an extremely thin plastic membrane under the sand.

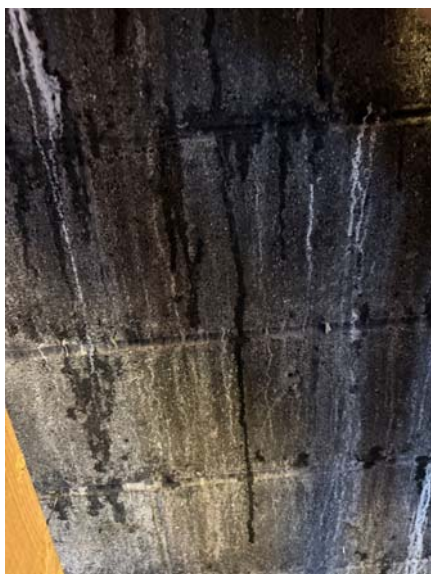
A ventilation shaft has been constructed, to the rear, within the blocked off door way. The location of the shaft corresponds with the plastic air vent fitted to the surface of the block liner wall in the basement.

It is probable the vent was installed because the boiler has been installed at basement level.
