*Report No. BC/MB/11.20.04.*

# **Preliminary Site Investigation: Land at Colliers Row, Merthyr Tydfil.**

**Maxiom Developments Ltd.**

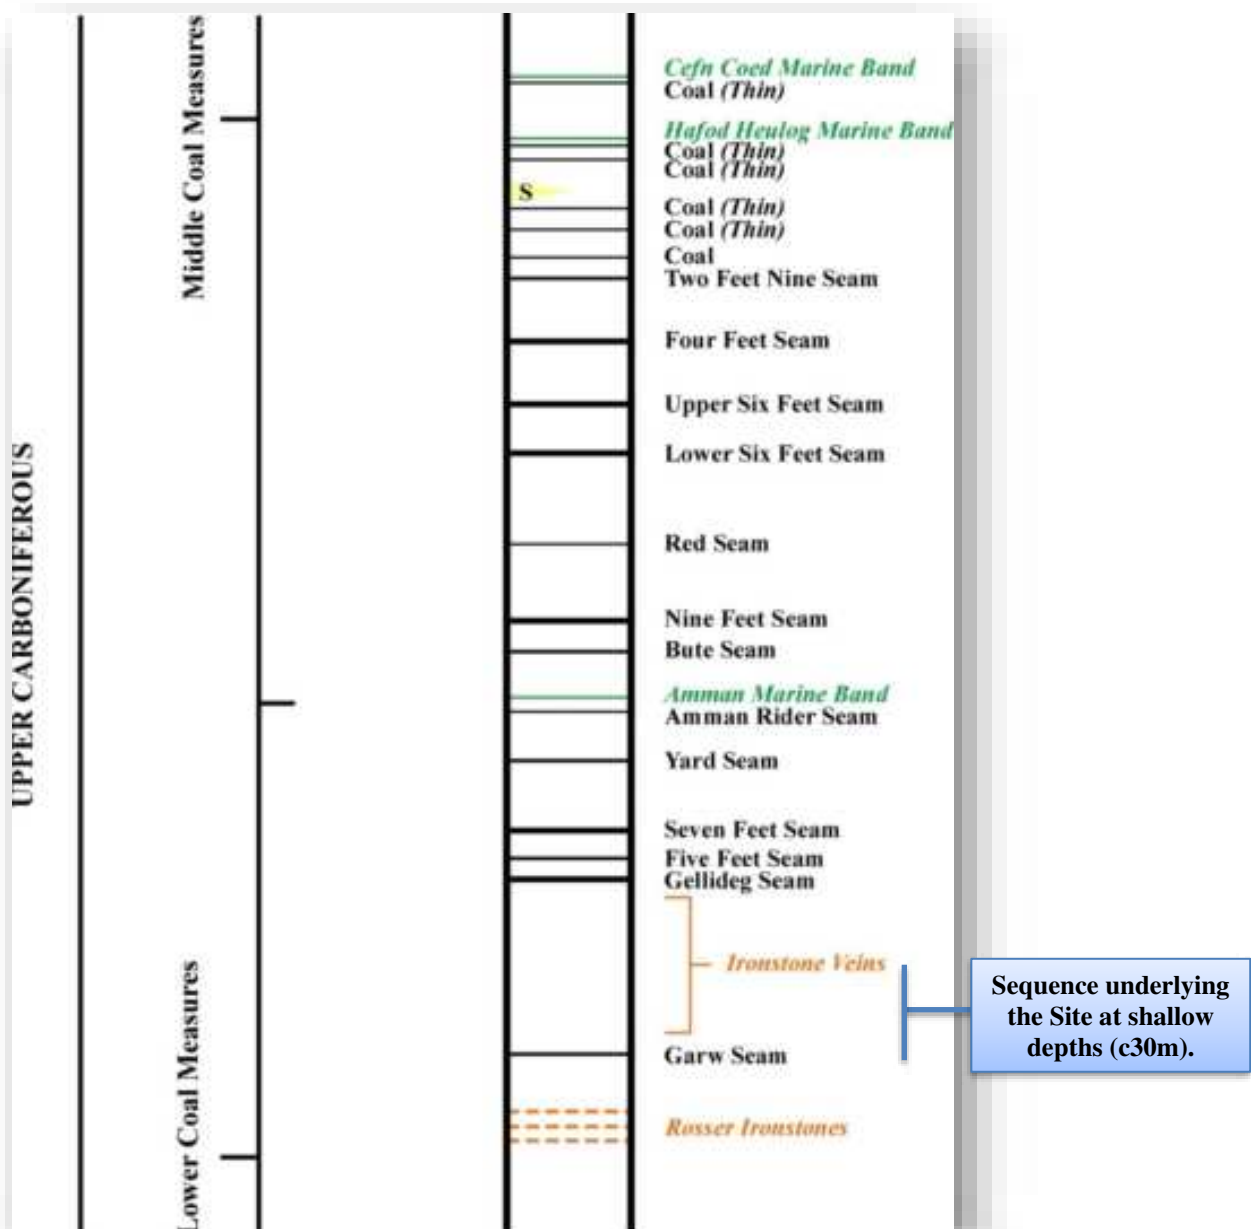
**Figure 2**  
**Part of the Stratigraphic Column.**

(SO 00 NW) shows the inferred positions of the outcrop of the Garw Seam to pass through the Site (see *Geology Plan, drawing no. BC/MB/11.20.04.02*). However, mining records indicate that the outcrops are south-east of the positions shown on the published geological sheet such that the outcrop of the Five Feet/Gellideg Seam passes through the south-west corner of the Site (see *Plan of Old Workings in the Five Feet/Gellideg Seam, drawing no. BC/MB/11.20.04.04*). A number of ironstone bands are present within the coal measures, occurring above and below the Garw Seam (see Figure 2, Part of the Stratigraphic Column).

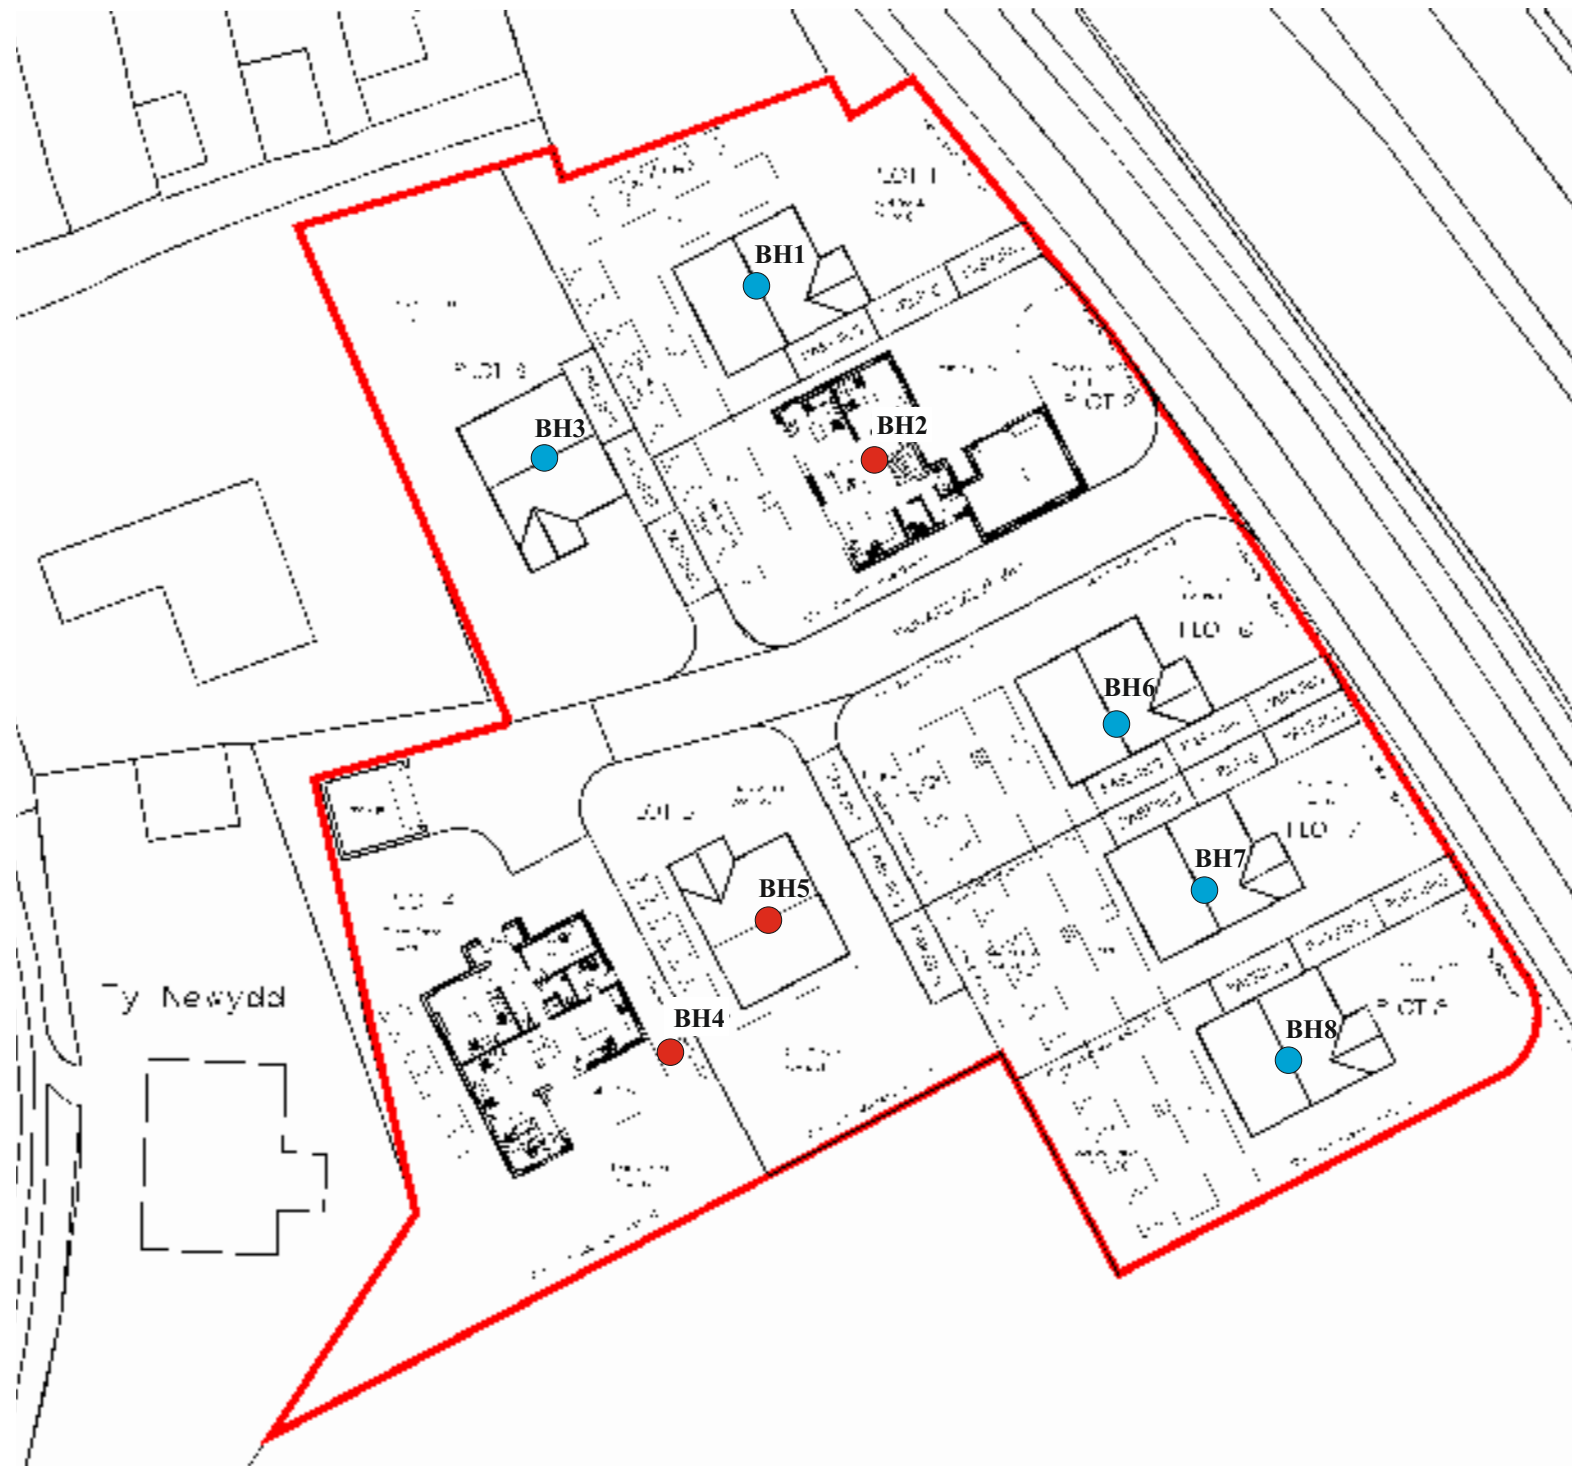
Drawing No: BC/MB/11.20.04.05.

The borehole positions are shown on the *Borehole Location Plan*, drawing no. BC/MB/11.20.04.05 and the graphic logs of the boreholes are contained at Appendix III.

The borehole provings are summarised in Table 1. Made Ground believed to be colliery spoil was encountered in all fourteen boreholes where its thickness was found to vary between 5.5m and 8.0m. Beneath the Made Ground Glacial Till was encountered in all the boreholes where the driller variously described it as Boulder Clay and elsewhere as Sand and Gravel. The Till was found to vary in thickness between 3.5m and 7.0m. Two ironstone vein horizons were encountered in the boreholes, the Blue and the Big Blue. Old workings were encountered in both ironstone veins in at least some of the boreholes.

The old workings encountered in the two ironstone veins were variously found to be broken ground or soft drill (backfilled old workings). The range of thicknesses encountered, when compared to the thickness of overlying bedrock, generally resulted in a strata: void ratio that is less than 10:1. A 10:1 strata void ratio is generally accepted as the limiting ratio whereby old workings are unlikely to reach rockhead. The strata: void ratio for the old workings encountered in the Garw Seam is 13.8:1; the workings are considered to pose no risk to the development.

It is recommended that as a minimum, where no old workings have been encountered on a given plot that a pattern of five boreholes is completed to confirm that no old workings are present beneath the footprint of the building. For buildings longer than 10m the number of boreholes should be increased to eight. If a borehole encounters old workings at the depths that pose a risk of them collapsing to the surface, then the borehole pattern should be modified to provide a grid suitable for the injection of grout to stabilise the old workings. For plots where the preliminary drilling has encountered old workings, the old workings underlying the plot should be stabilised by means of a drilling and grouting programme.

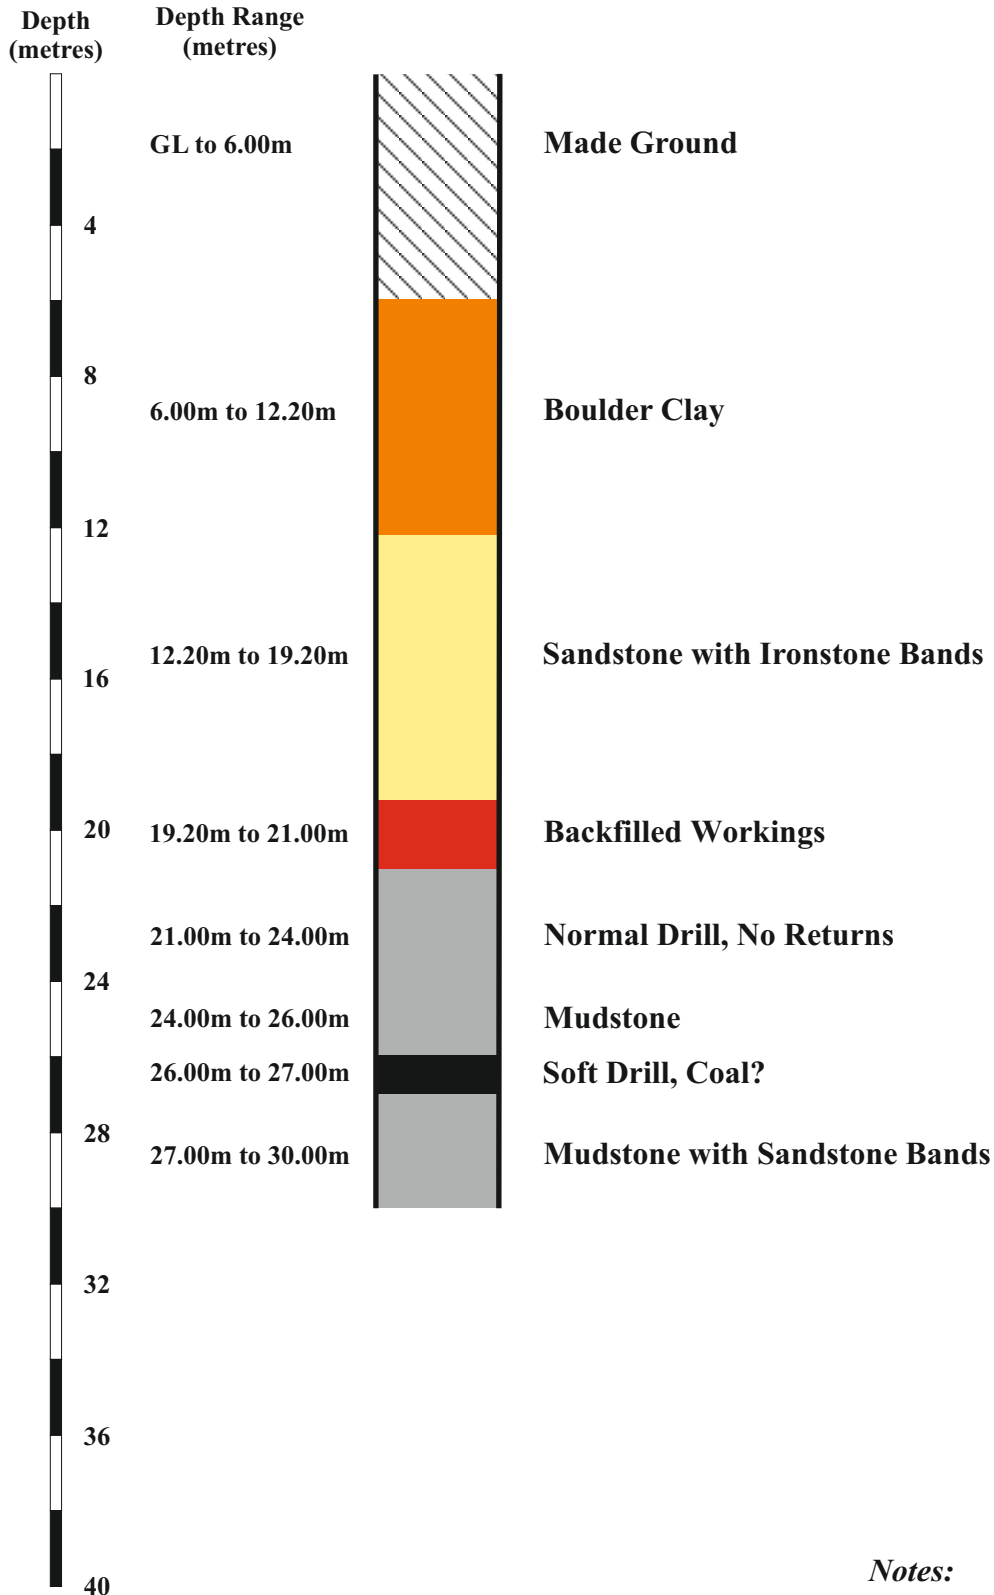
### *Borehole No. 4*

The Garw Seam was encountered at depths to the top of the coal of between 28.0m and 28.5m, the thickness of the coal seam was found to vary between 0.2m and 0.8m. Old workings were encountered in the Seam in Borehole 4, they were found to be 1.0m thickness of soft drill taken to be backfilled old workings.
