RHONDDA  
GEOTECHNICAL  
SERVICES

SLOPE STABILITY ANALYSIS  
GROUND LEVEL REDUCTION  
METHODOLOGY STATEMENT

MERTHYR MOTOR AUCTIONS  
PANT ROAD  
DOWLAIS  
MERTHYR TYDFIL  
CF48 3SH  
22/06/2021

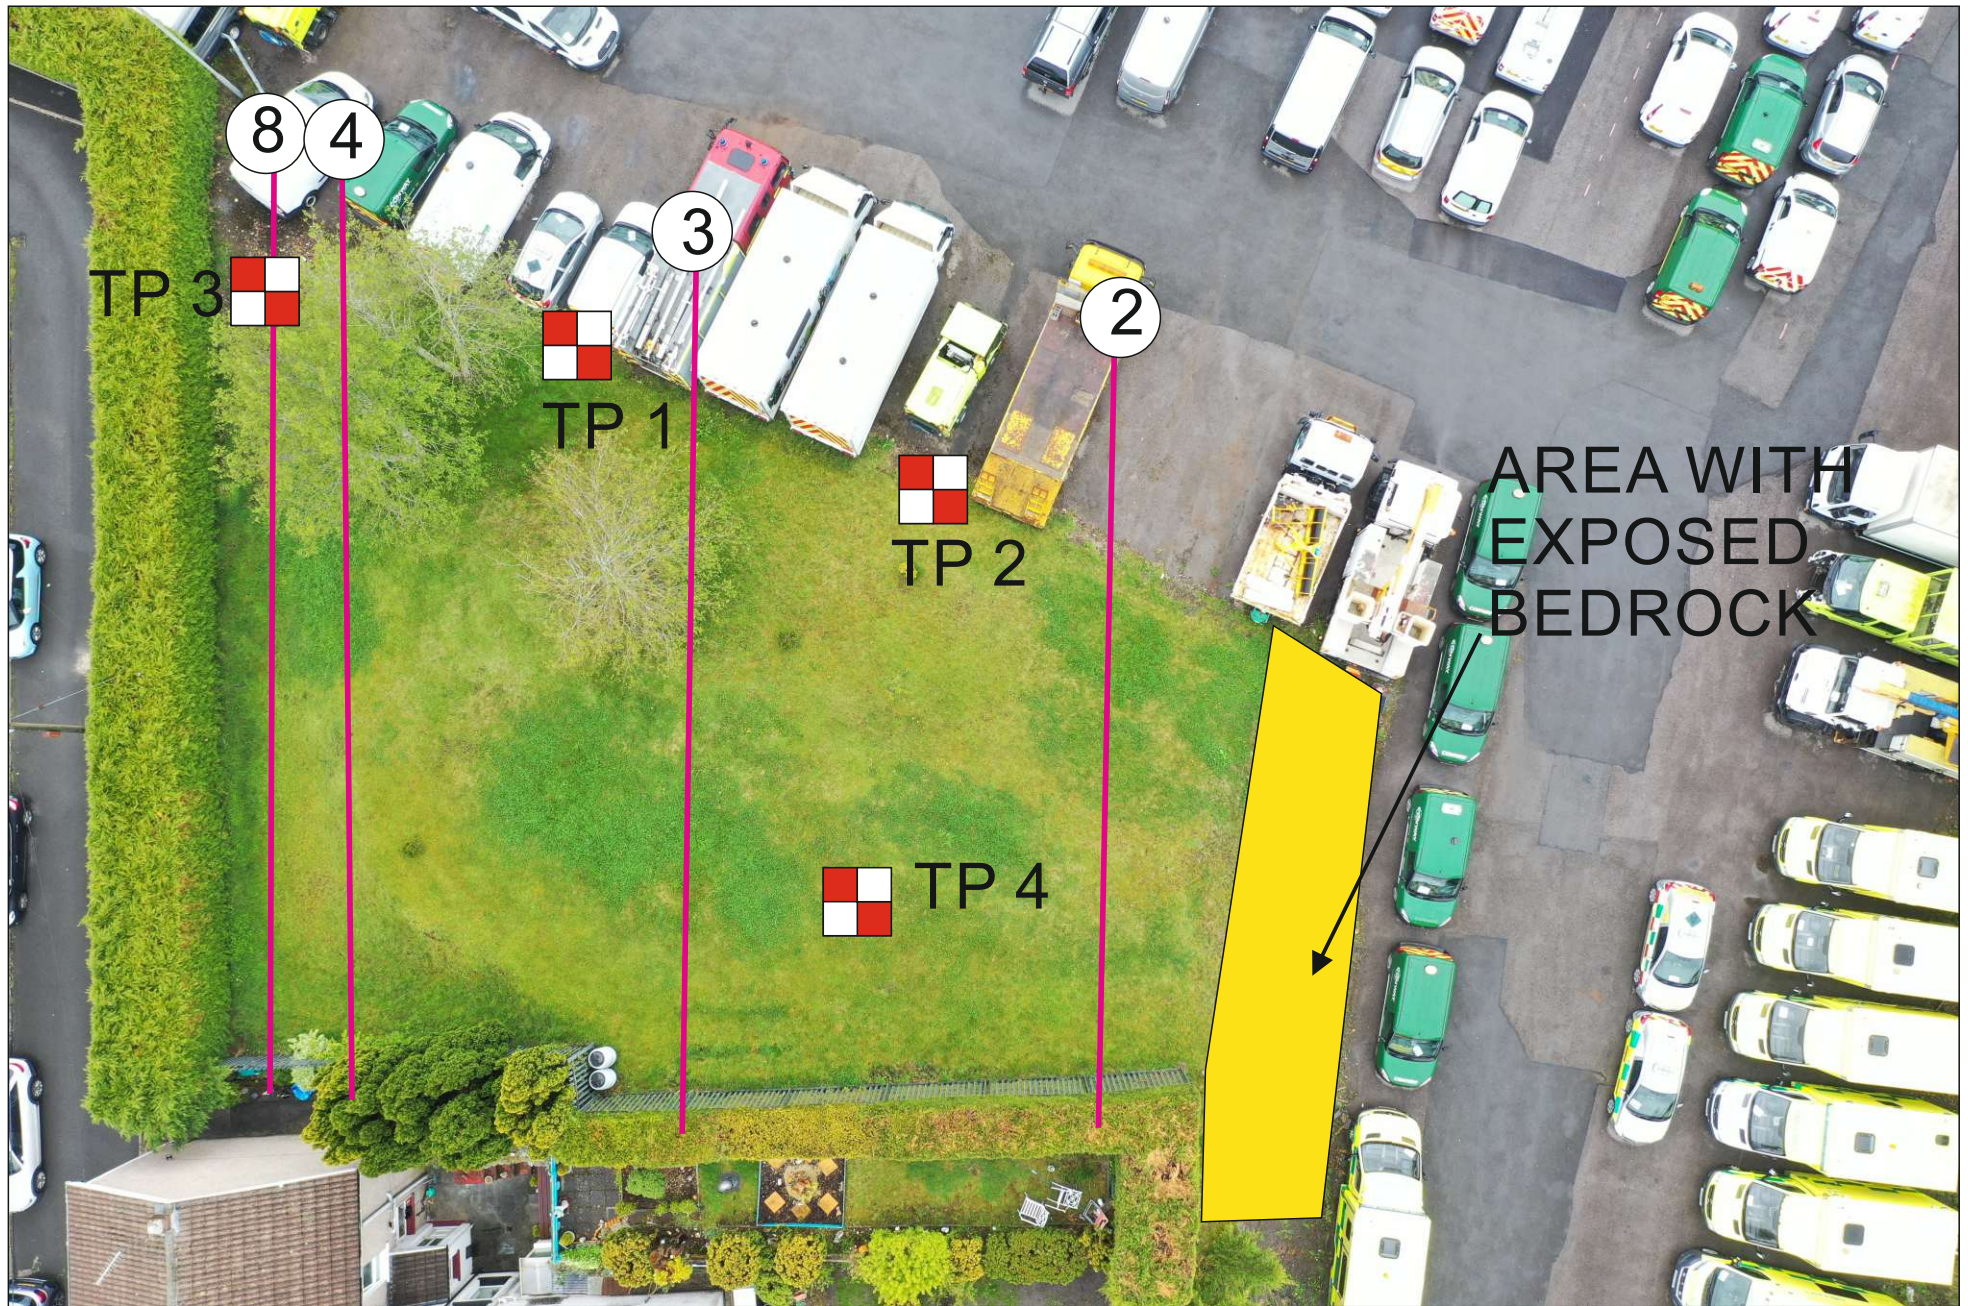
FIGURE 1  
AERIAL VIEW OF THE EMBANKMENT AT M.M.A. PANT WITH SECTION LINES

A detailed inspection of the embankment was carried out on Monday 2/11/2020. The embankment is at the same level as the elevated garden of no. 43 Llewellyn Street and is separated from it by a steel palisade fence with dense conifers behind it. It should be emphasised that the houses in Llewellyn Street are at approximately the same level as the existing yard of the auctions, only the gardens are at a higher level. These back onto the former railway cutting mentioned in the site history. The embankment has a flat top running away from the palisade fence and ranging from 8m-12m wide before running down to the yard level at an average slope of 30°. The top of the embankment and the slope are grassed over with three medium sized trees on the western part of the slope. A small hand dug trial pit was excavated on the top of the embankment. This revealed a gravelly soil which appeared to be Made Ground. The pit position is labelled TP4 on Figure 1 which is a recent photograph taken from a drone. In

addition two trial pits were machine excavated for infiltration tests. These were subsequently inspected by the author and samples for chemical analysis taken. At the author's request a third trial pit (TP3) was excavated. All three trial pits were excavated in gravelly made ground. This was mainly railway ballast, with occasional brick, ironworks slag and masonry. On the eastern flank of the embankment the underlying bedrock is exposed. This is a thinly interbedded series of Siltstone and Mudstone with Ironstone nodule horizons. Photographs are included in the original report. The bedrock has been cut back, presumably as part of the railway cutting. The slope angle is approximately 70°. Apart from very minor frost spalling this slope angle appears completely stable and has been so for a period of at least 150 years. As part of the planning application a series of ten sections of the existing and proposed embankments were produced by Utopia Designs. The four most relevant to the stability of the embankment are superimposed on the aerial photo in Figure 1.

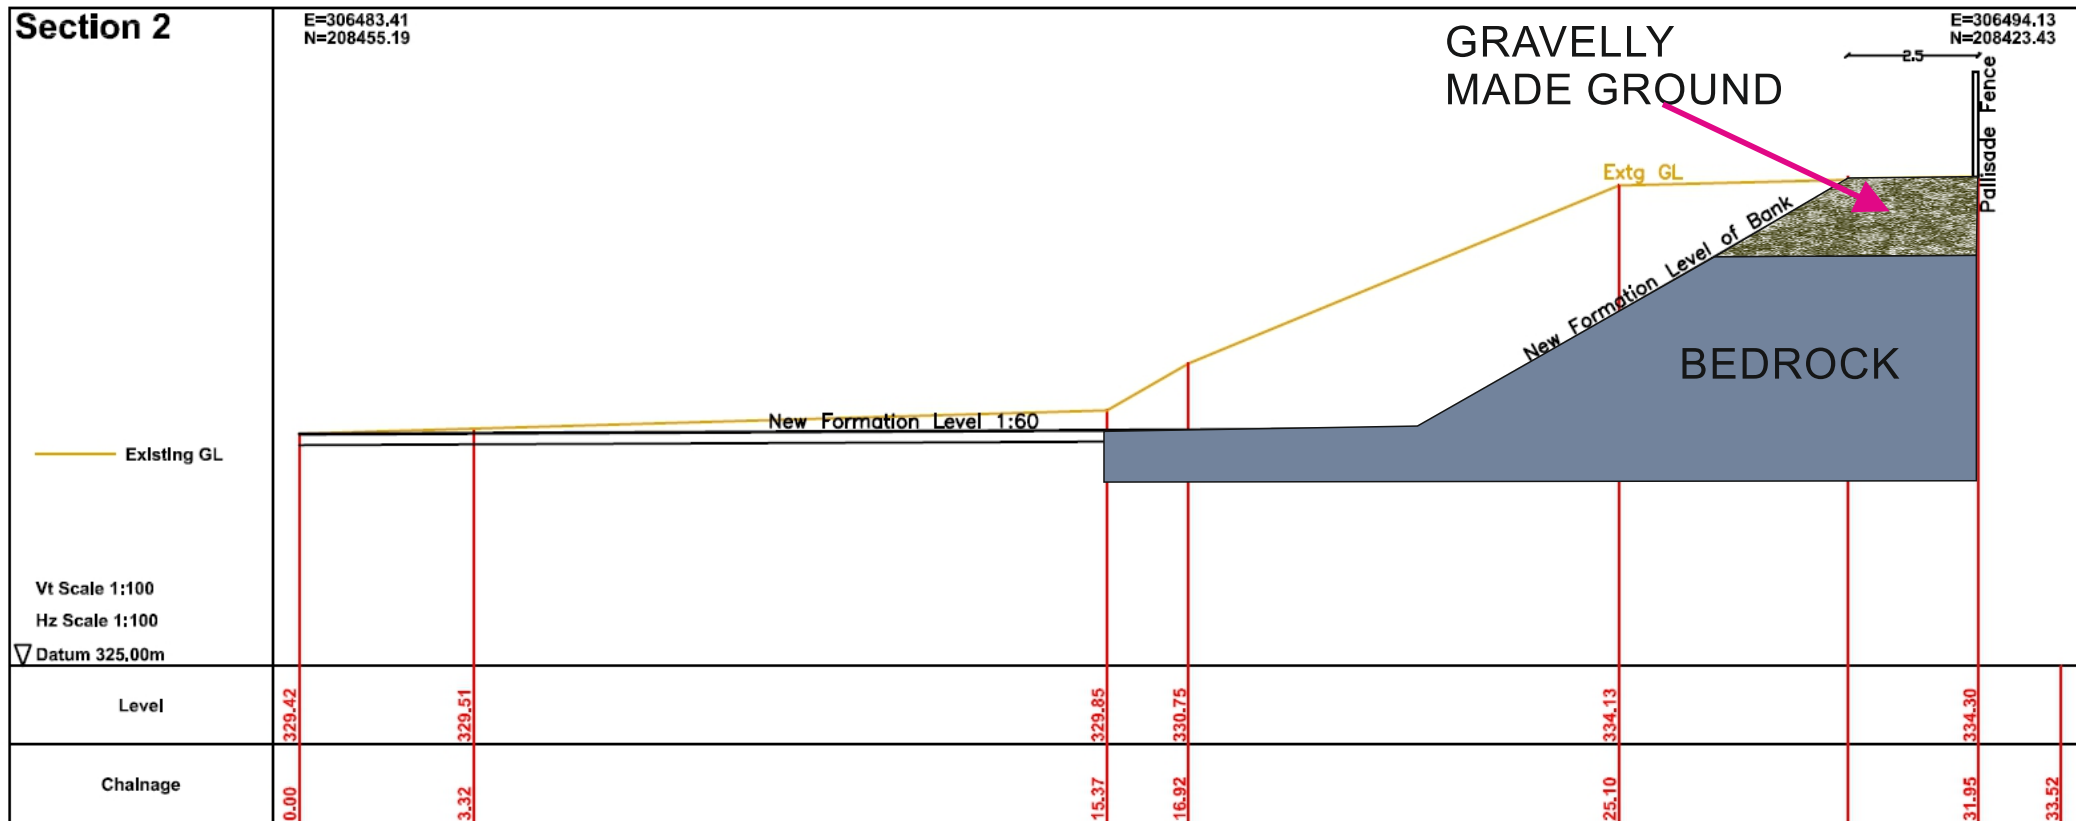
FIGURE 2  
ANTICIPATED GROUND CONDITIONS AT SECTION LINE 2

In addition to the visible bedrock and the trial pits historic aerial photographs were studied. The M.M.A. site was cleared and constructed in its present form in 1994-1995. The northern slope of the embankment was profiled at this time. This process was well recorded in a series of aerial photos. Only framed hard copies exist, and so cannot be reproduced here. The photographs are large and show the site with no vegetation. This has allowed a reasonable estimate of bedrock levels beneath the present embankment. These levels are shown in Figures 2-5.

It is anticipated that the bedrock surface will fall away to the west as shown through Figures 2-5. This will have no detrimental effect on slope stability. The original proposal was to cut the bedrock back at a much steeper angle. Because of the standoff restrictions this is no longer being proposed. Both bedrock and the Made Ground will be stable at the new uniform lower angle of 30°.
