# **Arboricultural Assessment Survey 2019**

## **Arboricultural Assessment of trees within boundary of Greenfields School, Pentrebach, Merthyr Tydfil.**

**Andrew Taylor  
Arboriculturalist**

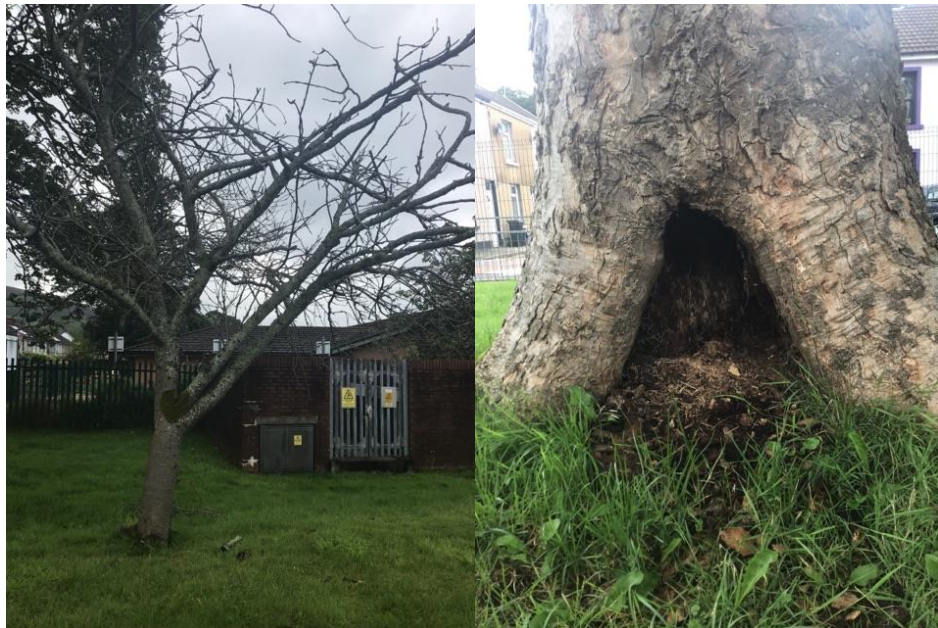
| Tree ID | Height (m) | Age Class | Width(mm) | Priority | Structural Condition | Common Name | Physical Condition | Recommendations | Species |
|---|---|---|---|---|---|---|---|---|---|
| 2463 | 4 | Dead | 300 | 1 year | Dead | Cherry | Dead | Fell | Prunus Spp |

| Tree ID | Height (m) | Age Class | Width(mm) | Priority | Structural Condition | Common Name | Physical Condition | Recommendations | Species |
|---|---|---|---|---|---|---|---|---|---|
| 2464 | 12 | M | 800 | 1 year | Extensive decay at base and ink cap mushrooms present. Decay extends from buttresses internally for over 2 meters and approximately a third of main bole defected. Many pruning wounds indicating internal issues. | Sycamore | Fair | Fell and replant | Acer pseudoplatanus |

**Image 1 and 2:** Tree ID- 2463 and 2464: Hazardous trees for removal

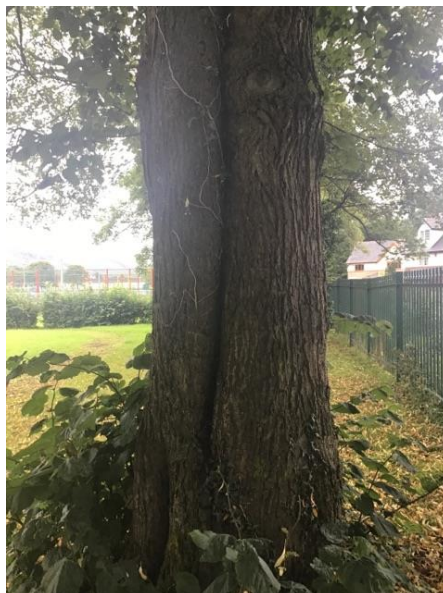
| Tree ID | Height (m) | Age Class | Width(mm) | Priority | Structural Condition | Common Name | Physical Condition | Recommendations | Species |
|---|---|---|---|---|---|---|---|---|---|
| 2451 | 16 | M | 950 | 1 year | Large vertical crack to northern side, 4meters in length with signs of decay, major structural floor | Large leaved lime | Good | Pollard to 4 meters above main union.to reduce mechanical forces on main bole | Tilia platyphyllus |

**Image 3:** Tree ID 2451 – Major longitudinal crack on mature lime, remedial action to reduce weight and mechanical forces.

- 6.2 2 trees in the report were detailed for remedial works which involves the reduction of canopies to reduce loads upon tree branch unions, decreasing the likelihood of future failure. This will increase the trees remaining contribution to the area.

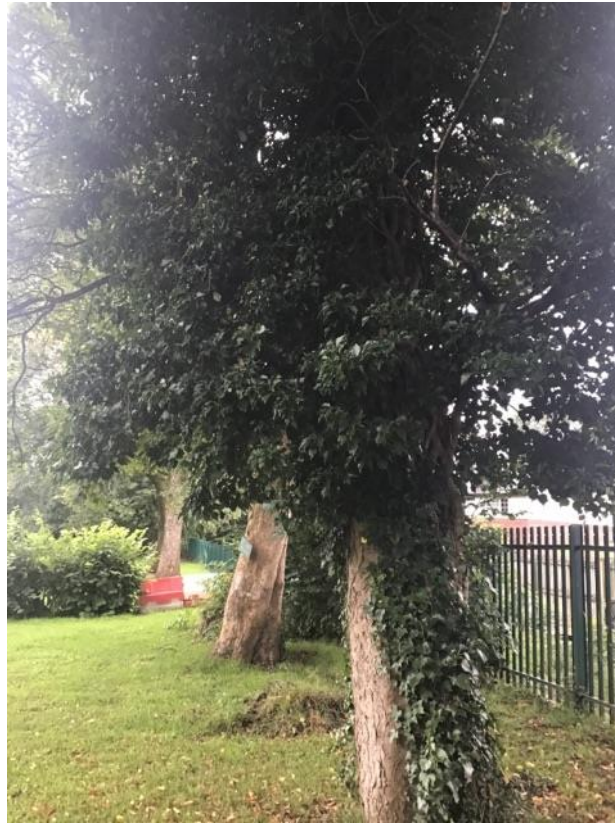
**Image 4:** heavy ivy present on some trees – needs to be removed before detailed inspection can occur.

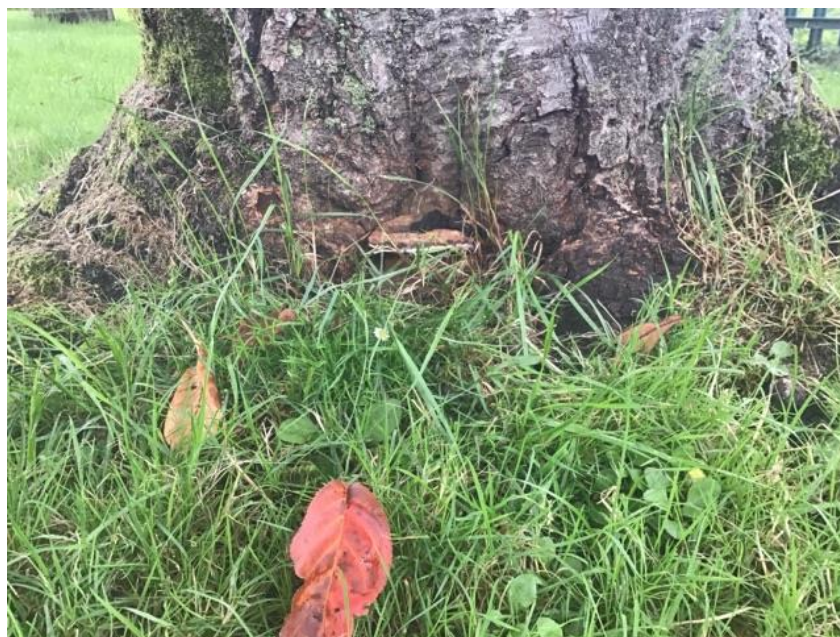
| Tree ID | Height (m) | Age Class | Width(mm) | Priority | Structural Condition | Common Name | Physical Condition | Recommendations | Species |
|---|---|---|---|---|---|---|---|---|---|
| 2460 | 3 | M | 550 | 1 year | Poor, ganoderma present within buttresses, dieback within crown | Wild cherry | Fair | Fell | Prunus avium |

**Image 5:** Ganoderma fungal colonisation within buttress - Tree ID 2460

- 6.1 All of the remedial tree works are detailed in the tree survey table and are located in section 5.1. In total 37 trees were surveyed, with 6 recommended for removal. Tree ID 2460 has a *Ganoderma* fungus which will kill the tree and create hazards. Tree ID – 2463 is dead, 2464 and 2471 regarding their structural or physiological state (safety reasons as they are dead). 2 further trees highlighted for removal are small and pose future issues regarding fence lines.

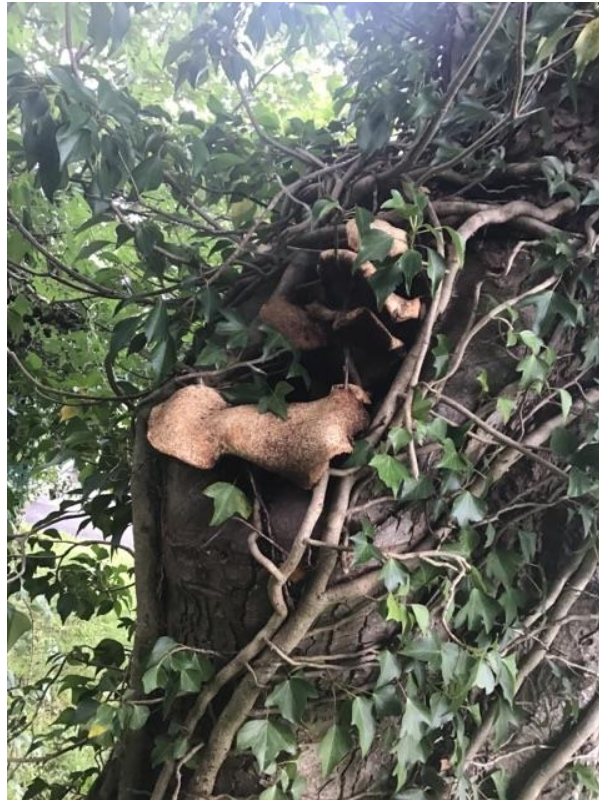
| Tree ID | Height (m) | Age Class | Width(mm) | Priority | Structural Condition | Common Name | Physical Condition | Recommendations | Species |
|---|---|---|---|---|---|---|---|---|---|
| 2470 | 14 | M | 900 | 1 year | Large saddle fungus bracket approx at 2 meters in large pruning wound, likely localised. Large amount of good wood remaining. | Sycamore | Good | Monitor cavity and crown for decline | Acer pseudoplatanus |

**Image 6:** Saddle fungus present in old pruning wound – Tree ID 2470

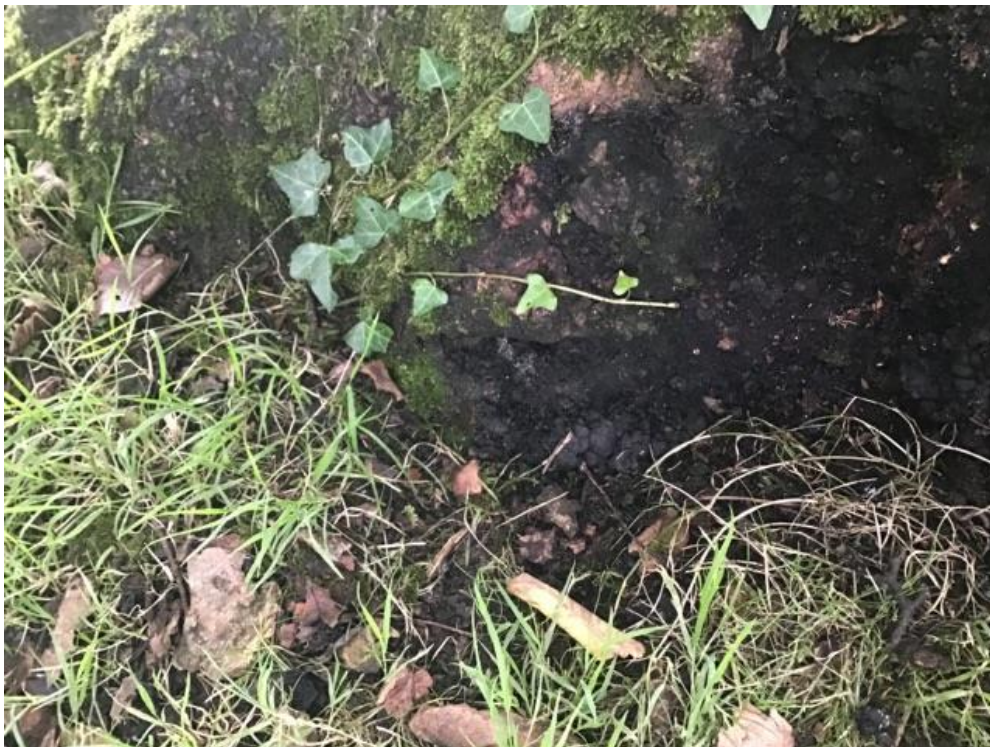
| Tree ID | Height (m) | Age Class | Width(mm) | Priority | Structural Condition | Common Name | Physical Condition | Recommendations | Species |
|---|---|---|---|---|---|---|---|---|---|
| 2471 | 10 | M | 790 | 1 year | Poor, canopy sparse, brittle cinder fungus present at base and within buttresses | Sycamore | poor | Fell | Acer pseudoplatanus |

**Image 7:** Brittle cinder evident on base of Sycamore – Tree ID – 2471

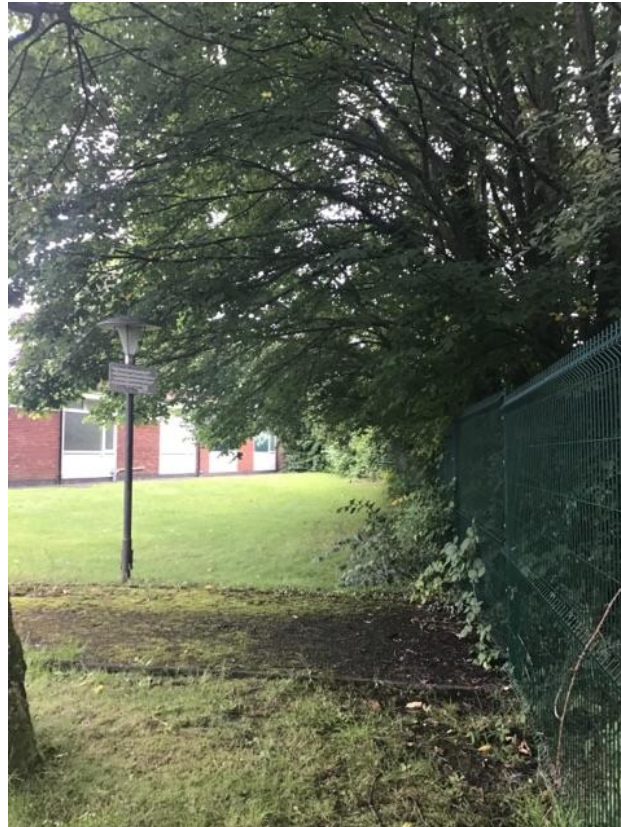
| Tree ID | Height (m) | Age Class | Width(mm) | Priority | Structural Condition | Common Name | Physical Condition | Recommendations | Species |
|---|---|---|---|---|---|---|---|---|---|
| Gp 001 | 8 | SM | 400 | 1 year | Low canopies and leaning into school grounds | Various | Good | Raise canopies and cut back to boundaries | |

**Image 8:** Severe overhang from outside invading school boundaries Gp 001

- 6.11 General maintenance of boundary trees needs to be addressed within the site, many trees are growing within fence lines and need to be removed to prevent damage to the fences, areas of the school boundary to the east towards the infants area have significant overhanging limbs from outside the boundary which should be

cut back to avoid future issues and maximise the space available with the school. Hedges and visual boundaries around the infants need to be cut back as some obscure paths and others invade play areas and may not be child friendly species (hawthorn and blackthorn). All hedges around the main school and need to be cut regularly.

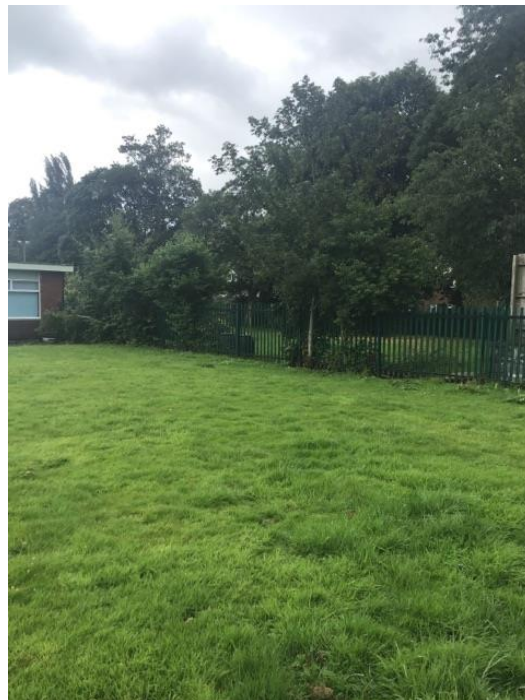
**Image 9:** Trees growing within fence line need to be removed before damage occurs.

| Tree ID | Height (m) | Age Class | Width(mm) | Priority | Structural Condition | Common Name | Physical Condition | Recommendations | Species |
|---|---|---|---|---|---|---|---|---|---|
| 2480 | 2 | Y | 150 | 1 year | Row of trees in fence line, will cause damage and future issue | Various | Good | Fell out of fence line | |
