## STRUCTURAL INSPECTION

Inspection Report upon an Existing Boundary  
Retaining Wall at The former Norton Tavern,  
High Street,  
Merthyr Tydfil,  
CF47 9HG

**Prepared for:** Raynes Scaffolding & Groundworks Ltd  
**Project Ref:** 20391

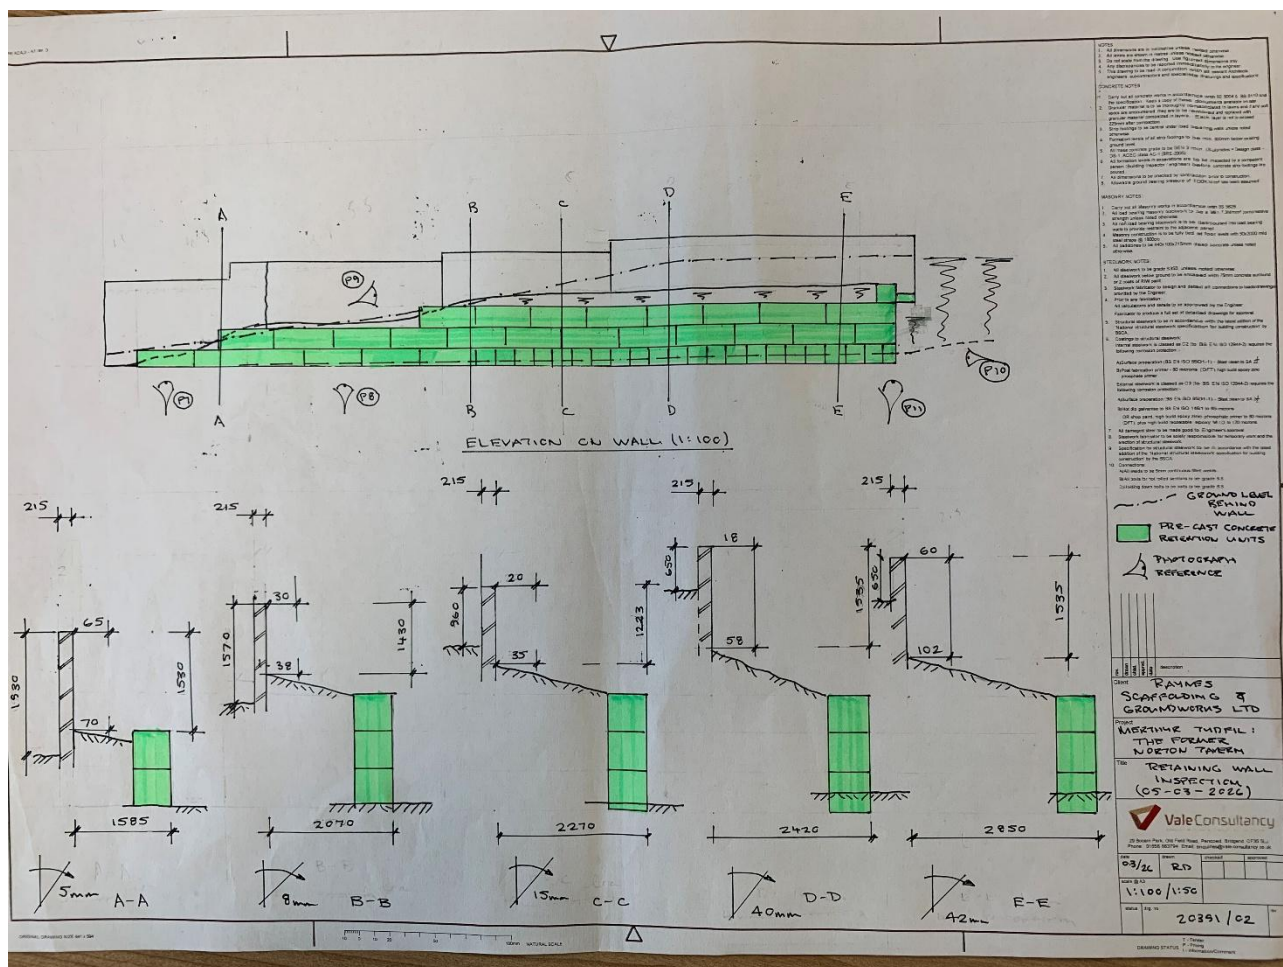
# 200391/02 Retaining Wall Inspection 05-03-2026

3.3 The out-of-plumb dimensions recorded during both inspections were as follows;

| Date | Location | | | | |
| | A | B | C | D | E |
| 21 January 2025 | 7 | 10 | 12 | 42 | 43 |
| 5 March 2026 | 5 | 8 | 15 | 40 | 42 |

**4.1** A comparison of the wall verticality readings between the two dates (14 months apart) records that there is negligible difference in movement of the wall given the accuracies of readings based upon the naked eye and use of a string plumb bob.

**4.3** The eastern section of the boundary wall exhibits a lean of 40mm-42mm. This slightly exceeds the theoretical limit for the wall to be considered as stable. However, the measurements confirm that the wall has effectively not moved over the preceding fourteen months and therefore, no strengthening works are recommended at this time other than a bi-annual check is undertaken upon the wall to ensure any subsequent movement is not progressive.
