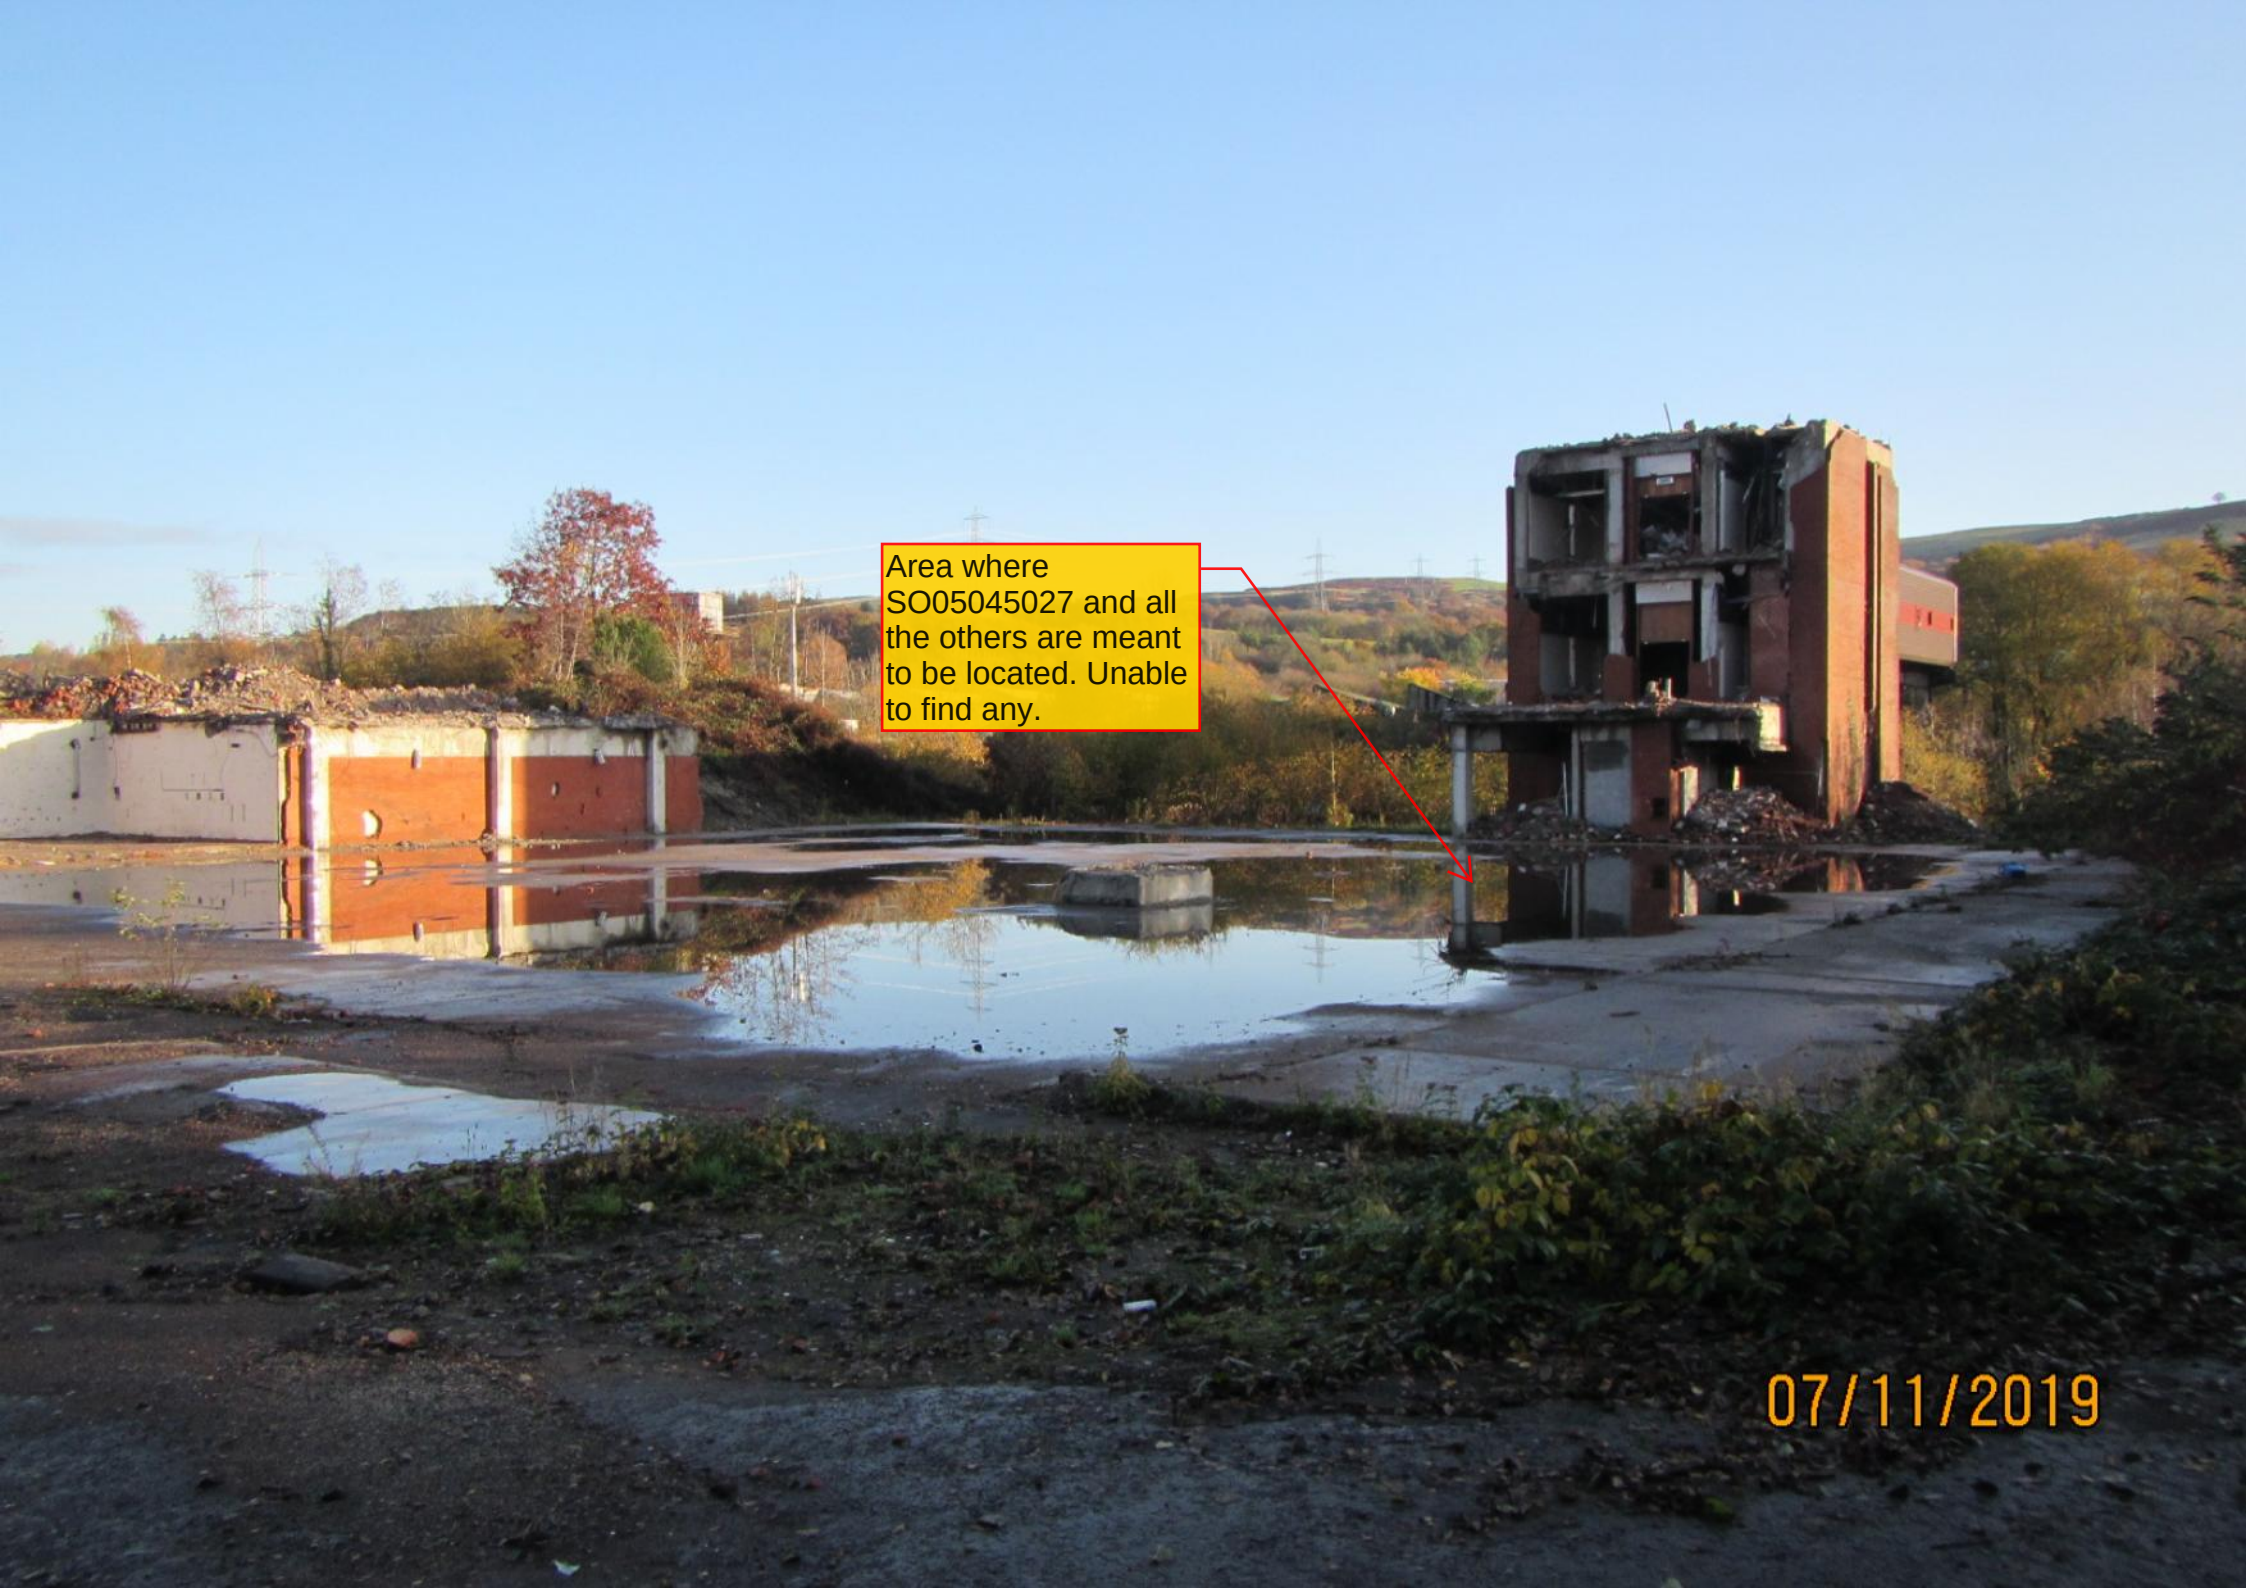
Area where  
SO05045027 and all  
the others are meant  
to be located. Unable  
to find any.

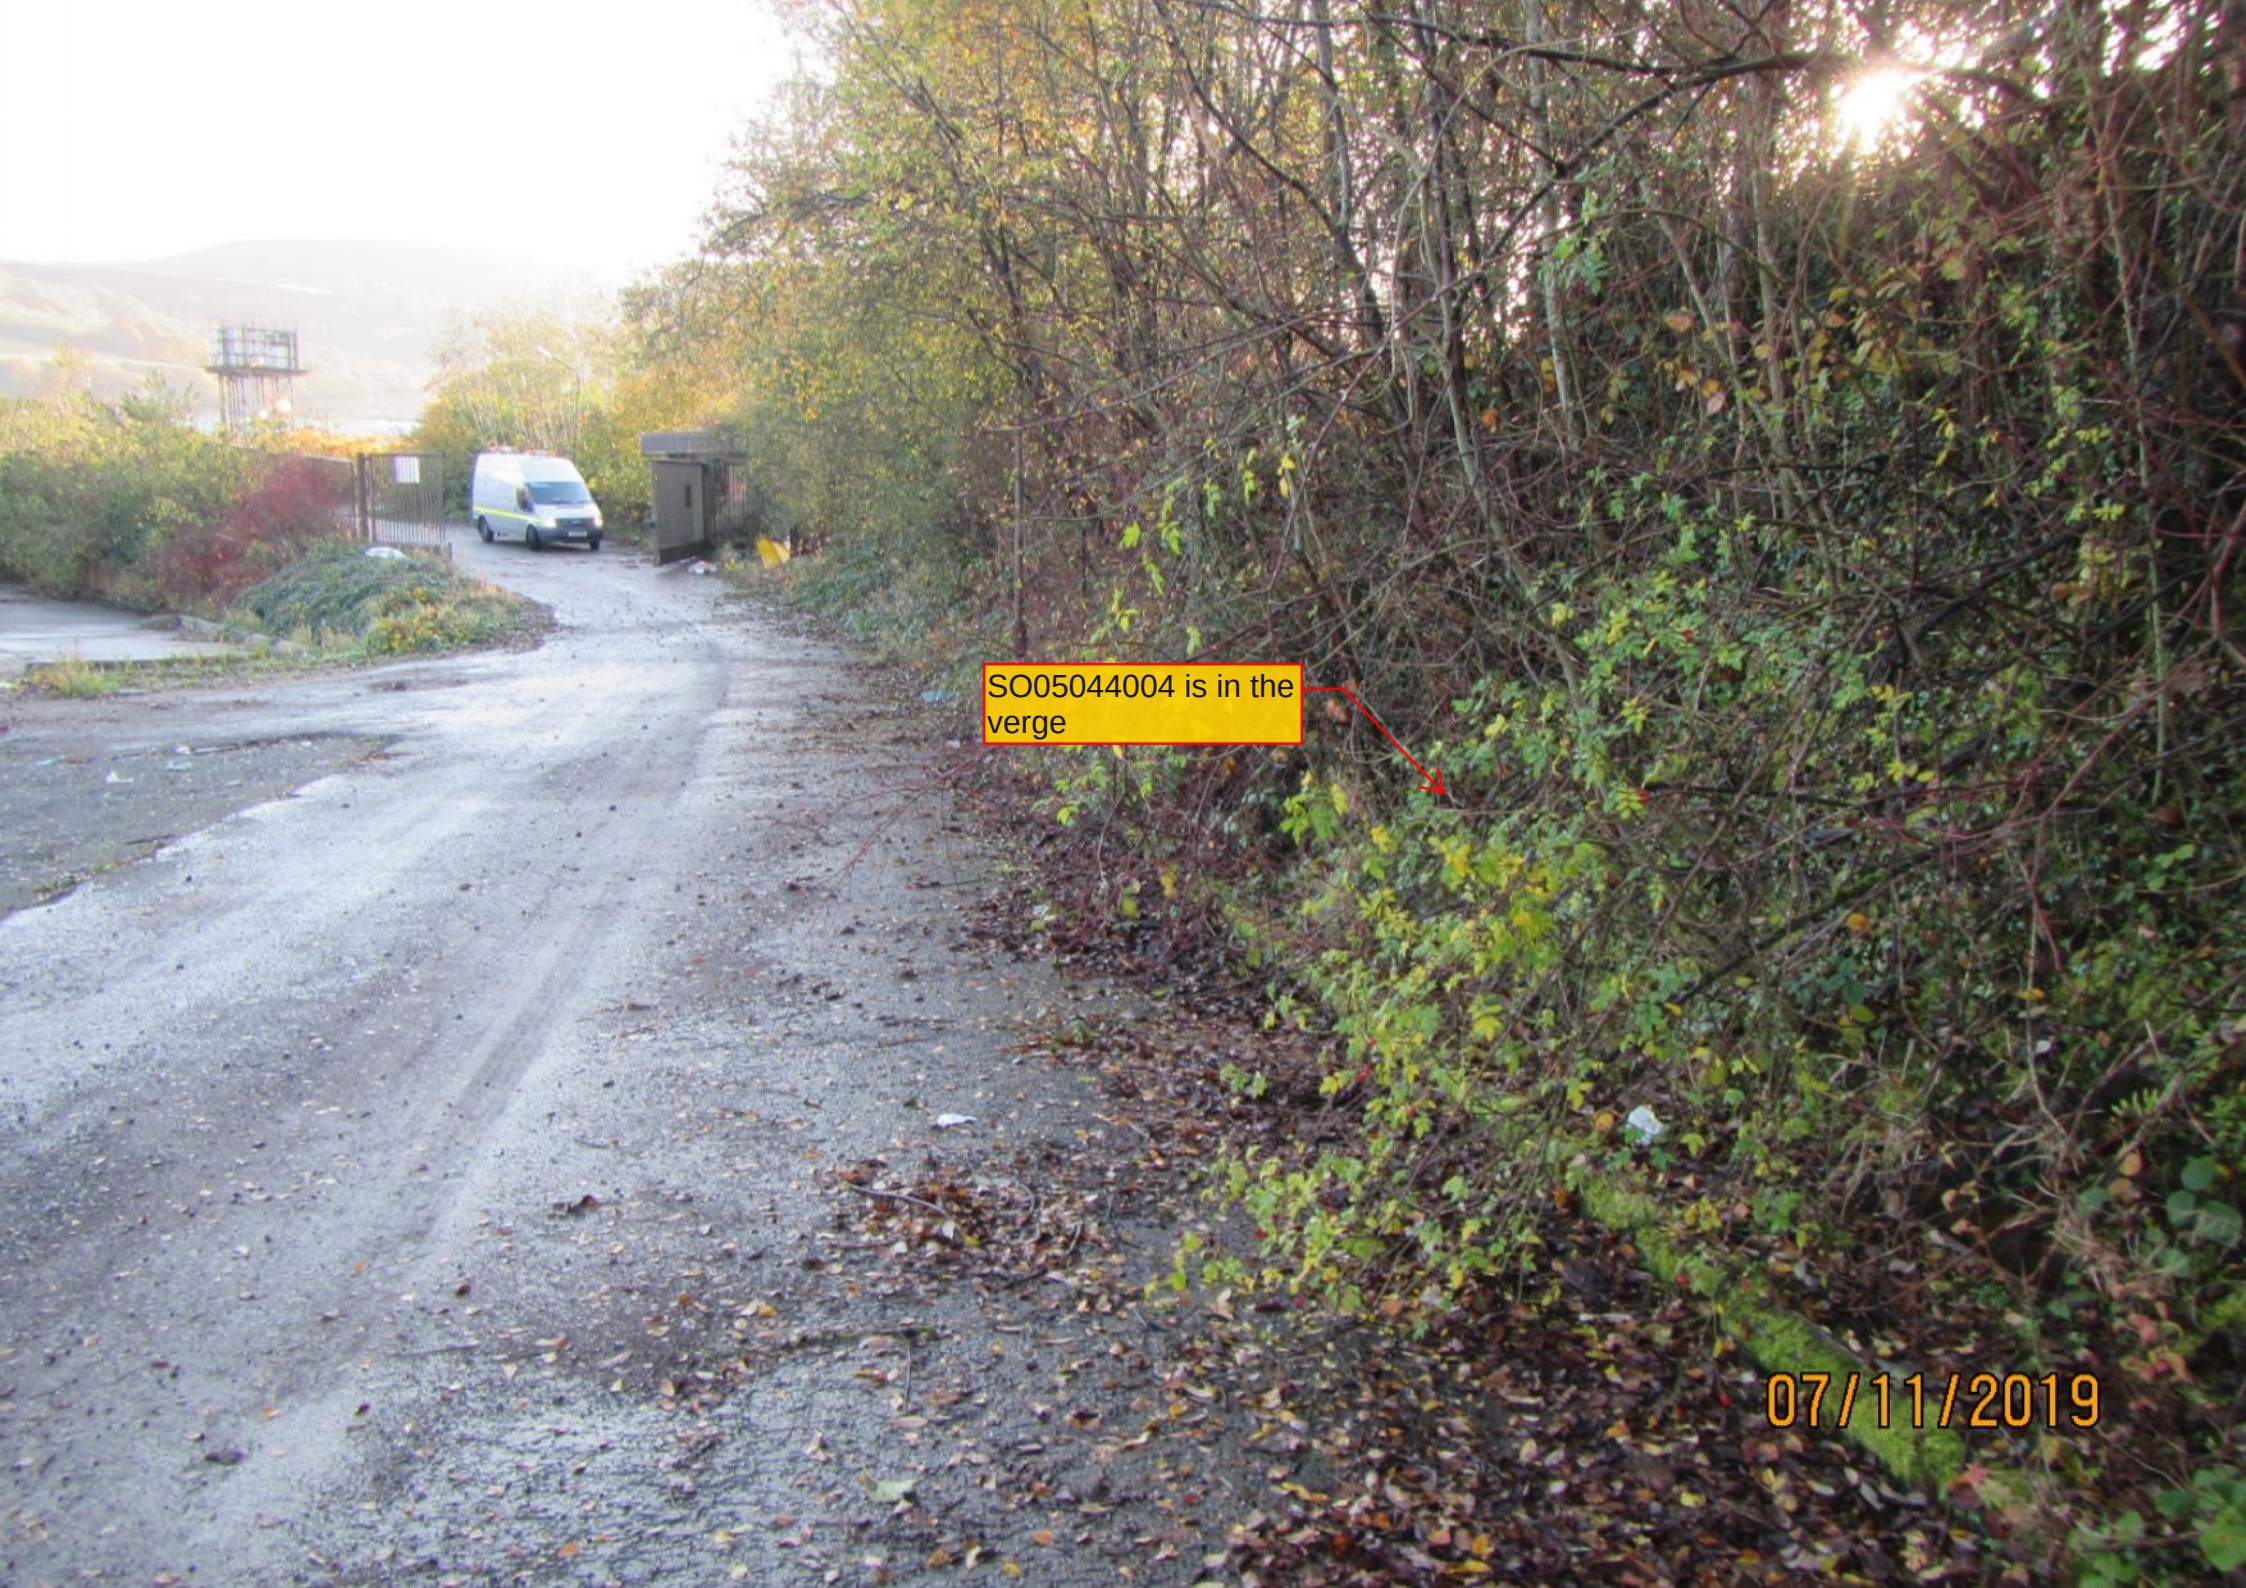
SO05044004 is in the  
verge

Cover has been  
stolen

Inside SO05044004,  
825mm trunk main

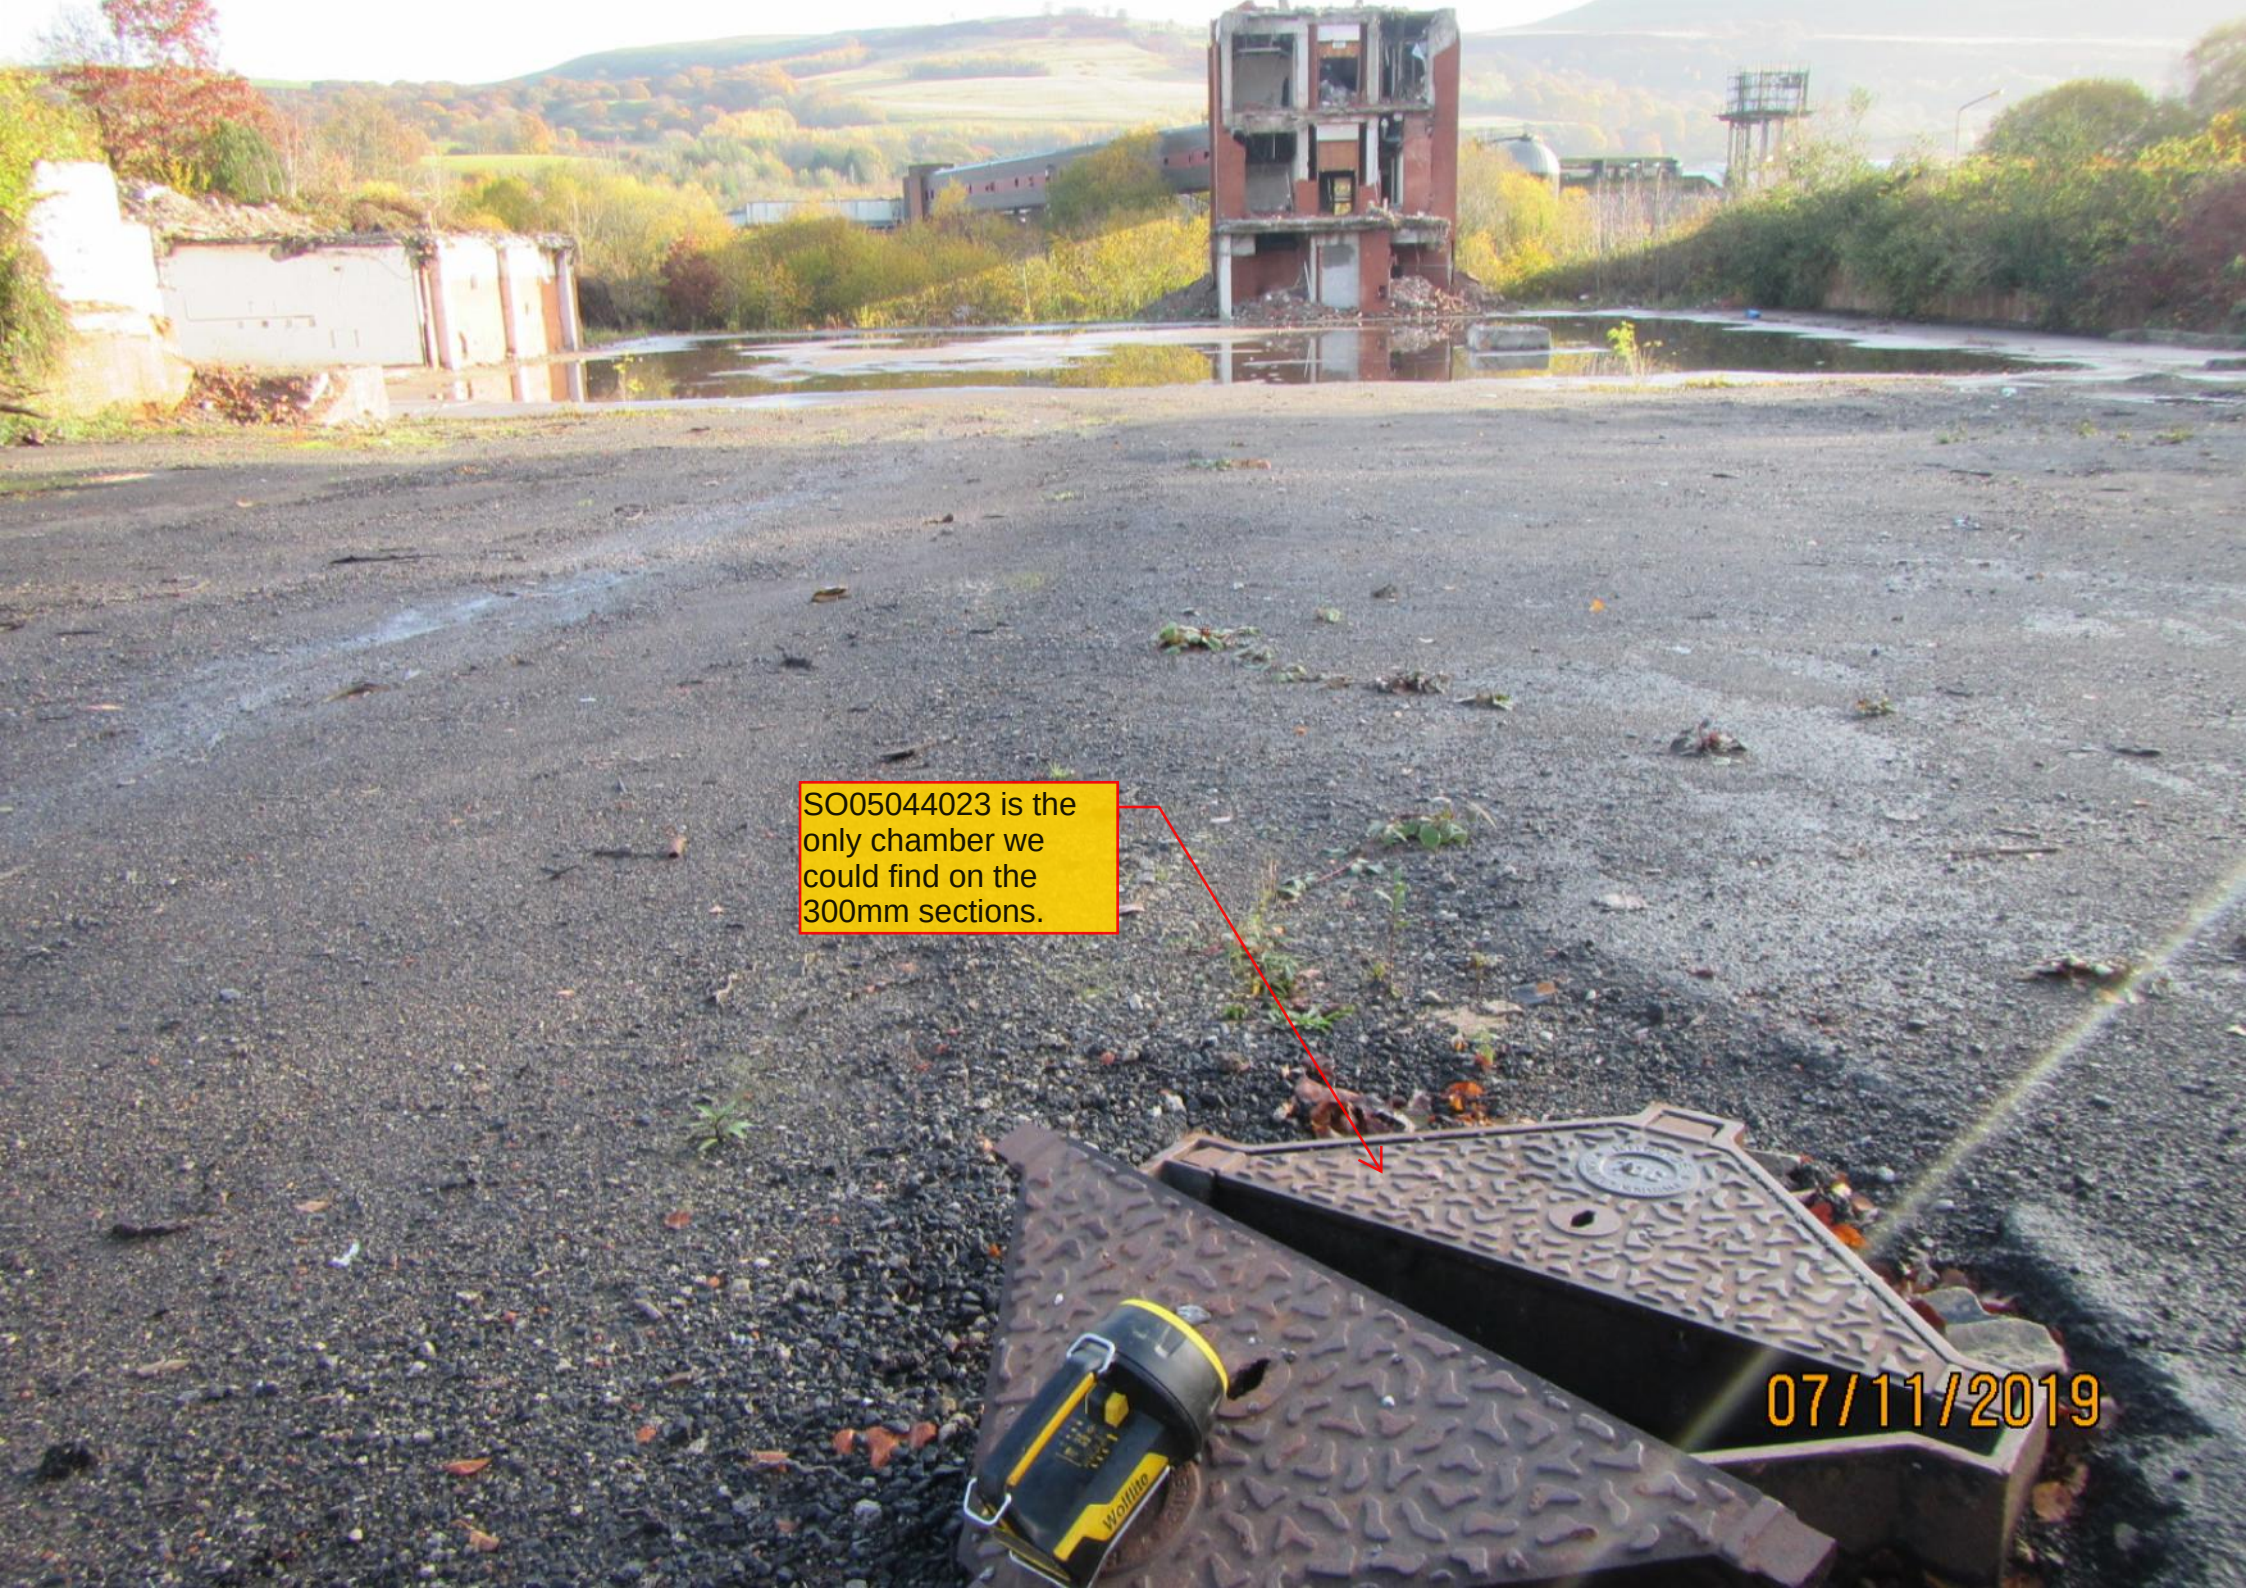
SO05044023 is full of  
rubble, but confirmed  
this drops into  
825mm main in  
SO05044004

SO05044004 over  
825mm trunk is 3.5m  
deep.

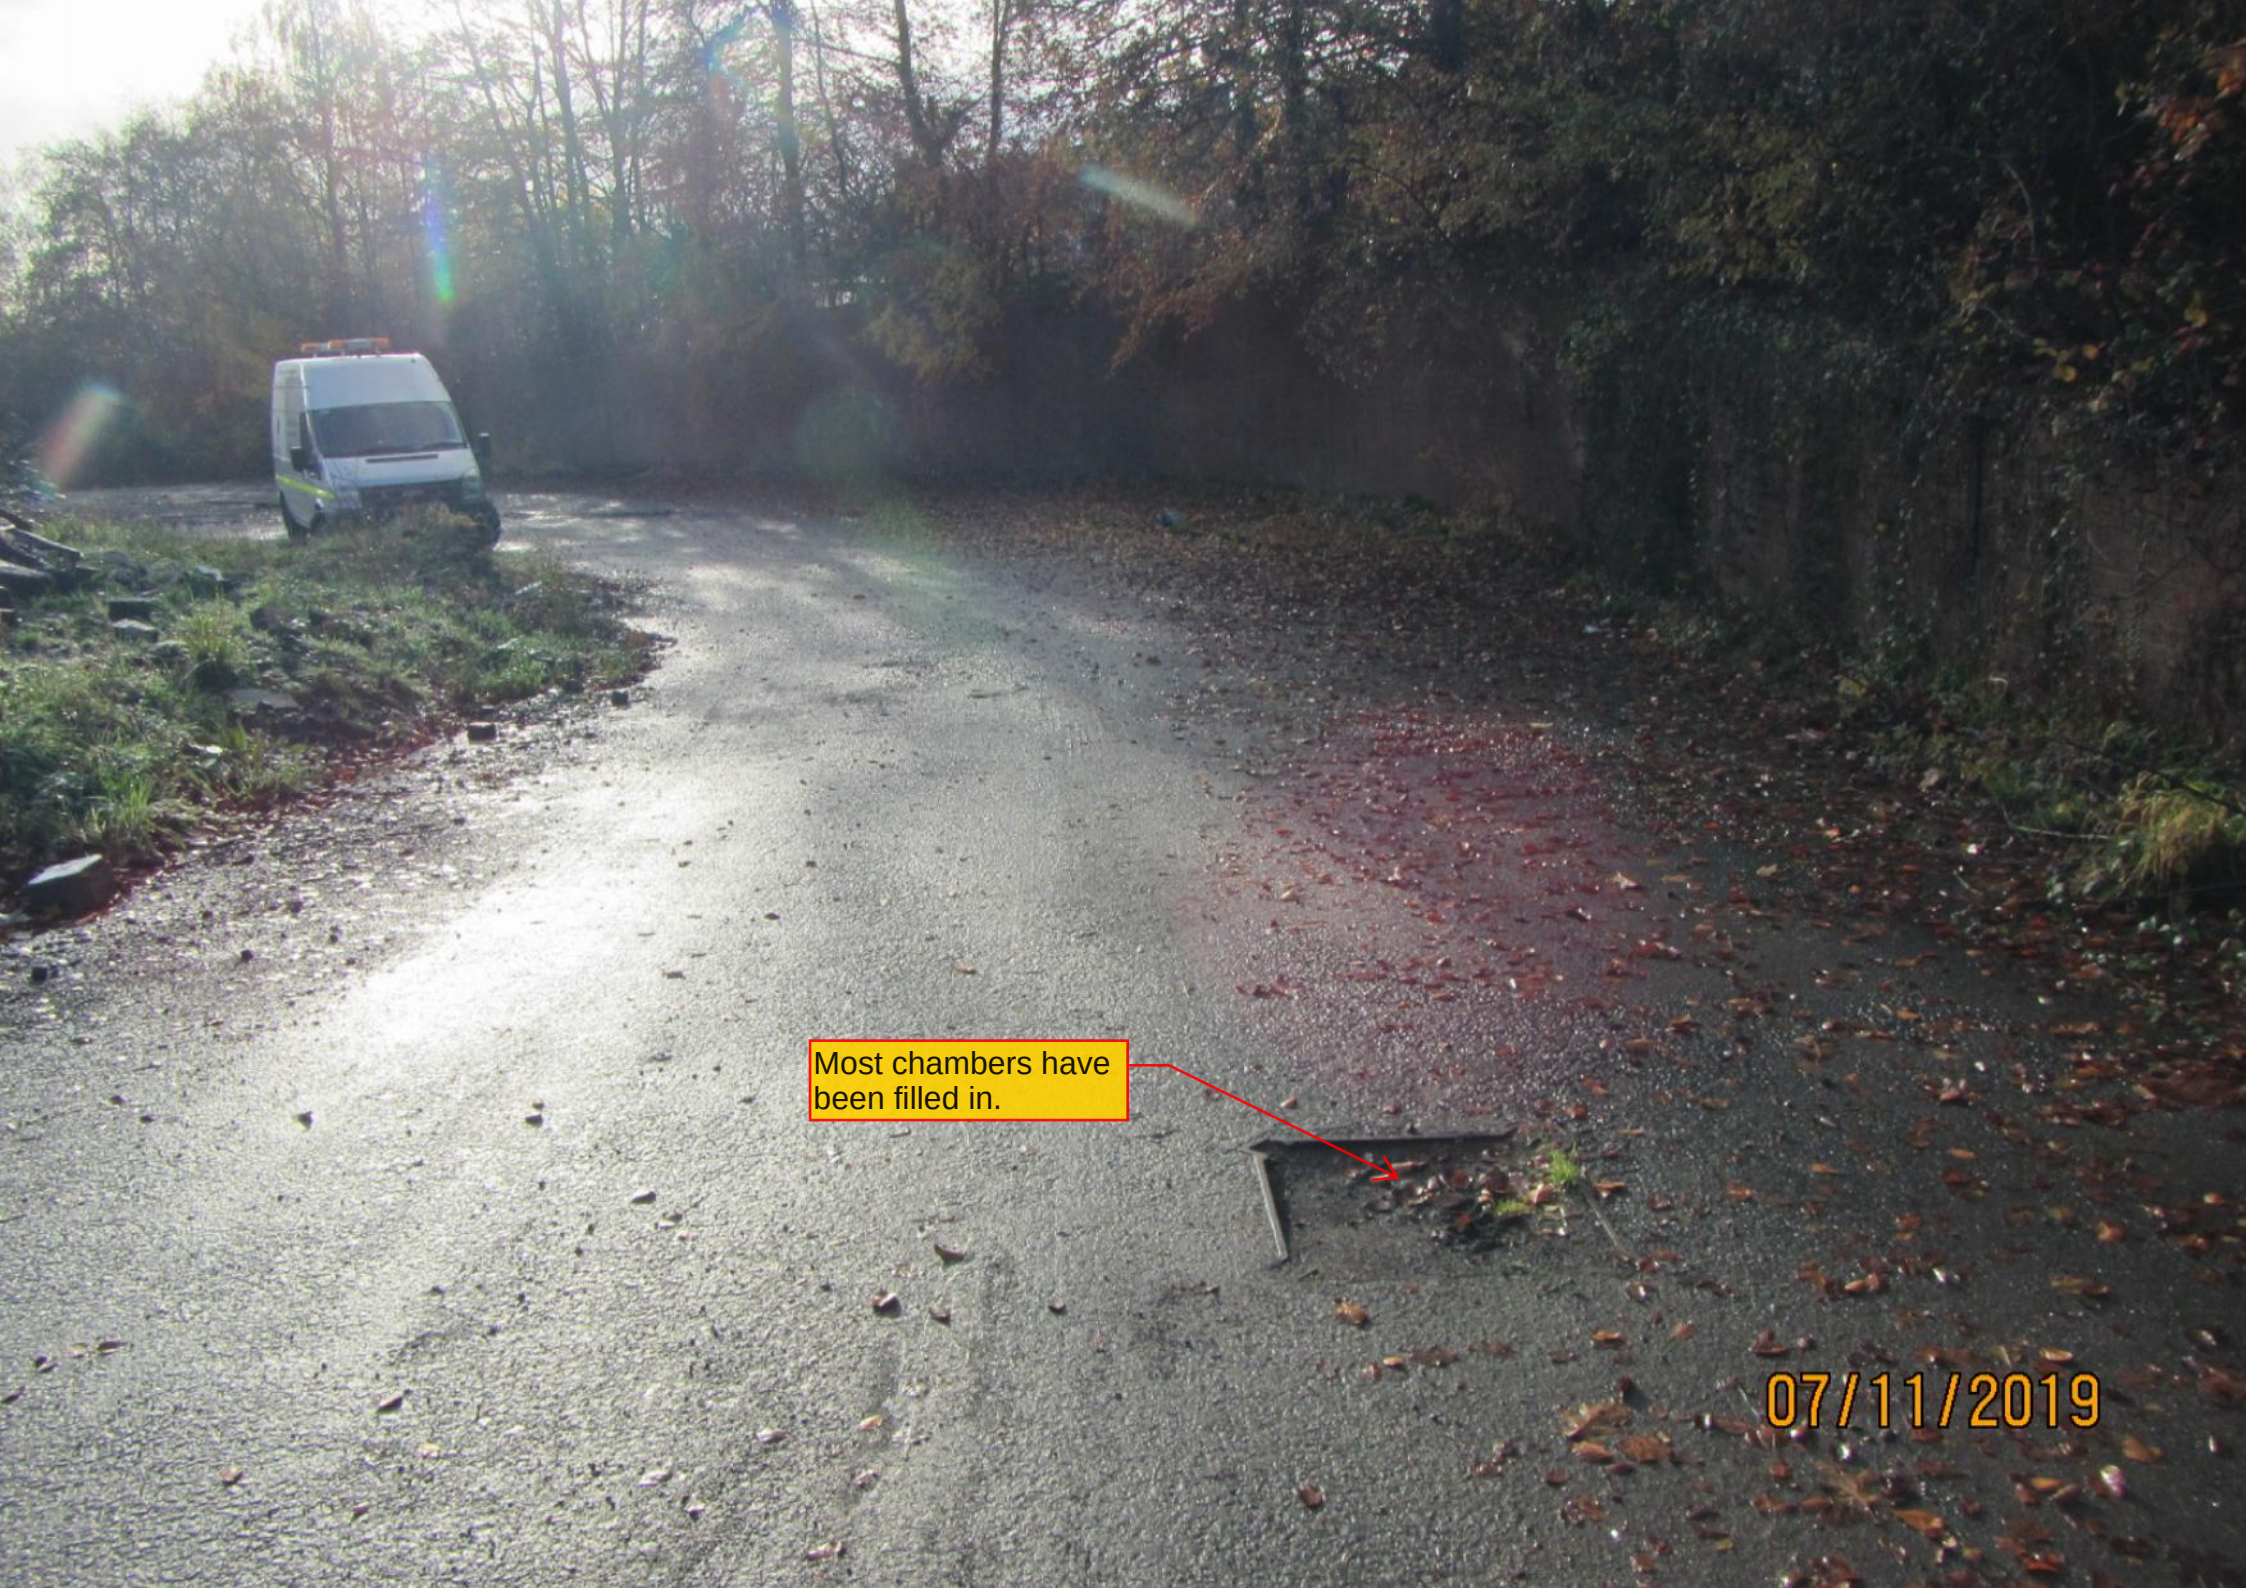
Most chambers have  
been filled in.

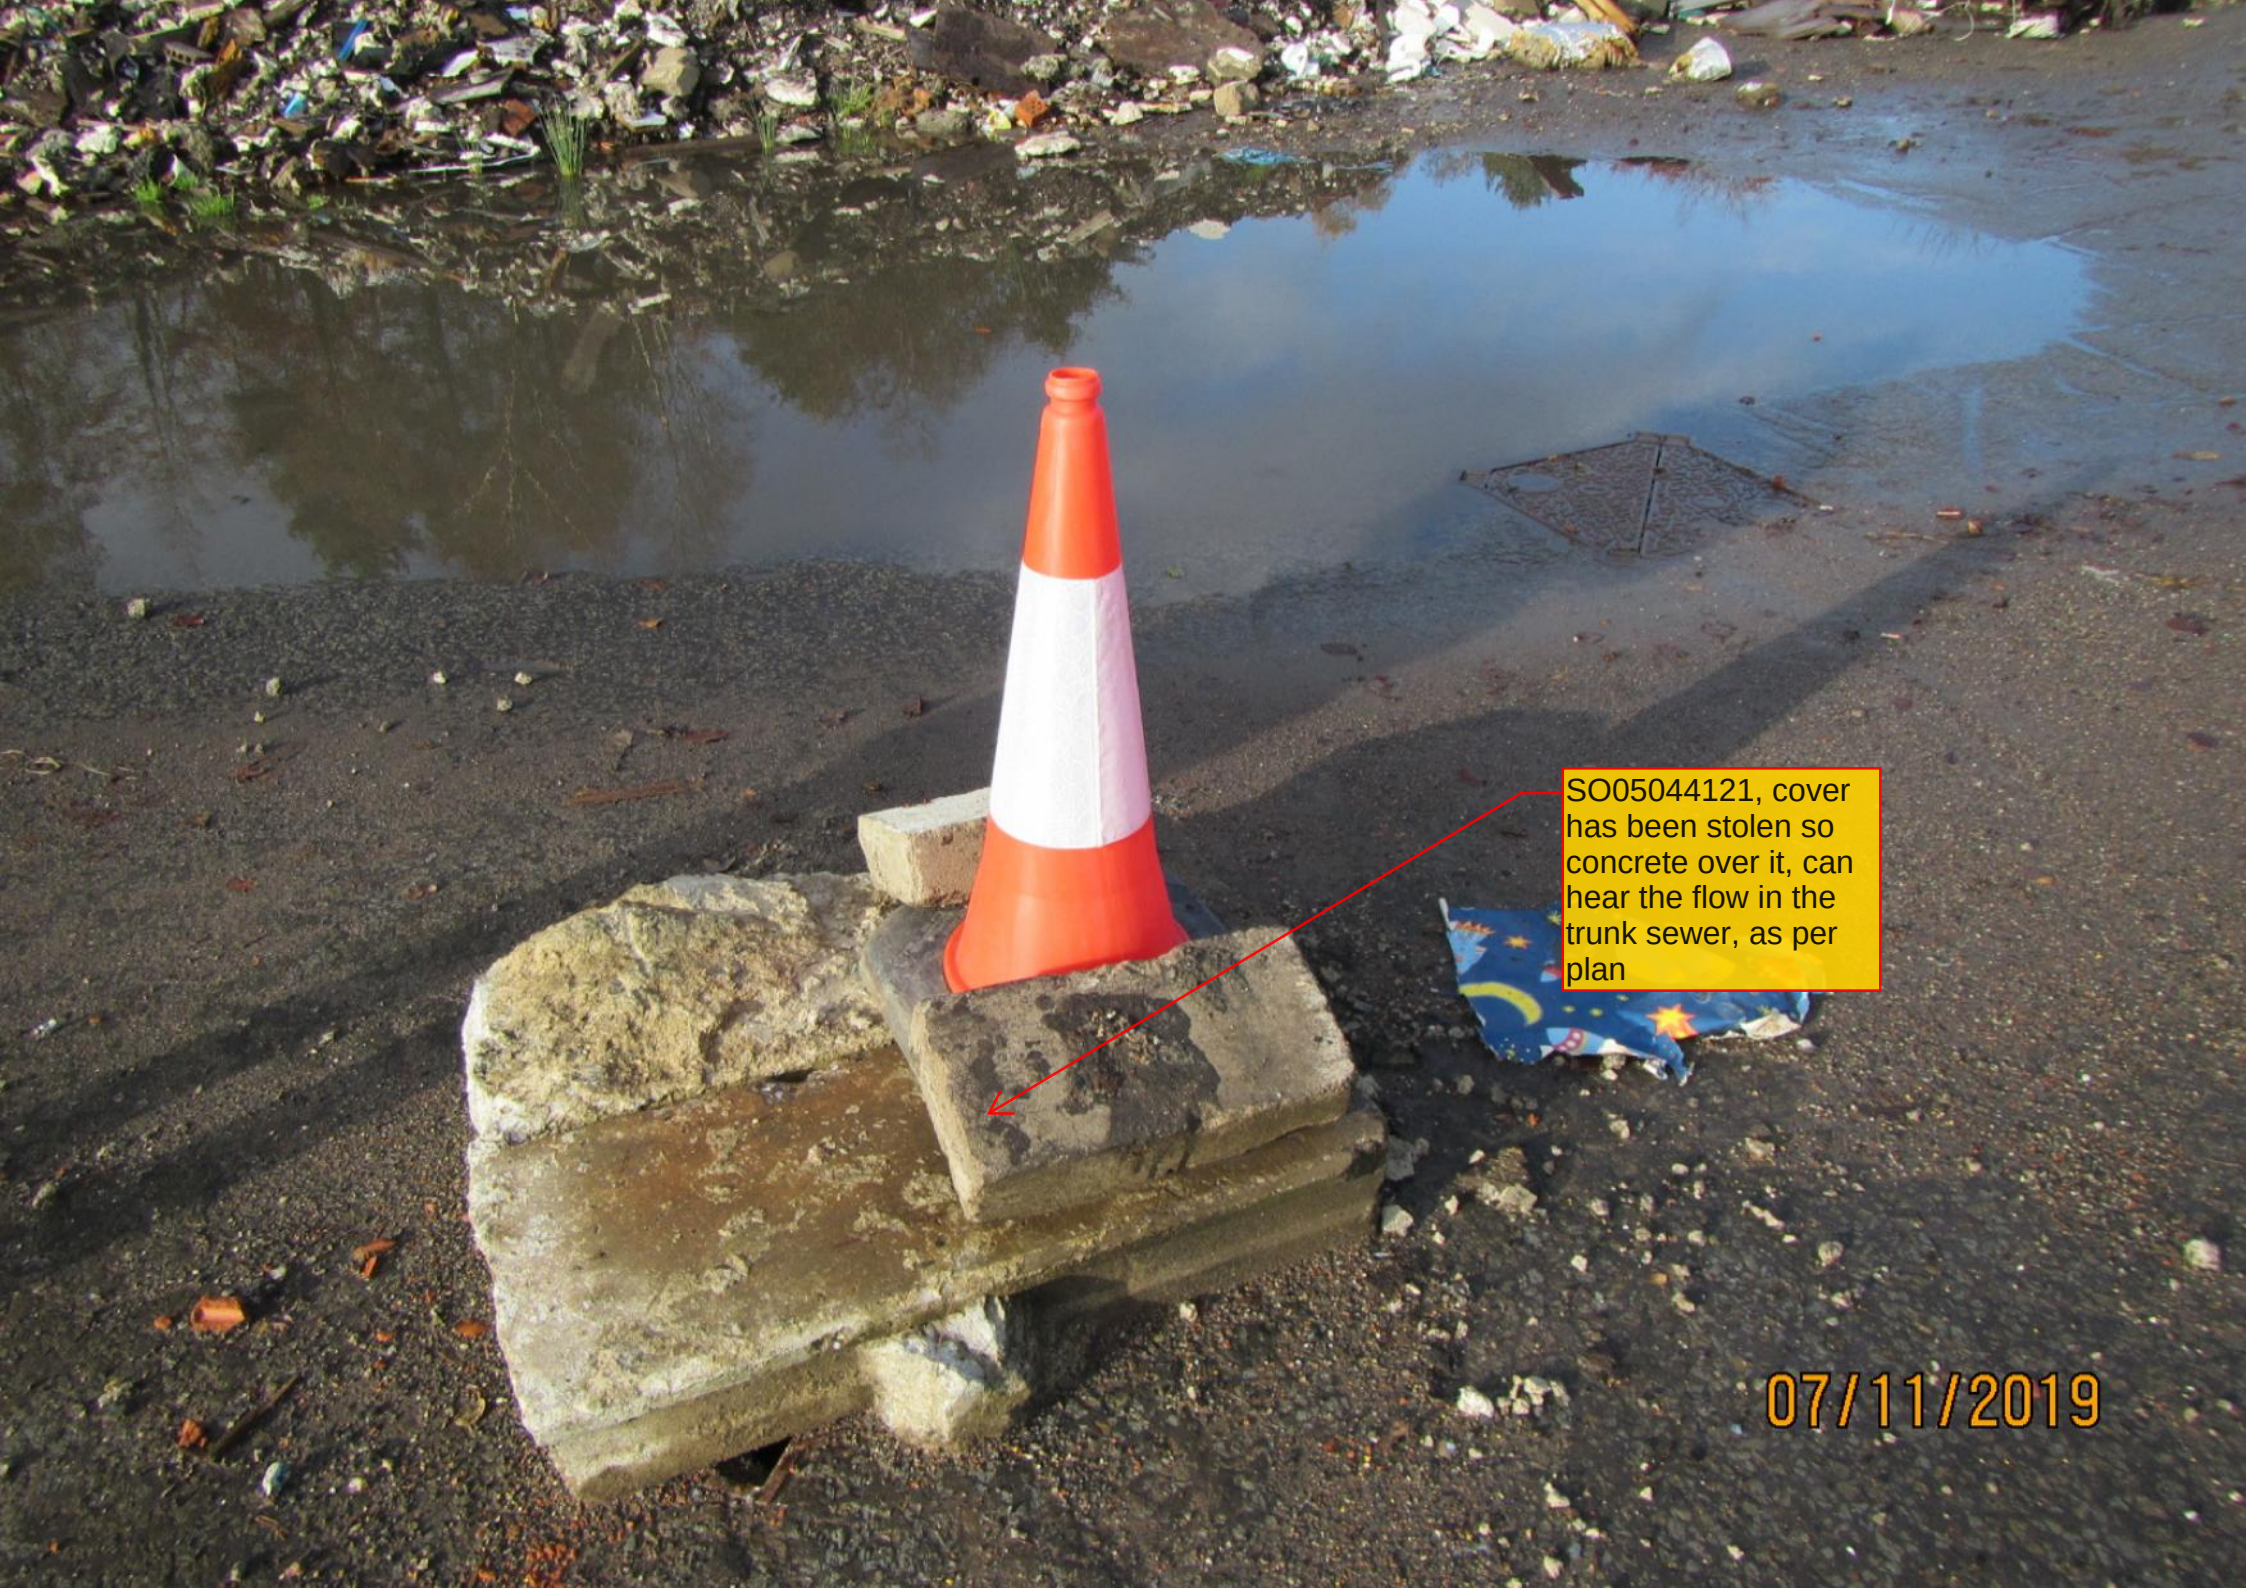
SO05044121, cover  
has been stolen so  
concrete over it, can  
hear the flow in the  
trunk sewer, as per  
plan

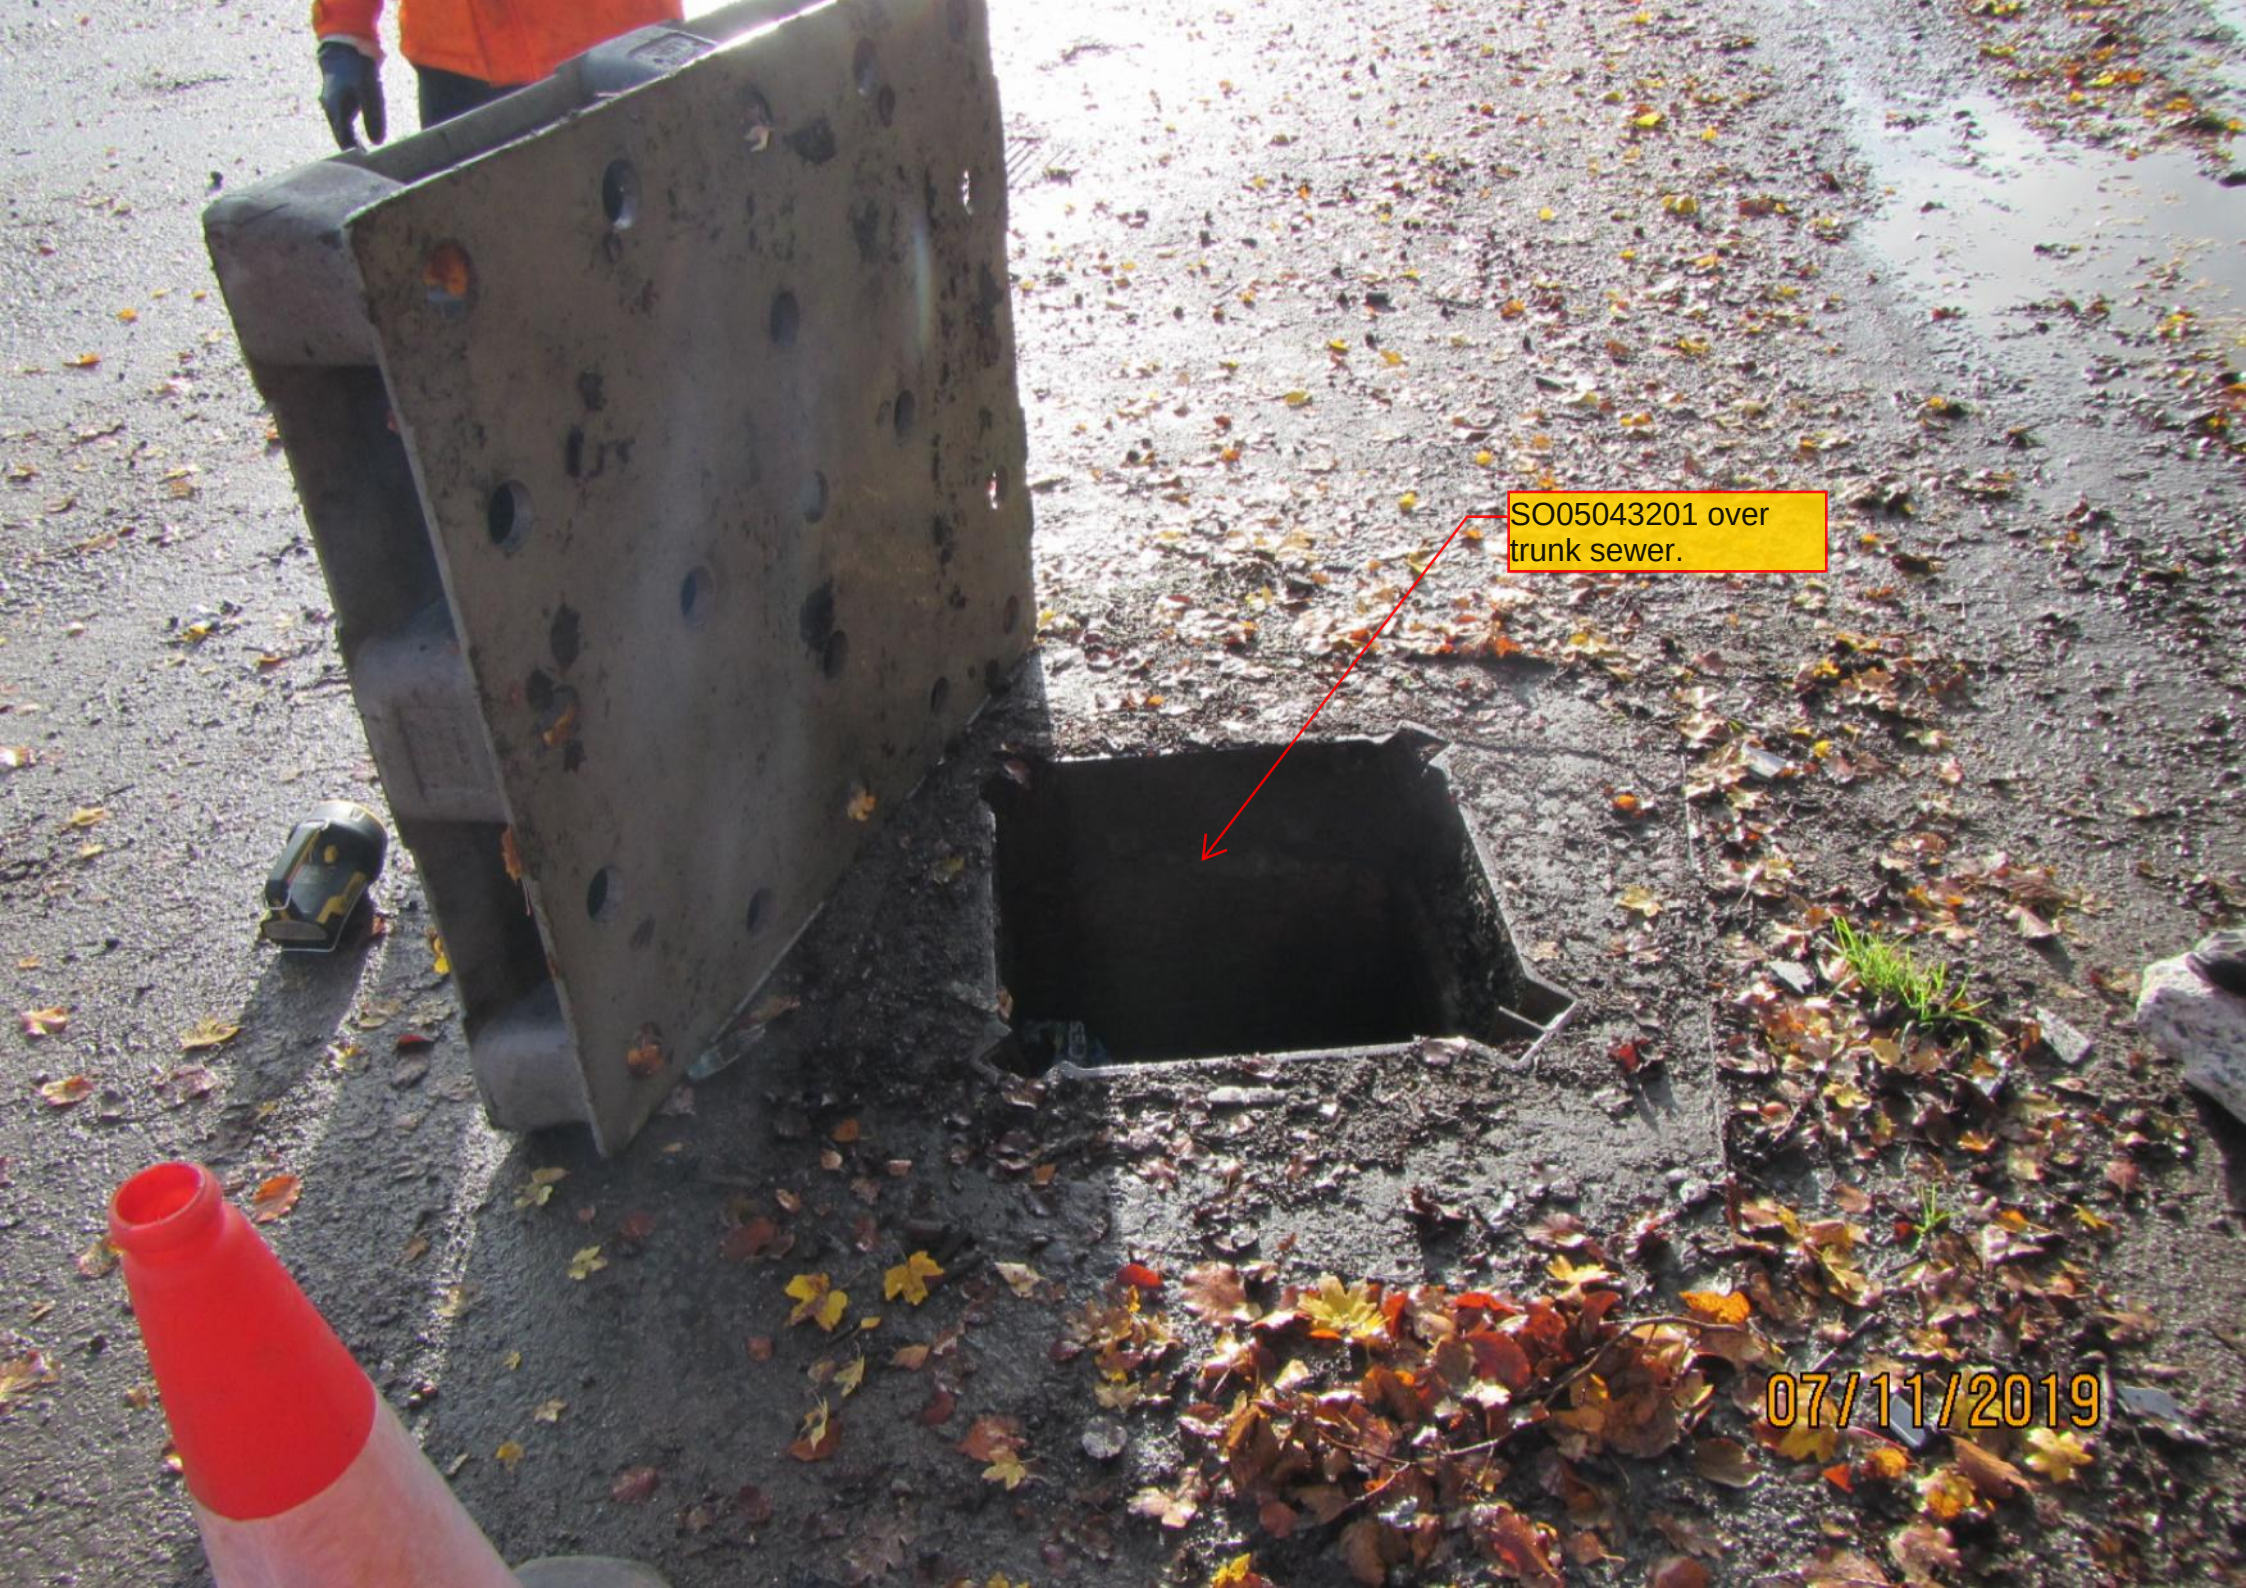
SO05043201 over  
trunk sewer.
