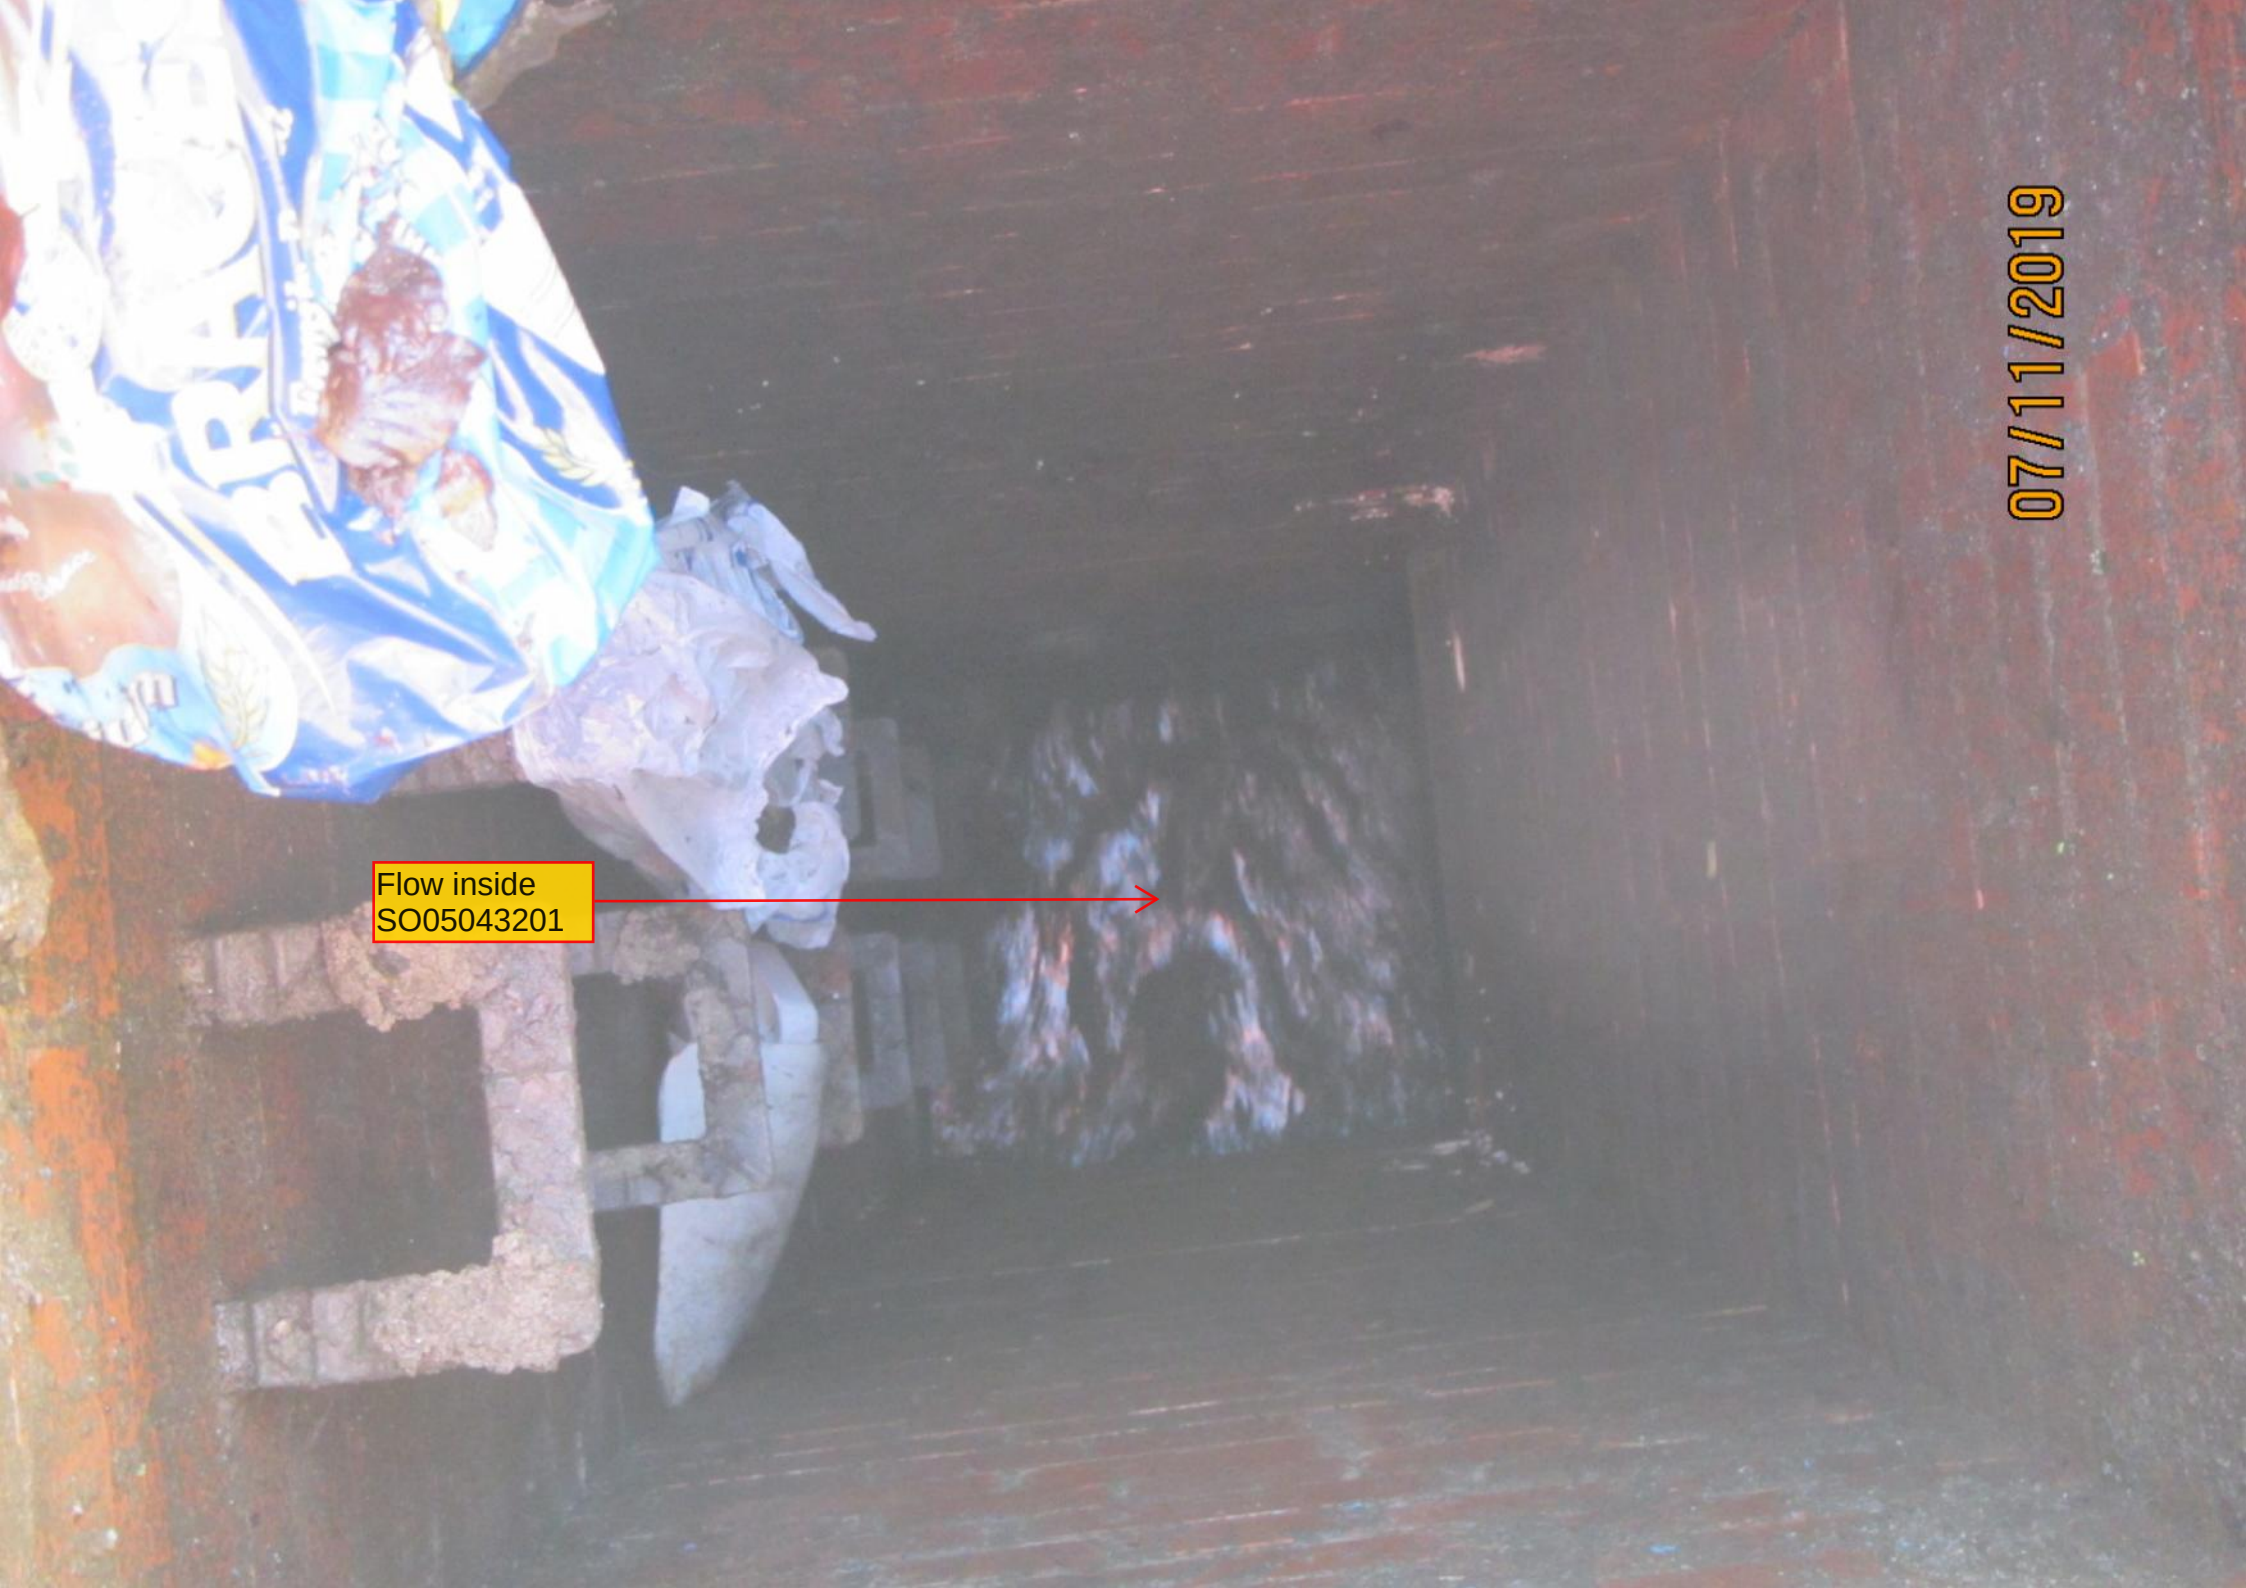
Flow inside  
SO05043201

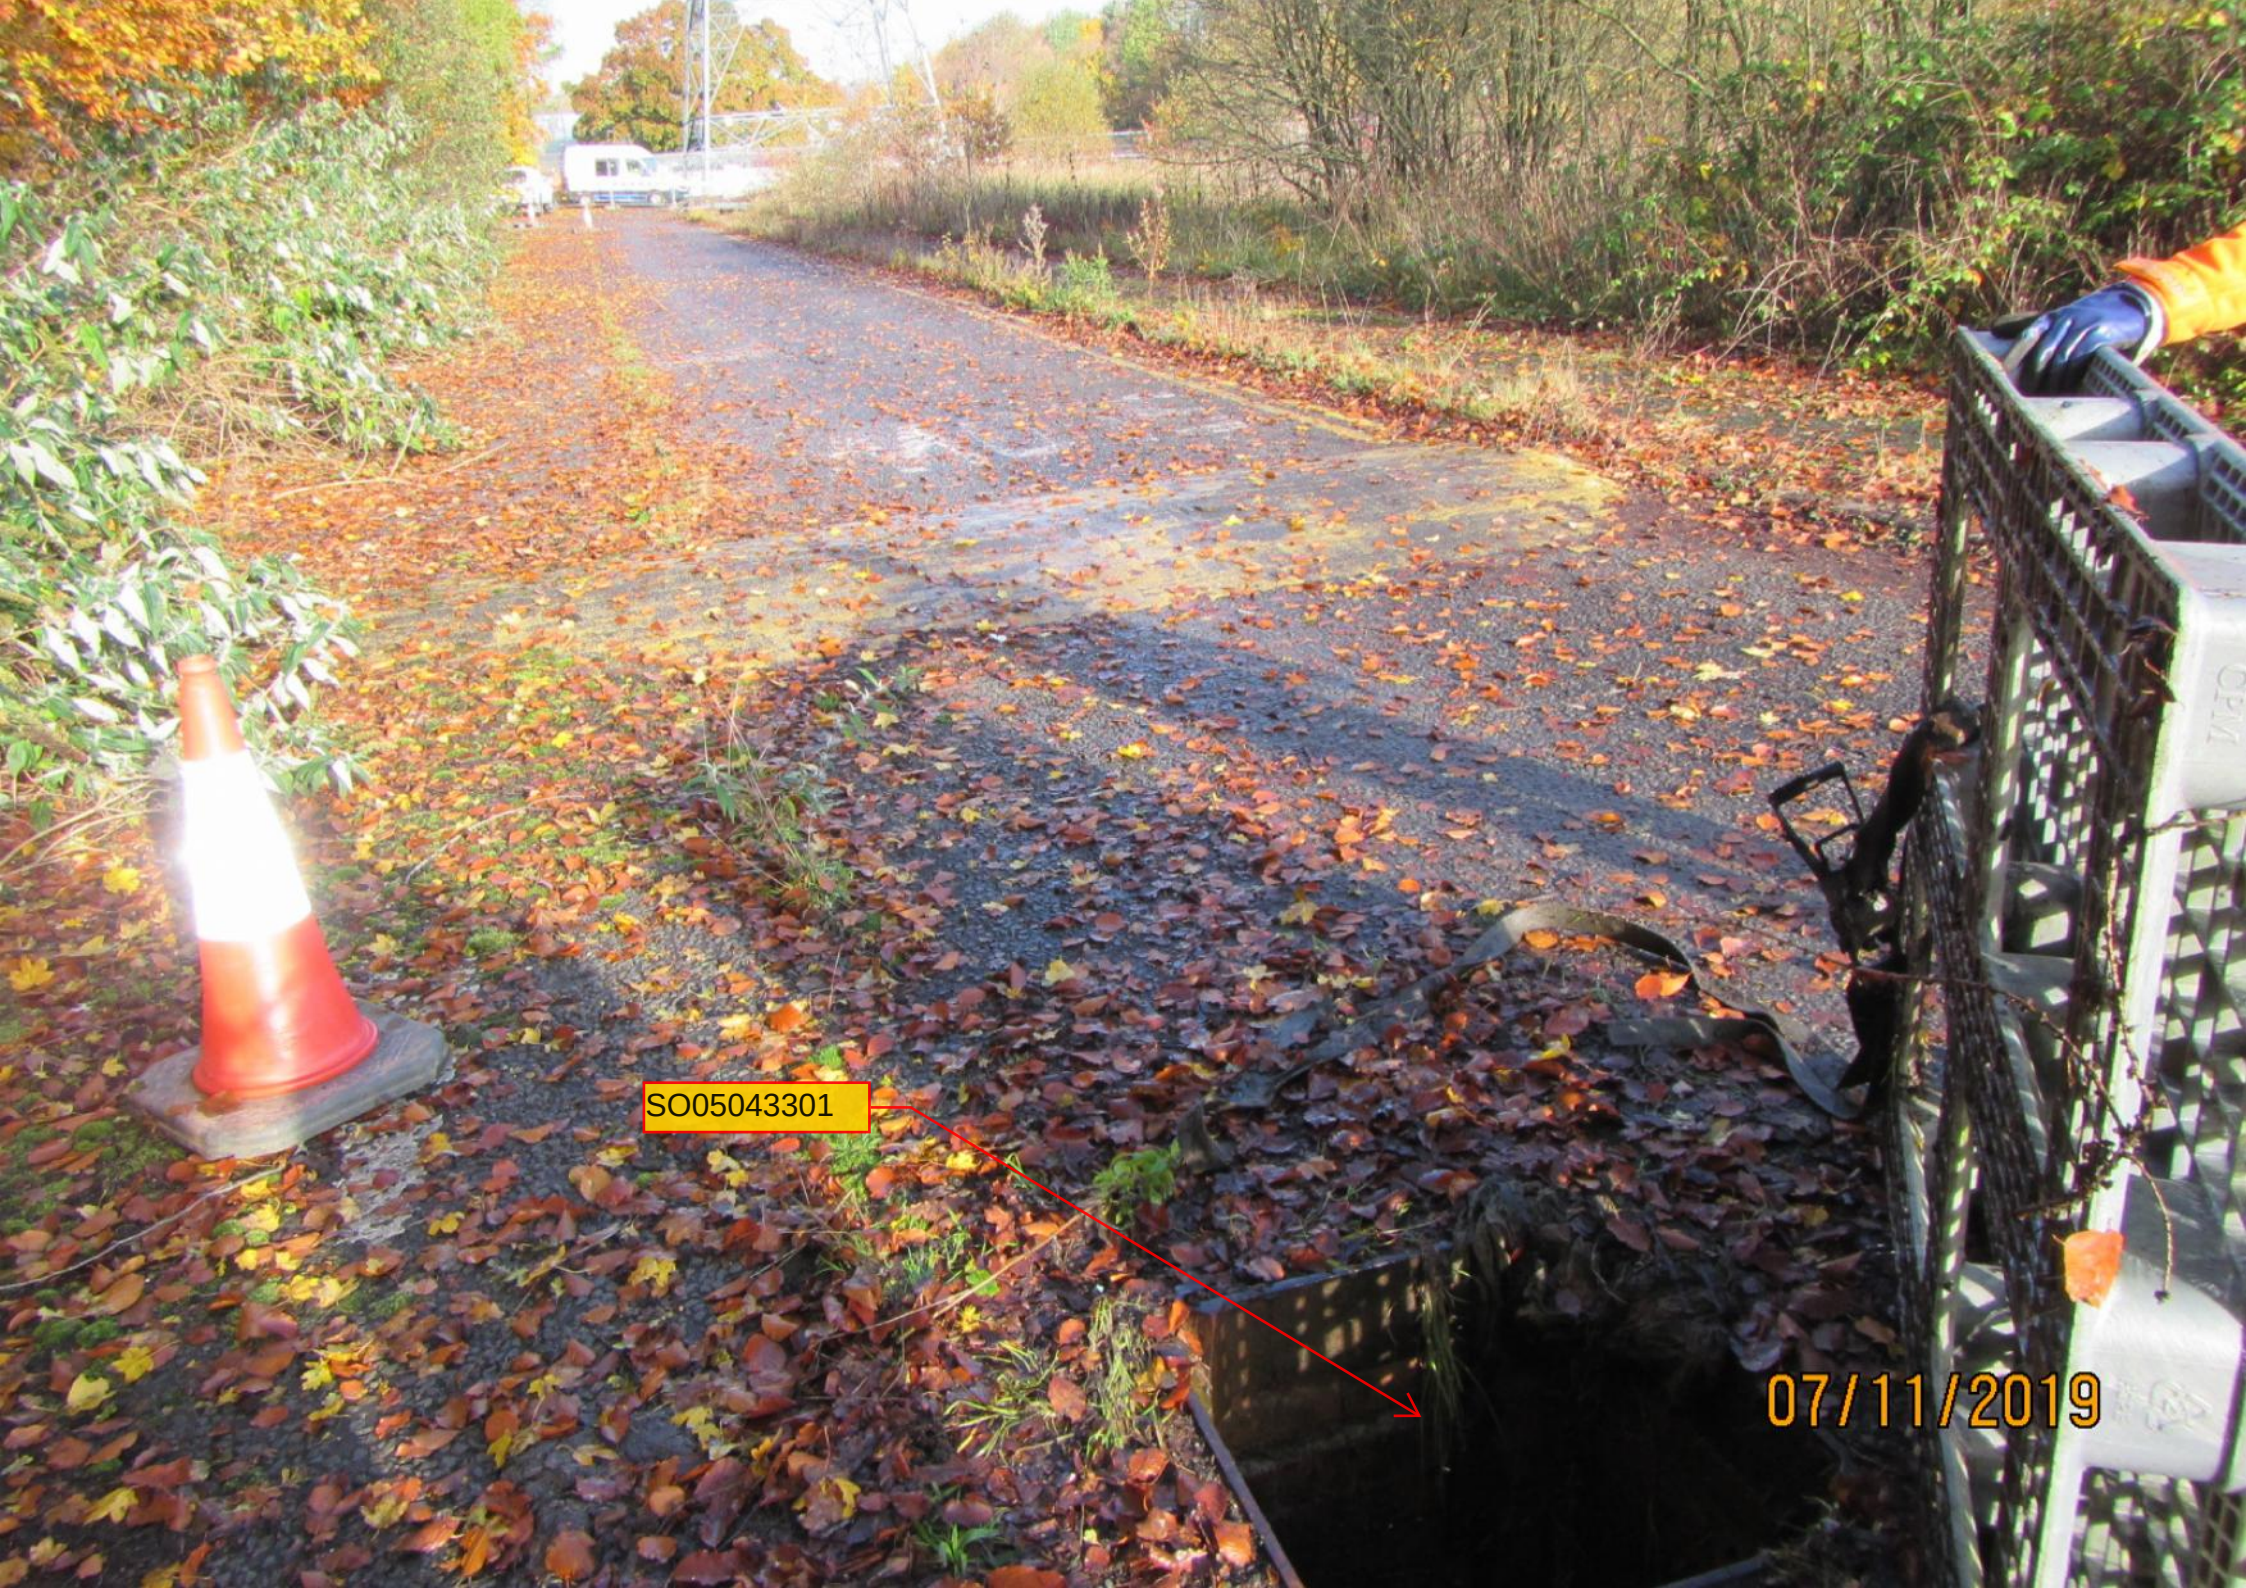
Inside SO05043301

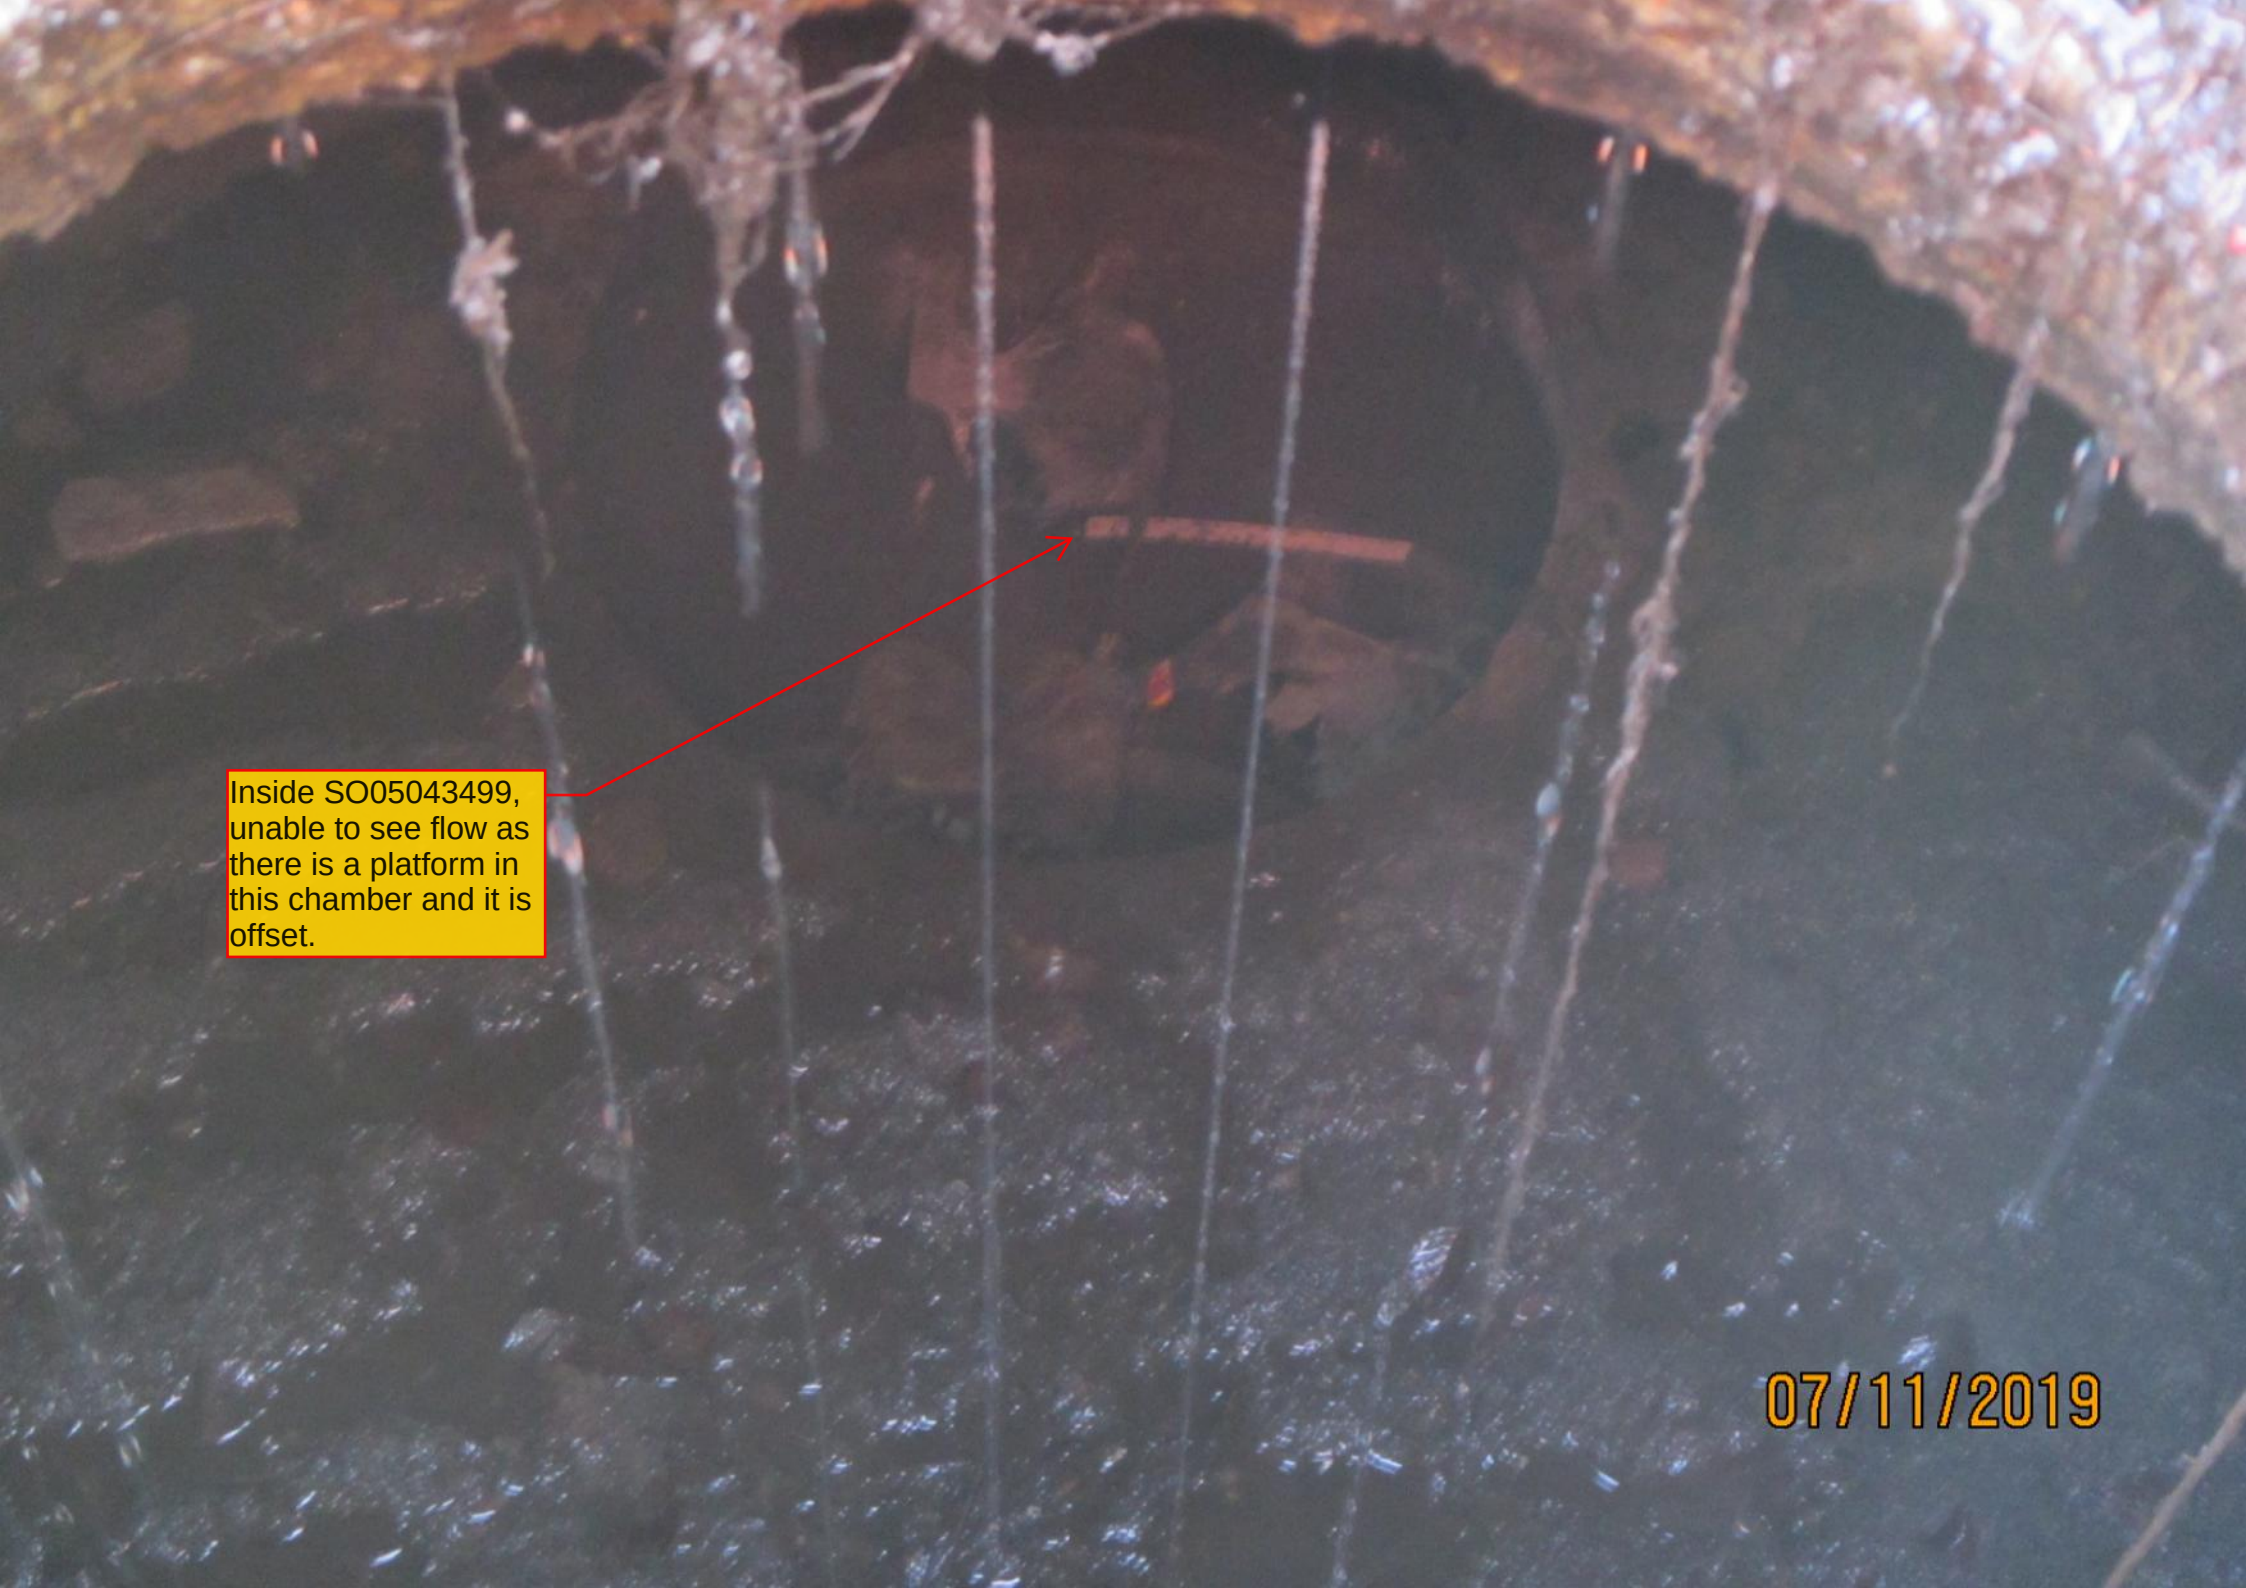
Inside SO05043499,  
unable to see flow as  
there is a platform in  
this chamber and it is  
offset.

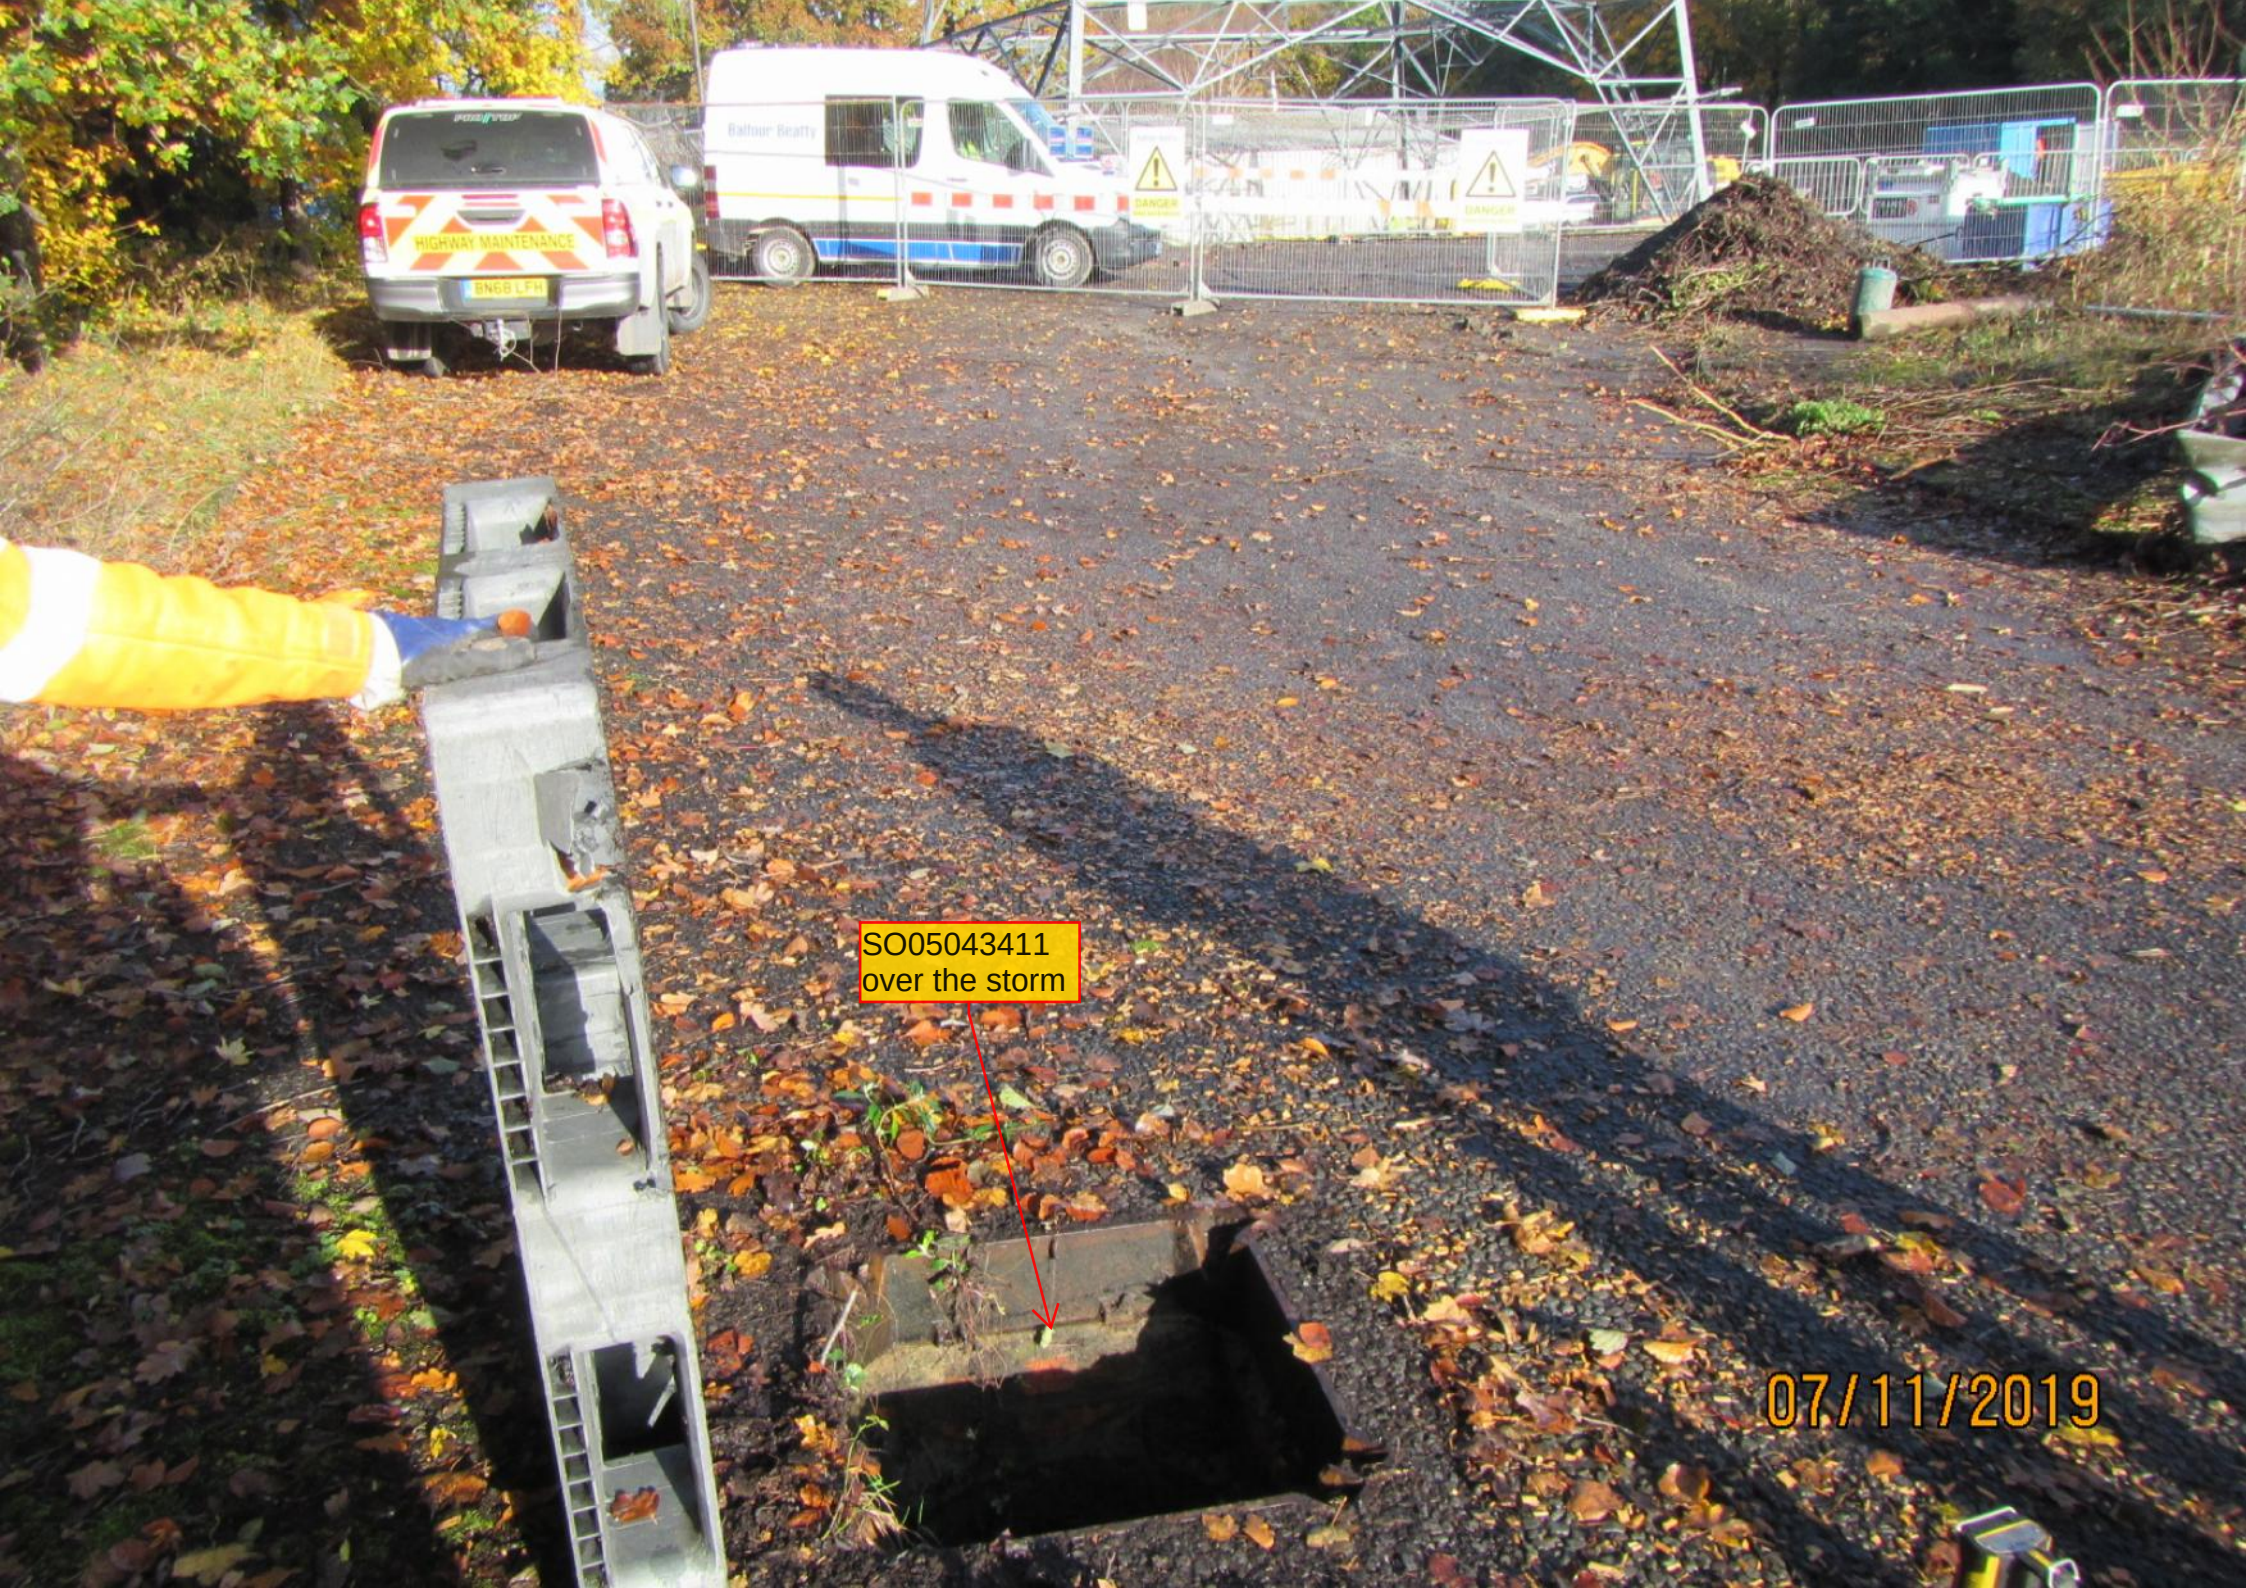
SO05043411  
over the storm

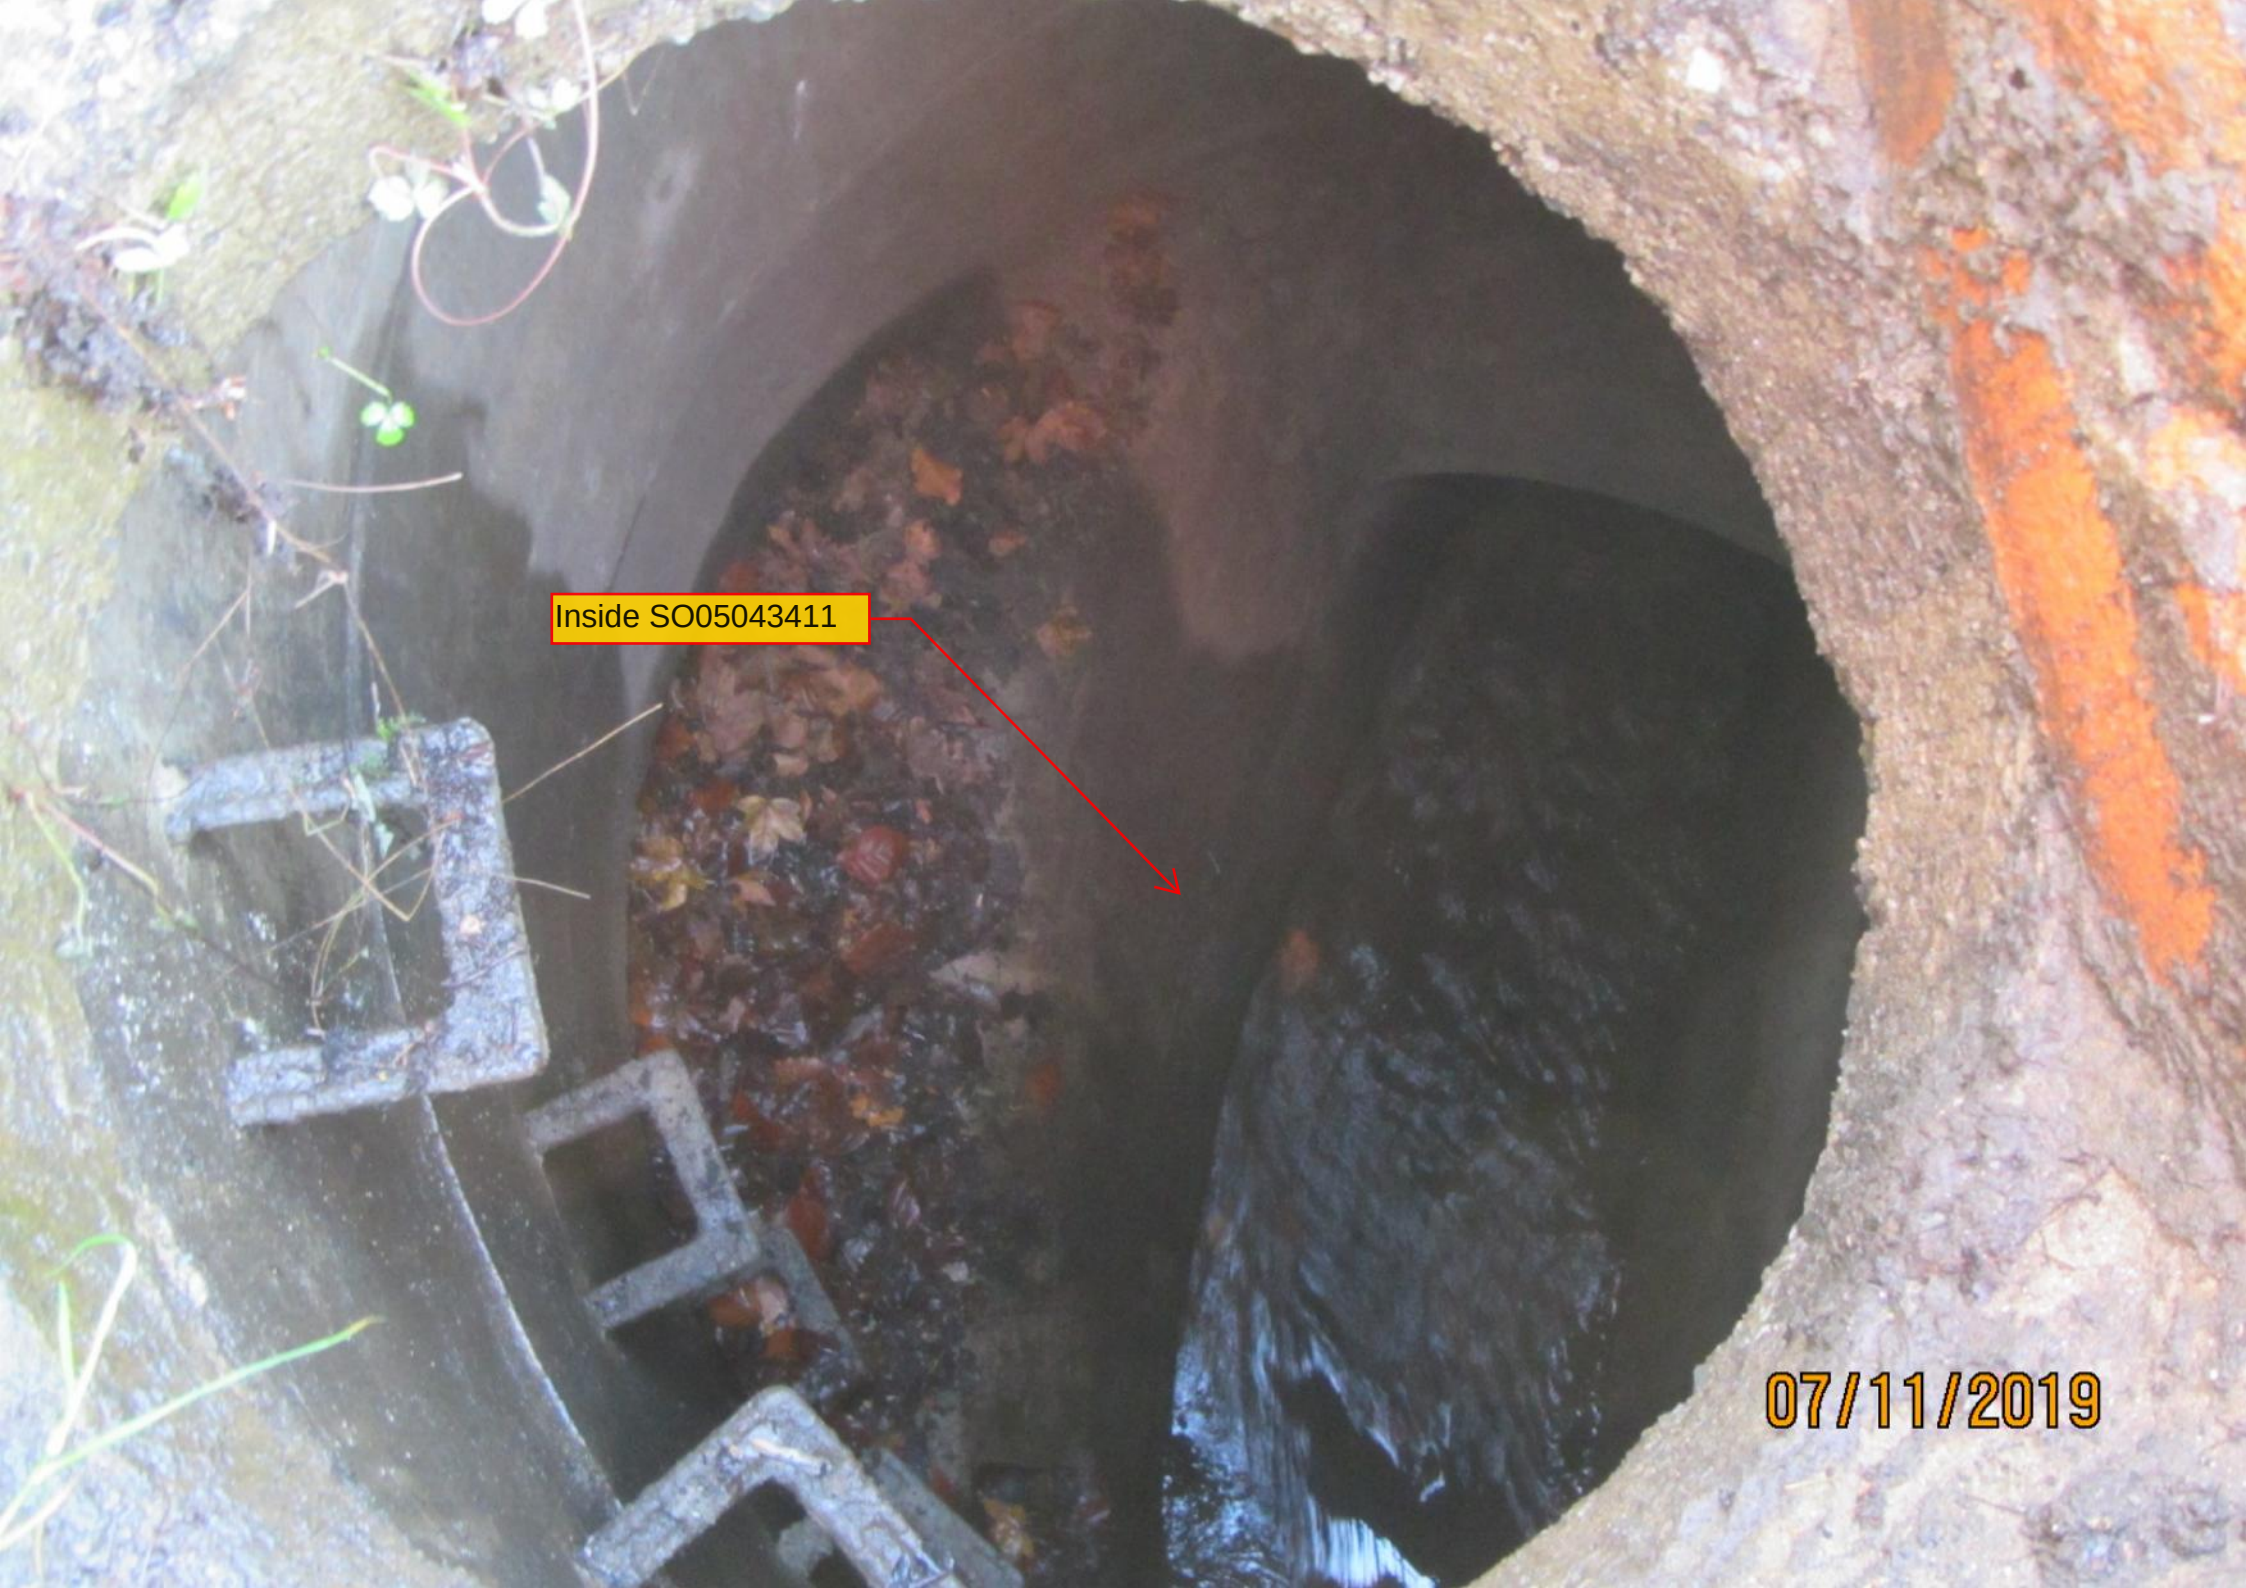
Inside SO05043411

Dye tested  
SO05043004 beside  
houses and  
confirmed 150mm VC  
sewer connected to  
SO05044004
