# Tynycoedcae Farm, Merthyr Tydfil

## Historic building survey

A report for Ray Gee Construction  
By Johnny Crawford BSc MA MCIfA

GGAT report no. 2019/039  
Project no. P2022  
National Grid Reference:  
SO 01457 07480

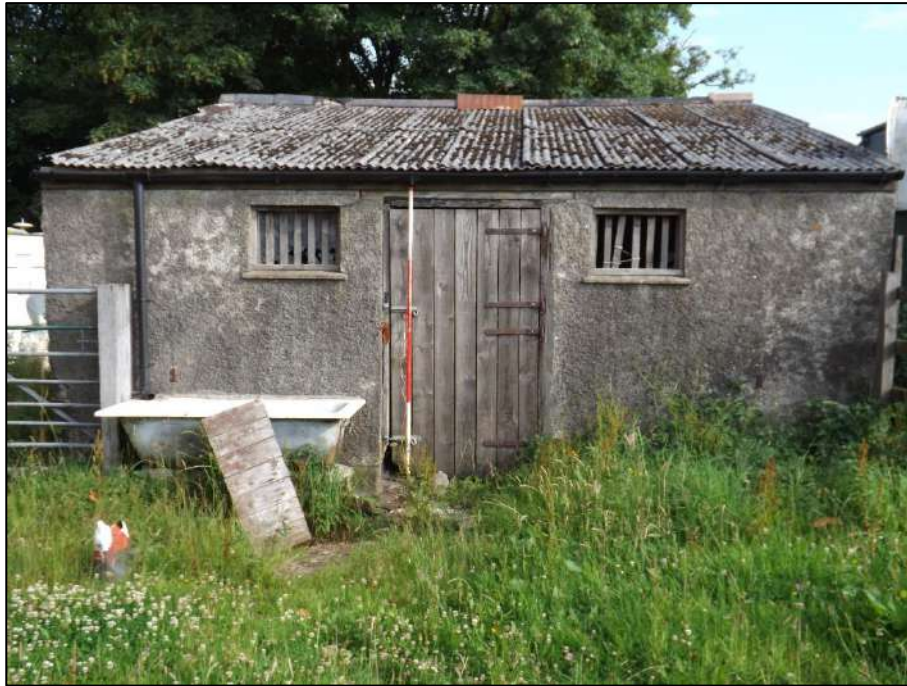
**Plate 1. South elevation of the hen house. Scale 2m.**

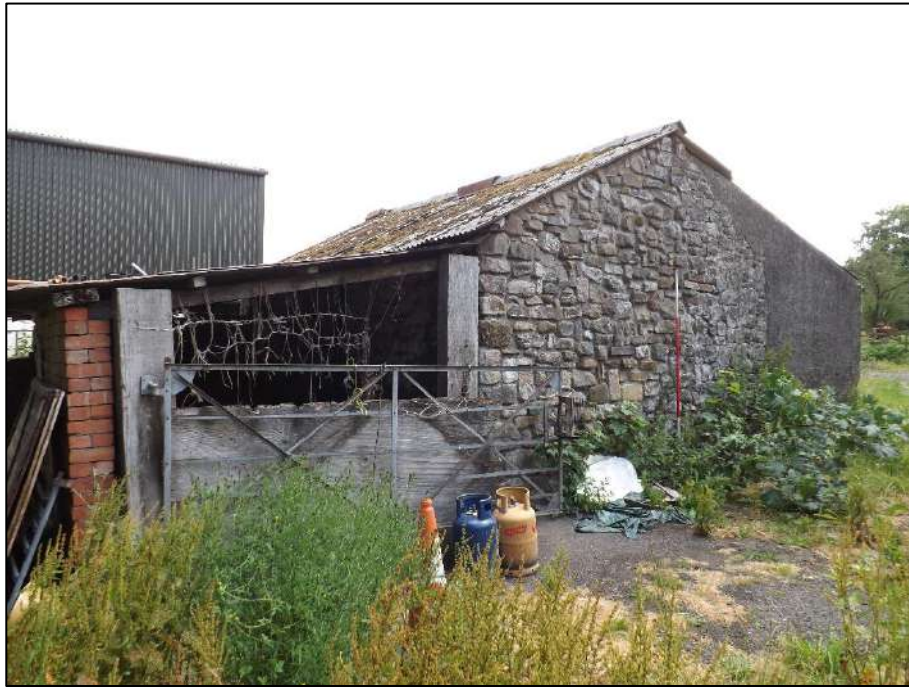
Photography of the west elevation was difficult due to the proximity of several caravans and it has been necessary to use an oblique photograph for this elevation. This elevation consisted of an asymmetric gable with evidence of two separate phases of construction. The elevation measured 10.1m in length and measured 3.45m from ground to roof apex. The first phase consisted of un-coursed local stone (sandstone and limestone) bonded with lime mortar. A possible blocked window was noted in the centre of the first phase elevation but this was not particularly clear. At least three phases of consolidation appeared to have taken place consisting of three different varieties of concrete pointing

to the stone. No trace of the original roofing method was visible but the ends of two timber purlins were visible, which were likely to be original. The second phase extension to the south was visible as an obvious separate construction, flat faced and rendered with concrete and fine pebble dash. Iron hinges were affixed to the south end of the second phase elevation for mounting a farm gate; reciprocal mounting points were noted on the north east corner of the barn for the other side of the gate. An open ended extension was present to the north of the first phase, being visible on the photograph as a red brick partition wall and two vertical timbers for mounting a farm gate. The ground outside the elevation was surfaced with worn tarmac.

**Plate 2. West elevation oblique view showing first phase construction (stone) second phase (pebble dash render) and open sided extension to the north. Scale 2m.**

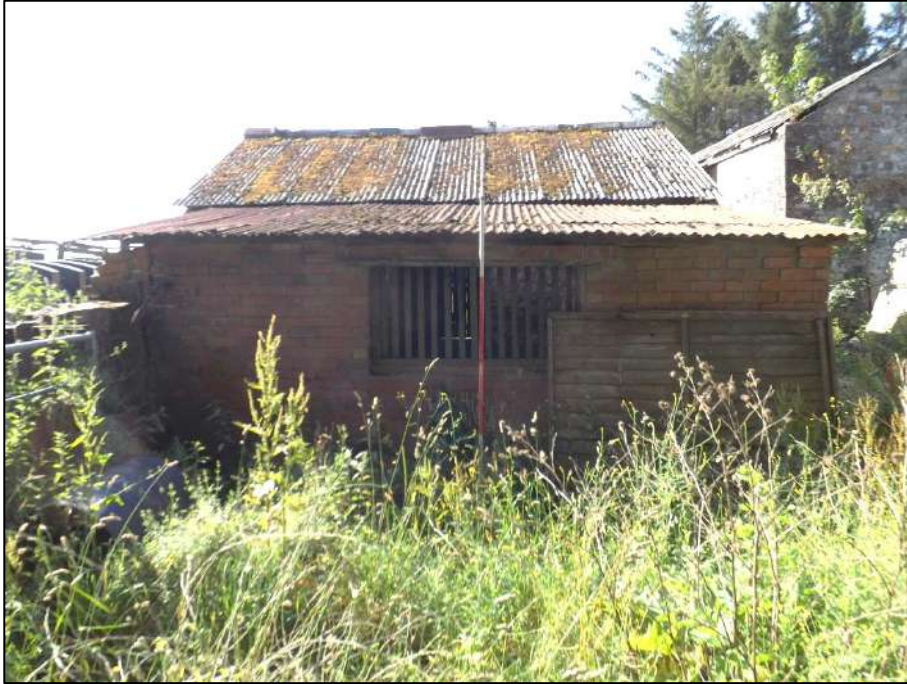
**Plate 3. North elevation, scale 2m.**

The north elevation consisted of a red brick partition wall, bonded with concrete, with its eastern end resting on an old boundary wall (left of the picture). It measured approximately 1.75m in height by 6m in width and was furnished with a rectangular window 1.5m wide by 0.8m in height. The window was of the same slatted wood style as the others in the building. The north elevation of the first phase of the building was concealed by the extension but consisted of a stone built wall covered in whitewash render. A single timber framed, stepped doorway in the centre led into the building, probably forming the original entrance into the structure.

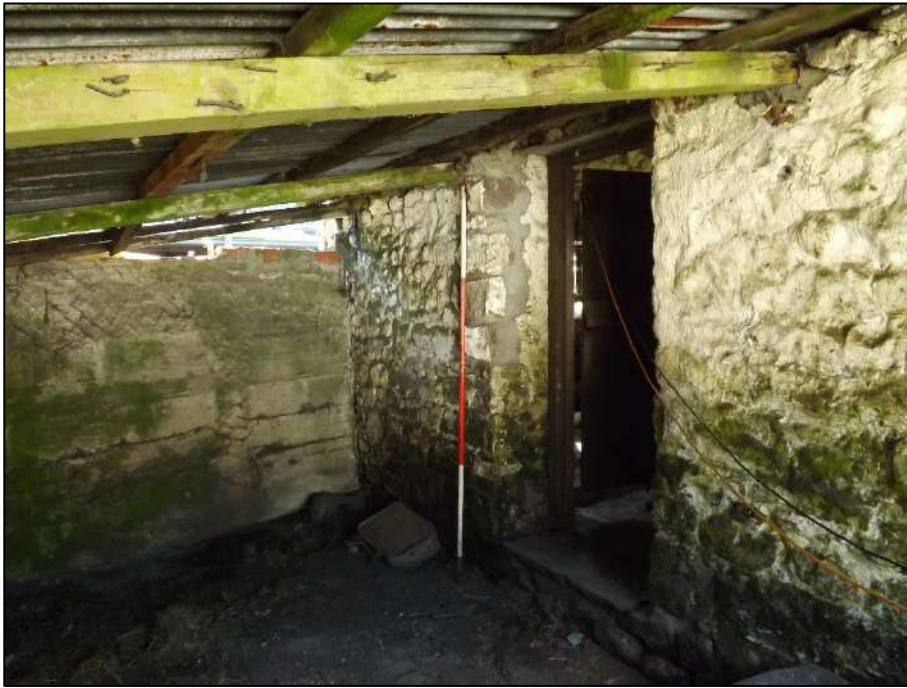
Plate 4. Oblique view of the original first phase north elevation, now contained within a later extension. Note reinforced concrete render to reverse of the old boundary wall. Scale 2m.

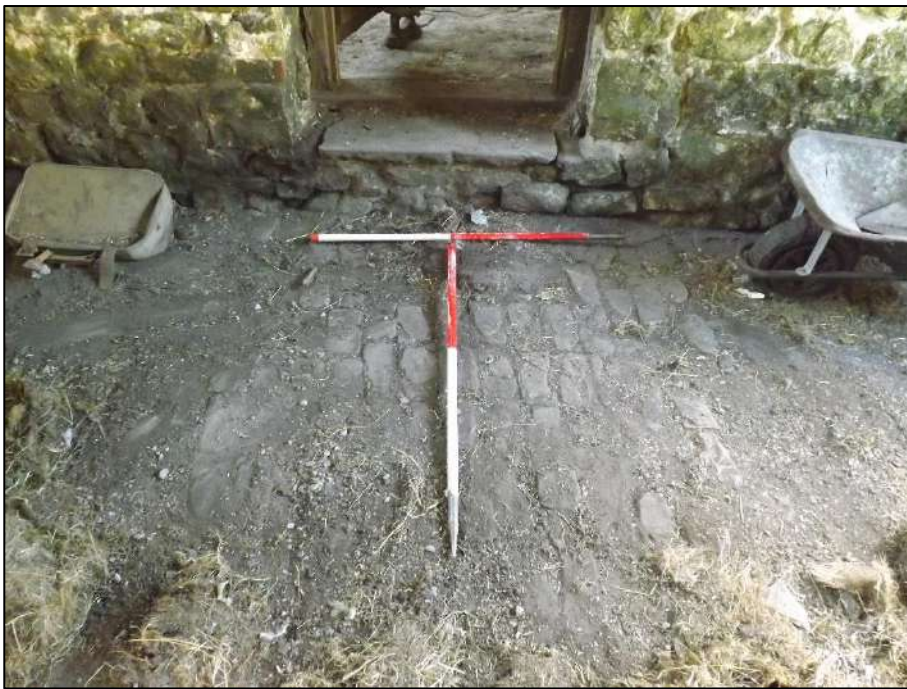
Plate 5. Cobbled surface immediately outside the original first phase north elevation. This is likely to be the original farmyard surface in the immediate vicinity. Scale rods 1m.

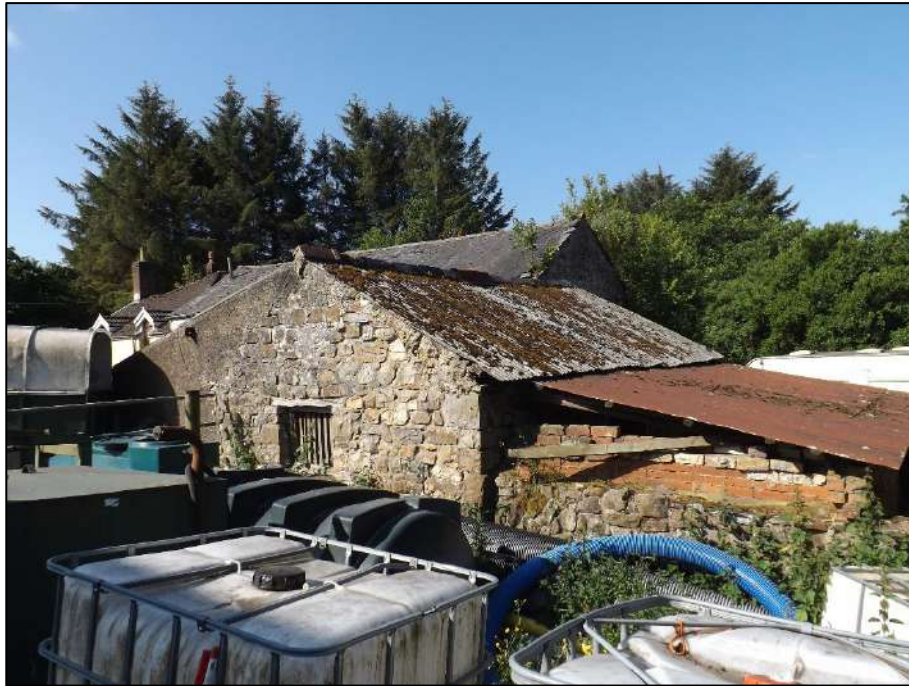
**Plate 6. East elevation. Note the extension to the right of the image that shows how the old boundary wall has been utilised.**

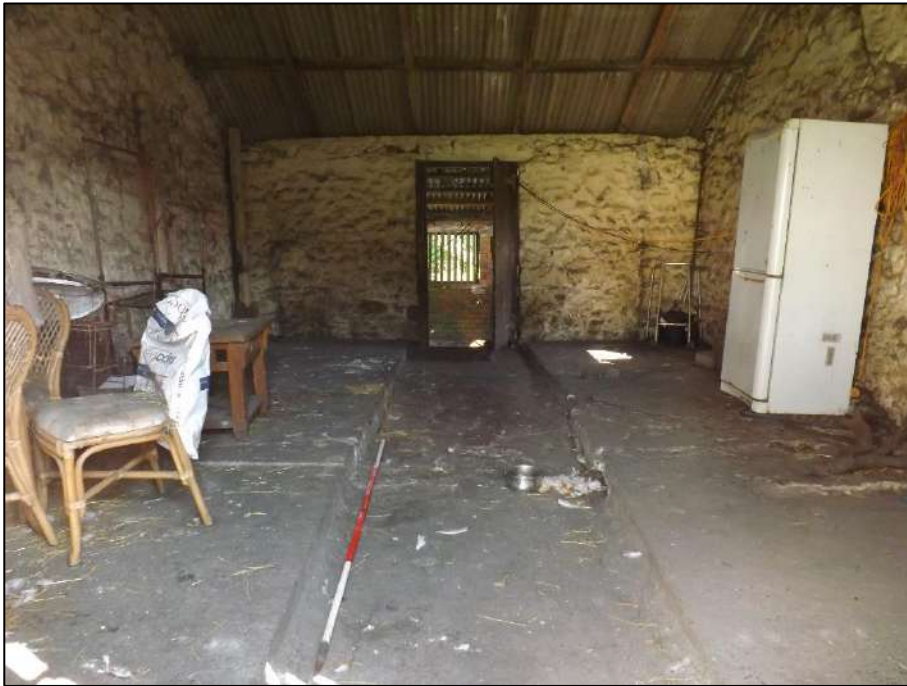
The interior of the building was relatively bare, with few visible fixtures or fittings. The first phase floor contained two timber post settings, possibly to support a partition or similar, with the remains of a vertically mounted timber affixed to the west wall. The second phase extension was clearly visible within the internal elevations and the original floor line had been used as the foundation for a breeze block partition which had been subsequently demolished. None of the roofing materials were original.

**Plate 7. Interior view of the hen house towards the north, looking towards the original doorway. Note the raised floor levels. Scale 2m.**

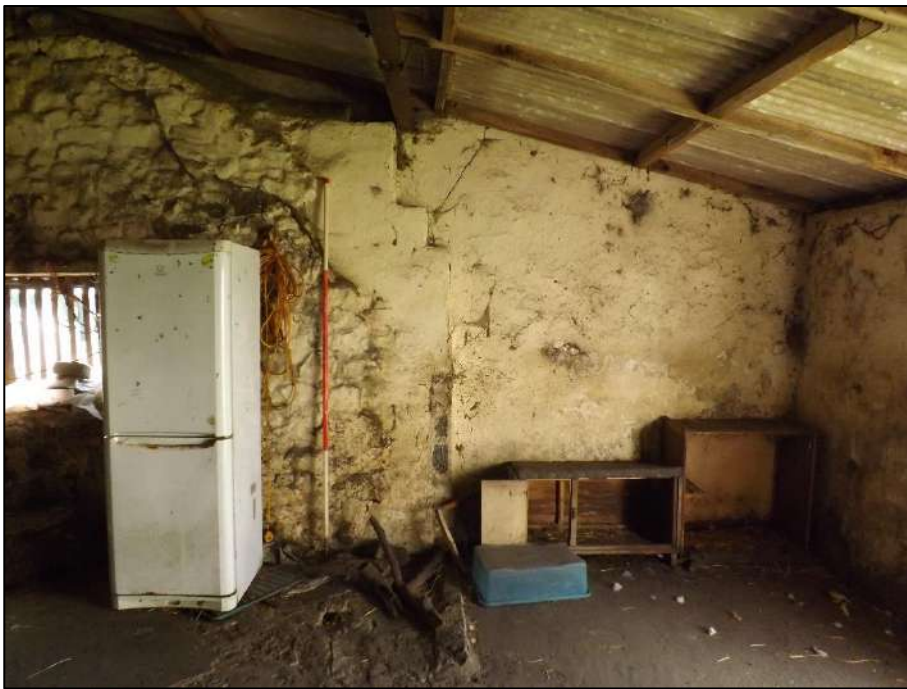
**Plate 8. Internal view of the east elevation showing the construction of the second phase extension. Note the remains of a breeze block partition to the left of the blue box. Scale 2m**

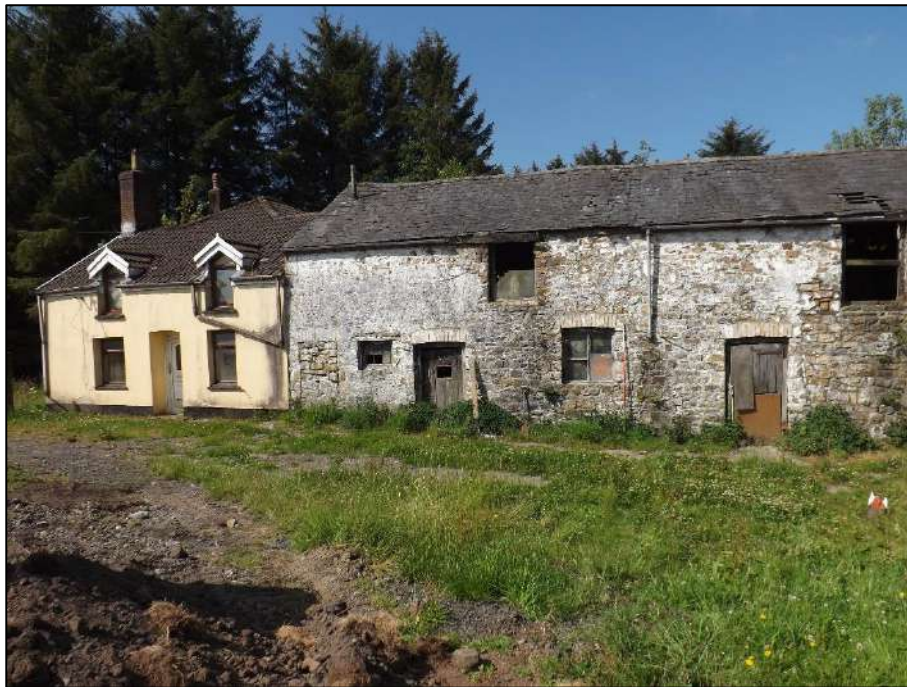
The east elevation measures 16m in length by approximately 4m in height, with the roof adding perhaps an additional 2m in height. The elevation was pierced by two doors on the ground floor and five windows. Three windows were positioned to illuminate the lower ground and two are positioned just under the roof line to illuminate the upper level inside the barn. A blocked doorway was present at the southern end of the elevation, together with another at the northern end. Each of these doorways was 0.9m wide by 1.7m in height and was furnished with an arched lintel of yellow refractory bricks. Window and door frames were all of wood and in a relatively poor state of repair; it was unclear as to whether these were original fittings but they were obviously of some age. The former roof line was not particularly obvious from this elevation but the two upper windows appear to have been added after the raising of the roof. The northernmost window appeared to have been created by partially blocking an earlier window or doorway. The southern upper window appeared to have been a completely new addition and was furnished with a sill of yellow refractory bricks. The roof was furnished with a timber soffit and a relatively modern metal gutter. The remains of a cobbled surface were noted fronting the east elevation, similar to numerous agricultural farmyards of the 19th century.

**Plate 9. General view of the east elevations of both the barn (right) and cottage. Scale 2m.**

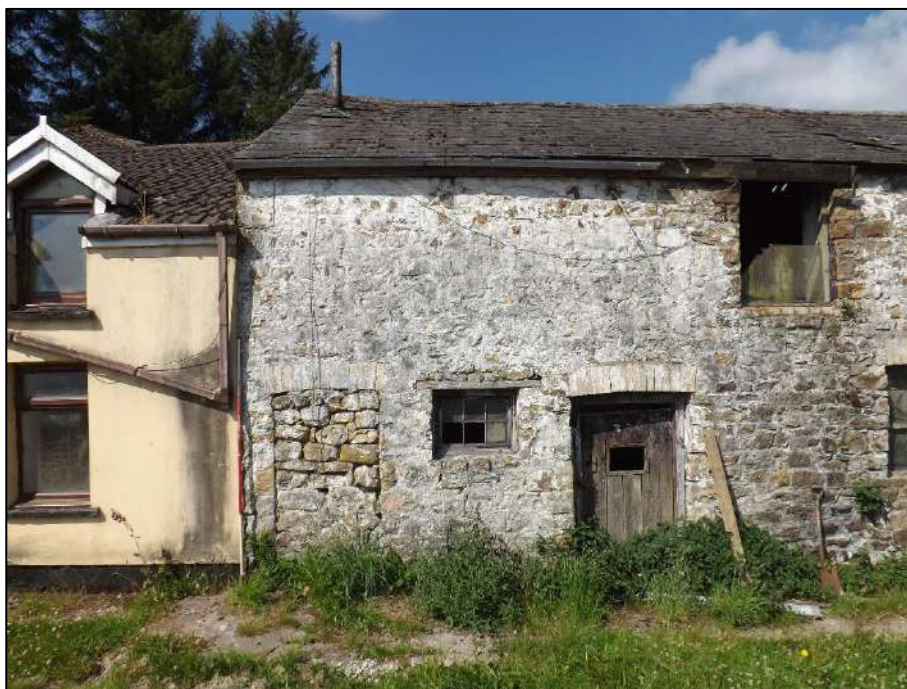
**Plate 10. Southern end of the barn showing the blocked doorway. Scale 2m.**

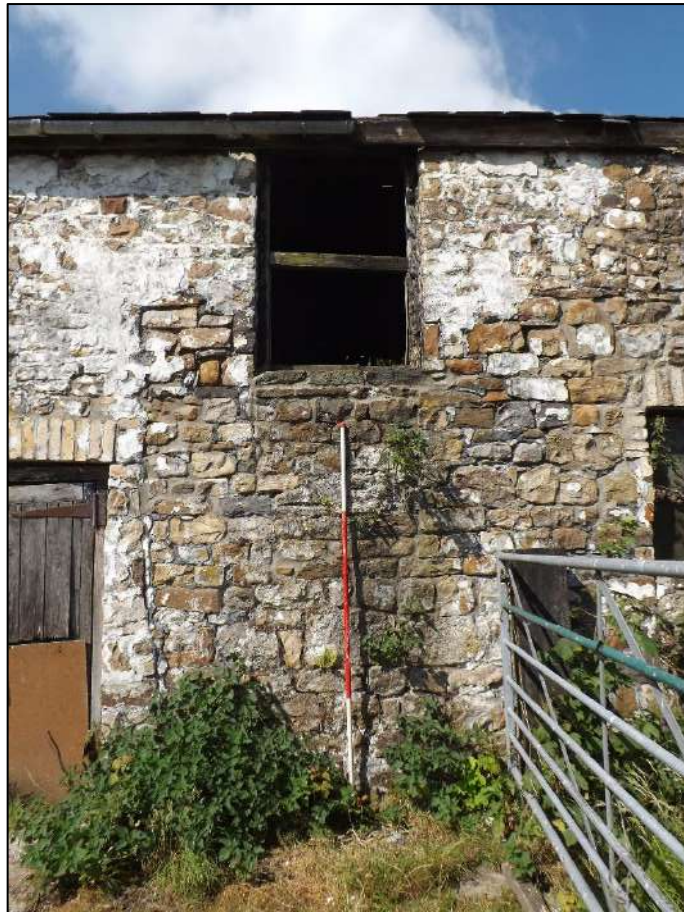
**Plate 11. The northernmost upper window created by partially blocking a previous window or doorway, probably when the roofline was raised. Scale 2m.**

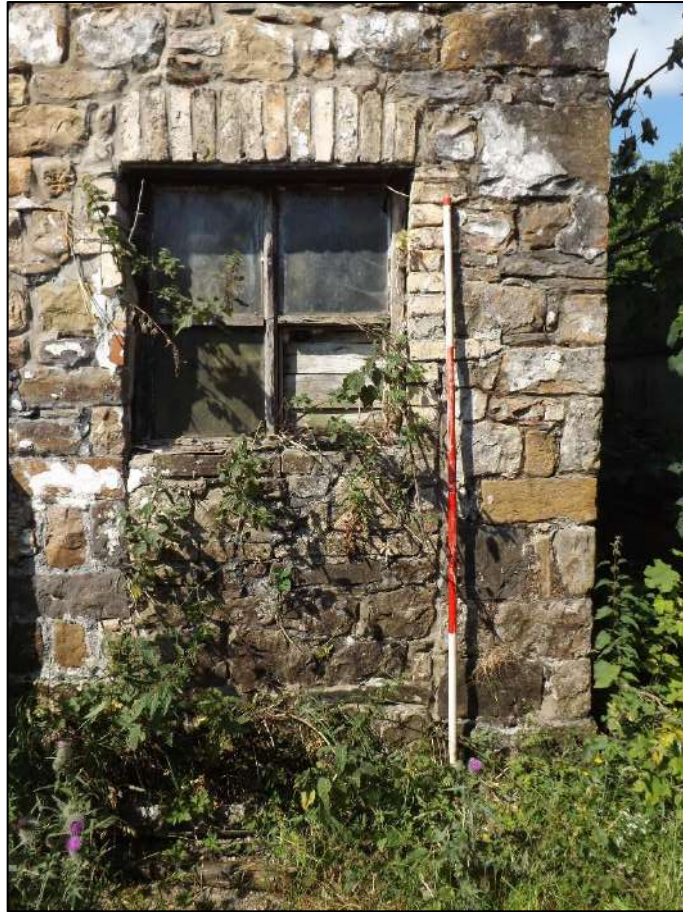
**Plate 12. Blocked doorway at the north of the east elevation. Unlike the blocked doorway to the south, this was converted to a window. Scale 2m.**

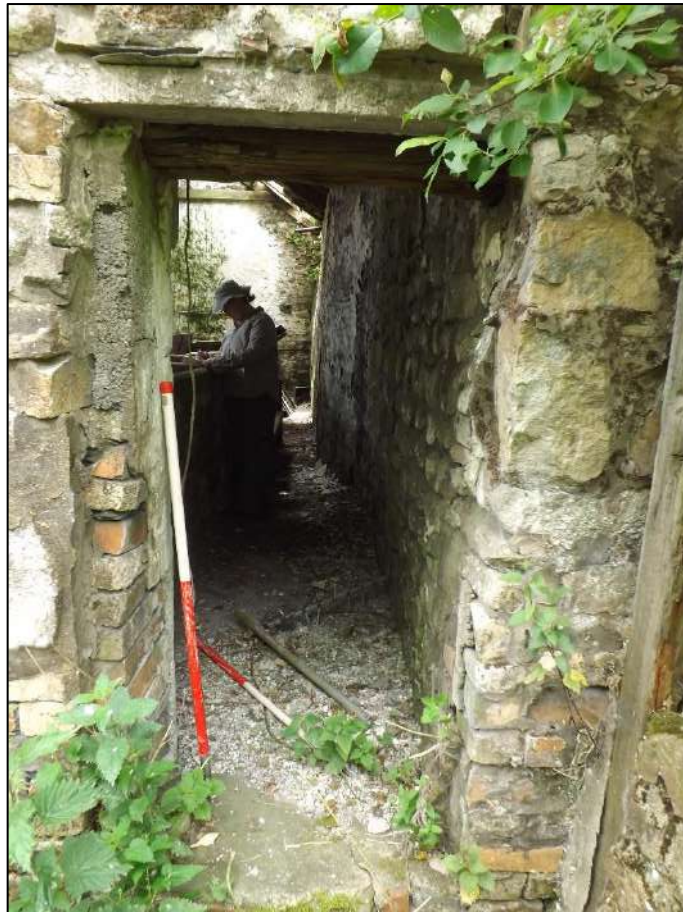
**Plate 13.** General picture of the doorway set into the north elevation of the barn. Note the breeze block and brick elements and the fact that there is no framing for a doorway. Scale 1m.

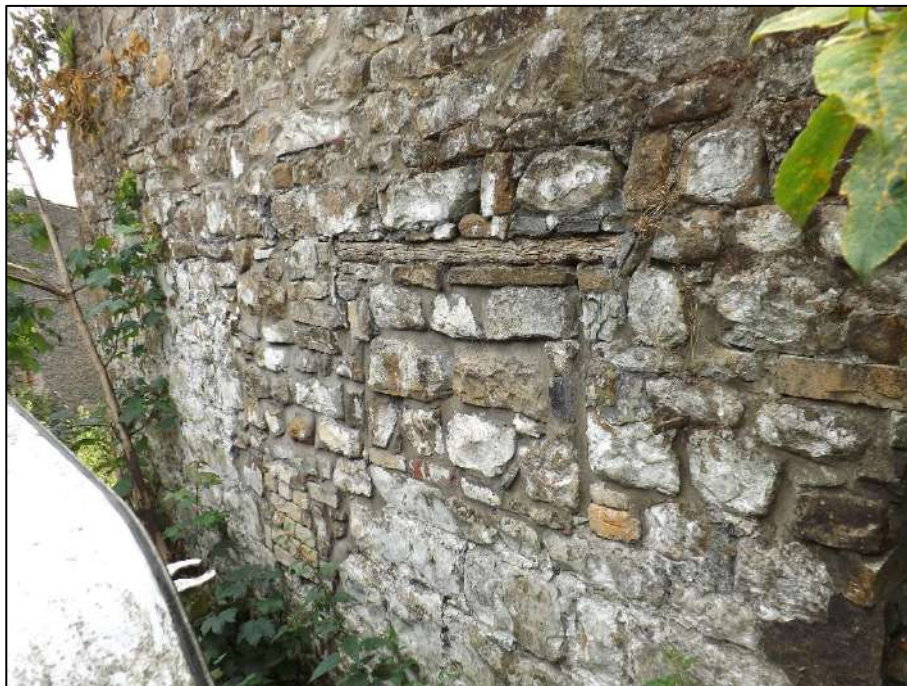
Blocking was visible in two discrete areas in the elevation. The first was at ground level, where the remains of a timber lintel marked the upper edge of a window in the centre of the gable end. The blocking consisted of local stone and yellow refractory brick and had been pointed with concrete. The blocking measured approximately 2m in width by 0.5m in height. At an upper level, a possible window had been blocked with stone and yellow refractory brick elements.

**Plate 14.** General oblique view of blocking of a window at the lower level of the north elevation of the barn. Note the timber lintel.

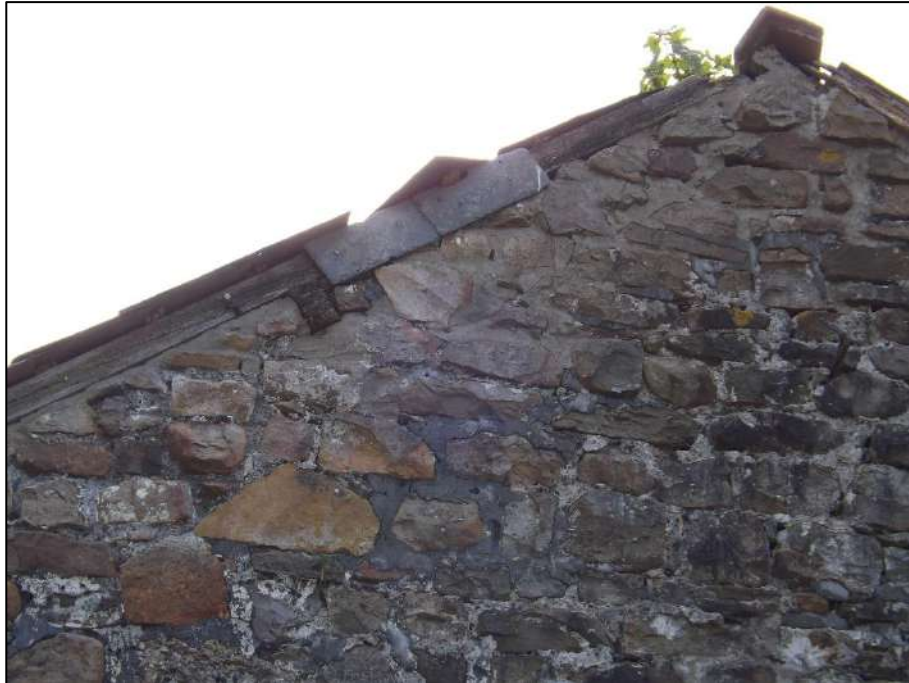
The most interesting feature noted in the north elevation was a series of triangular stones marking the original roof line for the barn. These had been retained and incorporated into the raised roof and provided the most compelling evidence that the roof level had been indeed been raised. The feature was too high to measure but is shown on elevation drawings.

**Plate 15. The former roofline was visible in the north gable of the barn. Note the remains of two slates nailed to the end roof joist as a weather board.**

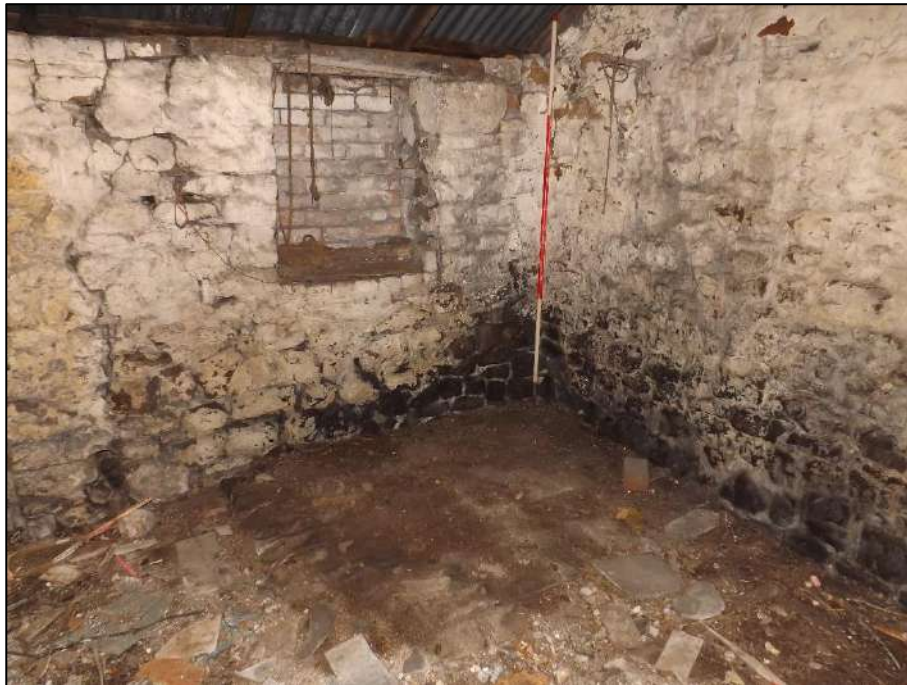
**Plate 16. North west corner of Annexe 1 showing the blocked window and raised floor. Just visible is the modern corrugated iron roof. Scale 2m.**

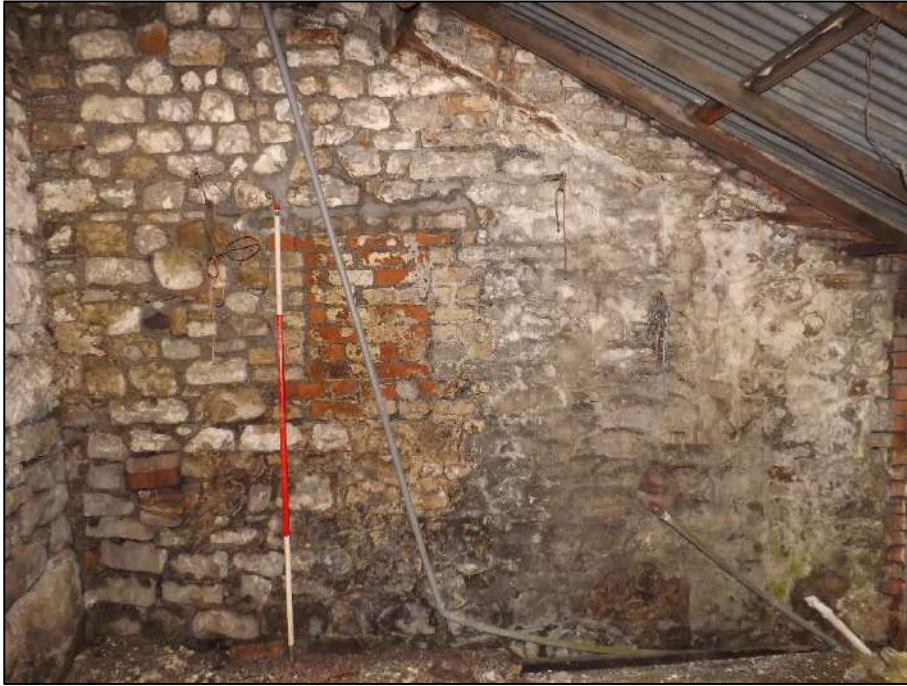
**Plate 17. South wall of Annexe 1 showing possible blocked window and old roof line. This wall, which forms part of the north wall of the cottage, was not keyed into the barn wall. Scale 2m.**

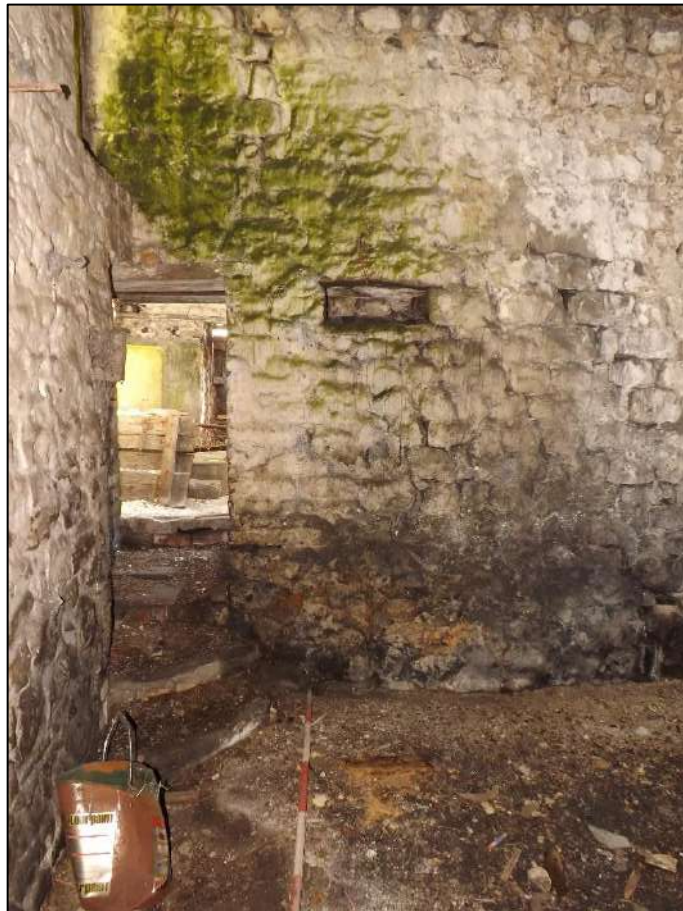
An internal doorway leading to the interior of the barn was present in the north east corner of the annexe. This had a highly unusual appearance, being set within a curving section of wall and being provided with two semi circular and two square stone steps up into the barn. The doorway was relatively small at 0.9m in width and 1.3m high but possessed no door. The final feature of note was a deliberately engineered recess, 1.6m above the floor level, in the west elevation just south of the door into the barn and at the same level as the top of the doorway. The recess measured 0.7m x 0.3m and had an approximate depth of 0.3m. A photograph of the interior of the recess revealed the presence of timber at the top and bottom and the rubble core of the barn wall but little else that might be useful for identifying it.

**Plate 18. West elevation of the barn inside Annexe 1 showing the access doorway into the barn interior and the engineered recess in the wall. Note the line of stones at the top of the image indicating the line of the former roof of the barn prior to its level being raised. Scale 2m.**

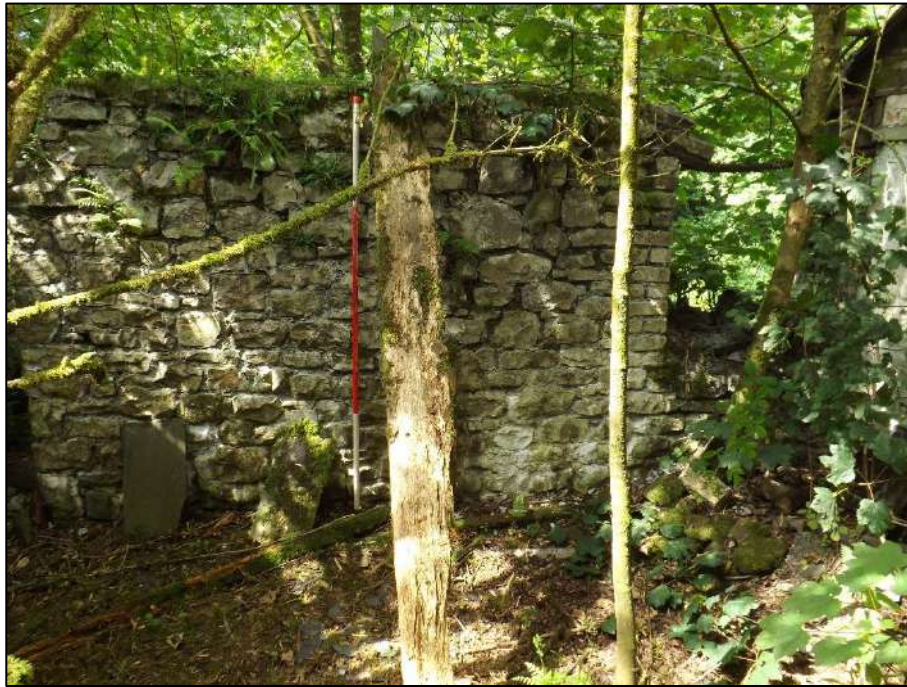
Annexe 2 enclosed a space of approximately 5.2m x 3.7m and comprised the north wall of Annexe 1, the west elevation of the barn and a stone and brick wall that formed the west wall of the annexe. The roof, which had been of timber and slate construction, had collapsed into the interior of the room, and small trees were flourishing in the space.

**Plate 19. Interior view of annexe 2 showing the west wall and damaged window on the right as well as trees growing in the interior space. Scale 2m.**

Of the two windows, the one in the west wall was edged with yellow refractory brick and badly damaged, whilst the other was intact high in the adjoining wall of Annex 1.

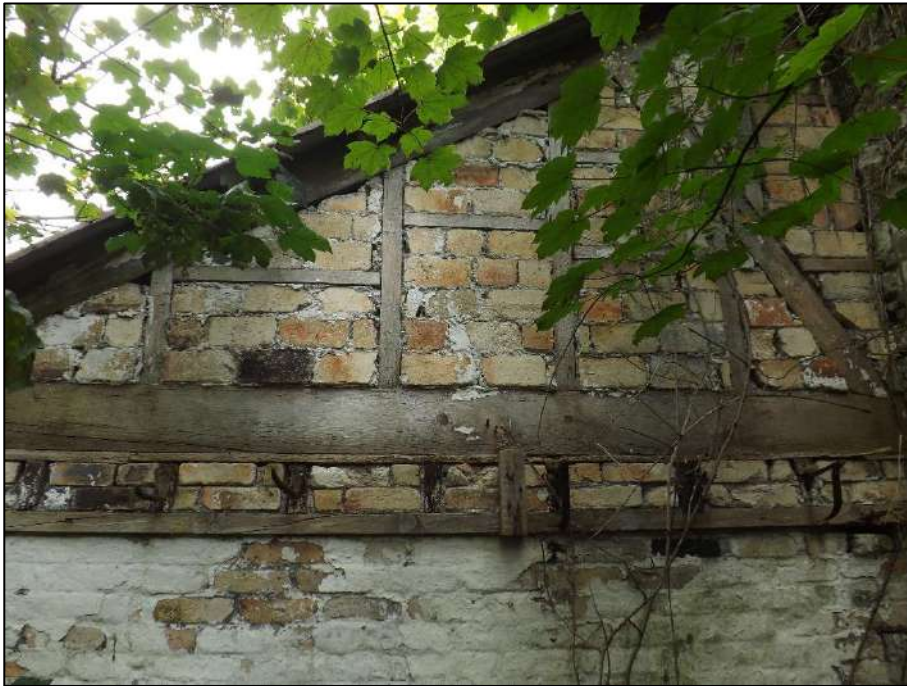
**Plate 20. North wall of Annexe 2 showing timber frame and brick infill construction of the upper part of the wall. Note the metal fixings which may have been for hanging implements.**

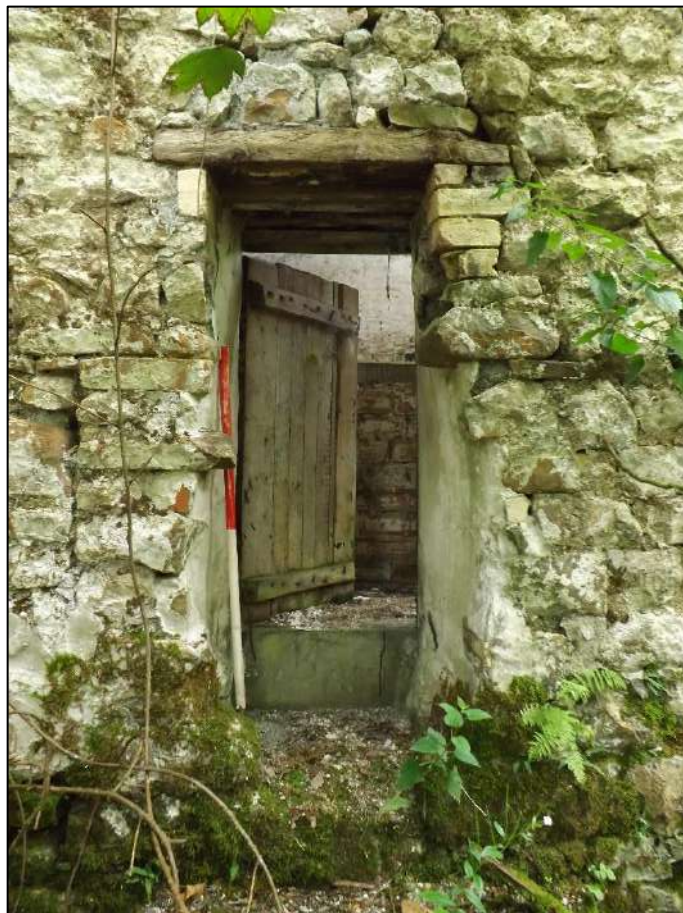
**Plate 21. Interior door from Annexe 2 to the barn showing the step and doorway. Scale 1m.**

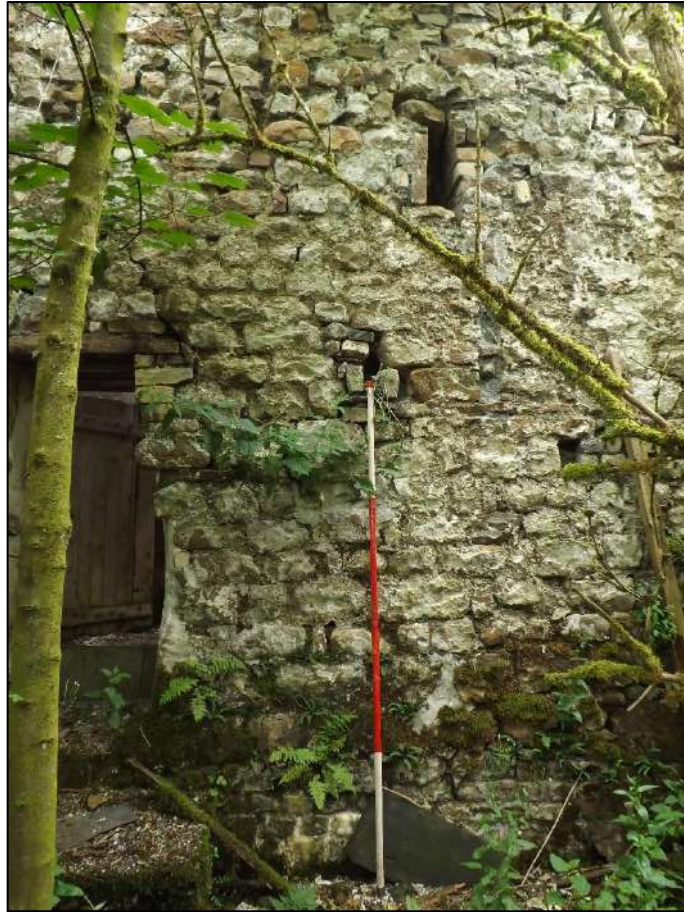
**Plate 22. Detail of the west elevation on the barn showing possible air vent and possible scaffolding hole. Scale 2m.**

The west elevation of the barn featured a possible ventilation window edged with stone and yellow refractory brick, together with a possible scaffolding hole. The ventilation window was of note as this was the only feature of this nature to be noted and there is therefore a possibility that the slot may have served as a socket for a roof timber. Unfortunately the feature was located too high to closely inspect.

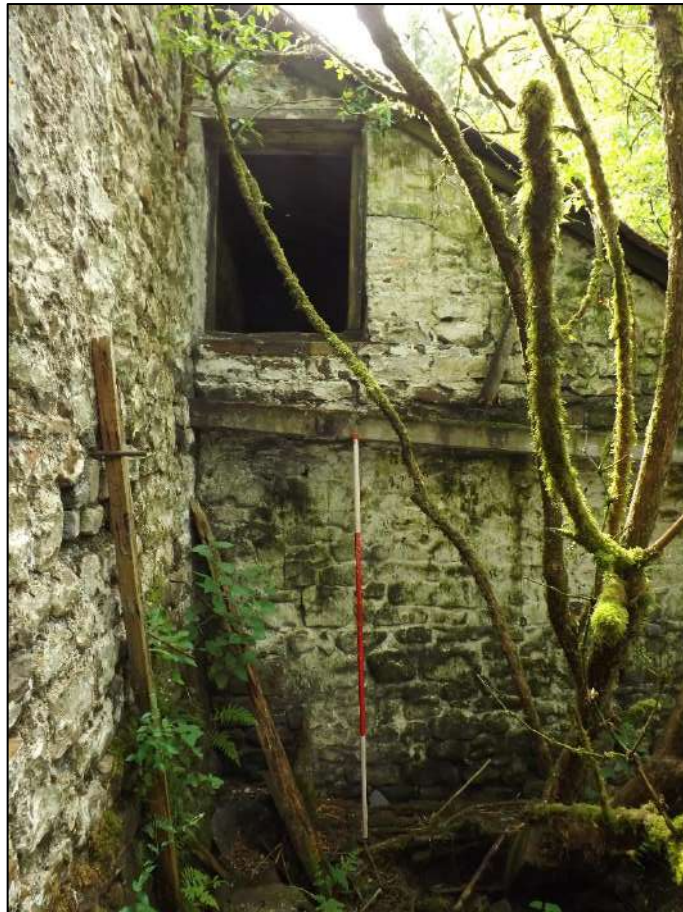
**Plate 23. North elevation of Annexe 1 which also formed the south wall of Annexe 2. Note the window with surviving framing. Scale 2m.**

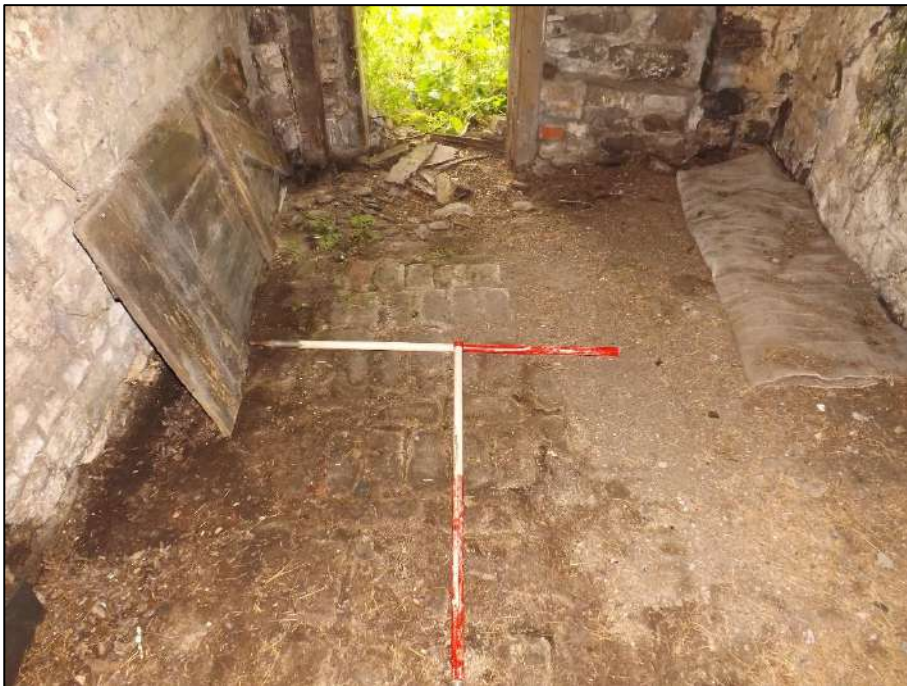
Annexe 3 appeared to have been used as a store room or similar but may have initially been built as a small animal pen. The floor sloped to the west possibly to aid drainage, and the wide door as was initially constructed would aid the passage of animals or larger equipment.

**Plate 25. Brick and cobble floor of Annexe 3. Scale 1m.**

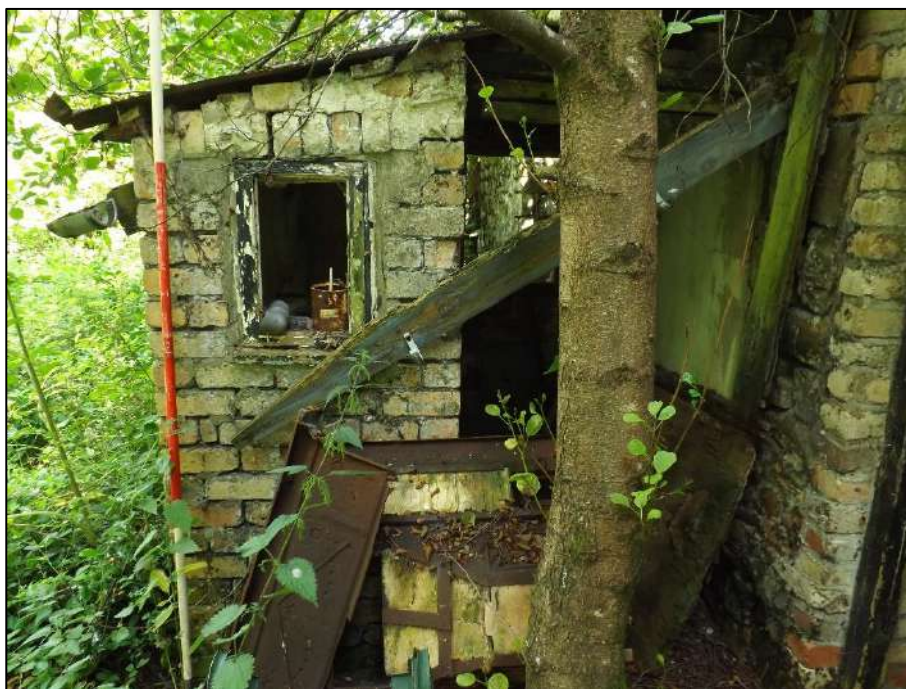
**Plate 26. Outhouse abutting Annexe 1. The only visible interior features were shelving. Scale 2m.**

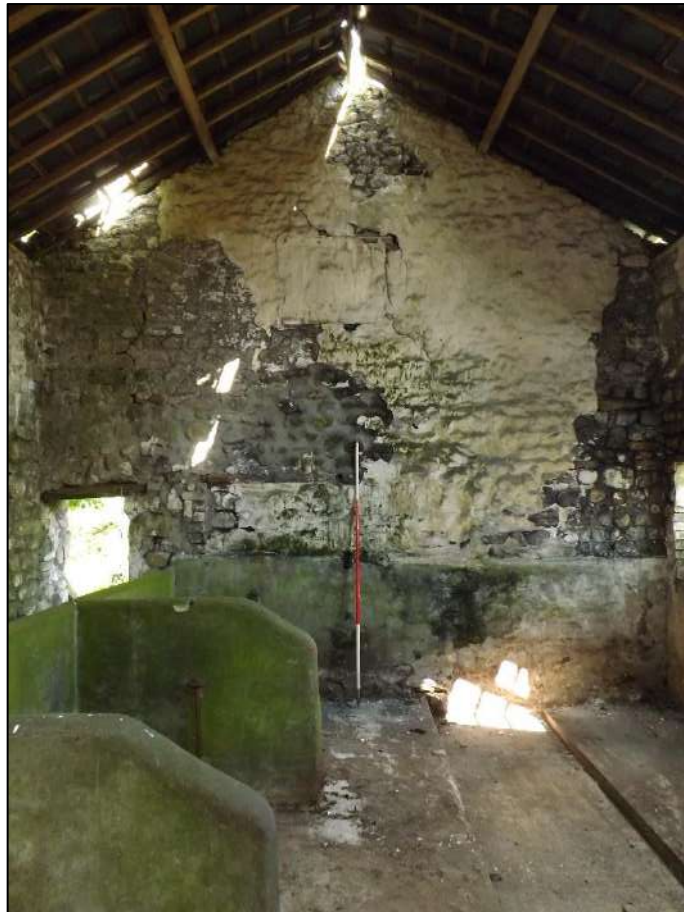
Plate 28. North wall of the barn interior. Note the blocked window in the upper level of the gable and the concrete render that extended round from the byre. Scale 1m.

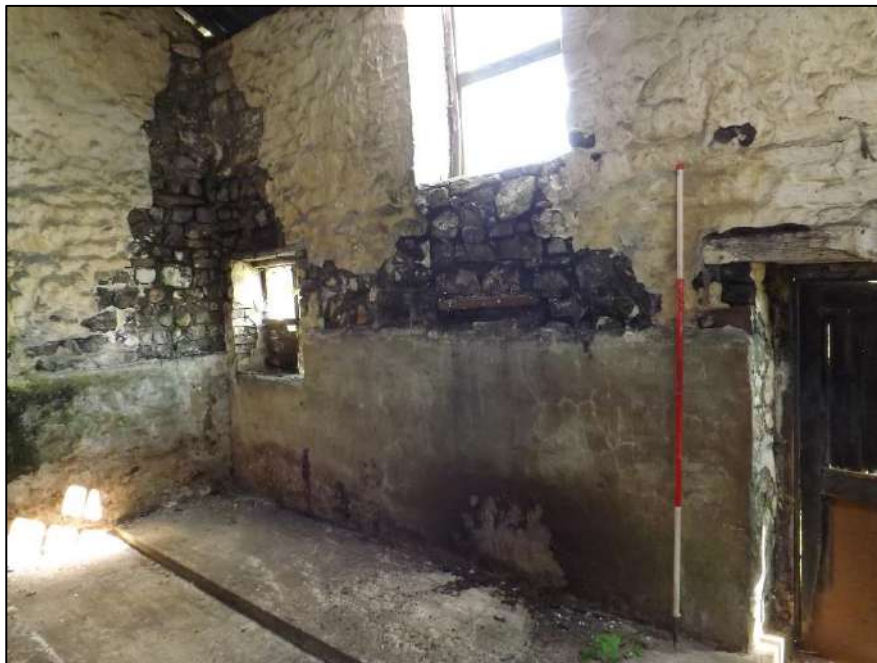
Plate 29. Oblique view of the north east interior of the barn. Note the original sill for the partially blocked upper window and the former doorway in the corner that had been converted into a window. Scale 2m.

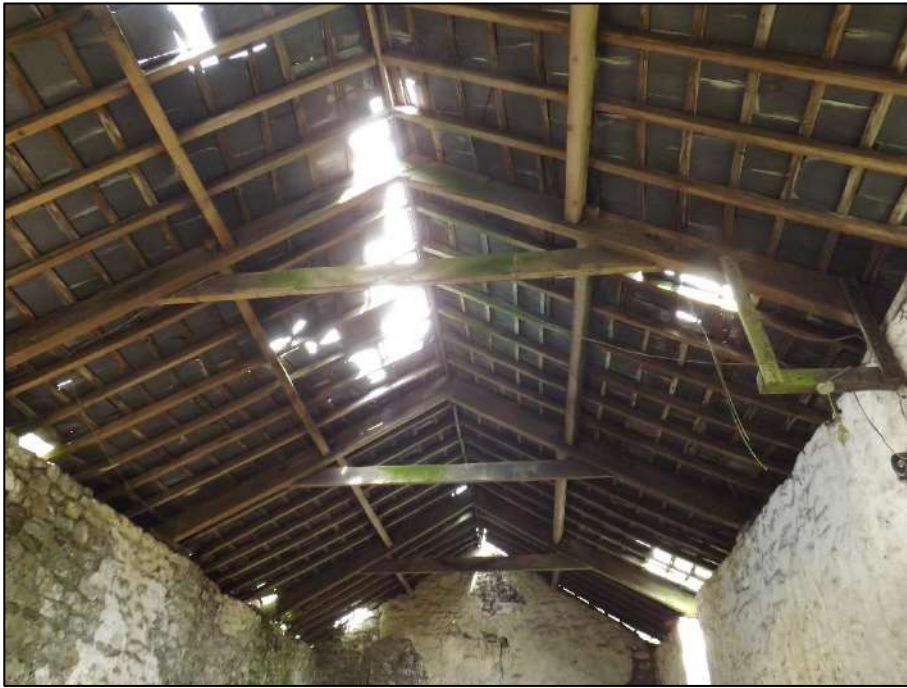
**Plate 30. Detail of the roof construction of the barn interior. Note the slates have been affixed directly onto the timber. It is unclear as to whether this is the original roof but it is certainly of some age and may date to the re-modelling of the farm before 1875.**

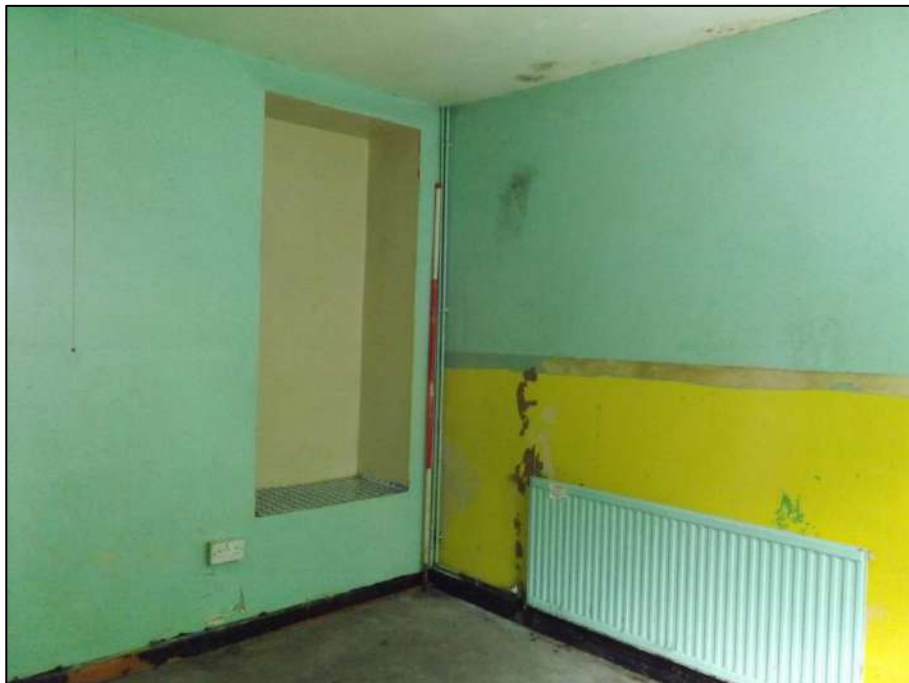
**Plate 35. Rectangular recess in the south east corner of the kitchen. This was almost certainly a blocked doorway that once led into the barn that was repurposed for storage.**

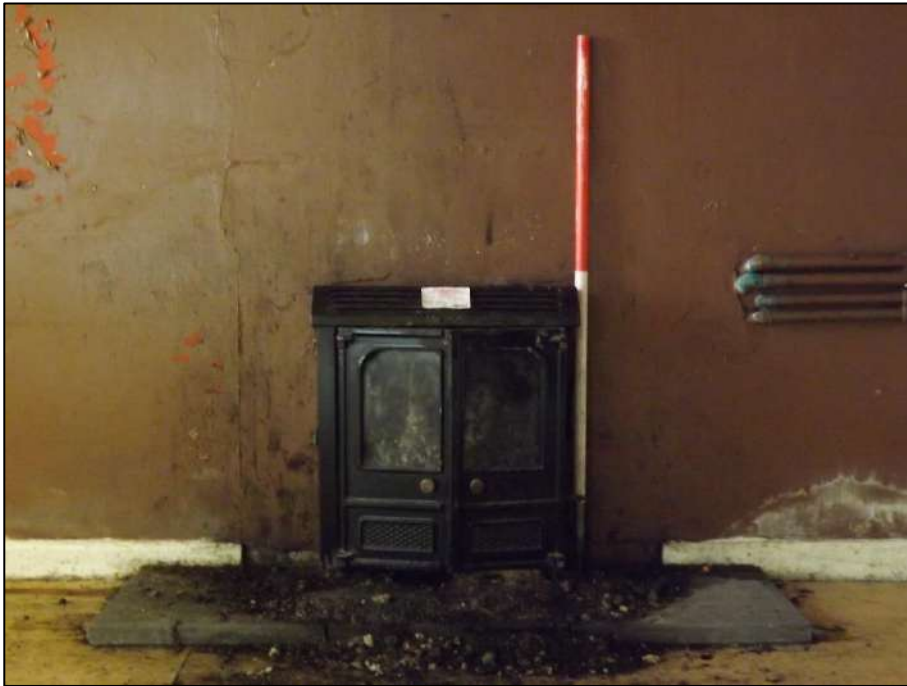
**Plate 39.** The fireplace in the living room. This is a later addition as fractures in the render and the gaps in the skirting board indicate the presence of an earlier fireplace behind the grate. Scale 1m.

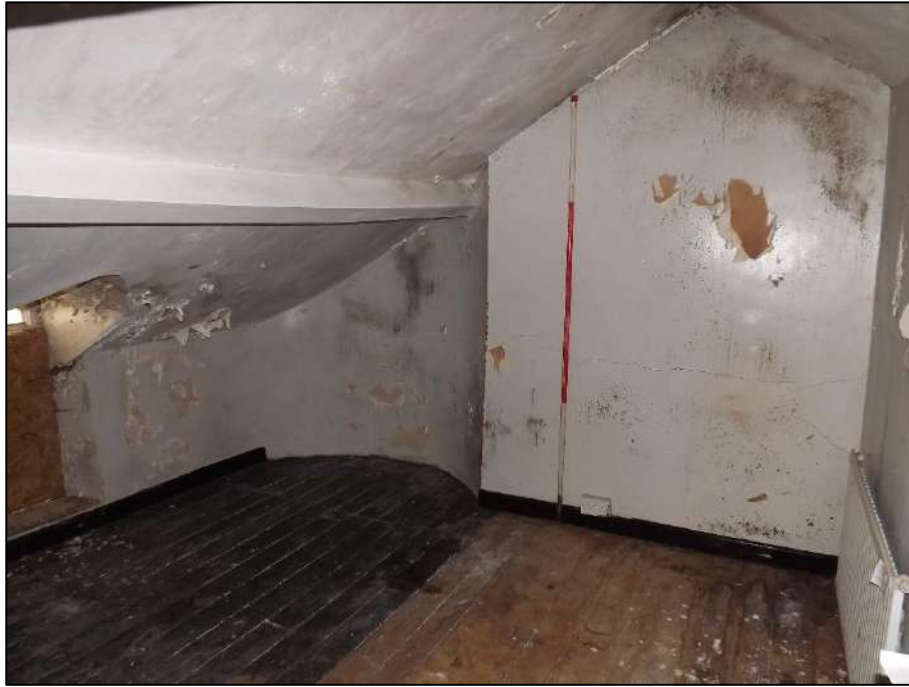
An unusual semi-circular recess, measuring 1m in width by 0.5m in depth was noted in the south east corner which had no apparent function. It was initially thought that this recess was another blocked doorway but as the feature extended to the first floor bedroom above (see below). It is possible that the feature was simply a niche but some thought must be given to the idea of the feature being part of a circular stairway.

**Plate 41. Semi-circular feature in the south east corner of the main bedroom. Note the cut line in the floorboards. This feature may be the vestigial remains of a stairwell. Scale 2m.**
