# Tynycoedcae Farm, Merthyr Tydfil

## Historic building survey

A report for Ray Gee Construction  
By Johnny Crawford BSc MA MCIfA

GGAT report no. 2019/039  
Project no. P2022  
National Grid Reference:  
SO 01457 07480

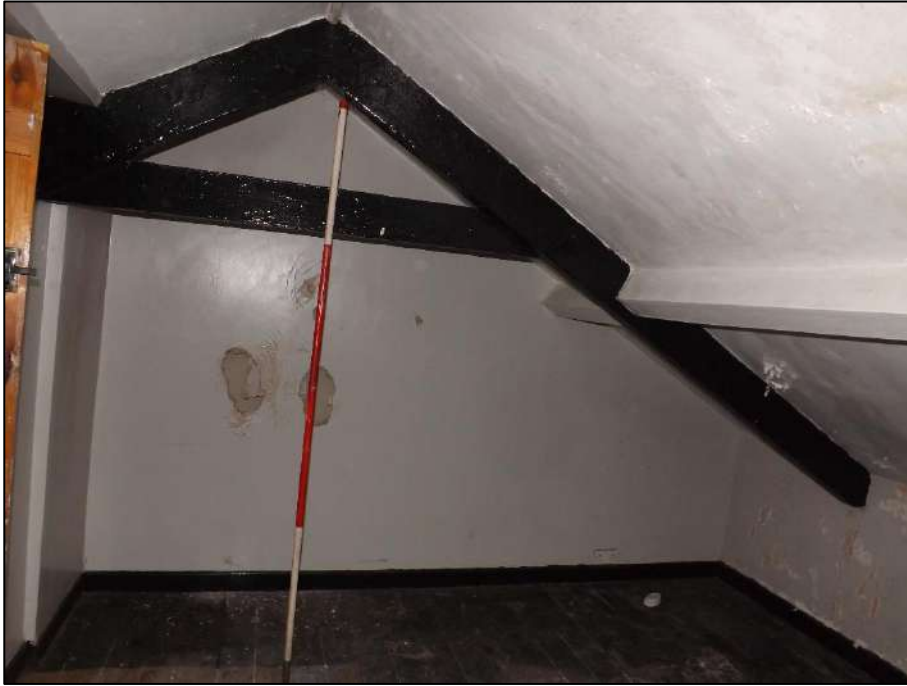
**Plate 42.** Heavily painted roof beams in the south east bedroom. The beams were tied with metal bolts but although hidden under layers of paint, they are likely to be original beams dating to creation of the cottage. Scale 2m.

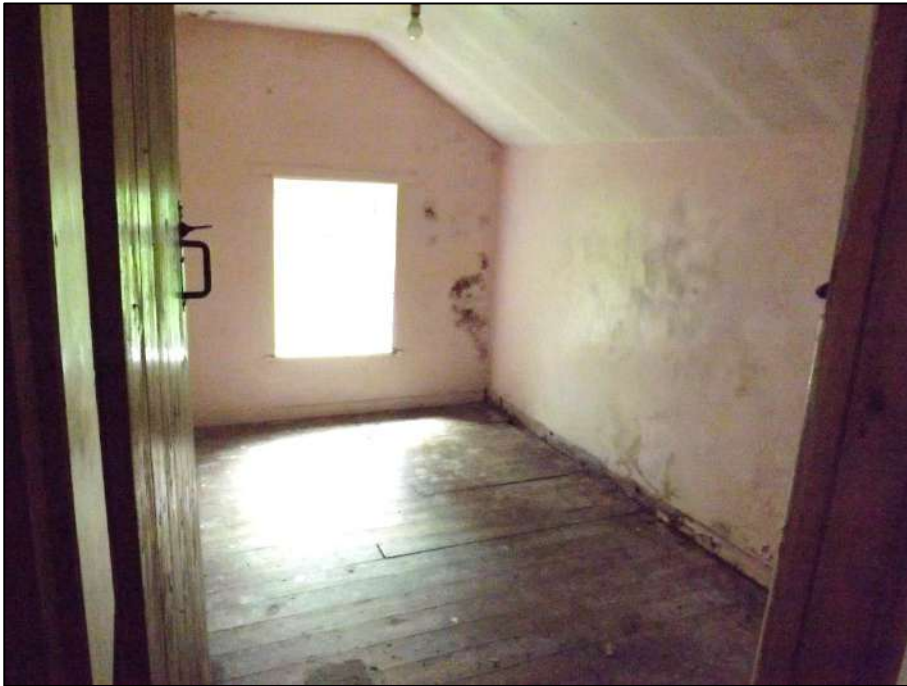
Plate 44. View into the north west bedroom. Rotten floorboards prevented entry into the room.

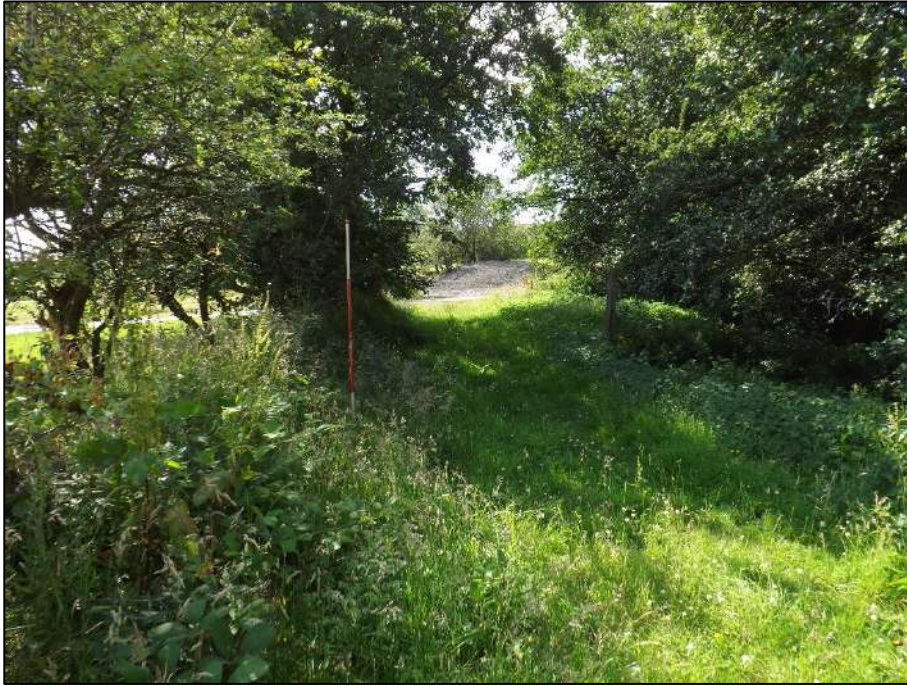
**Plate 48. The overgrown original access road to the farm looking south. The low stone banks either side are only partly visible Scale 2m.**
