# **Goetre Primary School – Signalised Junction**

## **Signalised Junction Road Safety Audit Stage 1 & 2 – Designers Response**

**Project Ref:** 26CB01

| <b>Document reference</b> | 26CB01-CAM-10-XX-T-C-0006 |

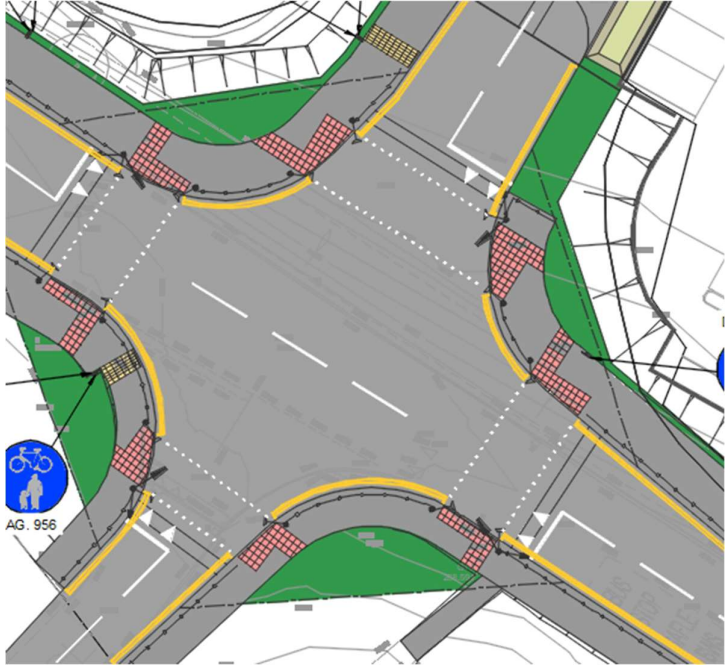
| <b>RSA problem</b> | <p><b>PROBLEM 3</b></p> <p><b>LOCATION:</b> Centre of the signalised junction.</p> <p><b>SUMMARY:</b> Omission of lane guidance carriageway markings may increase the risk of head-on type collisions.</p> <p>2.8 The scheme drawings do not indicate any lane carriageway markings to advise drivers turning right from both the Goitre Road arms of the junction where to position their vehicle if held up in the centre of the junction by opposing vehicle movements. Omission of advisory carriageway markings could potentially increase the risk of head-on type collisions.</p> |

| <p><b>Design</b><br/><b>Organisation</b><br/><b>Response (DOR)</b></p> | <p>As pointed out by the Auditor there are currently no road markings in the centre of the junction, which we believe is standard for this type of arrangement.</p> <p>DMRB states in CD123 Section 7 that <i>“The use of lane markings within the junction intervisibility zone, can be beneficial to direct streams and reduce conflict where entry- and exit-lane widths vary or the alignment through the junction is not a direct path”</i> which is not the case here.</p> <p>However, a short section of white lining to Diagram 1004 could be provided as shown below if Merthyr Tydfil CBC Highways deem it suitable.</p> |
