**R 144 North West Elevation - Terracotta Supply**

| YMCA, Merthyr Tydfil | | |
| North West Elevations - Terracotta Supply | | |
| | | 3510_R_144 |

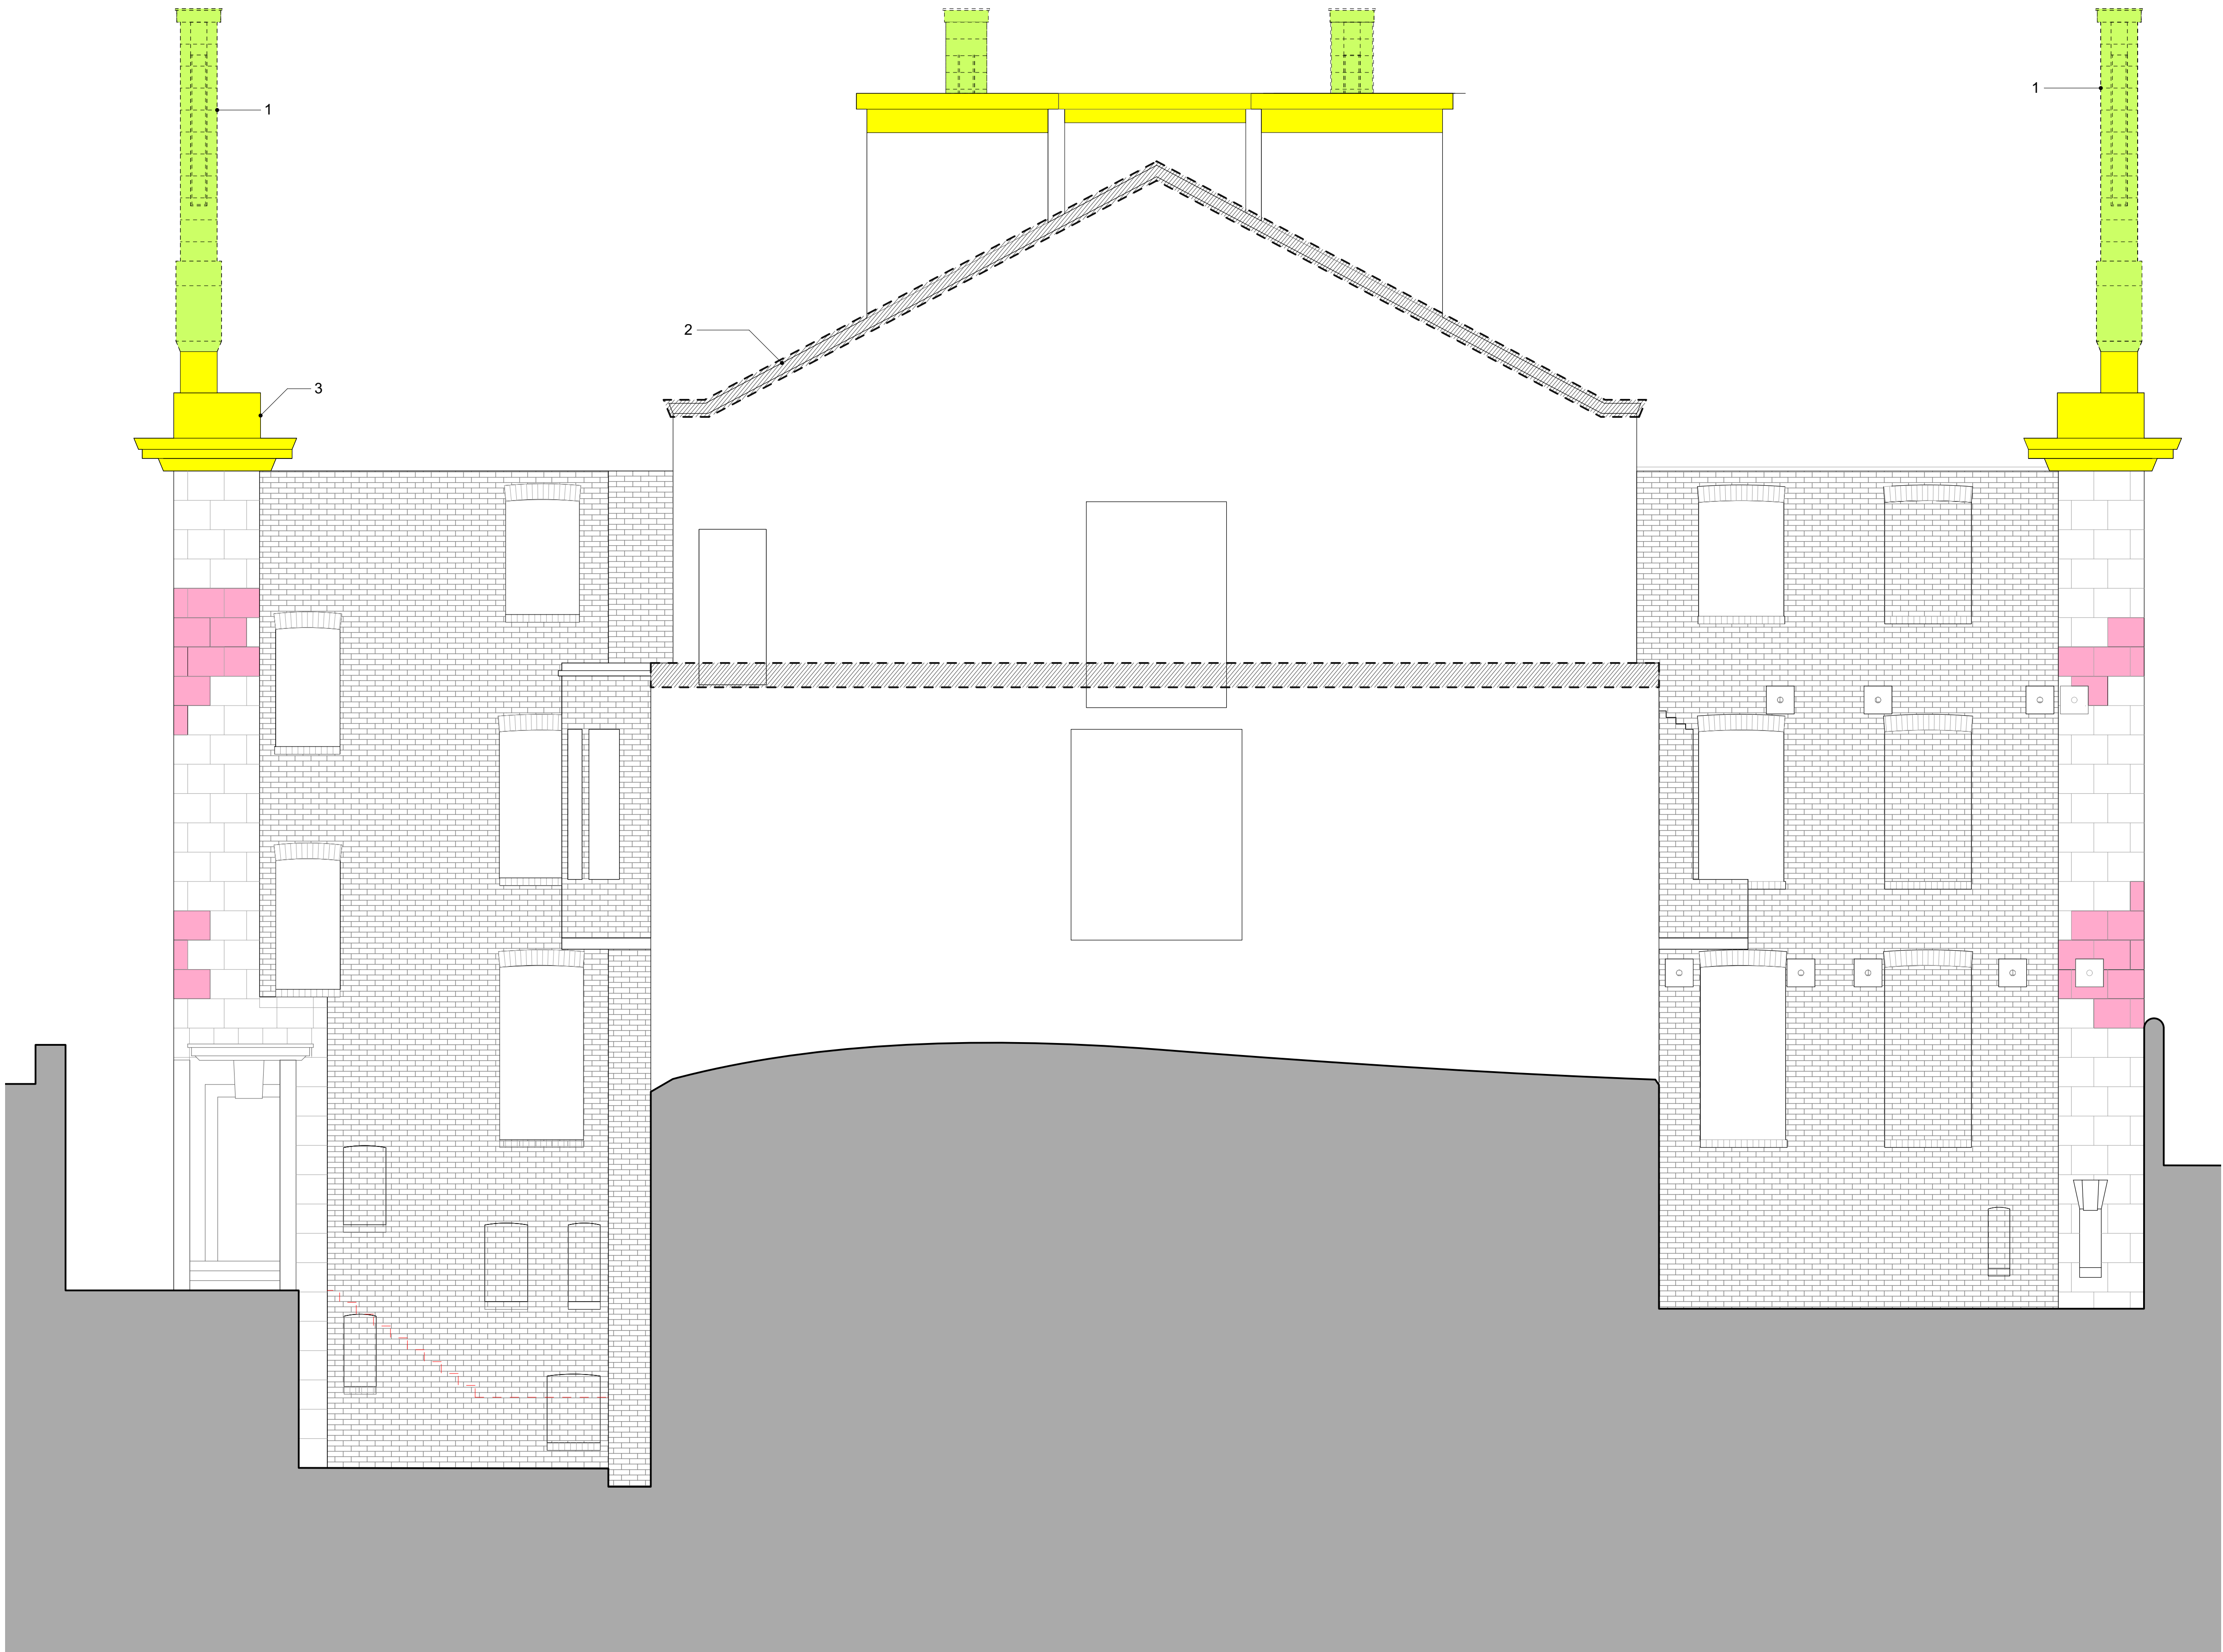
**Defective terracotta unit** - Allow for careful removal/ of existing terracotta and replacement with new as specification section C41.

**Missing terracotta units** - Allow for careful removal of any remains of existing terracotta unit and replacement with new as specification section C41. (Units may be found on site).

**Partially Damaged terracotta unit** - To be repaired where possible. Allow for careful removal of damaged units, repair and reinstatement, supplemented with new as specification section C41.

1. Entire gable end chimney is missing, new terracotta required to rebuild.
2. Existing coping is in poor condition, consider repair/ replacement.
3. Replacement terracotta required.

**NOTE:** Exact quantity and type of repair is to be confirmed by CA following site inspection.

**Proposed terracotta unit** - as specification section C41.
