**GEOENVIRONMENTAL ASSESSMENT  
FORMER ST TYDFIL HOSPITAL  
MERTHYR TYDFIL  
ST TYDFILS DEVELOPMENTS LLP  
GEA-21988-21-80  
JUNE 2021**

GEOENVIRONMENTAL ASSESSMENT  
FORMER ST TYDFIL HOSPITAL  
MERTHYR TYDFIL  
ST TYDFILS DEVELOPMENTS LLP  
GEA-21988-21-80  
JUNE 2021

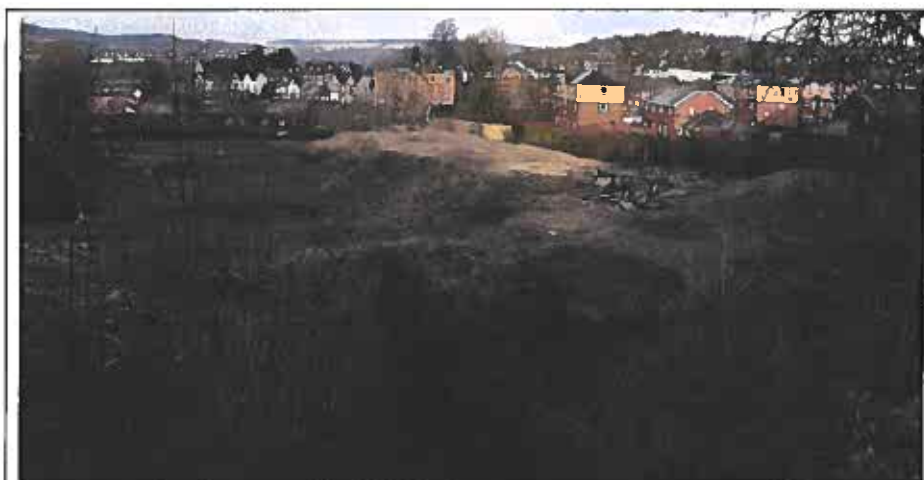
5.1.2 The northern portion of site is dominated by black-grey made ground consistent with nearby stockpiles. Although mostly flat, the surface contains coarse sharp fragments

and is uneven. Multiple open inspection chambers and manholes are present, which have had their metal coverings removed. Towards the northern margin of site is a small pile of concrete and rebar next to a concreted slope and area of apparent in situ foundations. Stockpiles 1 to 5 plus a portion of Stockpile's 8, 9 and 10 are located in the north of site. See Plate 1 for an overview of the northern portion.

Plate 1: Panorama photograph lower level northern portion of site's flat topography and location of stockpiles.

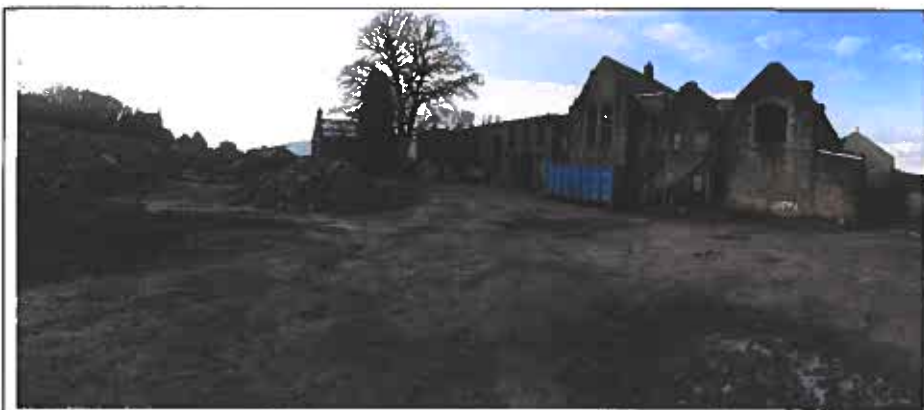
- 5.1.3 The majority of the southern area of site was dominated an asphalt court-yard and access road, with areas of concrete and vegetated topsoil and sparse tall trees. The asphalt is smooth and flat with few coarse sharp fragments. The listed buildings are present in the southwestern corner of site and along the southern margin. A small pile of concrete is located on the court-yard area, and Stockpile 6, 7 and 8 are located on the southern portion of site.

Plate 2: Panorama photograph of lower level site showing the asphalt court-yard.

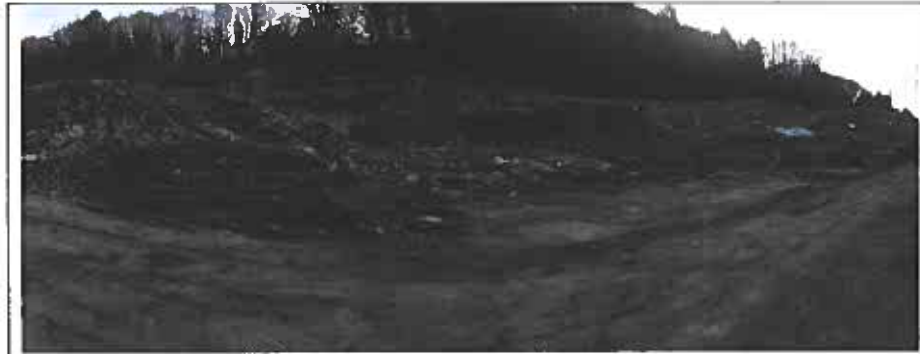
- 5.1.4 The central portion of site is dominated by Stockpiles 7 to 10. To the east of the access road is two areas of in situ concrete slabs or foundations, the northern area is slightly raised. See Plate 3 for an overview of the central portion of site.

Plate 3: Panorama photograph of the centre of lower level of site showing the asphalted road with an area of concrete foundations to the east partially covered in stockpiles.

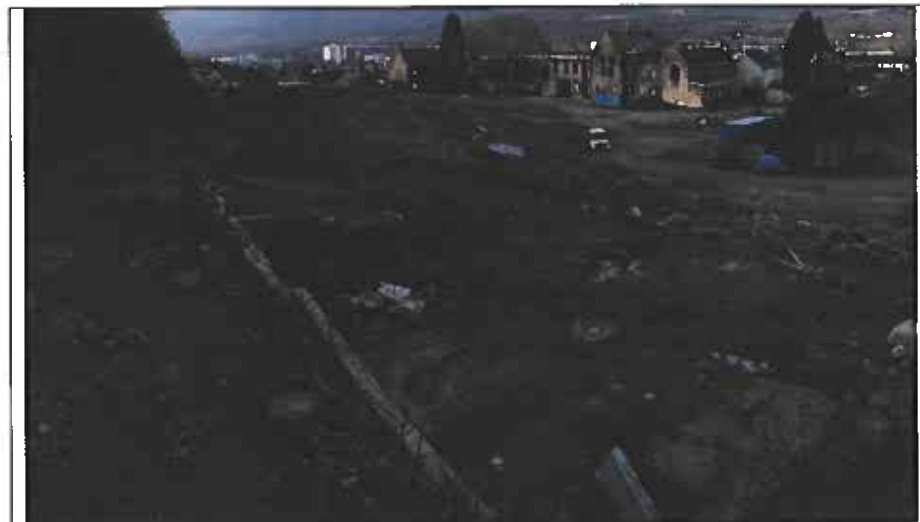
- 5.1.5 The rear or eastern portion of site is dominated by a sloped asphalted road, connected to the elevated parking area in the east of site. This is an even road, with rare to occasional coarse sharp fragments and uncovered inspection chambers/manholes.
- 5.1.6 The eastern parking area is an even, flat asphalted area with a retaining wall to the east and overgrown topsoil areas around the perimeter.

Plate 4: Panorama photograph of the middle level of site (eastern portion near old tank structure) overlooking the asphalt road and top of stockpiles 6, 7 and 8.
