GEOTECHNICAL REPORT  
ON SLOPE STABILITY  
AT  
MERTHYR MOTOR AUCTIONS  
PANT ROAD  
DOWLAIS  
MERTHYR TYDFIL  
CF48 3SH  
10/11/2020

## **INTRODUCTION**

### **1. SITE DESCRIPTION**

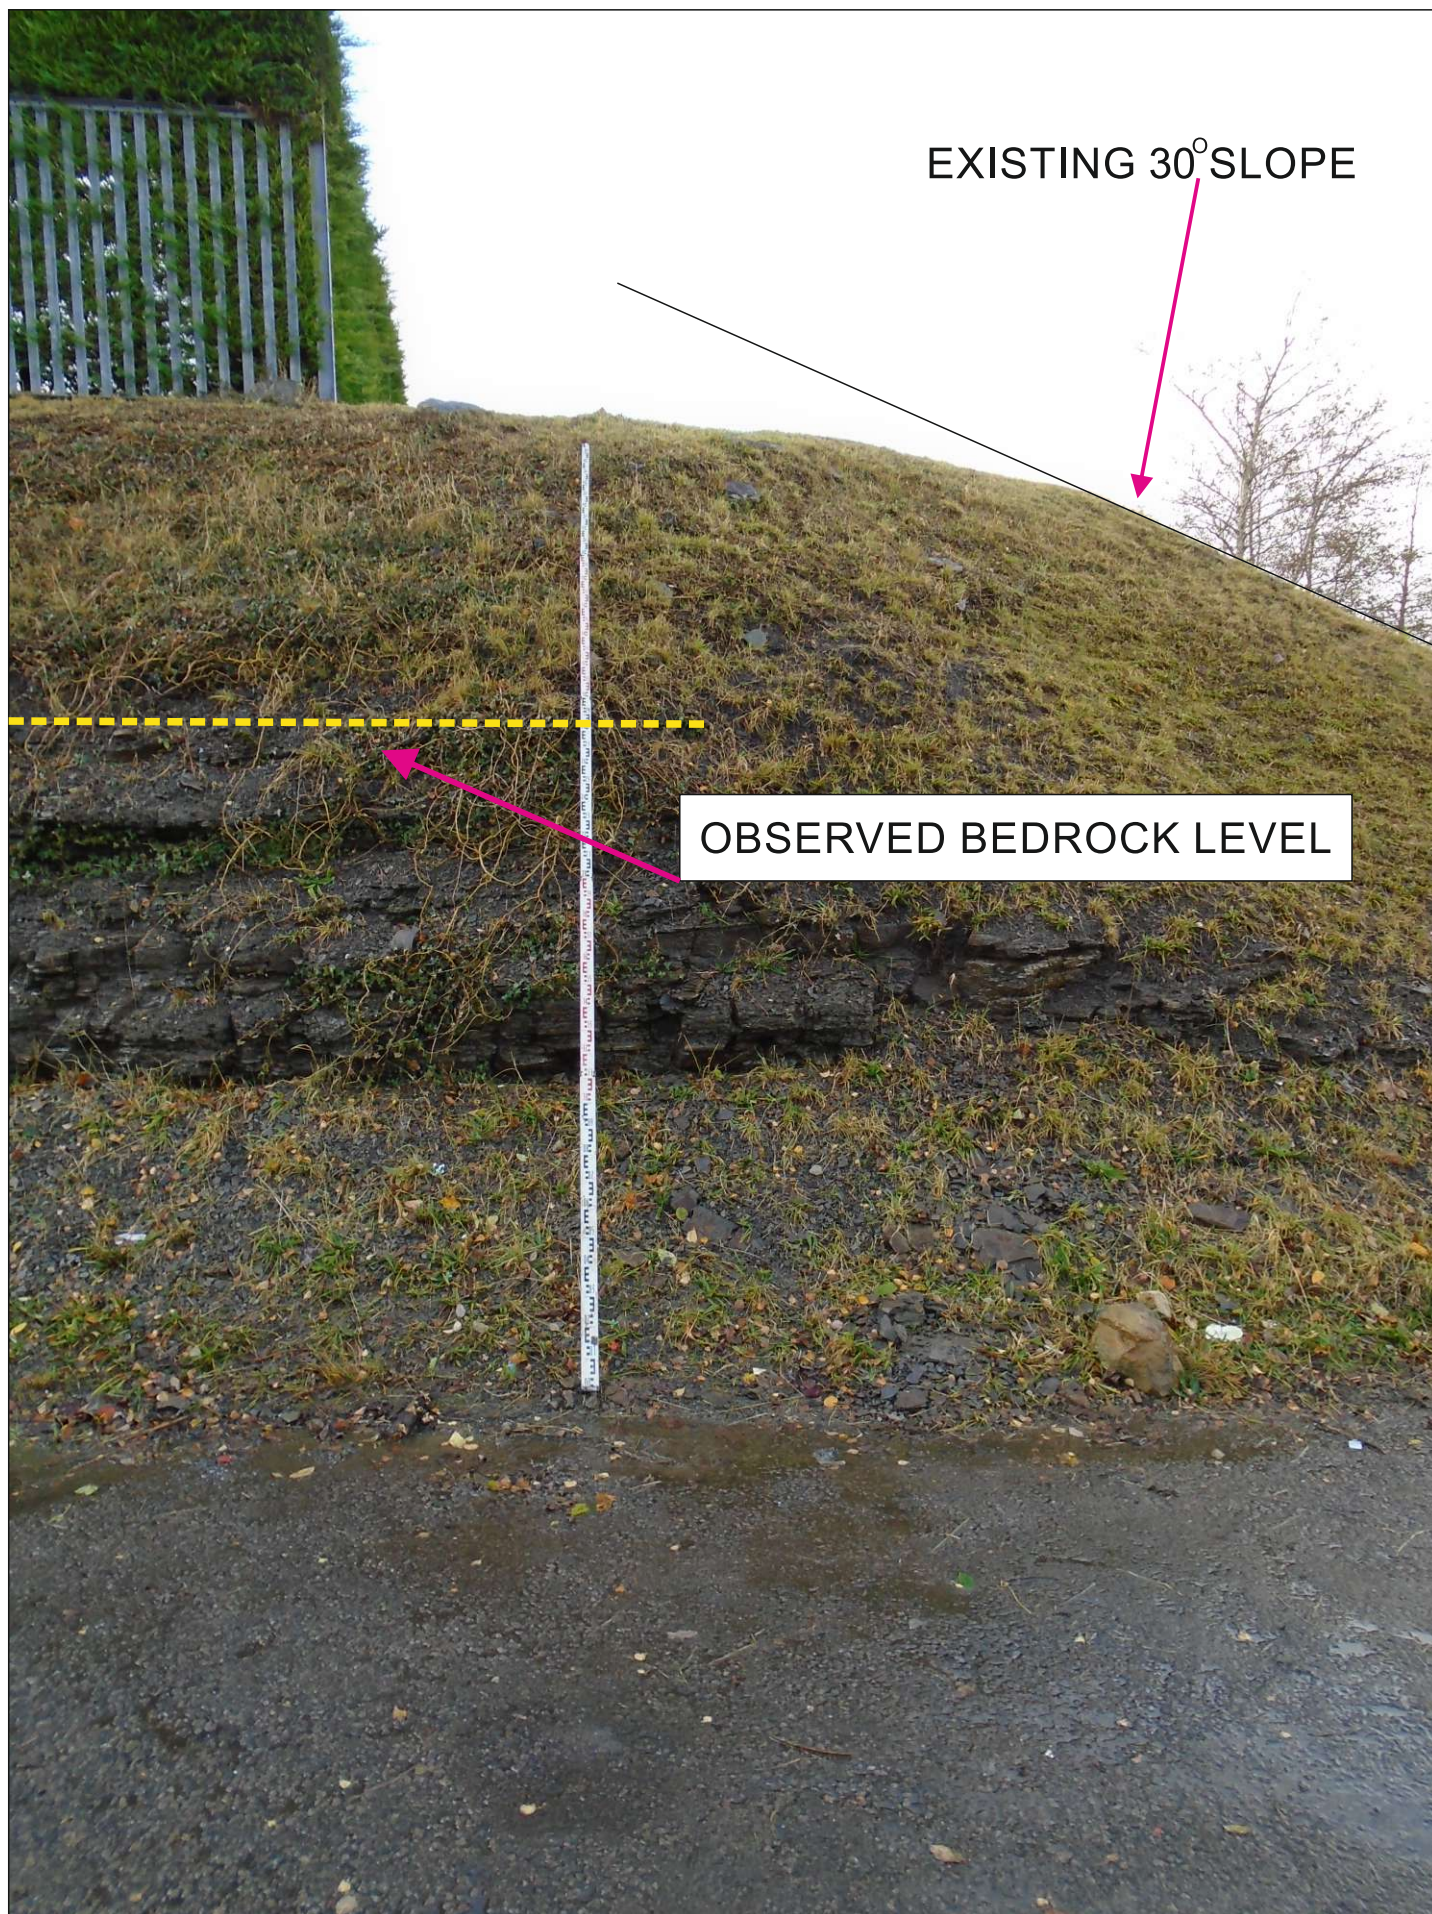
FIGURE 3

THE SURVEY STAFF IS OPEN TO 5m BUT IS LEANING BACK. THE BEDROCK IS SEEN APPROXIMATELY 3m ABOVE THE YARD LEVEL, BUT THEN APPEARS TO DROP AWAY.

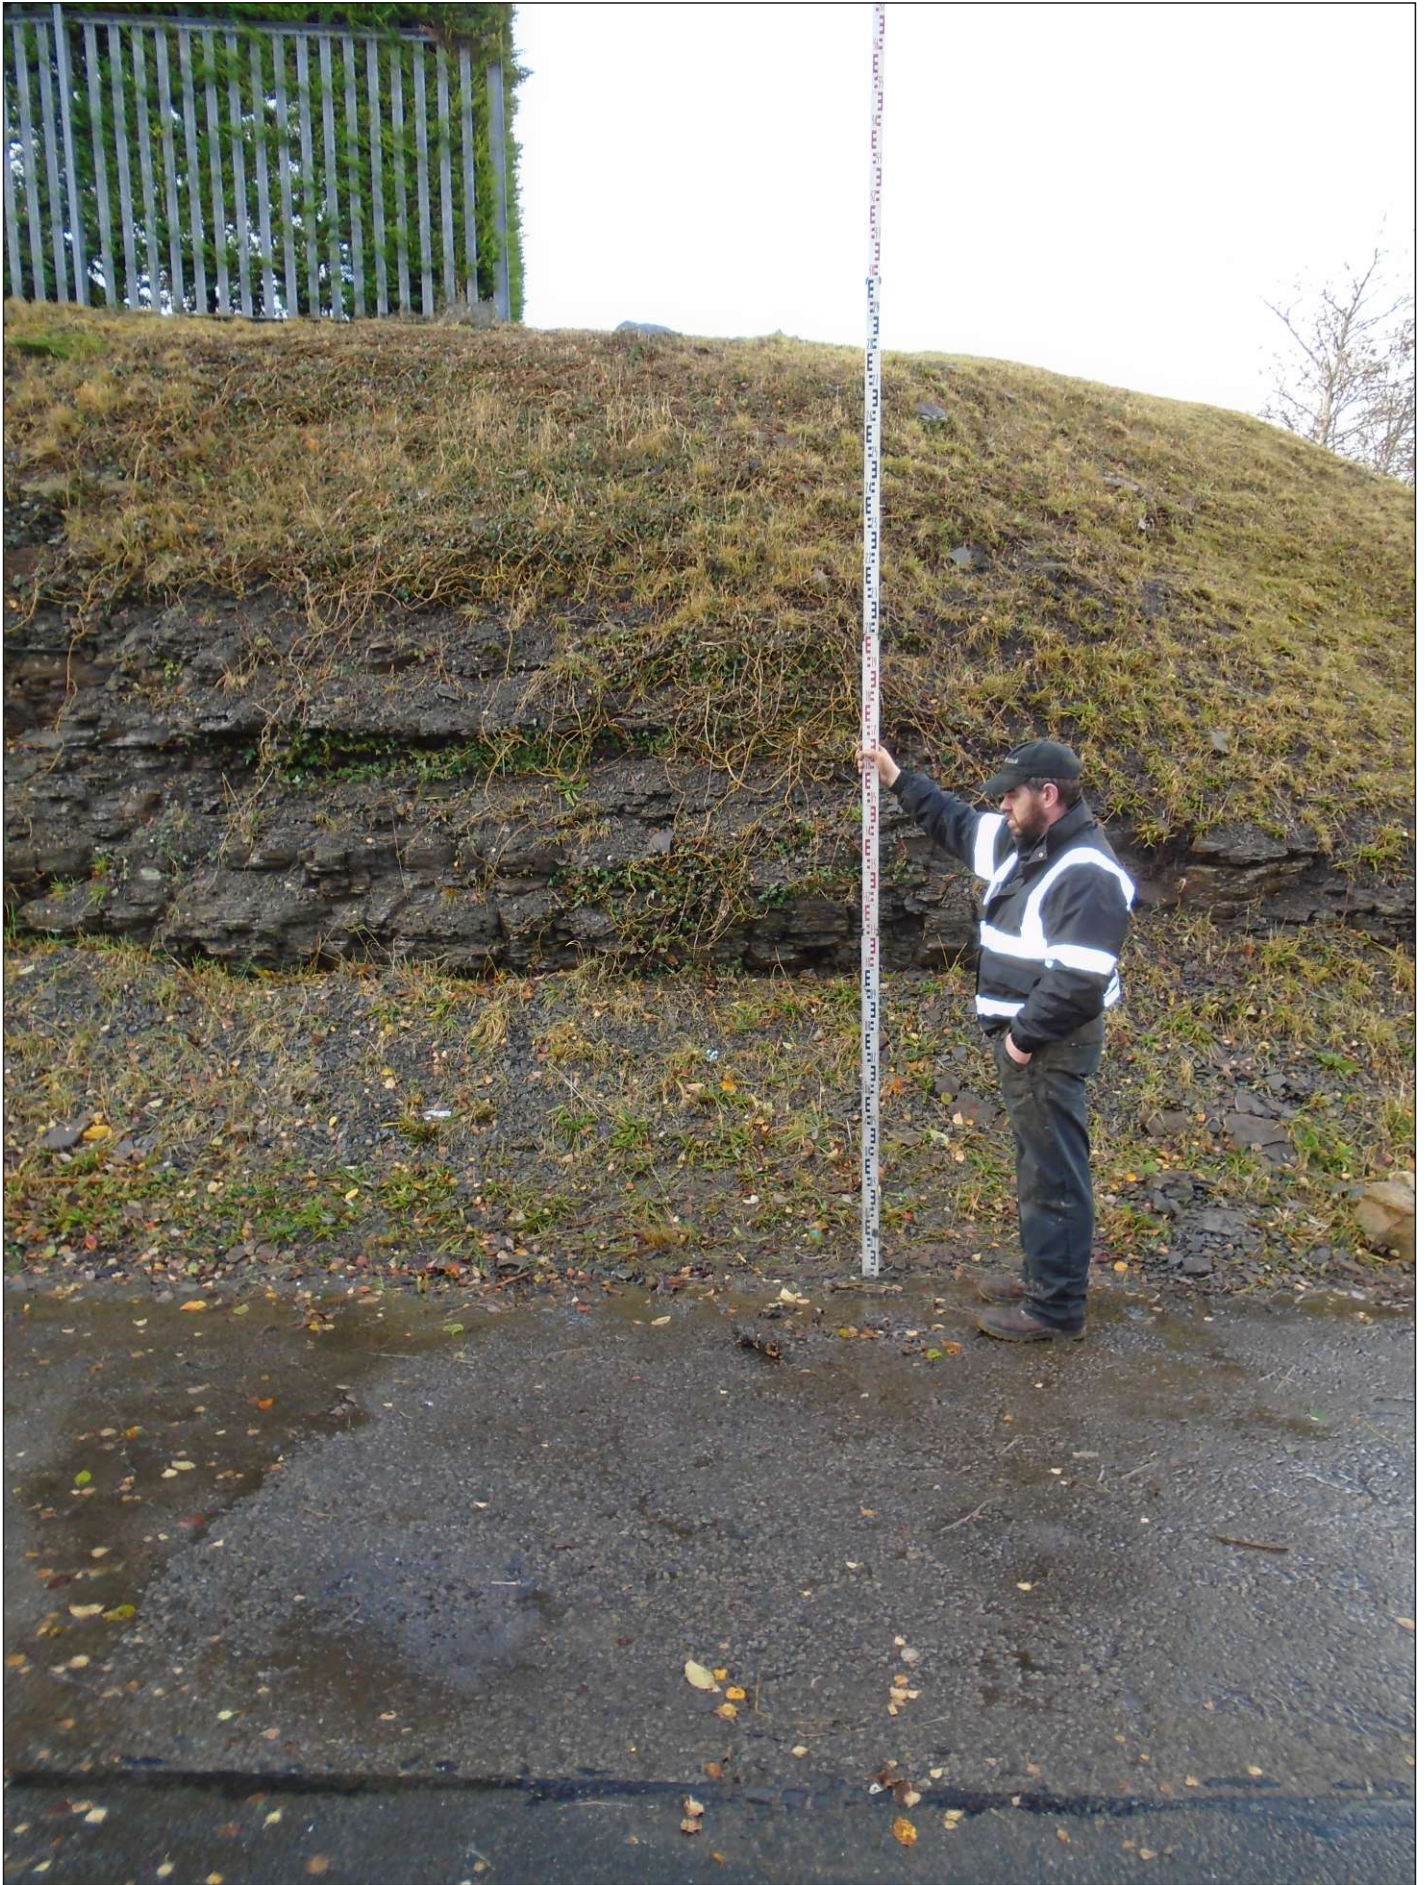
FIGURE 4  
WITH THE STAFF HELD VERTICALLY THE TOP OF THE  
EMBANKMENT AT THE CORNER OF THE PALLISADE FENCE  
WAS APPROXIMATELY 4.2m ABOVE THE YARD LEVEL

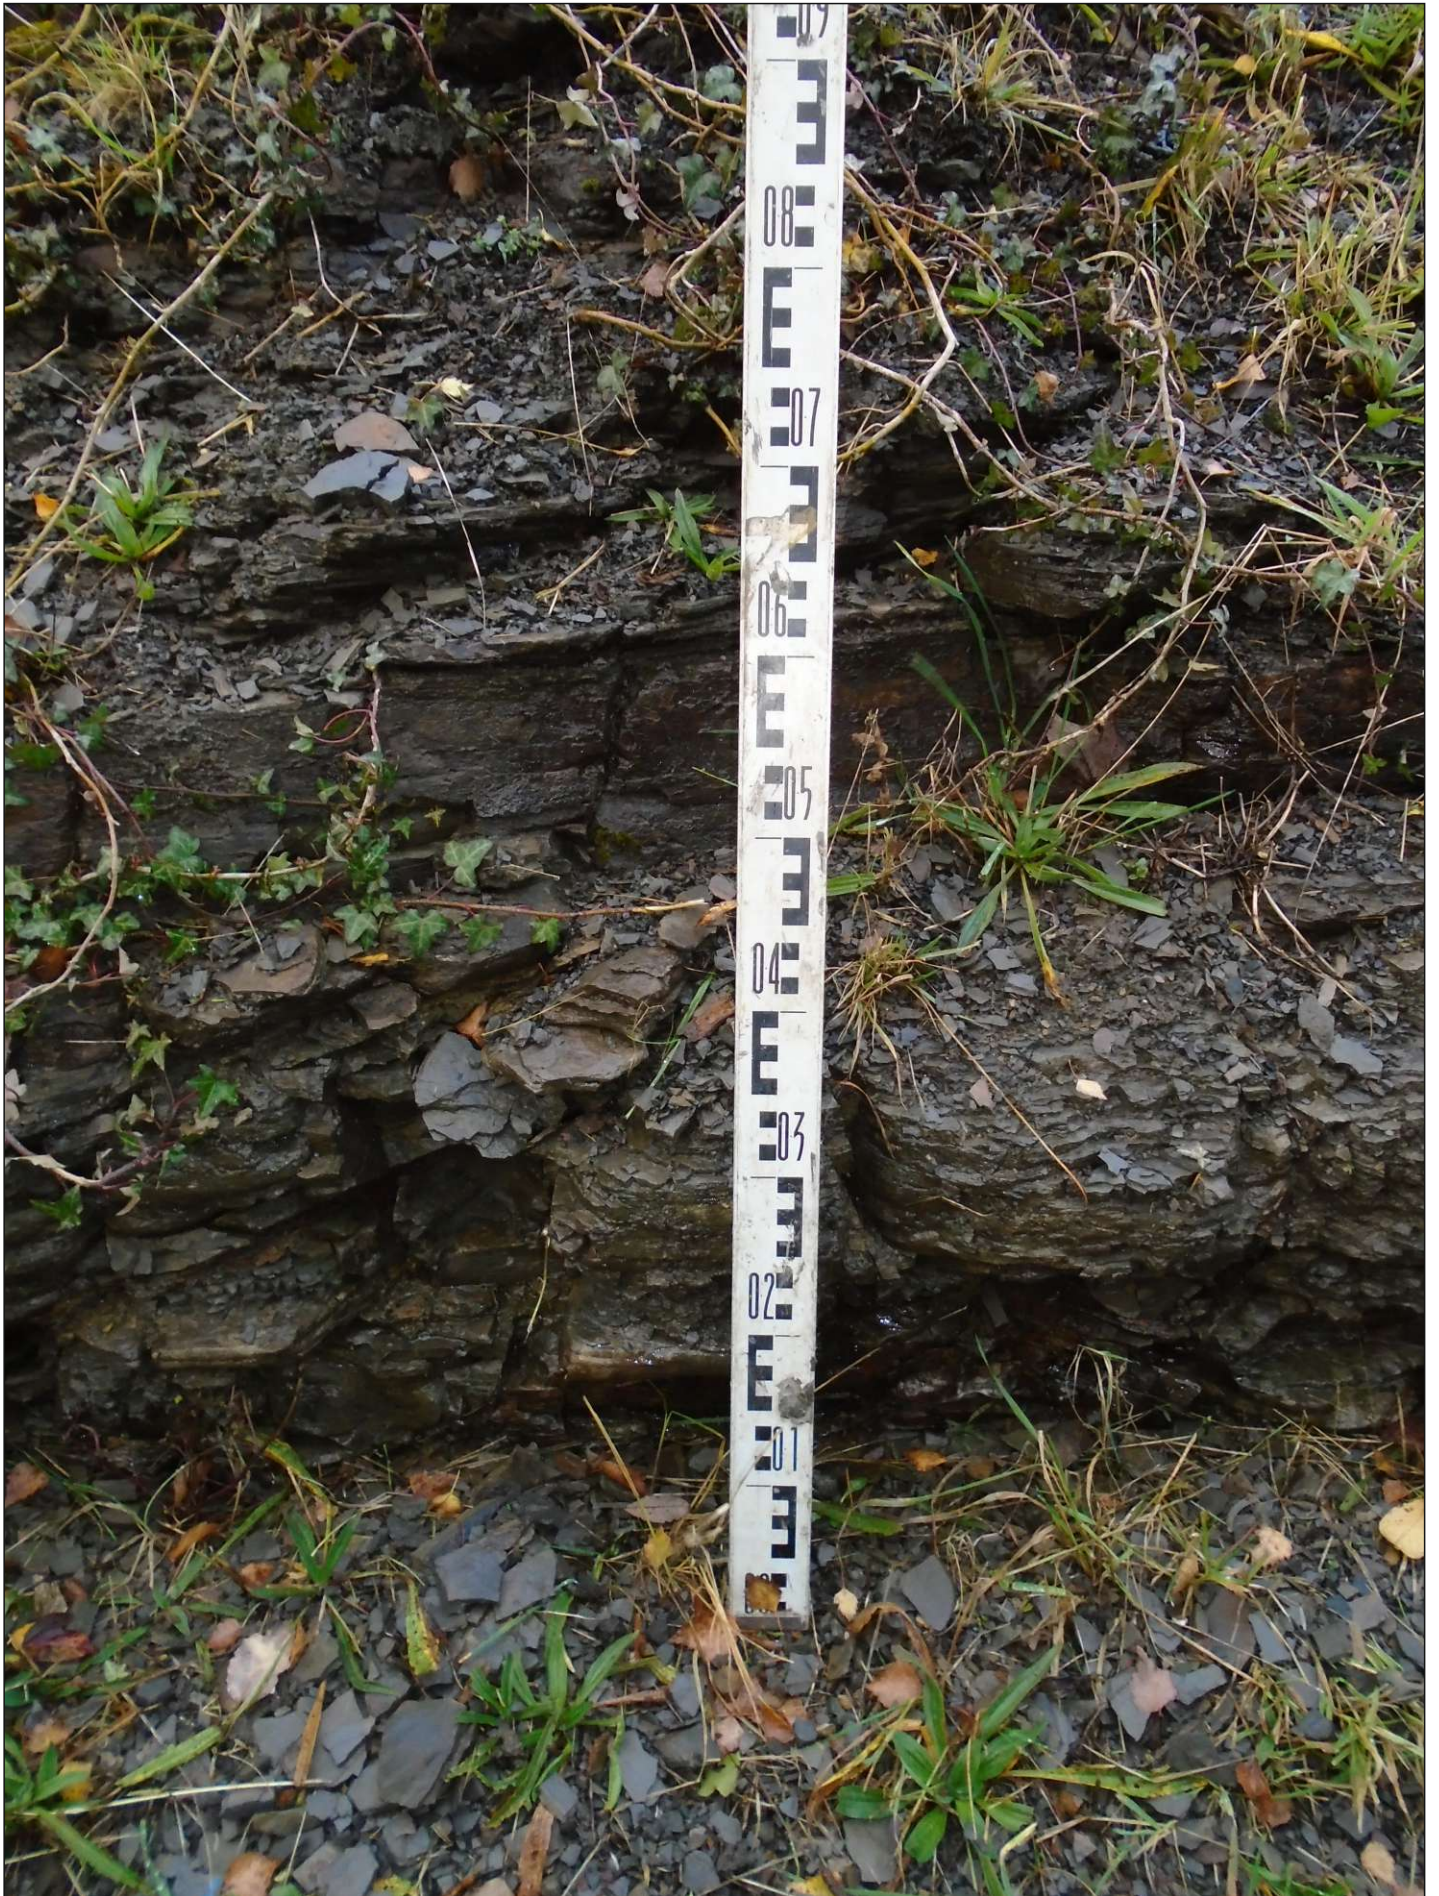
FIGURE 5  
INTERBEDDED MUDSTONE, SILTSTONE AND IRONSTONE NODULES  
EXPOSED IN THE EMBANKMENT.

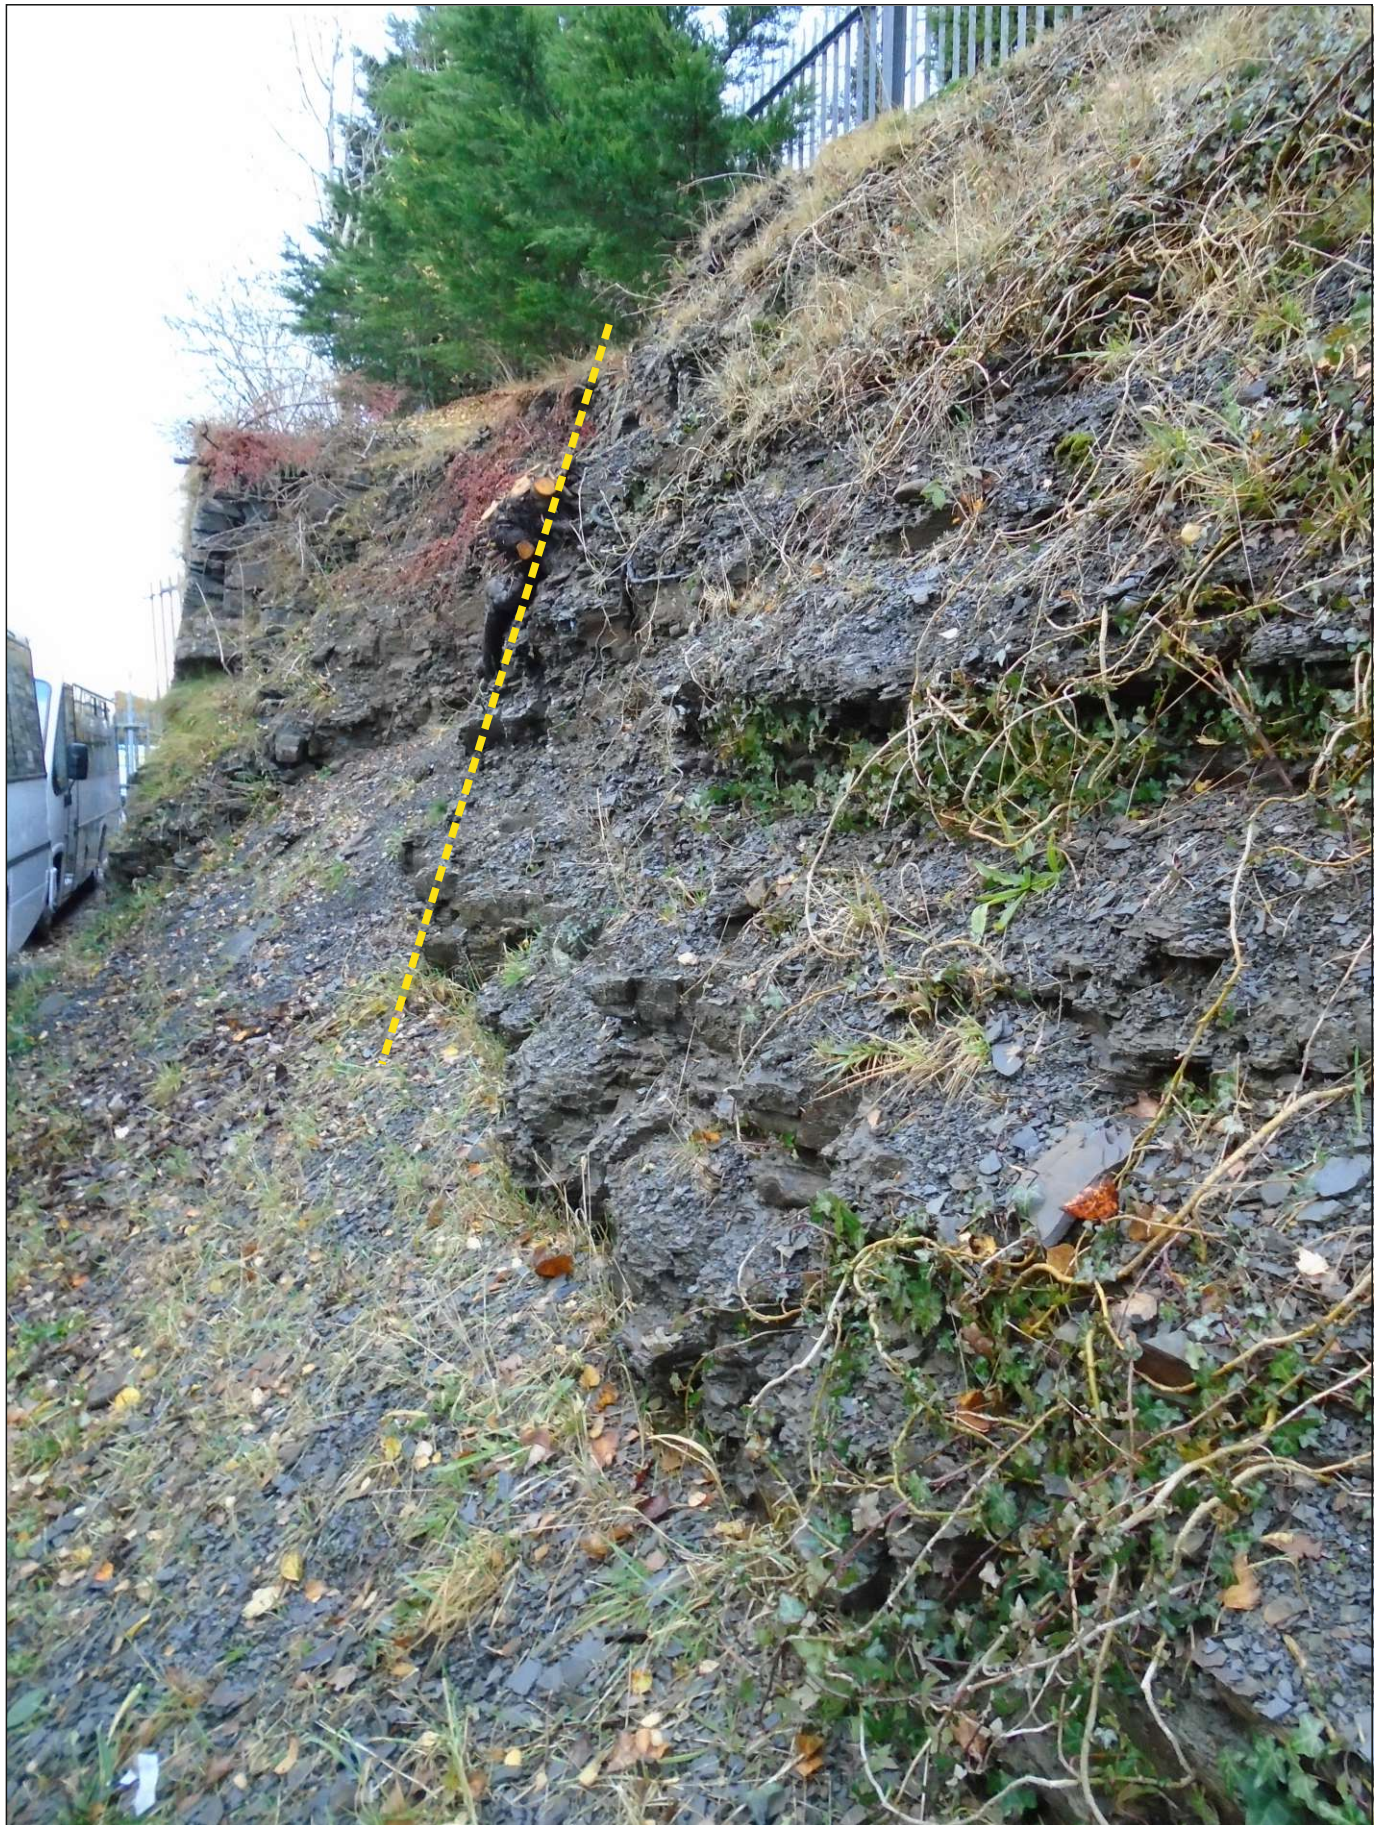
FIGURE 6  
BEDROCK PROFILE AT 70° LOOKING SOUTH FROM BENEATH  
THE CORNER OF THE PALLISADE FENCE.

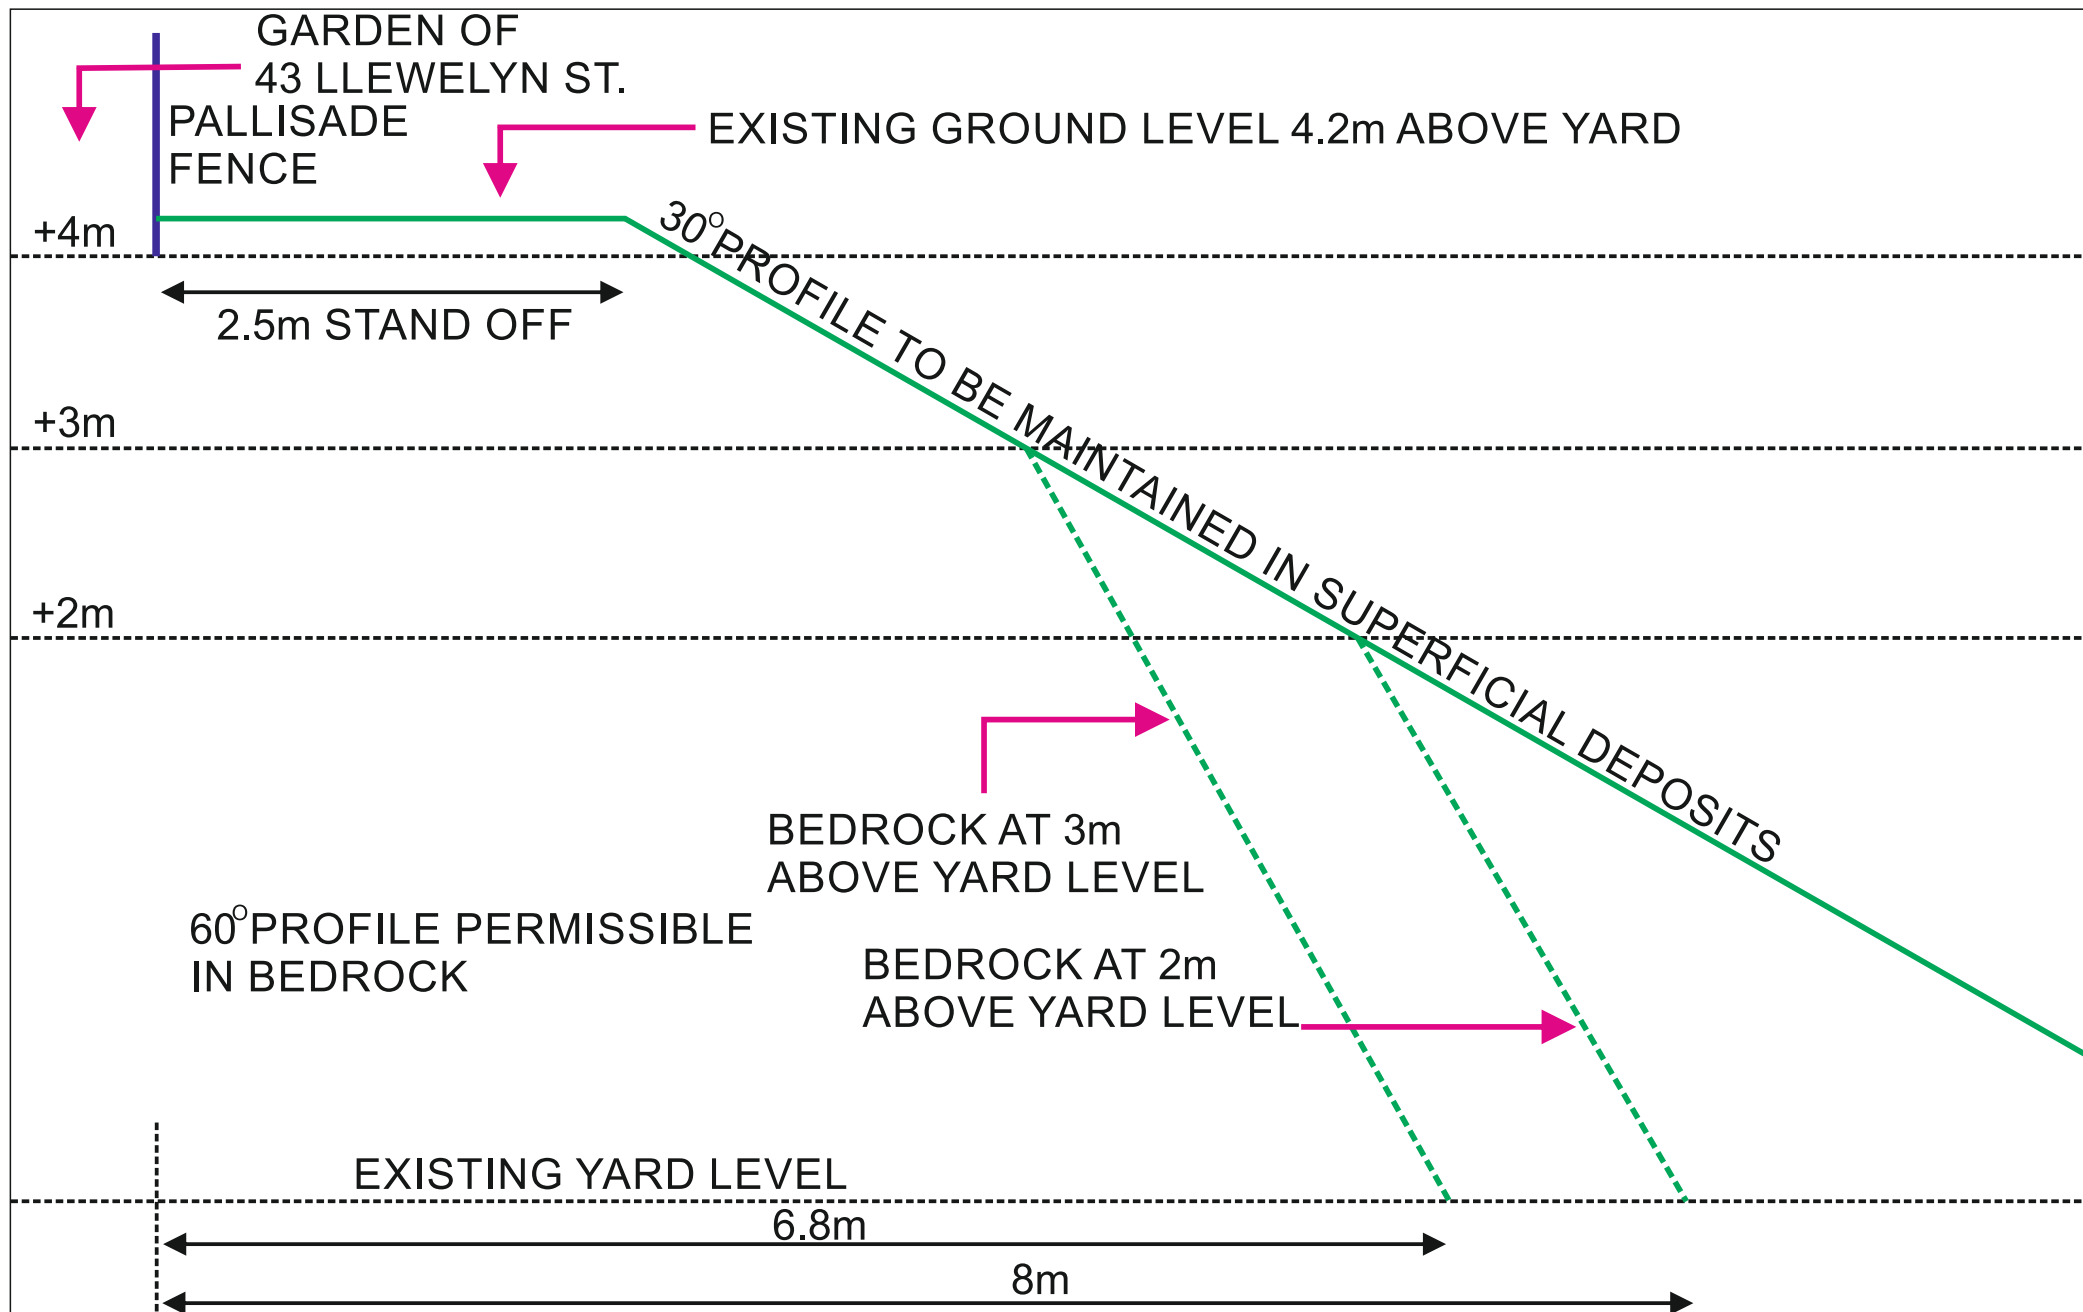
The embankment has been in its current form for 25 years and is clearly stable. The granular superficial material has an internal friction angle higher than 30° and there is no sign of slumping or shear on the northern slope. When re-profiling the embankment it is intended to keep this angle for any superficial deposits on top of the bedrock. The height of the bedrock above the yard level is unknown within the mass of the embankment. It is observed at approximately 3m above yard level close to the palisade fence but then is obscured by loose material. The bedrock is stable at a 70° profile as seen in the eastern embankment side but it may be more prudent to reduce this angle to 60° in any new cut. The bedrock position within the embankment will control the profile of any new cut as seen in the cross section in Figure 8. This in turn will affect the amount of area gained in the yard when removing the embankment. What is not a variable is the 2.5m wide stand-off zone from the palisade fence. This is a very conservative figure for ground which is underlain by bedrock at slightly over a metre depth. This must be retained whatever the final slope design is. The slope will then be contoured down at 30° through the superficial deposits. If bedrock is not encountered during this operation the 30° slope will be continued to yard level as a proven safe angle for the granular material. It is far more likely that bedrock will be encountered and two possible scenarios are shown in Figure 8 with bedrock at different depths. The bedrock can then be cut down at a 60° angle which is perfectly acceptable for a cut between 2m-3m high. The variable effect bedrock depth will have on the amount of additional yard space created is shown in Figure 9 in plan view.

FIGURE 8  
PROPOSED CUT PROFILES AT MERTHYR MOTOR AUCTIONS DEPENDENT  
ON BEDROCK LEVEL ENCOUNTERED DURING EXCAVATION

Removing part of the embankment as detailed above will present no threat to the ground stability of the garden of 43 Llewelyn Street south of the embankment. This is providing the stand-off zone and slope angles are kept to the specifications in Figure 8. The embankment is already sloping gently to street level on its western margin so there will be no change on that side. Likewise, there will be no alteration to the eastern boundary other than the actual embankment removal. This cannot affect the lower ground of the yard. There is no other ground or structure that will be affected by the proposed earthworks. The final fine tuning of the design will need to be decided on site during excavation works. This will need to be done by a qualified geotechnical engineer with reference to the level and competency of the bedrock exposed during initial

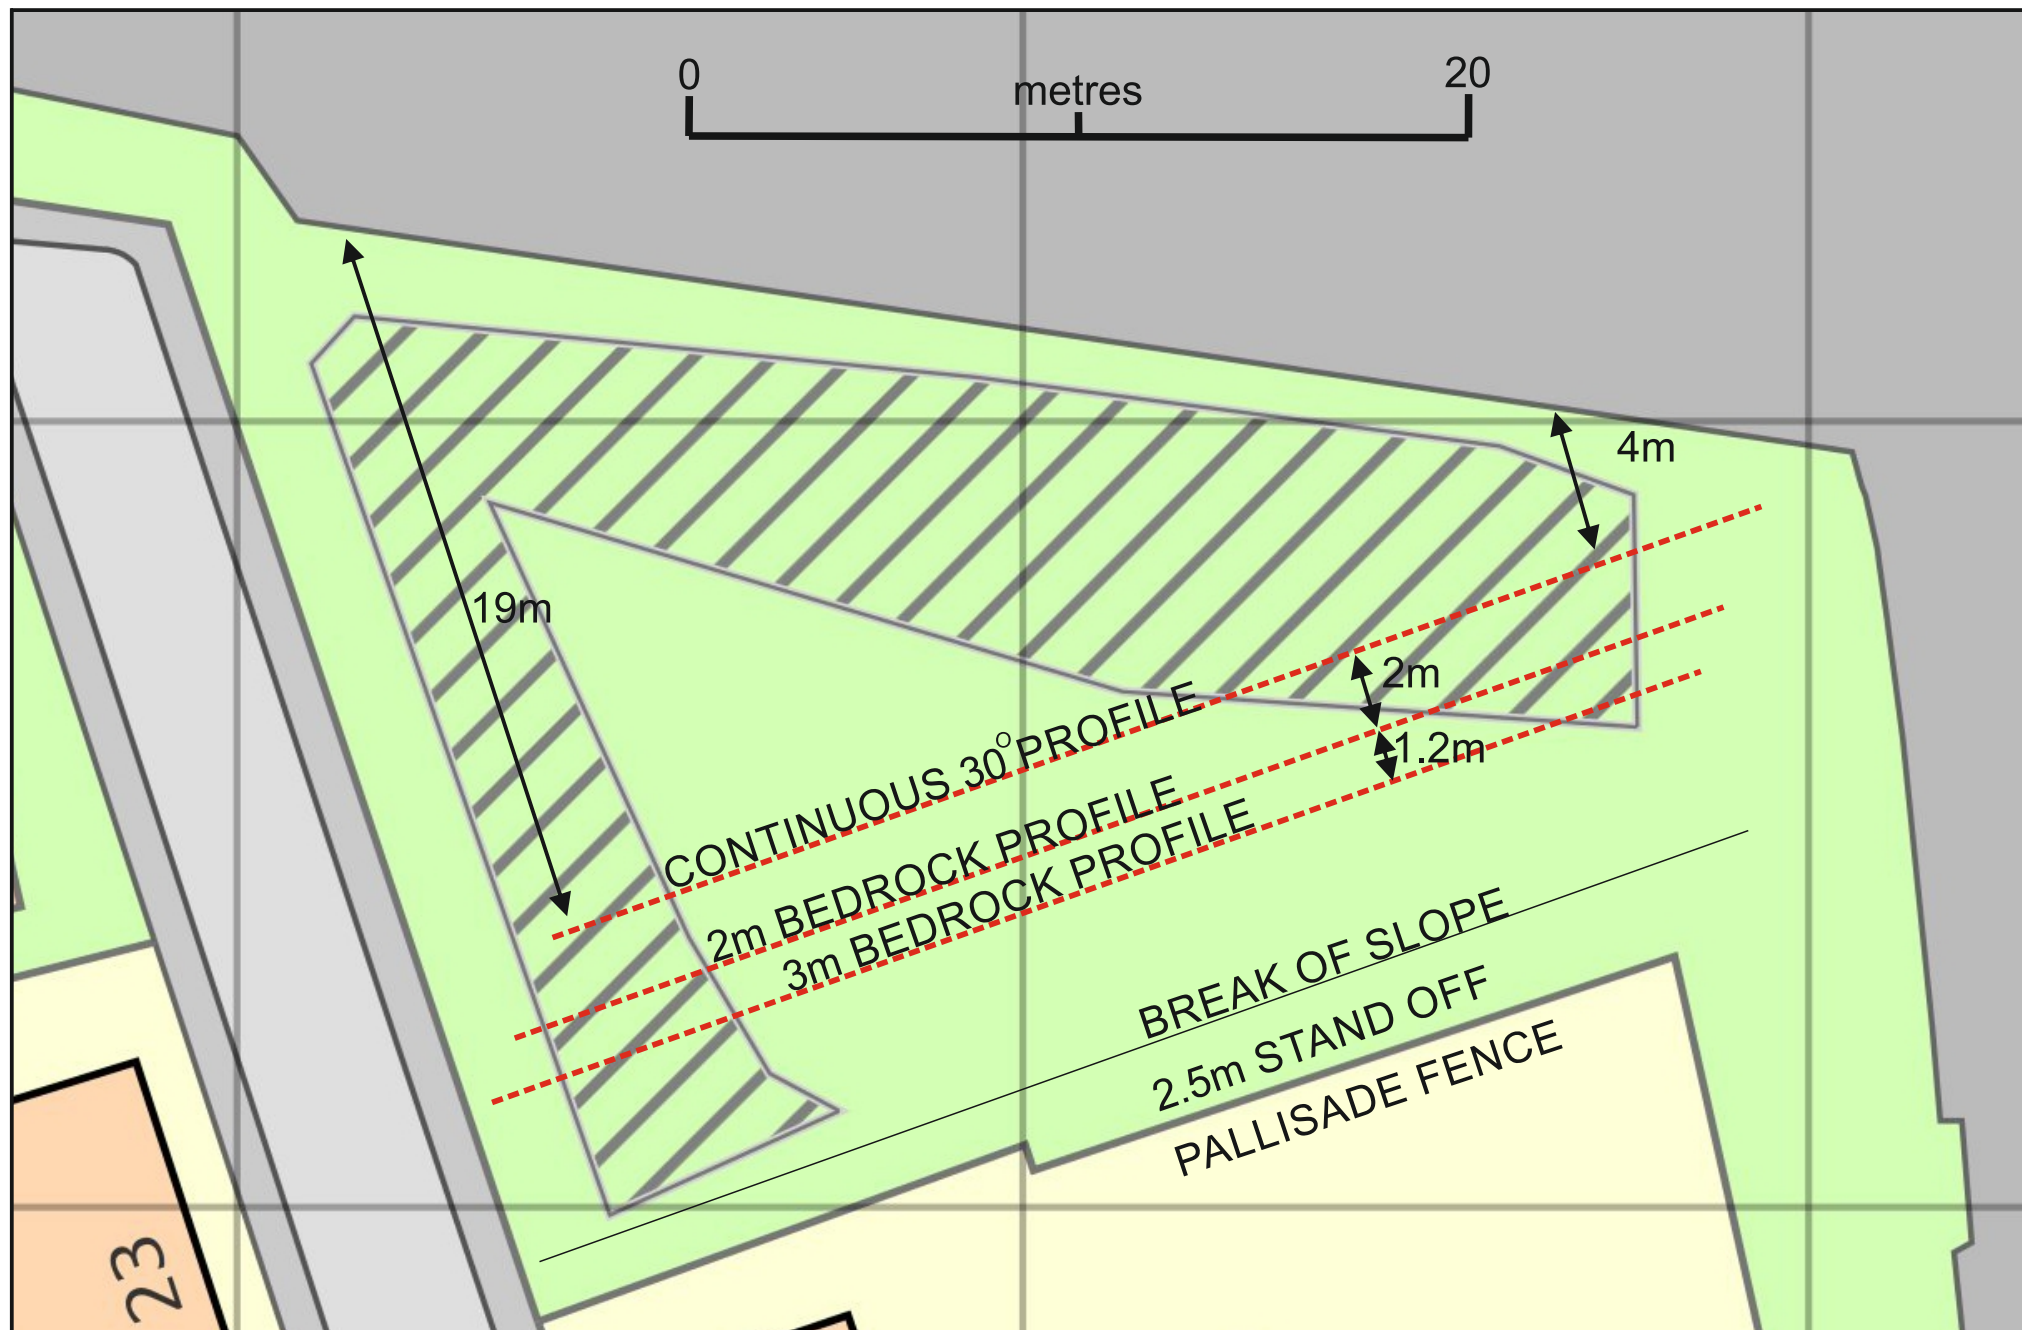
FIGURE 9  
PLAN VIEW OF THE AREA CLEARED WITH THE THREE ALTERNATIVE SLOPE PROFILES
