**A HERITAGE IMPACT ASSESSMENT**  
*in support of a*  
**RETROSPECTIVE LISTED BUILDING APPLICATION**  
*for*  
**EMERGENCY WORKS**

**at**  
**THE YMCA, MERTHYR TYDFIL**

Pontmorlais West,  
Merthyr Tydfil  
CF47 8UU

**Merthyr Tydfil County Borough Council**

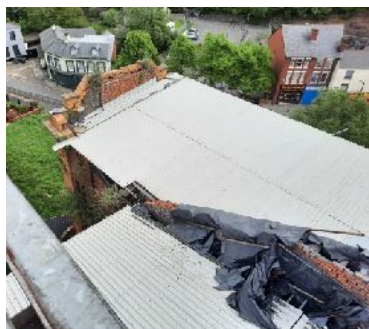
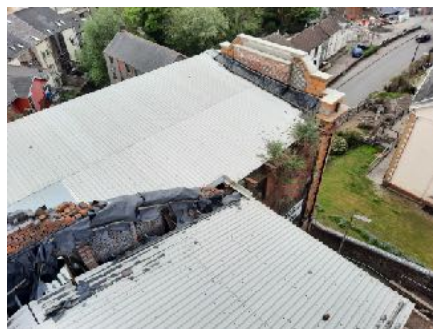
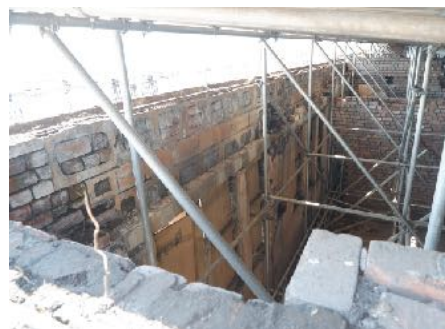
*Above right and middle: Various views of the original temporary roof, prior to commencing the current emergency works. Abutment flashings had failed generally, high-level masonry collapsing and vegetation thriving.*

*Above right: The 2015 temporary roof structure, built-up upon the original concrete floor slab generally..*

1. **TEMPORARY ROOF:** The existing temporary roof was well beyond its designed lifespan:
  - Flashings to surrounding abutments were failing, water increasingly penetrating the surrounding fabric and interior beneath.
  - It was supported on an internal scaffold structure, primarily propped off the existing floor slab beneath. Water penetration has caused this floors condition to deteriorate significantly, the existing scaffold support system preventing its repair. Its consequently been replaced with a more robust design, over-sailing the walls beneath to provide greater protection. The new roof is supported via timber joists bearing on:

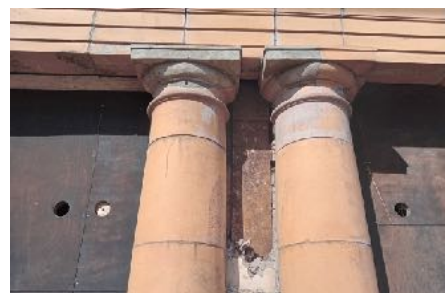
*Above: The internal face of the steelwork beams and columns forming the ground floor colonnade. Terracotta components encase both, the voids between infilled with ash-mortar.*

*Above right: The exterior of a typical beam and column junction. Note the:*

- *Failed or splitting terracotta generally. Though clearly intended to be freestanding, settlement of the building has resulted in the terracotta now being under compression (from the loads above). A cement-rich mortar has previously been used to repair the damage caused.*
- *Render finish between exterior terracotta columns, applied directly to the steelwork.*

*Little resistance has historically been provided to water penetration, with the consequent substantial corrosion of the primary load-bearing steel frame within, particularly to the connections.*

4. FRONT BUILDING (GROUND FLOOR ~ SOUTH): This entire facade is primarily supported by steel columns within the ground floor colonnade. Corrosion of the steelwork, particularly the baseplate and beam junctions, has substantially reduced their structural capacity. 2 options to address this defect were considered:

1. Replacement of the columns complete. This required larger columns (to meet modern structural standards) and damage to the terracotta cladding to the beams (to provide temporary 'needling' support).

2. Supplementing the existing columns with new adjacent steelwork. This option could be completed without any invasive temporary support.
- Both options required the removal of the existing terracotta columns. Though these were originally intended as purely decorative external cladding to the structure behind, settlement over the years has resulted in these increasingly becoming load-bearing. This probably explained the majority of damage evident within. To minimise loss of historic fabric, option 2 was completed.

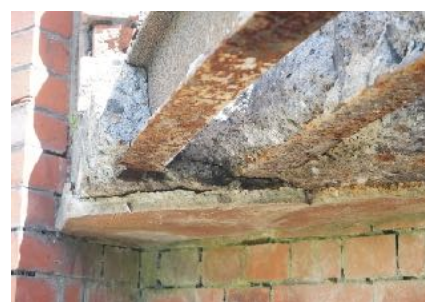
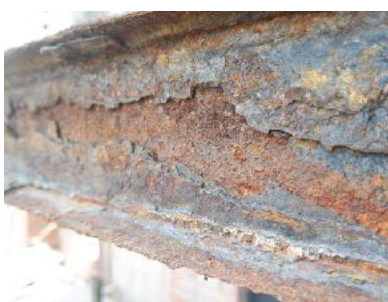
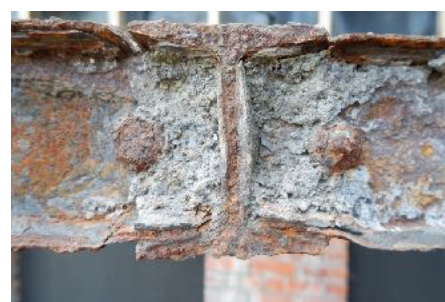
*Above: The steel structure supporting the east and west oriel windows were originally encased in concrete (above left), with a render coating. Subsequent water penetration has caused substantial corrosion of this steelwork, its structural capacity significantly weakened (above middle and right).*

5. MIDDLE BUILDING (ORIEL WINDOWS): The curved steel beams supporting the external face of these projecting windows was poorly detailed and maintained from the outset: original concrete infill had subsequently been lost, the ends built into surrounding external solid-masonry walls corroding. The roof over both projecting bays had been missing for decades. The brickwork mullions between the many tall window openings were also extremely slim and in very poor condition; the windows had previously been removed, temporary strengthening applied to the mullions in 2015. Continuing water penetration had caused increasing deterioration/deflection of the cantilevered steel and concrete floor supporting the projecting bays and external walls, the external face of both oriels becoming unstable as a result. To address this dangerous situation:

1. All beams, floors and walls within both oriels were removed. The beams were stored within the building (to provide templates for future replacement).
2. The beams ends were left within the wall (their removal requiring significant damage to the existing historic fabric), adjacent brickwork being made-good.
3. The resulting large gaps within the east and west facades were infilled with new timber-frame panels, supported on new steelwork beams. This new structure also provided required restraint to the otherwise free-standing Middle Building north elevation.
4. A new suspended floor was added internally, this structure also tying the surrounding walls together.

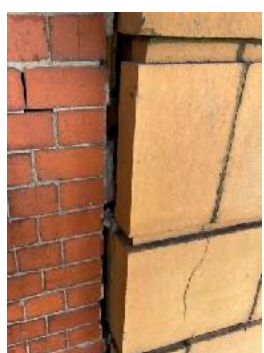
*Left: The Front Building's south-west corner, with typical 'long and short' terracotta quoins. These quoins are just a veneer generally, applied over the load-bearing brickwork behind (with no ties between each); only the 'short' are built into the brickwork. A fundamental weakness was thereby created from the outset, with a lack of structural continuity between adjacent elevations. Note:*

- *The tapering gap between the brickwork side elevation and terracotta quoin, caused by the front and side elevations 'peeling apart' from each other.*
- *Cracks within the terracotta facing, this enabling water penetration to the voids behind.*
- *Repointing previously carried out using a sand:cement mortar.*

1. **FRONT BUILDING (STRUCTURE):** The corner junction between each facade was poorly constructed from the outset ~ due to a lack of integration between the terracotta quoins and adjacent brickwork, individual elevations were 'peeling-apart' generally. Joints within had opened-up, water penetration (and the freeze/thaw cycle) causing further progressive deterioration. To address this and thereby ensure the buildings structural stability, various reinforcing rods/anchors were inserted to tie the corners together. Also:

- Anchors were terminated externally with bolts bearing on stainless steel patress plates, strategically located to respect the pattern of the existing terracotta. In conjunction with new terracotta cladding, these plates can be recessed behind the terracotta at a later date, should the desire be to hide the current 'honest-repair'.

- Gaps in the masonry were infilled, then repointed.
2. **FRONT BUILDING (CORNICE):** Water penetration within the high-level masonry above the main projecting cornice has resulted in the complete loss of structural integrity within this masonry generally. This failure of the wall above has enabled the substantial cantilevered components forming the projecting cornice to 'rotate/droop';

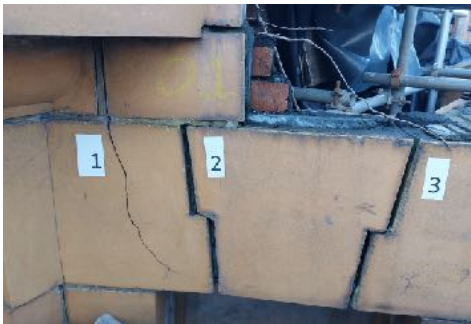
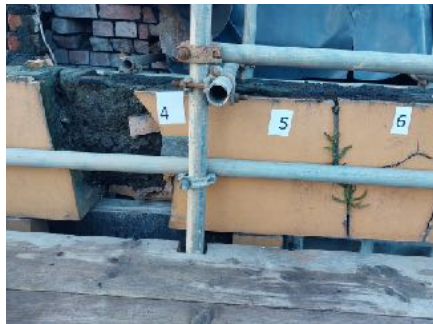
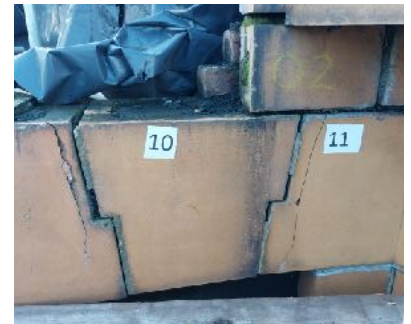
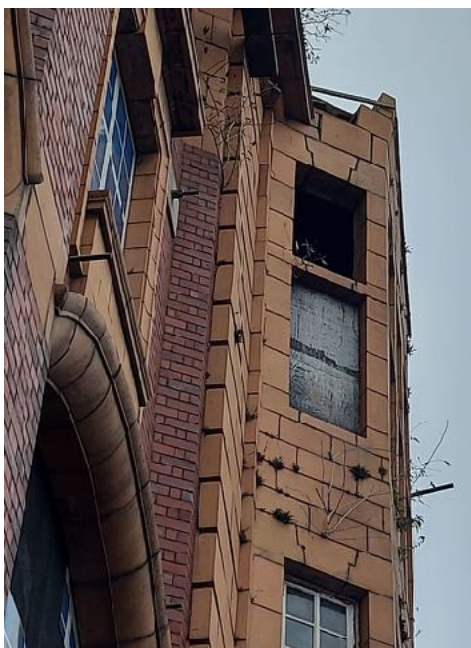
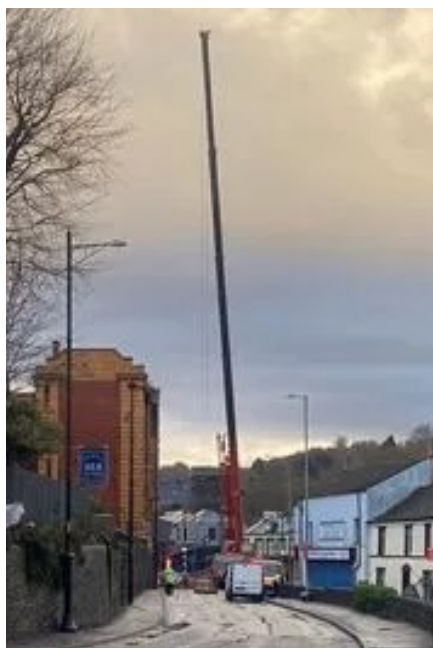
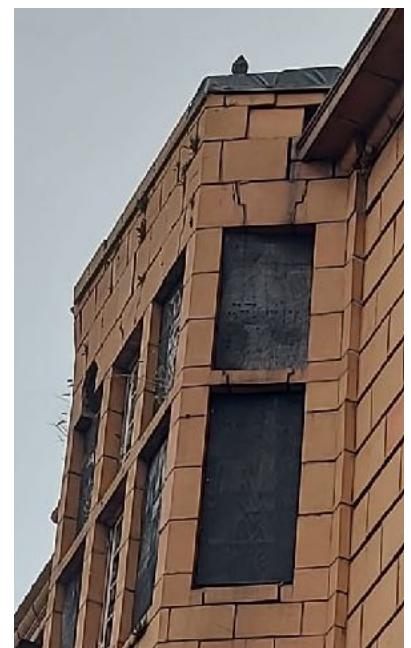
*The contractors appointment enabled detailed inspection of the high-level masonry, via a crane and basket. This revealed the parlous condition of the south oriel window: individual terracotta components separating and/or de-laminating, all at risk of imminent collapse. The adjacent main road was immediately closed and emergency demolition of this dangerous structure carefully progressed.*

*Below: The terracotta cladding is fundamentally a decorative veneer of hollow blocks, the void within filled with black-ash mortar. This cladding is not tied to the brickwork behind. Water penetration and poor maintenance has resulted in vegetation growing within the voids, this:*

- *Forcing the cladding apart, both between adjacent components and from the brickwork behind.*
- *Causing cracks within and de-lamination of the facing of individual terracotta units.*

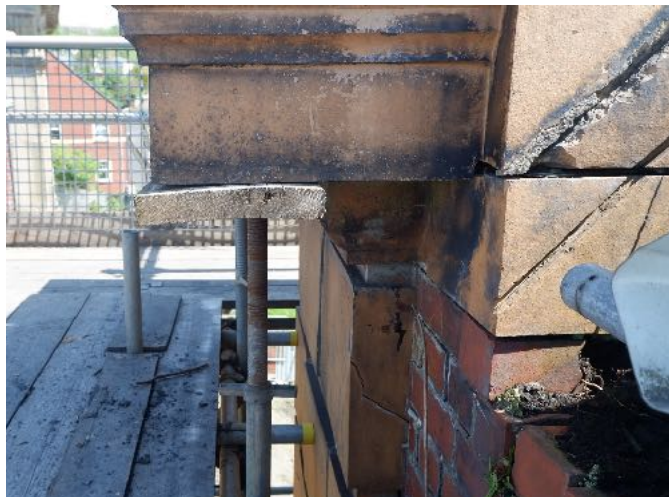
*Below: The extent of masonry above the terracotta cornice to the Front Building north (rear) elevation was far less than to the south; no additional metal restraint was also provided. These units had consequently 'overturned' far more than the front. They were also in far worse condition (presumably as a result of the failing temporary roof), with many cracks within individual blocks. The consequent water penetration has caused the mortar infill to wash-out, resulting in a lack of structural continuity between adjacent units.*

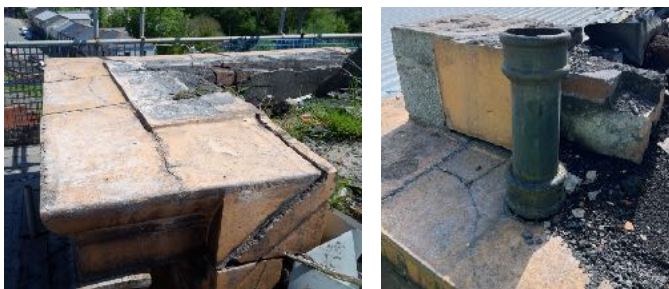
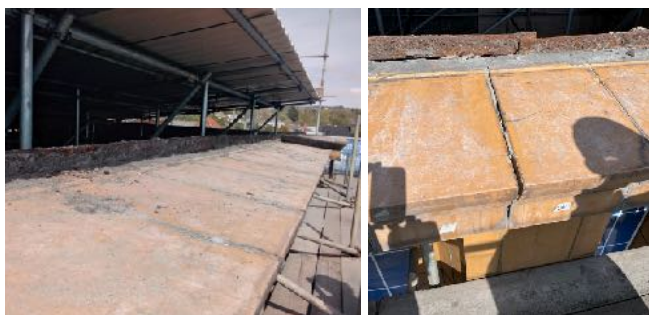
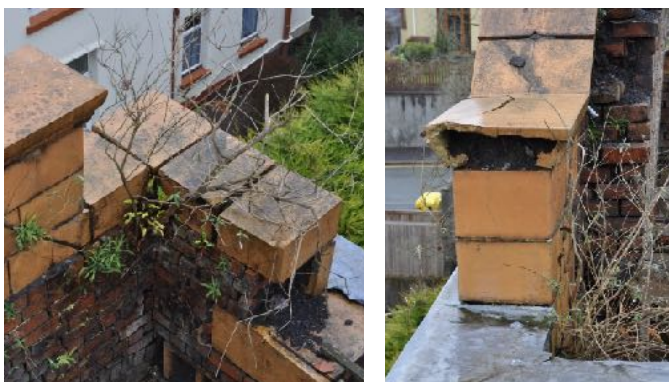
*Below: The terracotta projecting cornice to the Front Building south (front) elevation was originally prevented from overturning by:*

*Water penetration had resulted in:*

- *The integrity of the masonry over being lost;*
- *The corrosion of all metalwork, the rods mostly rusted through; And*
- *Failure of the pointing between individual units.*

*As a result, the large cantilevered projecting cornice units were all 'overturning', and at risk of falling.*

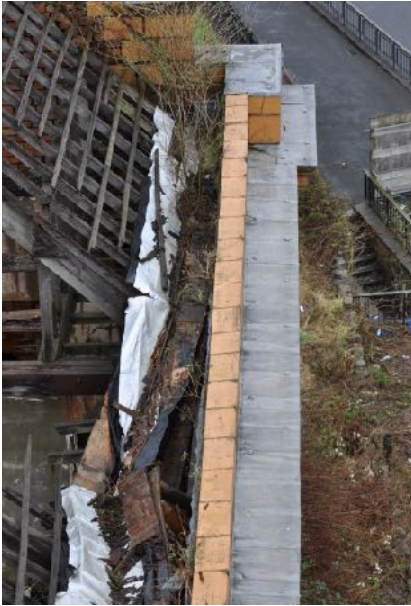
*Left: Images of the rear projecting cornice, prior to commencing the emergency works completed in 2015. These illustrate the same problems currently visible within the buildings fabric generally, particularly within the high-level masonry. The fabric's condition has increasingly deteriorated for at least 35 years (since the building became roofless following a fire), and resulting in the current unavoidable demolition.*

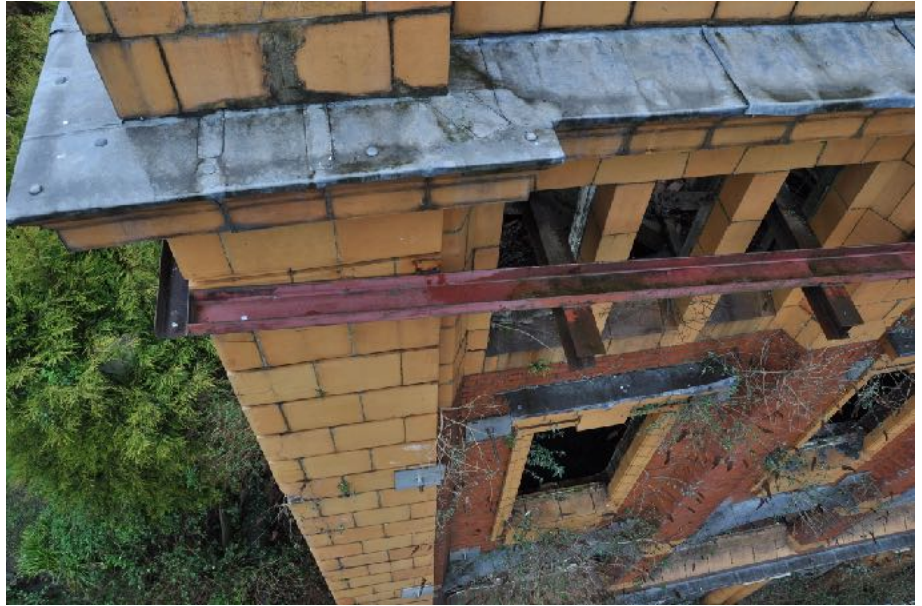
Above: Images of the Front Building south (front) elevation, prior to commencing the emergency works completed in 2015. Alterations within the current emergency works include:

- Removing the modern steel bracing, introduced following the 1990's fire. This was providing no structural support to the building, though was eroding the decorative terracotta facade.
- Introducing temporary weather-protection to the decorative projecting terracotta mouldings generally, in the same location as the original lead weatherings/flashings (removed during the previous emergency works).

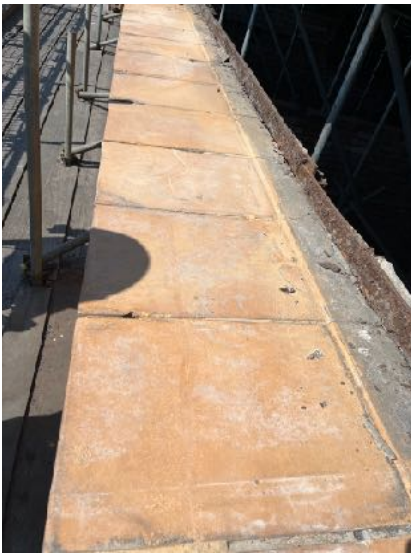
Left: Terracotta repairs within the high-level projecting cornice. Note also the original metal strap that tied-down the inner edge of this cornice, along the front elevation. This strap, together with the rods that anchored it to the masonry below, were all highly corroded and with all structural integrity lost.

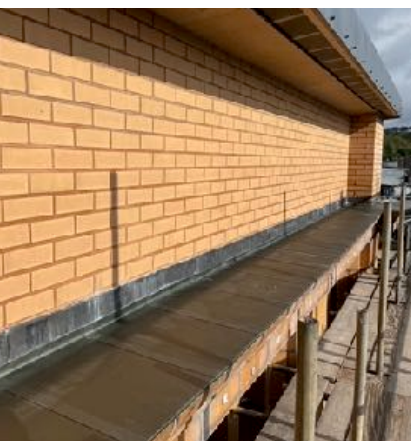
Left: The temporary weathering applied to the high-level projecting cornice; large sheets butted together, narrow strips applied over to cover the joint beneath.

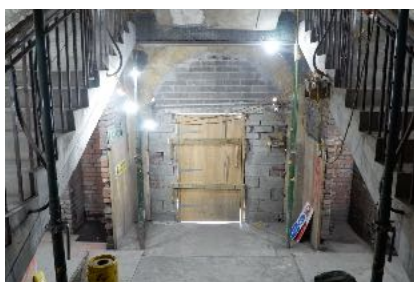
*Left: The concrete repairs completed to the the exposed edge of the main central staircase were finished slightly proud of the existing surface.*

2. Concrete Edge Repair: Removal of concrete where in poor condition, cleaning of the reinforcement within, and replacement with new concrete.

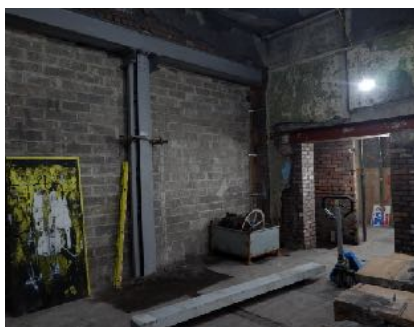
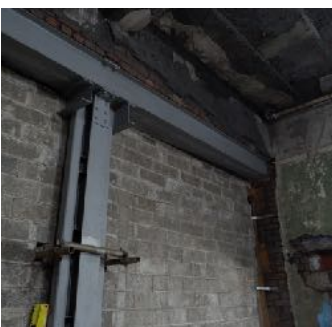
*Below left and below: The ground floor steelwork supporting the Front Building, eastern colonnade:*

- *Existing steel columns and beams have been blasted clean and repainted, gaps between the beams grouted with concrete.*
- *New steel columns (with spreader channels to the top of each) added to each side of the retained existing columns.*

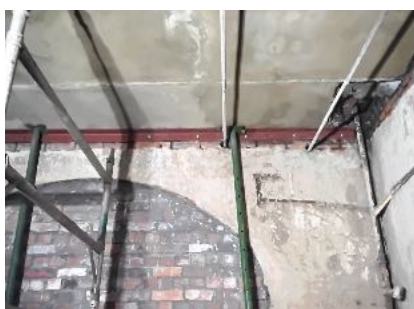
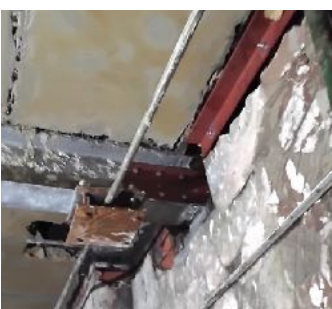
*Left: The load-bearing capacity of various existing steel beams has been compromised (by corrosion and consequent loss of section). Additional steelwork has been added to compliment (rather than replace) the existing.*

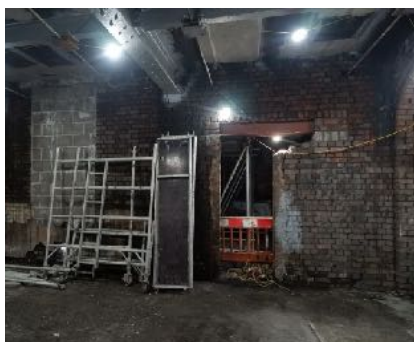
*Left: Various internal repairs and alterations:*

- *Existing steelwork blasted clean and repainted.*
- *Existing concrete floors have been 'patch repaired'.*
- *External openings infilled (using salvaged brick generally).*
- *New steel lintels used over new openings within existing internal walls.*

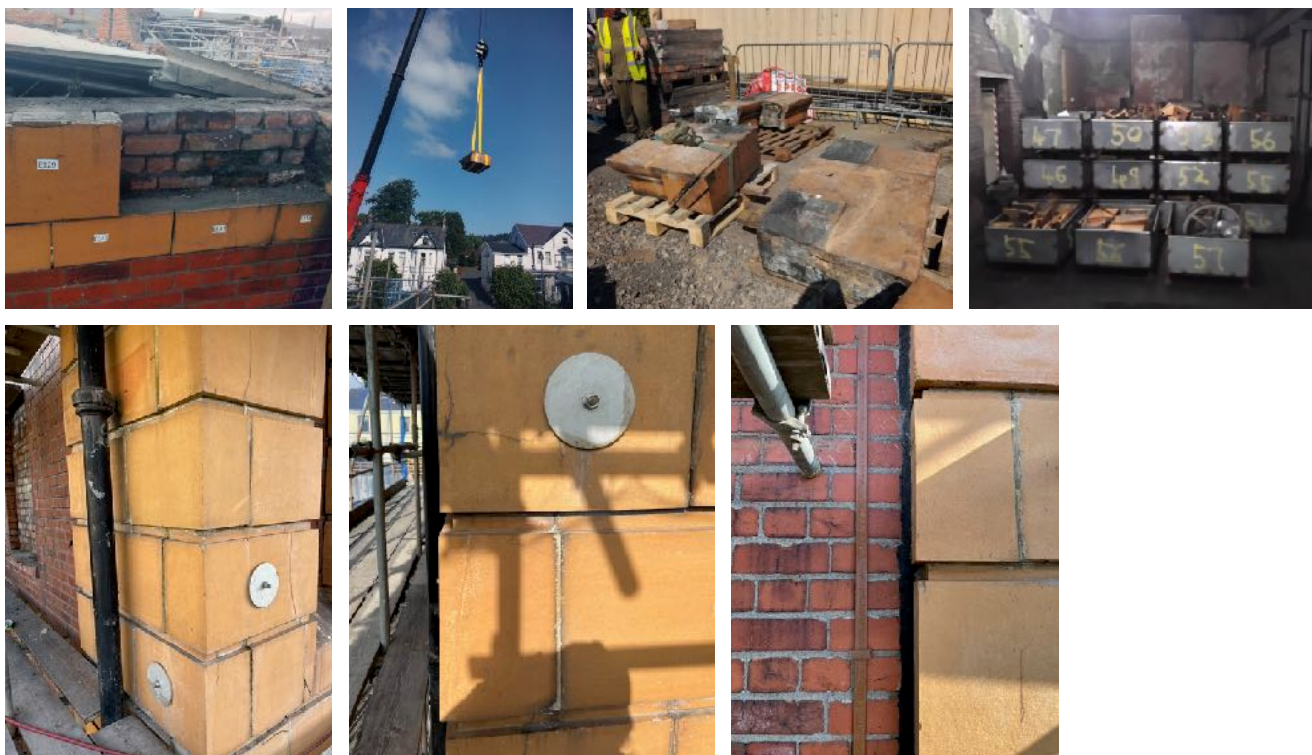
*Below: Prior to their removal, individual terracotta components were individually labelled and their position recorded. They were then removed and stored within the building, in a combination of palettes and stillage bins (depending upon their individual weight). All can therefore be repositioned in their original position, during future reconstruction.*
