# FAR Structures Ltd

*Our Ref: 25004/AR/01*

22<sup>nd</sup> January 2025

**Ref: Structural Inspection of Boundary Retaining Wall at Queens Road, Twynyrodyn, Merthyr Tydfil, CF47 0HE**

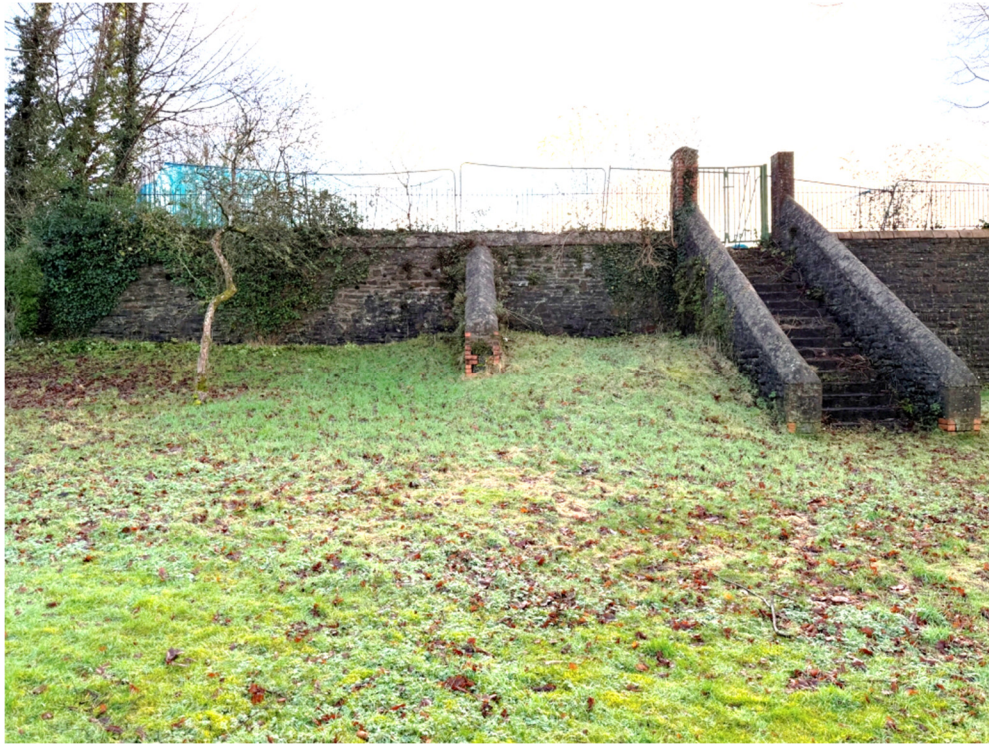
The stone retaining wall is split into two lengths by a wide set of stone steps with side buttress walls. An addition stone buttress wall is located to the left of the access steps. Please refer to Photographs 1 and 2 in Appendix A.

Photograph 1: View of random stone boundary retaining wall to left of access steps.

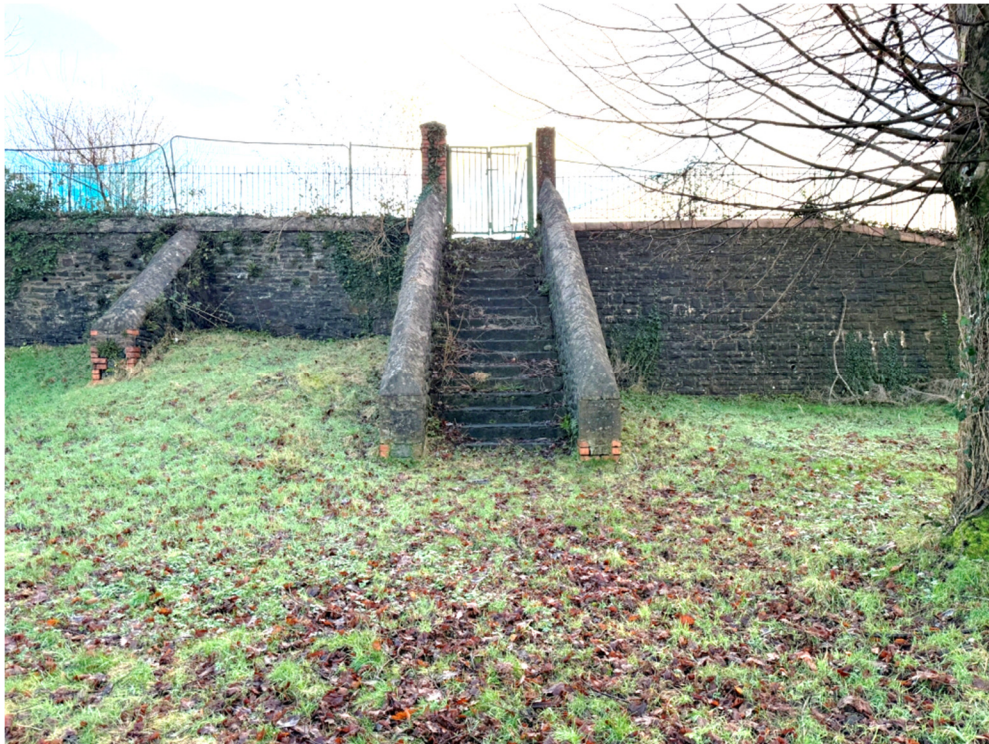
With reference to Photograph 2, ground levels are higher at the right hand side of the access steps when compared to the left hand side lower ground levels. It is not known whether ground levels have been previously raised to aid the stability of the right and length of retaining wall.

Photograph 2: View of access steps and stone buttress adjacent retaining wall.

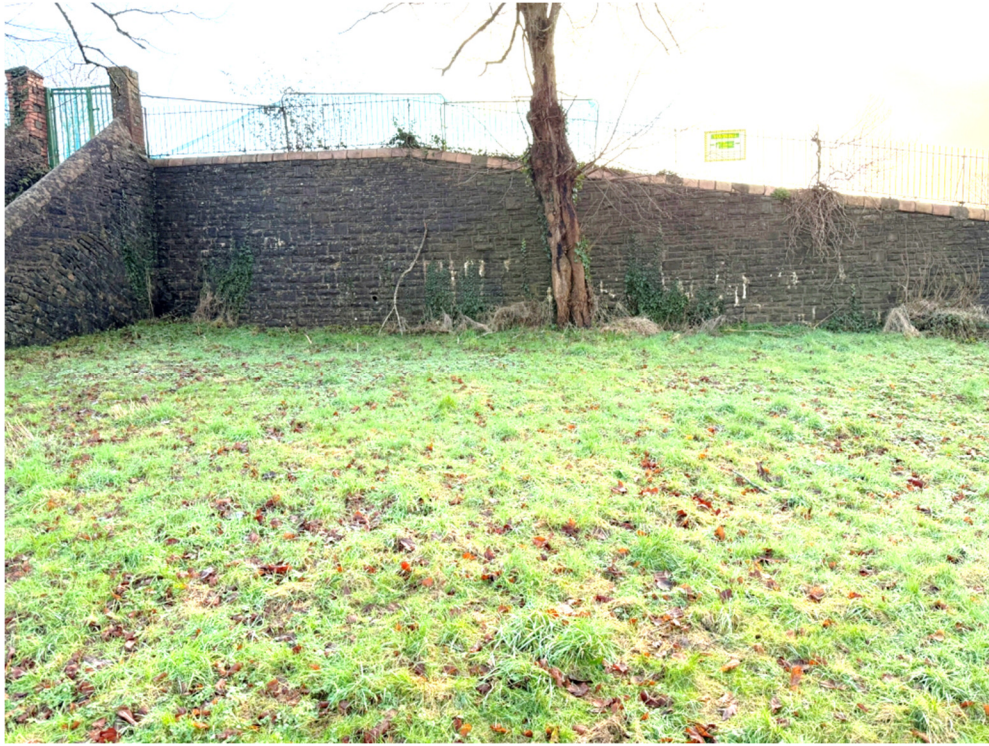
The stone retaining wall at the right hand side of the access steps continues in a straight line to the corner of the site. Please refer to Photographs 3 and 4 in Appendix A. A large tree exists to the right of the access steps and can be seen in Photograph 3. The retained height reduces as the retaining wall travels to the corner of the proposed development site.

Photograph 3: View of random stone boundary retaining wall to right of access steps

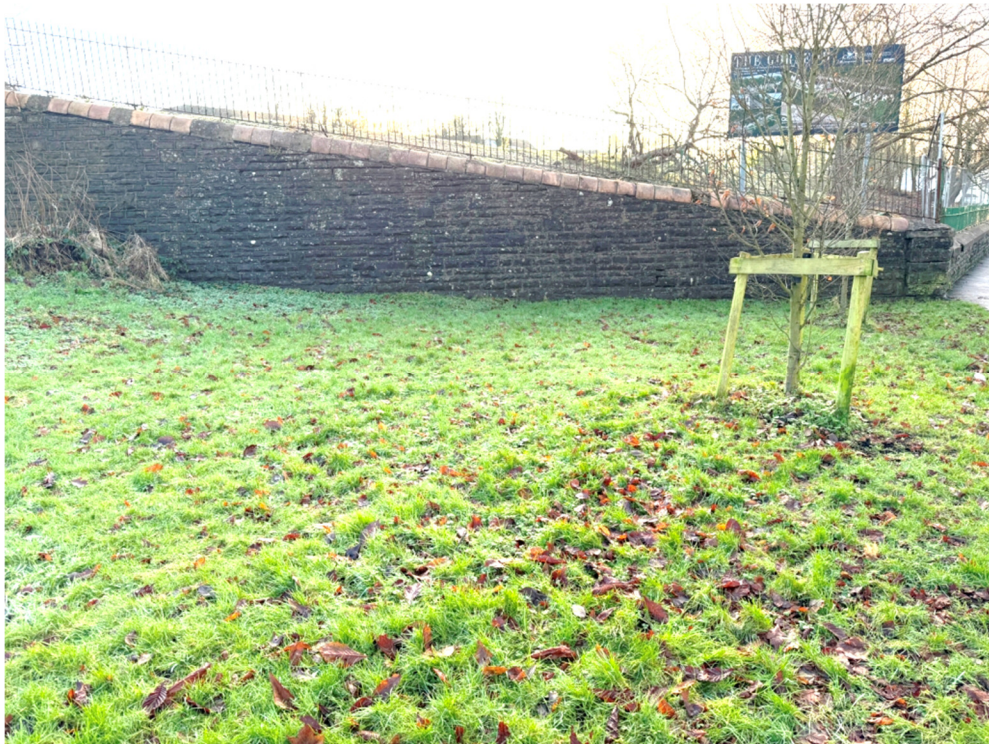
Photograph 4: View of right hand length of retaining wall with diminishing retained height.

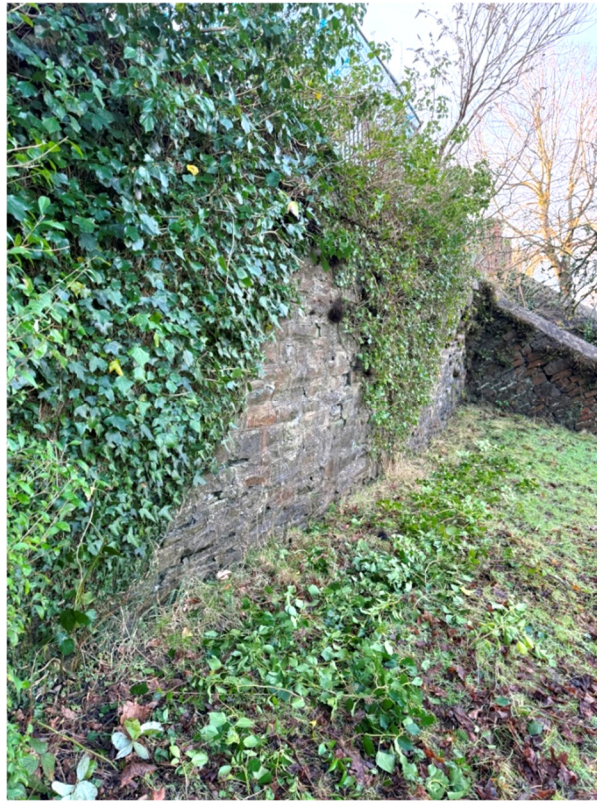
A closer inspection of the left hand length of stone retaining wall, between the northern corner of the development site and stone access steps, confirms a significant forward lean in the retaining wall of more than 150mm. Ivy has also embedded itself into stone jointing. Please refer to Photographs 5 and 6 in Appendix A.

Photograph 5: Retaining wall to right of access steps has a significant forward lean in excess of 150mm.

Due to the amount of distortion and lateral forward movement confirmed in the left hand length of retaining wall, we would recommend this length of wall, between the corner of the development site and stone access steps, be carefully taken down and a new retaining wall designed and constructed at this location.

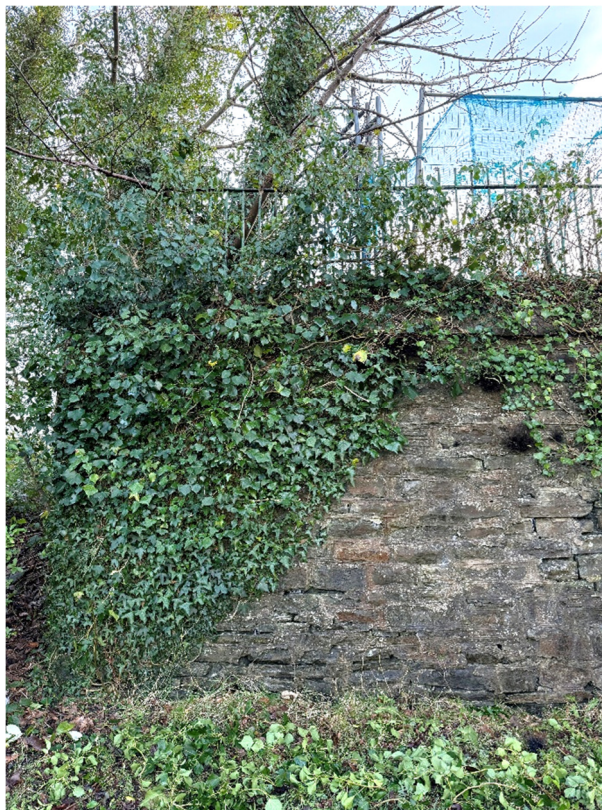
Photograph 6: Ivy has embedded itself into wall joints.

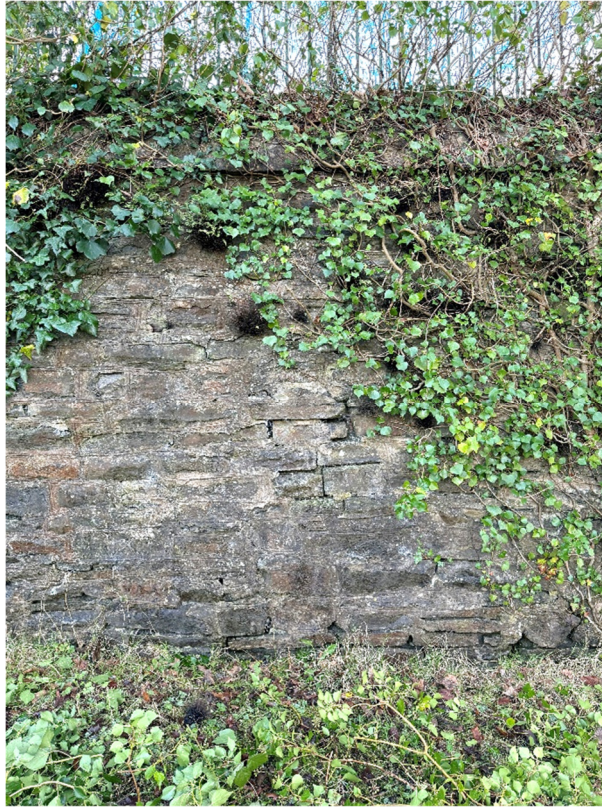
Stonework is cracked and has suffered from significant forward displacements at various locations along this section of retaining wall. Please refer to Photographs 7, 8 and 9 in Appendix A.

Photograph 7: Open jointing is noted within the right hand section of retaining wall.

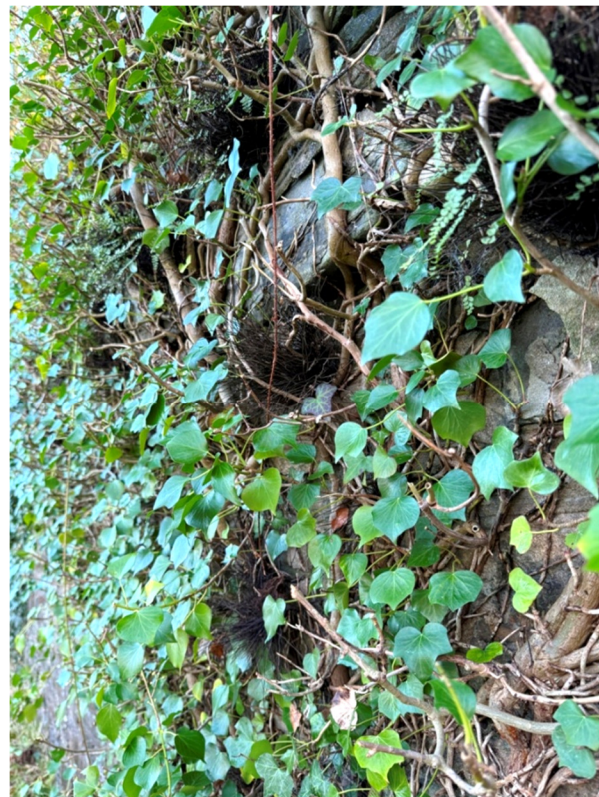
Photograph 8: Inspection shows displaced stonework approximately 50mm out of line at various locations.

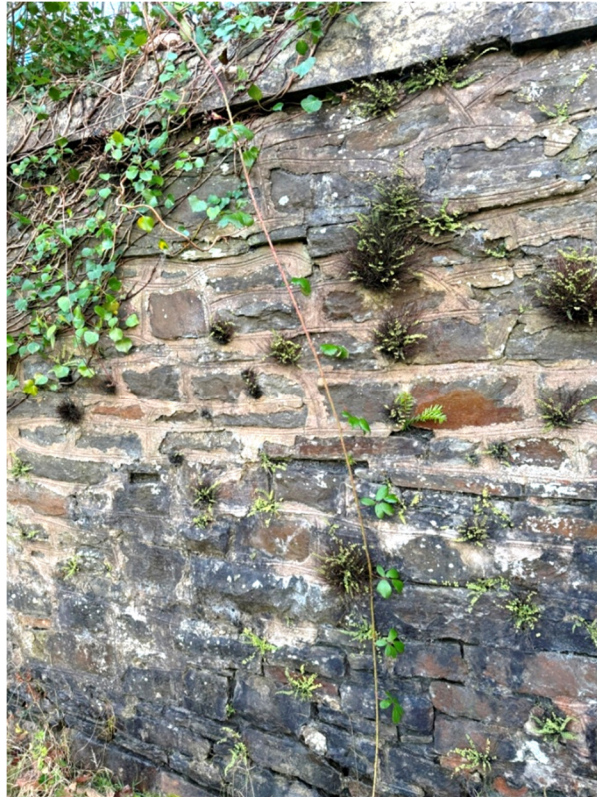
Photograph 9: Another view showing displaced stonework at upper levels of retaining wall.

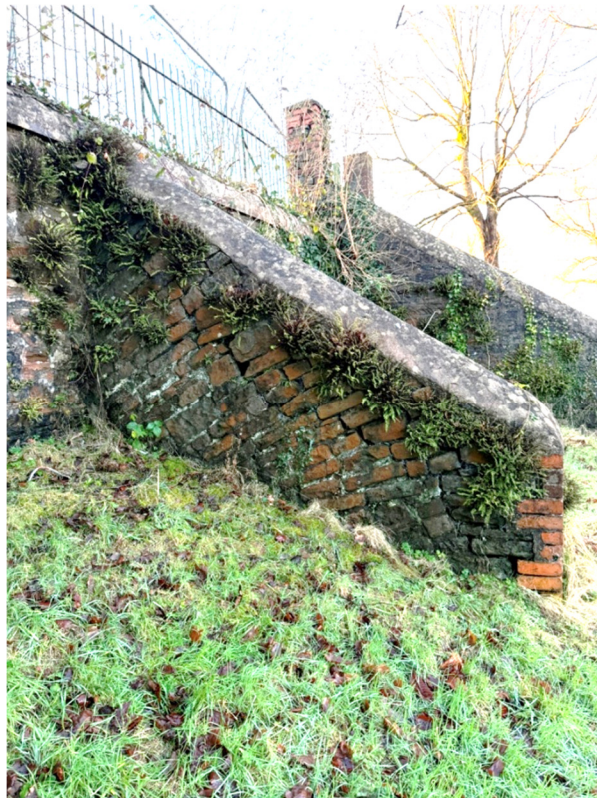
A stone buttress wall exists to the left of the stone access steps. Stonework has been constructed on an incline. Open jointing in this section of stonework is evident. Please refer to Photographs 10 and 11 in Appendix A.

Photograph 10: View of left stone buttress (left side).

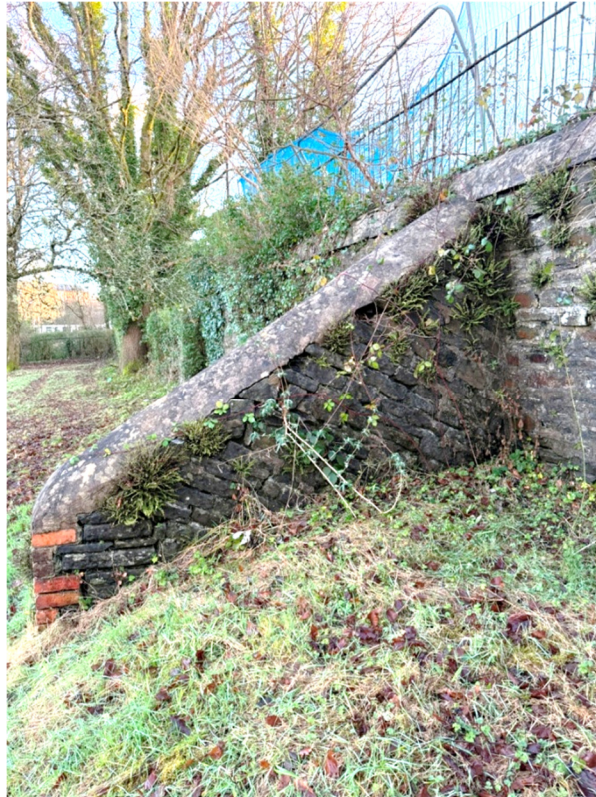
Photograph 11: View of left stone buttress (right side).

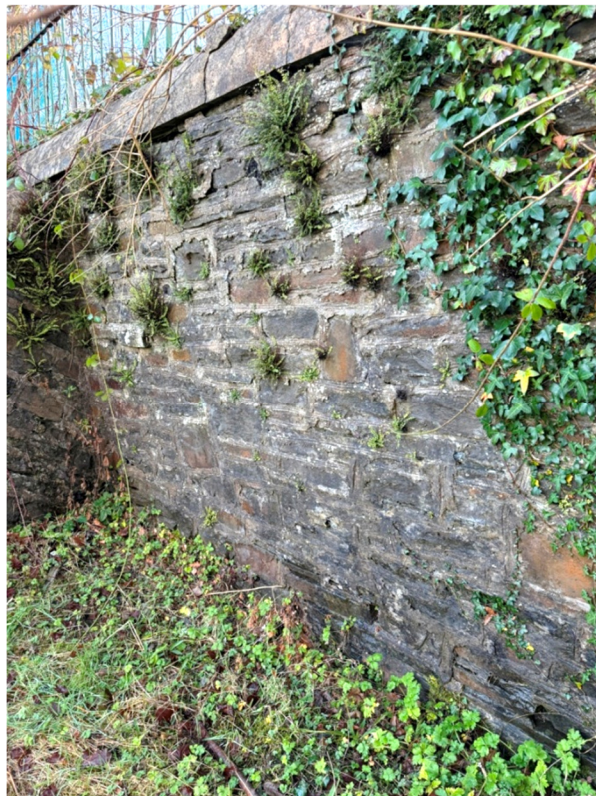
The length of stone retaining wall between the buttress wall and stone steps has also suffered from lateral distortion and has a significant forward lean. Please refer to Photograph 12 in Appendix A.

Photograph 12: View of leaning section of retaining wall in between left buttress and access steps.

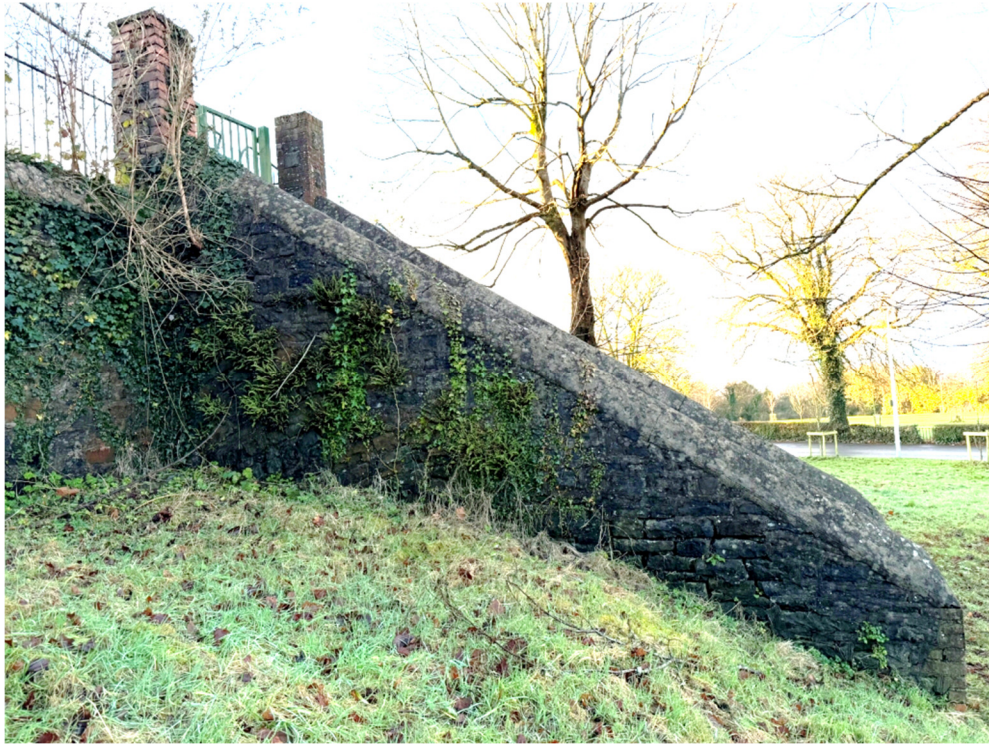
With reference to Photographs 13, 14, 15 and 16, stone buttress walls exist either side of the access steps. Open jointing in stonework is noted. Stonework has been constructed on an incline. No structural cracking or lateral distortion noted to buttress walls.

Photograph 13: View from side of access steps show ground levels raised against the retaining wall.

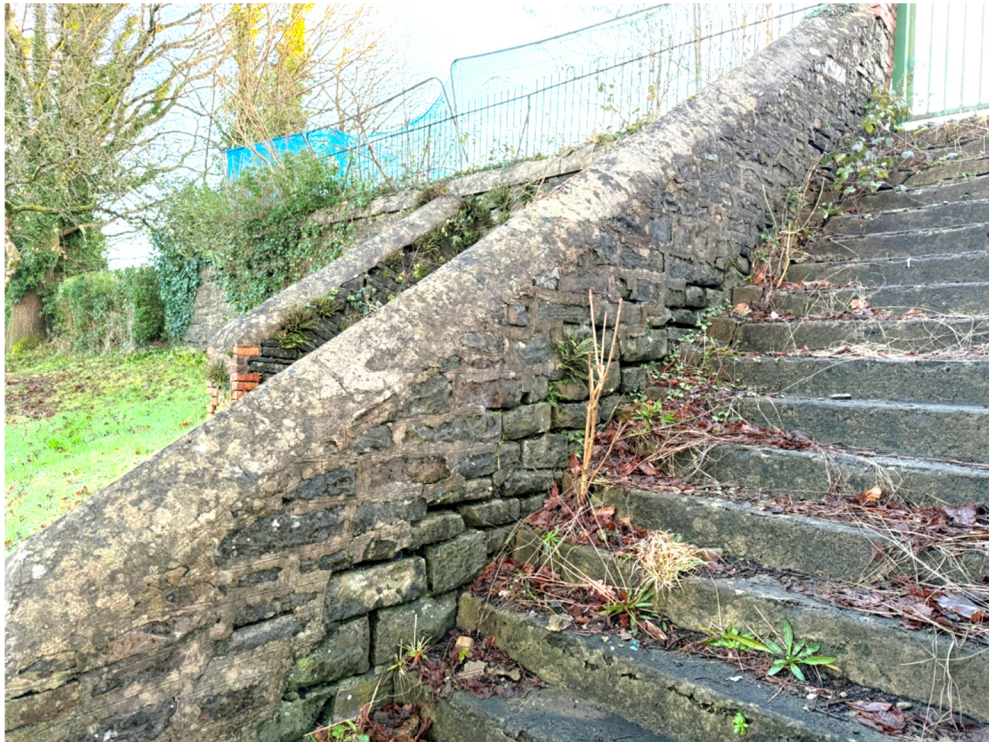
Photograph 14: Open jointing noted to random stone side walls of access steps.

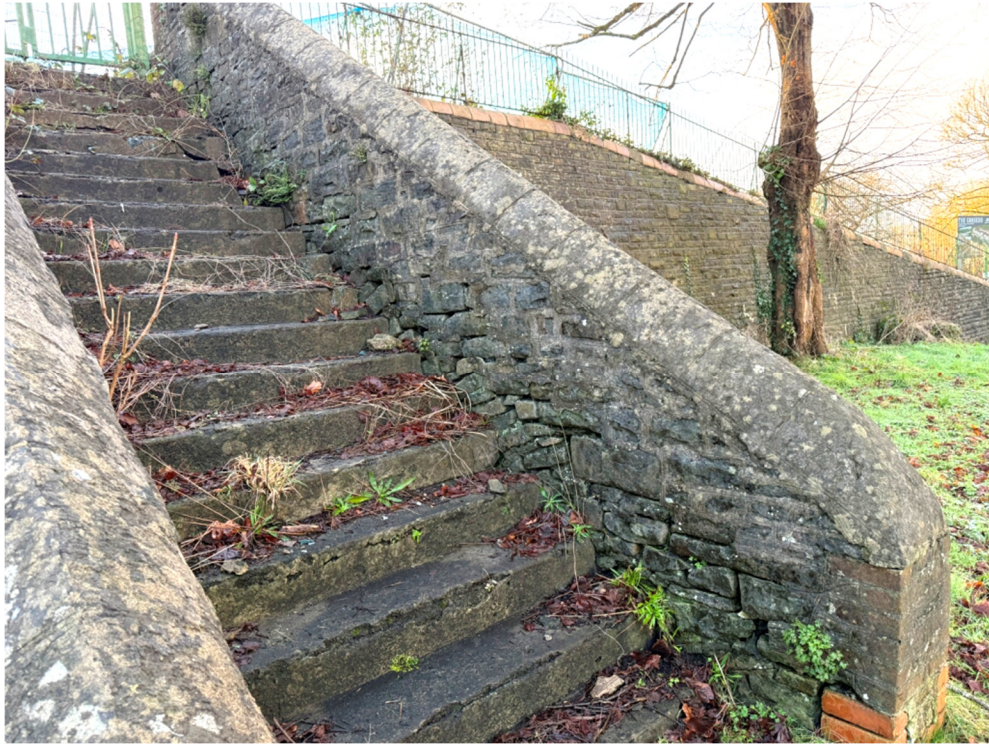
Photograph 15: View of right hand side wall of access steps. Open jointing noted.

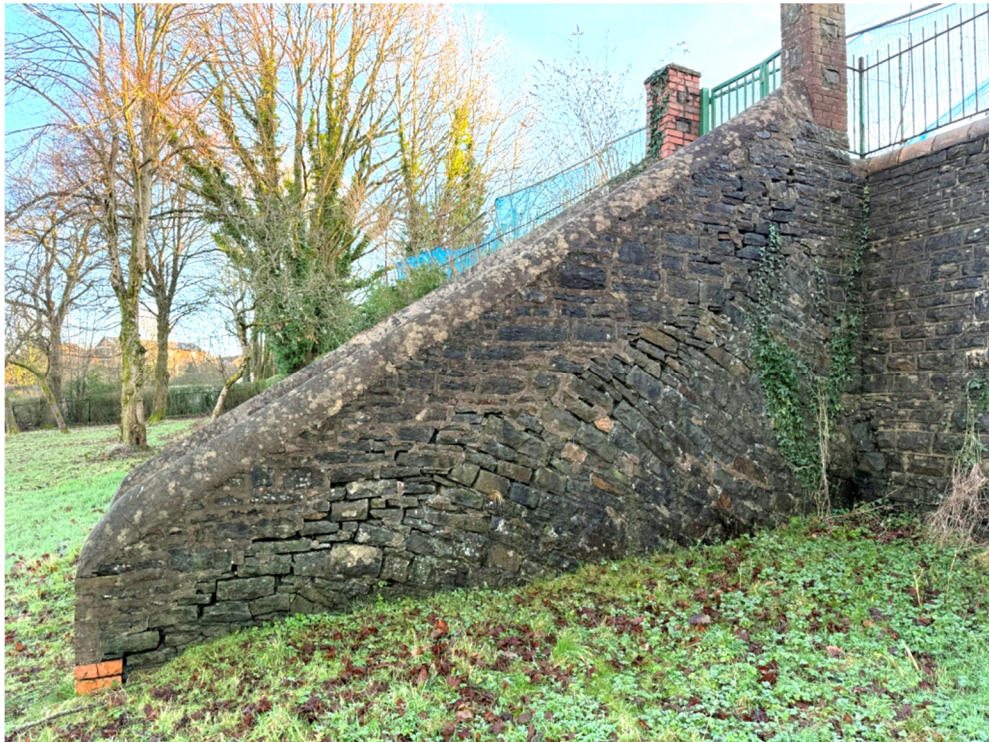
Photograph 16: Ground levels on the right side of the access steps are lower than the left side.

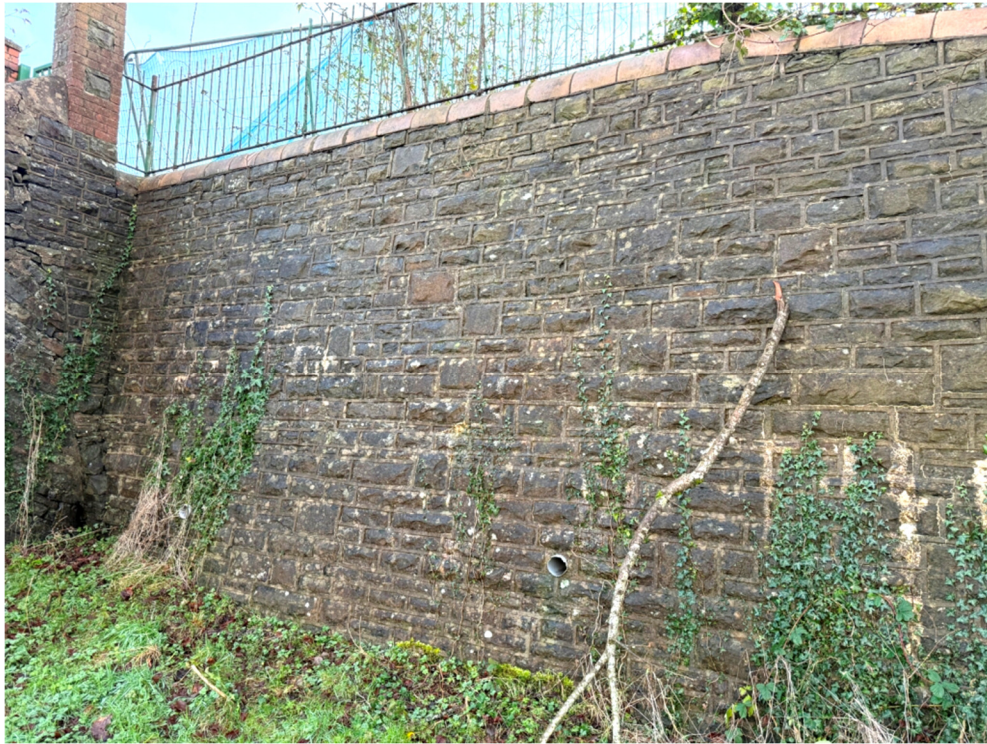
The stone retaining wall at the right of the access steps is approximately 3.50m in height. Two drainage weep holes have been provided and can be seen in Photographs 17 and 18 in Appendix A. This length of retaining wall has been constructed with a slight backwards lean. No evidence of structural cracking or lateral distortion is noted along the right length of stone retaining wall.

Photograph 17: Retaining wall is approximately 3.50m high at its maximum. Right side retaining wall appears structurally stable with no sign of cracking, open jointing or lateral distortion.

One recommendation in relation to the right hand length of retaining wall is to provide 100mm diameter drainage weepholes at 1500mm centres along the length of wall to prevent excess pore water pressure building up within the retained soils and allow ground water to seep out.

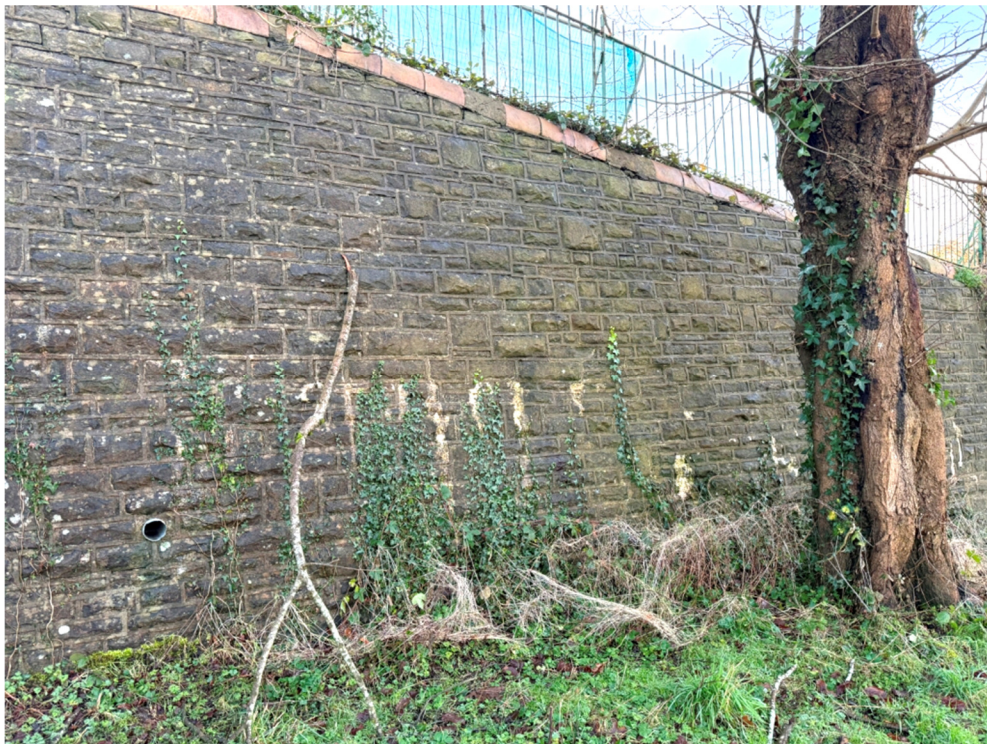
A large tree exists near the right hand retaining wall and is evident in Photograph 18 in Appendix A. No structural damage or cracking is noted within the stonework construction directly opposite this tree.

Photograph 18: 2no. drainage weep holes are evident just to the right of the access steps. No evidence of damaged to the retaining wall from tree roots.

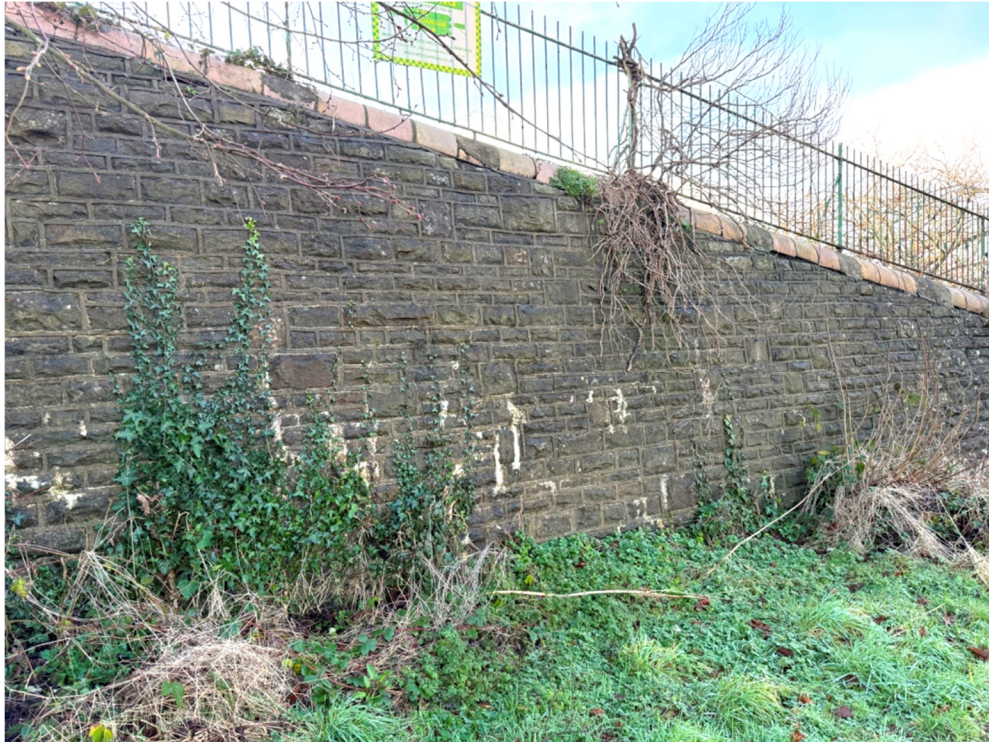
As this length of retaining wall travels south towards the western corner of the development site, the retained height is reduced. Please refer to Photographs 19 and 20 in Appendix A. Some open jointing is noted in localized areas.

Photograph 19: No other drainage weep holes are provided. Right hand retaining wall appears in a stable condition at the time of our inspection.

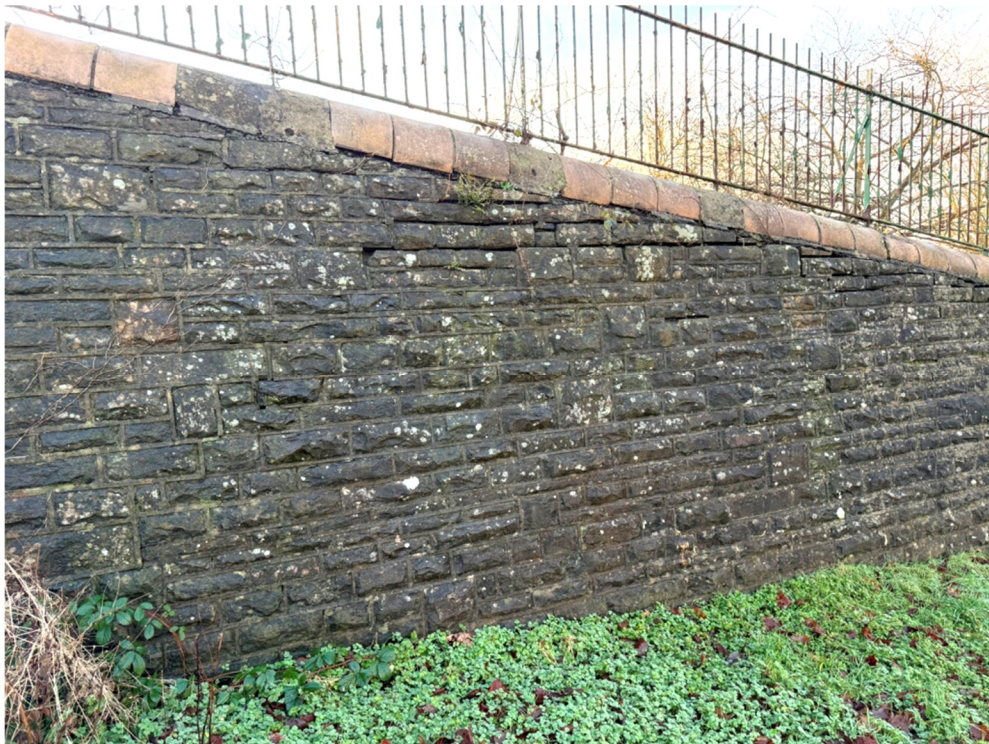
Photograph 20: Another view of right hand length of random stone boundary retaining wall. Retaining wall along this length appears in a stable condition at the time of or inspection.

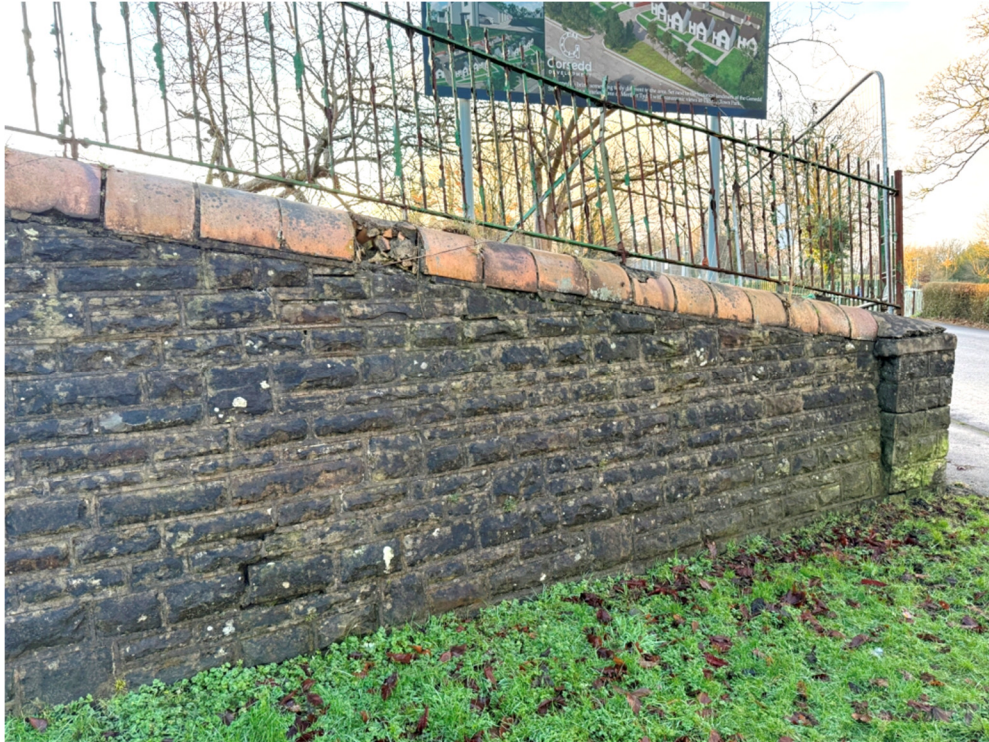
Some damage is noted to capping stones at the top of the retaining wall. Please refer to Photograph 21 in Appendix A.

Photograph 21: Minor damage noted to coping stones along the top of the retaining wall.

Also, remedial works to wall capping stones to ensure all capping stones are securely bedded onto the top of the retaining wall.

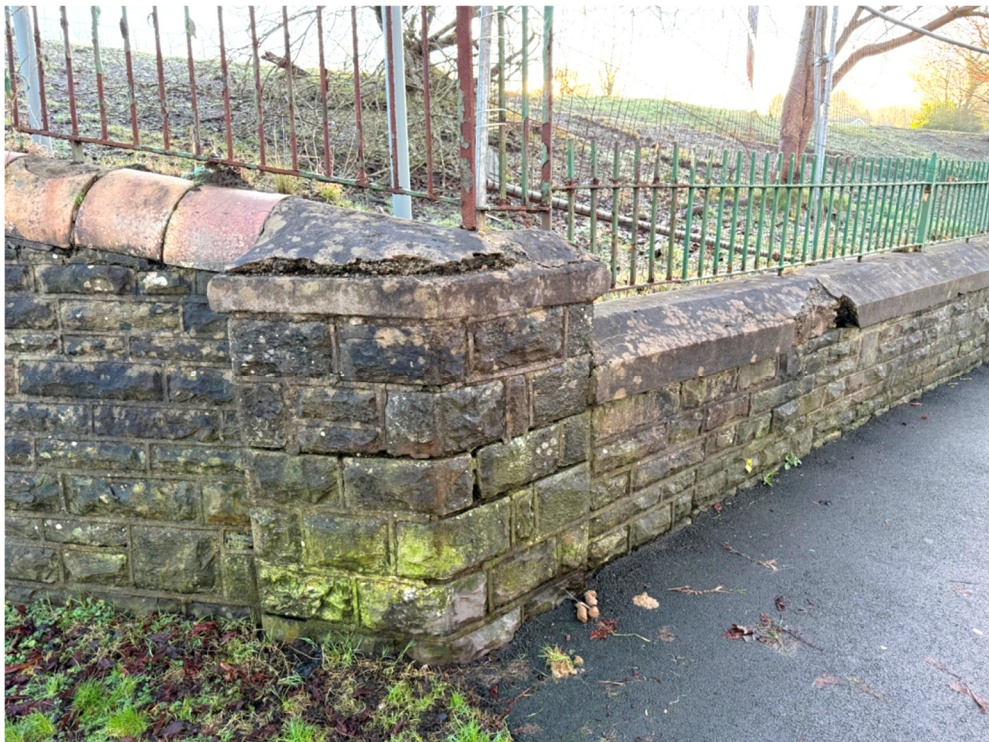
A square stone pillar exists at the site boundary corner. Some open jointing within the stonework is noted here. Please refer to Photograph 22 in Appendix A.

Photograph 22: View at retaining wall corner. Some open jointing but otherwise structurally stable.

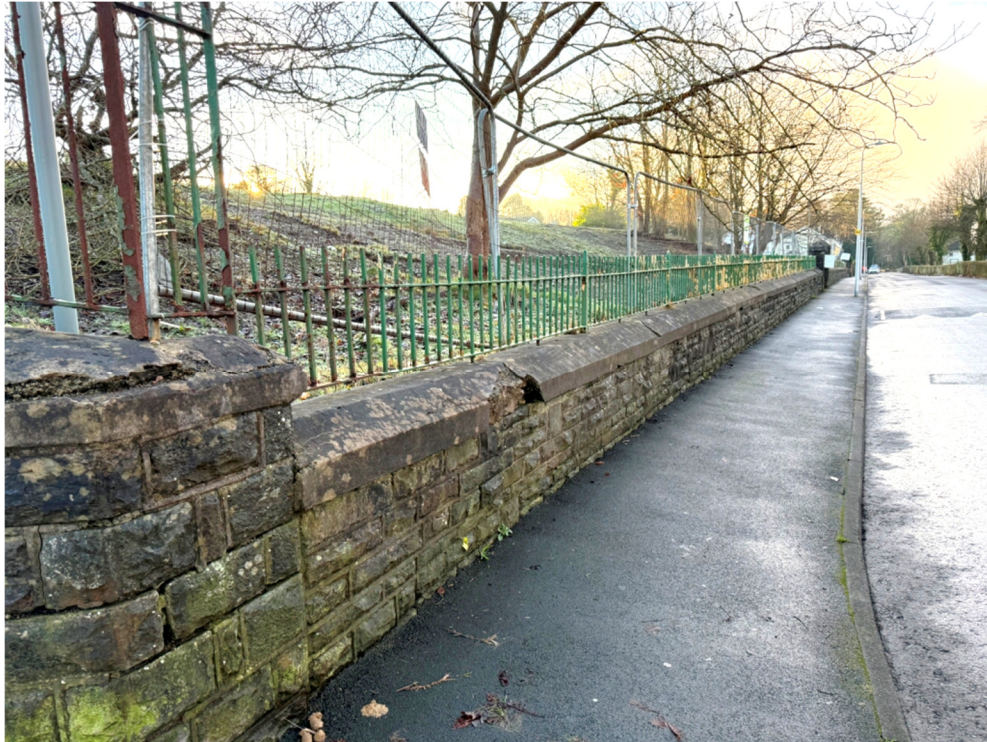
A small retaining wall exists along the remainder of Queens Road and appears structurally stable. Please refer to Photograph 23 in Appendix A.

Photograph 23: View of small front retaining wall along Queens Road.
