# Synagogue, Merthyr Tydfil

## RECORD OF BUILDING AND CONDITION ASSESSMENT REPORT

.....  
(449)2503-GVVP-A-HIS-P00

Date: 17.03.25

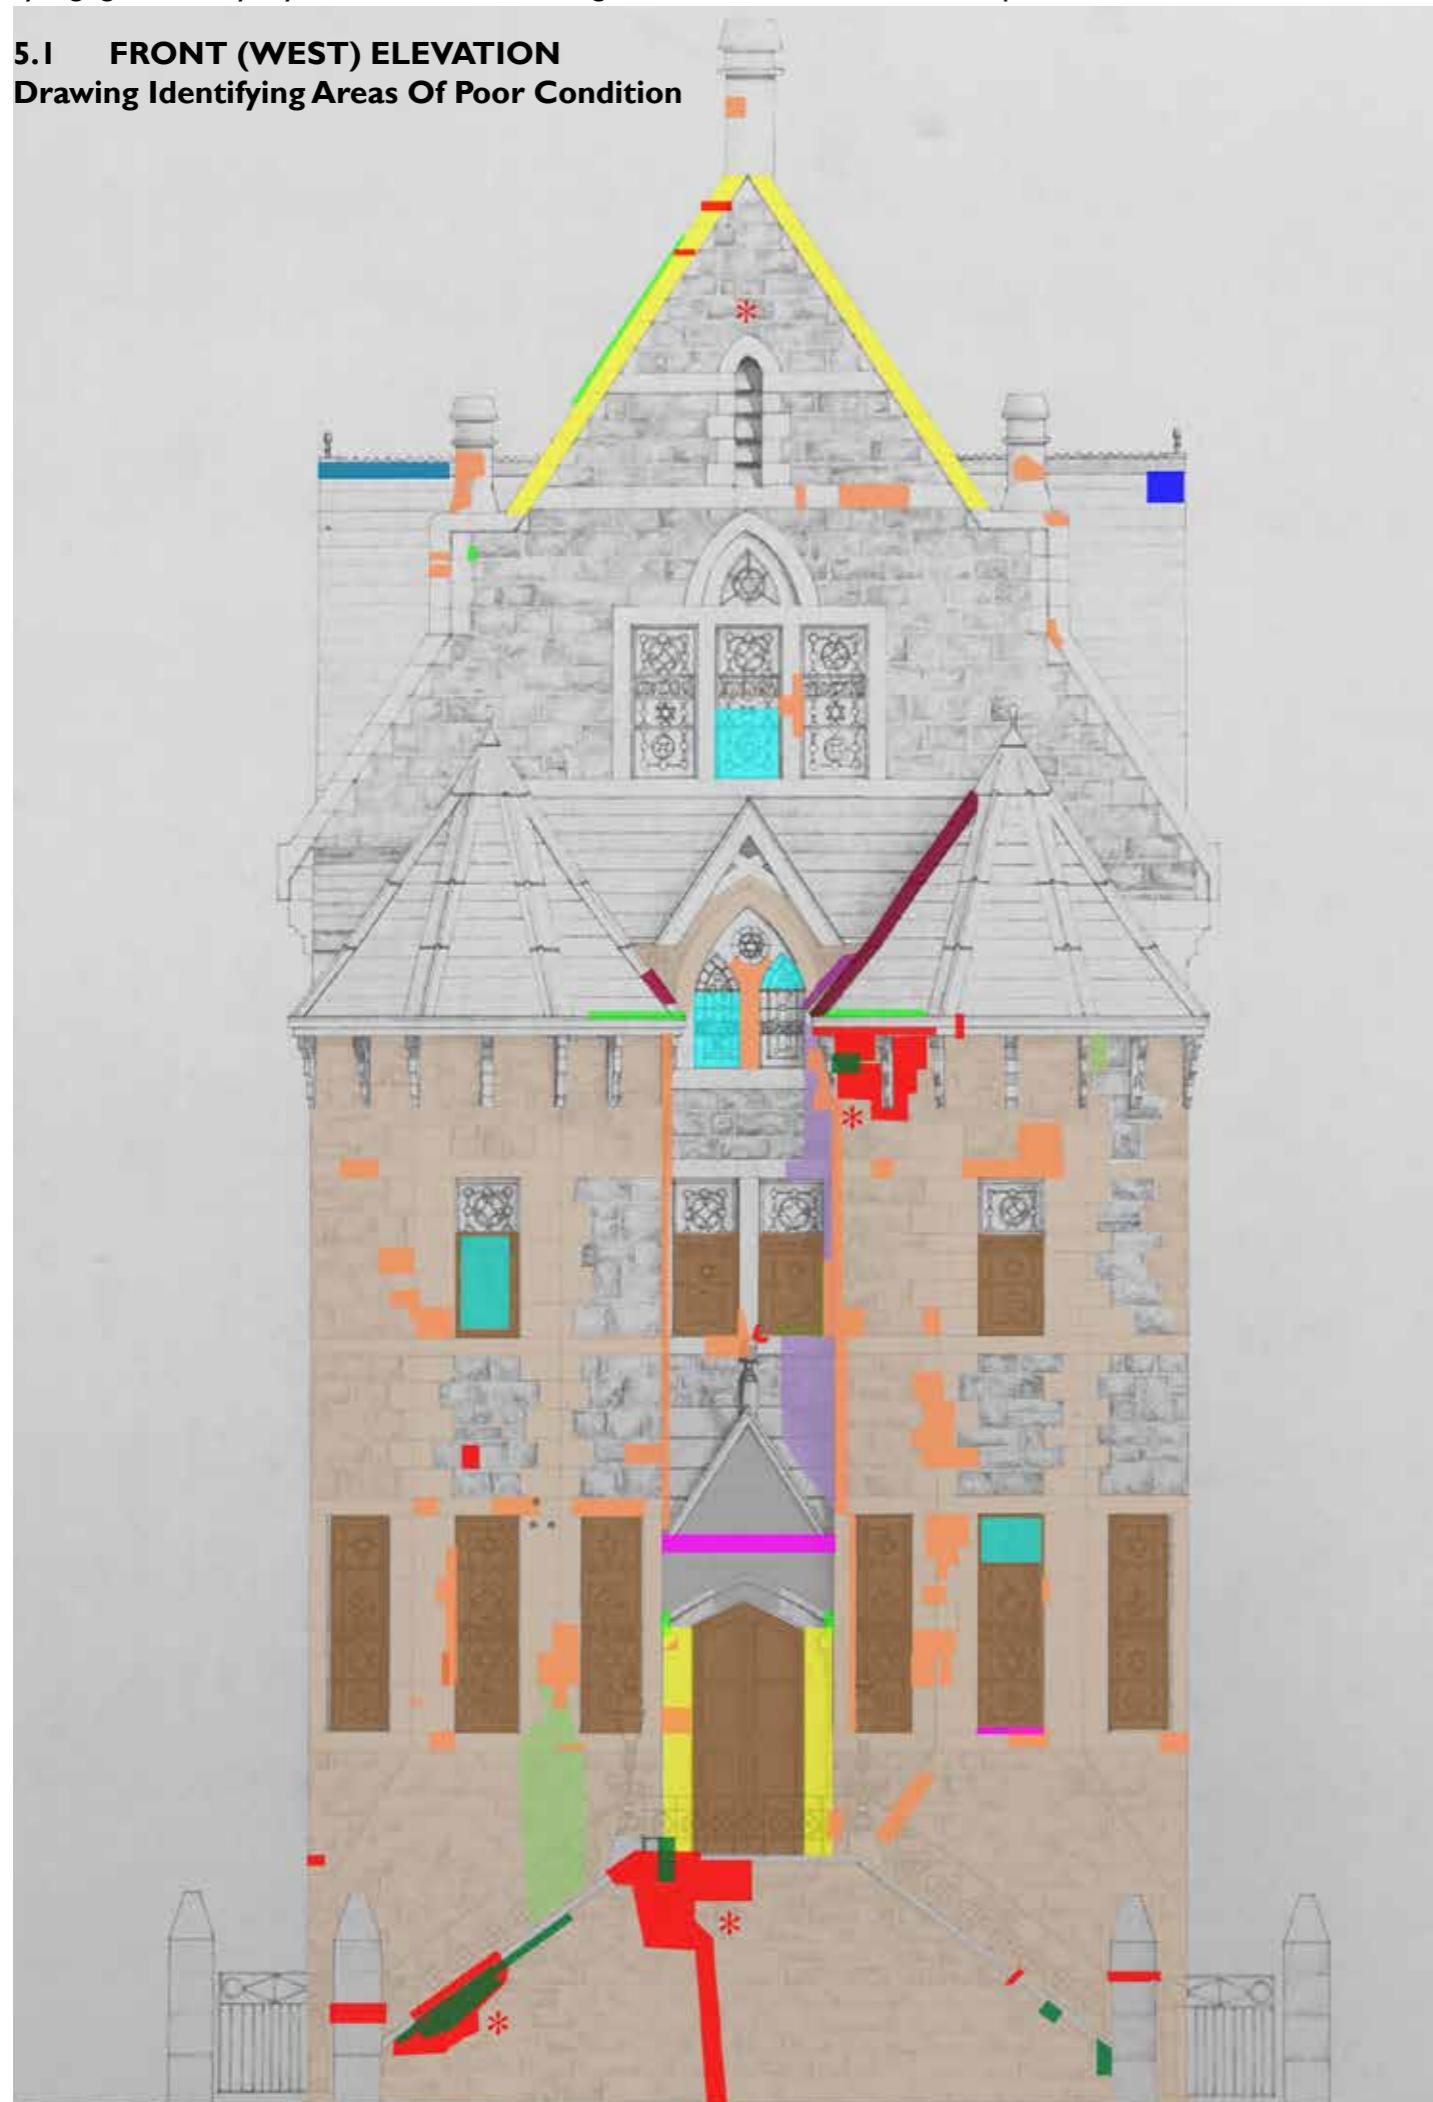
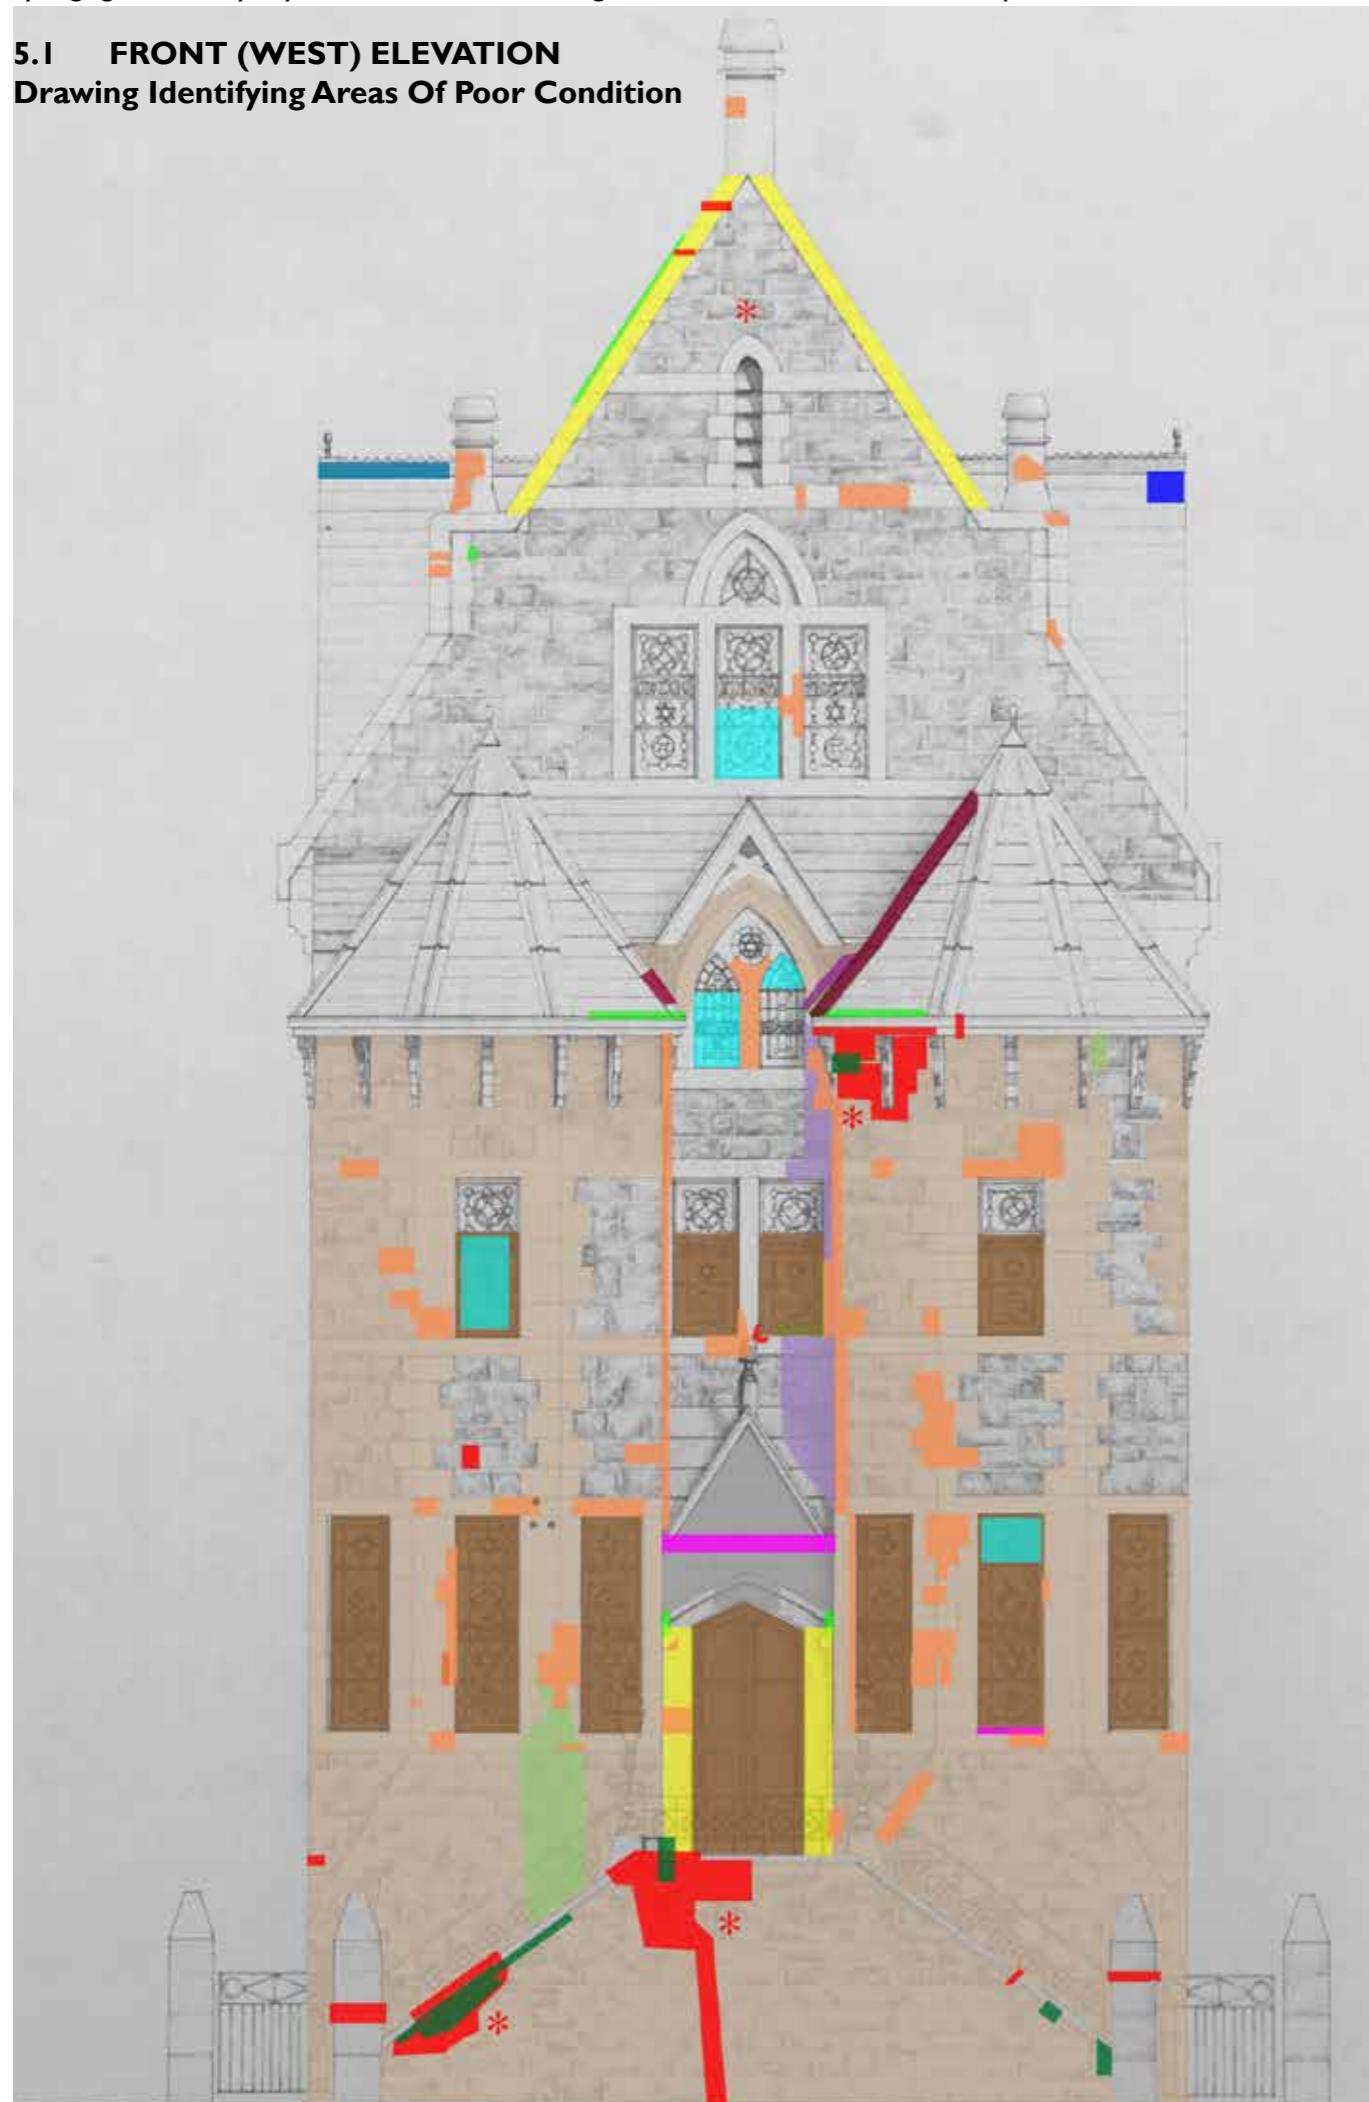
## 5.1 FRONT (WEST) ELEVATION

Drawing Identifying Areas Of Poor Condition

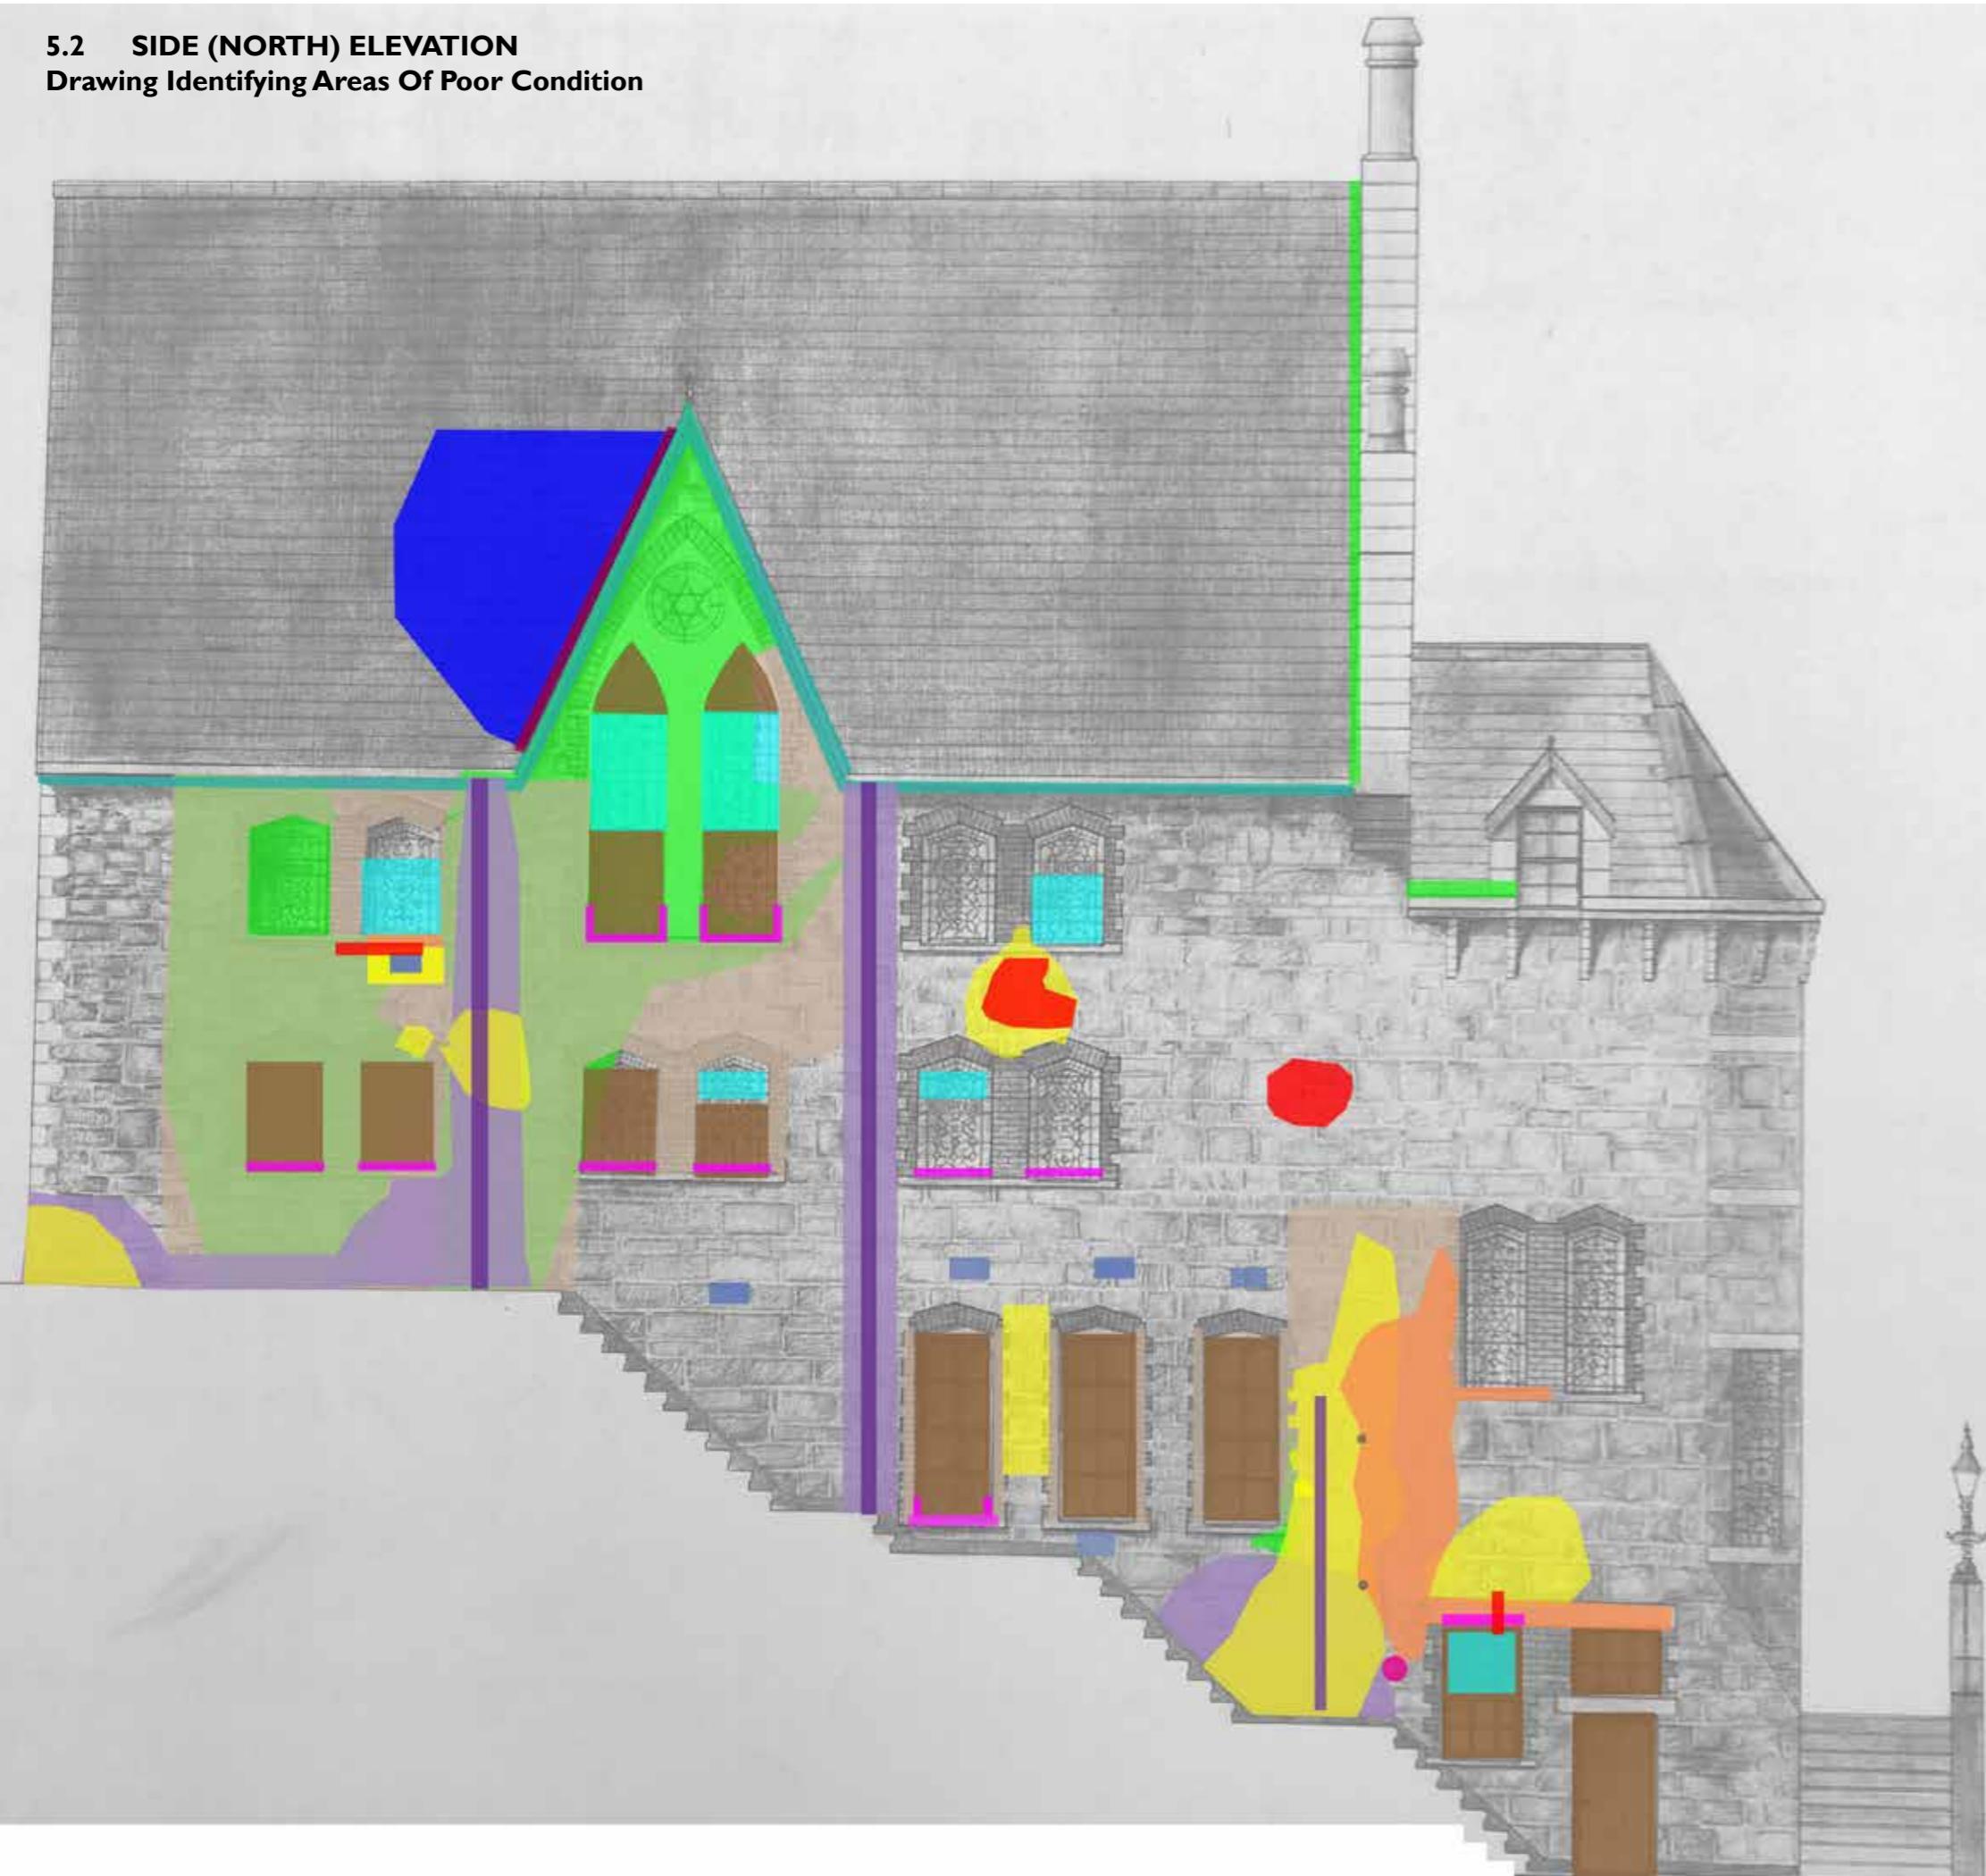
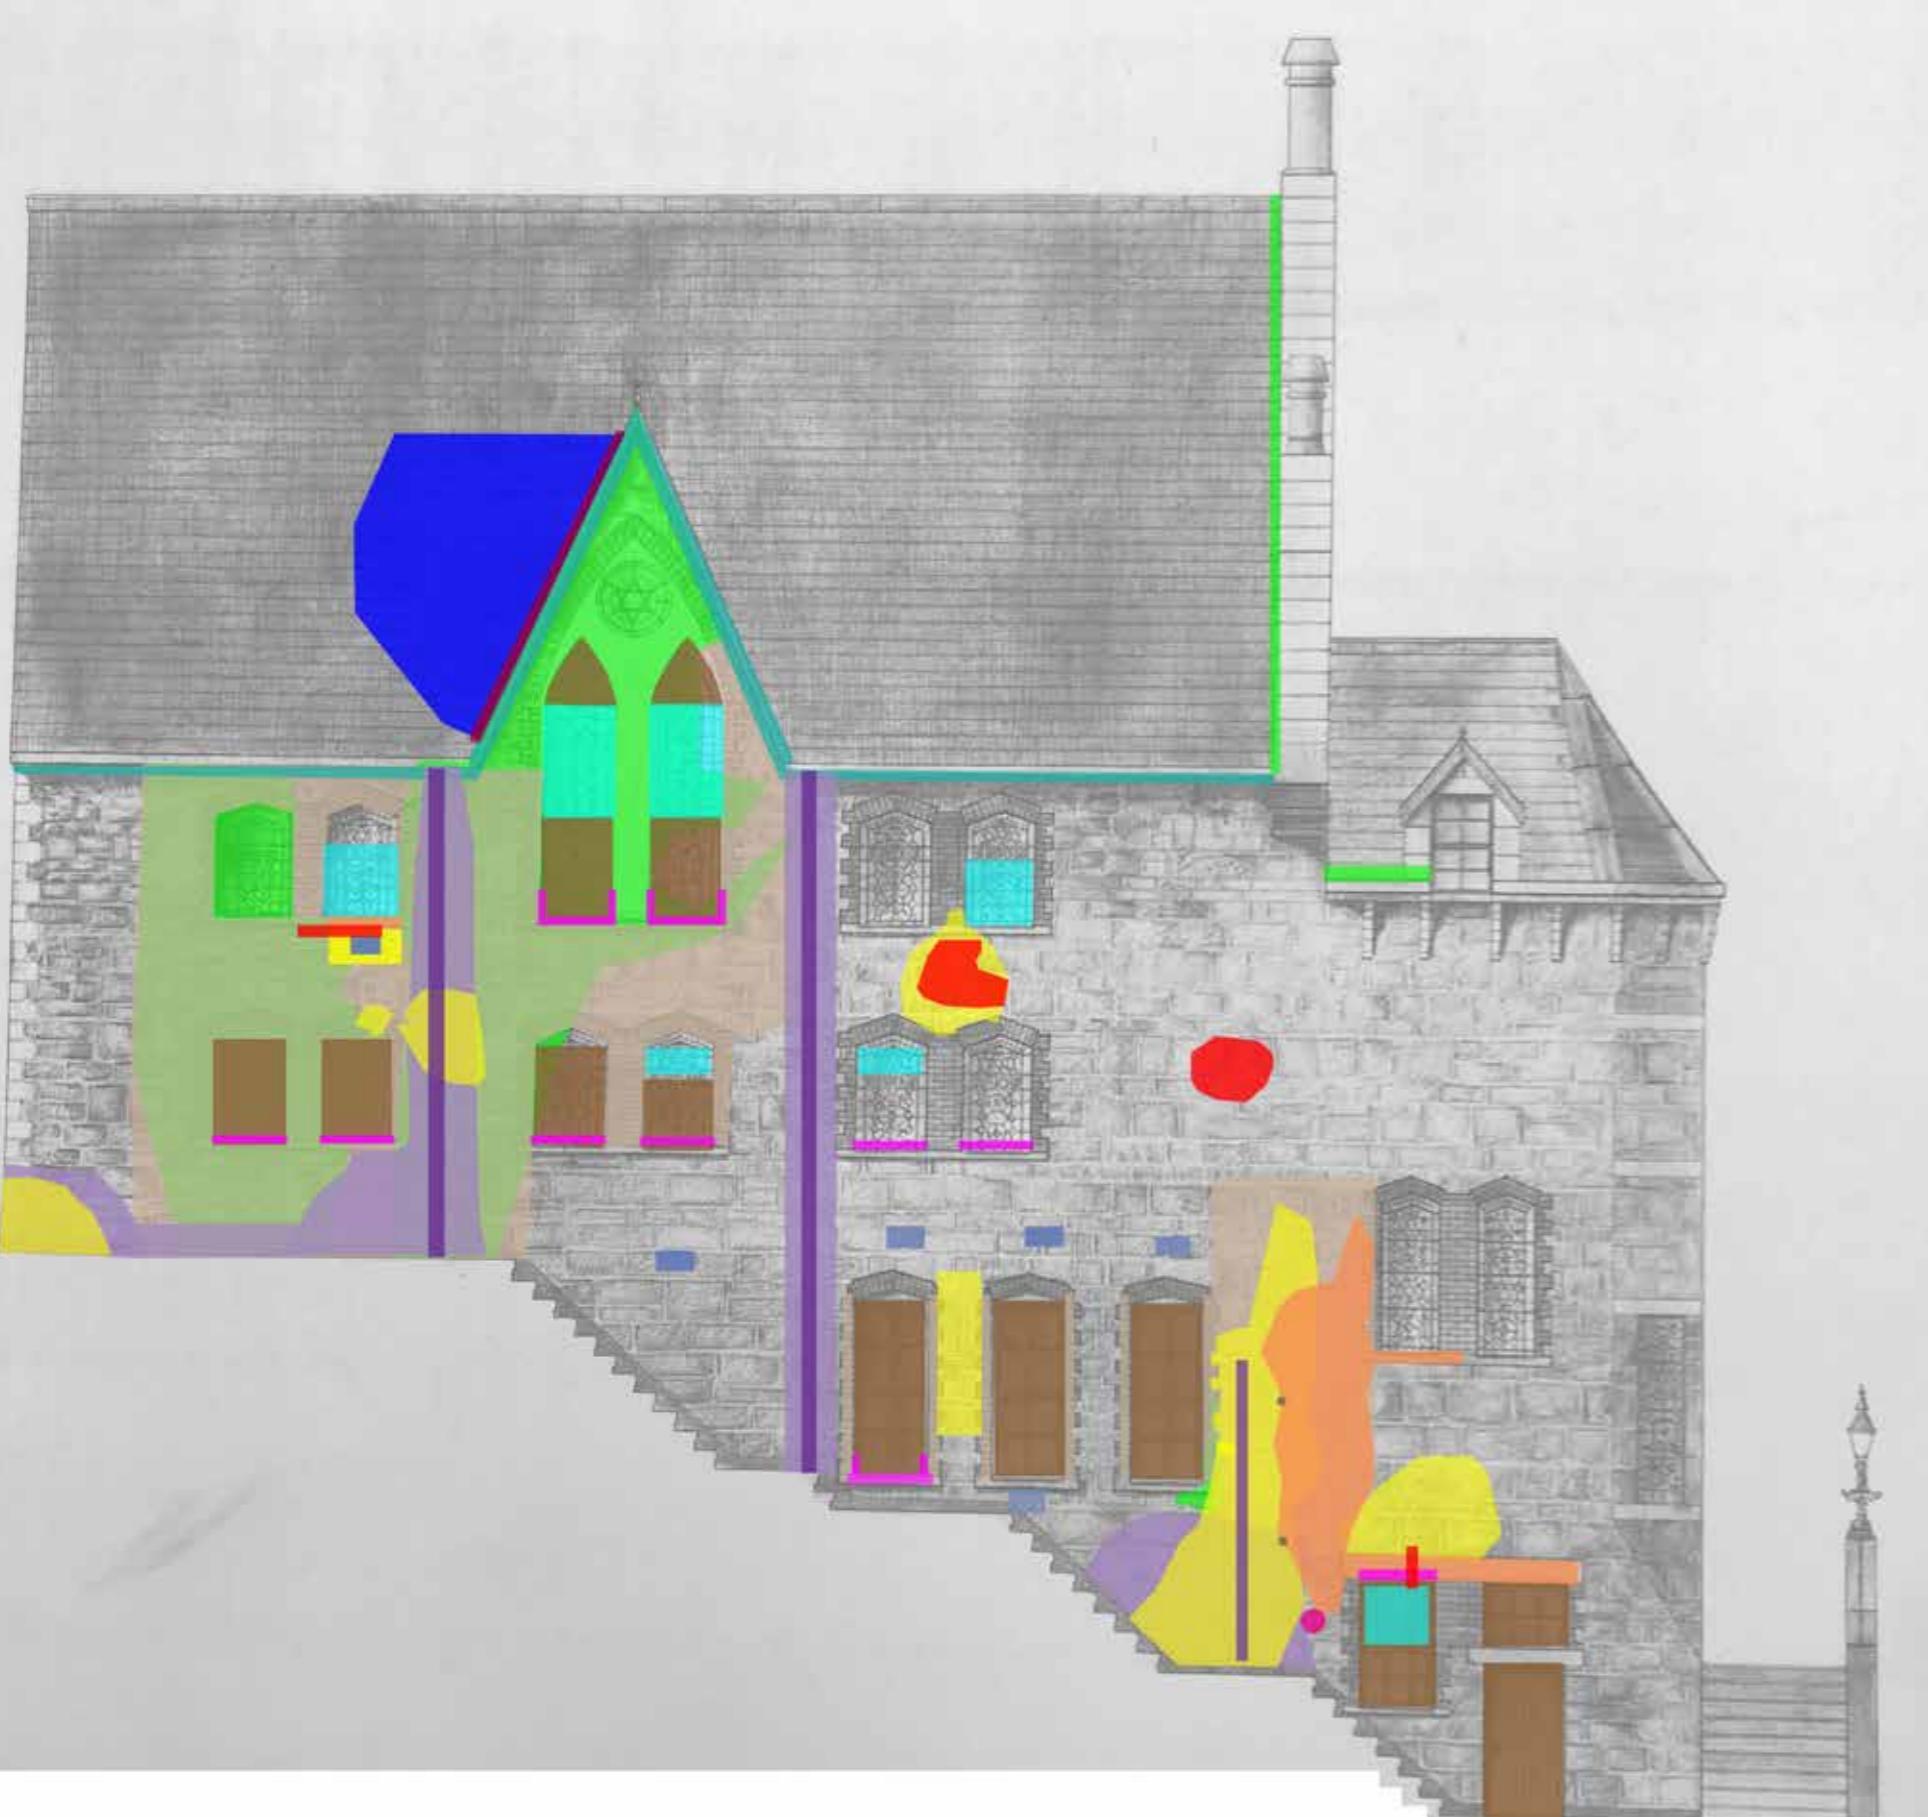
## 5.2 SIDE (NORTH) ELEVATION

## Drawing Identifying Areas Of Poor Condition

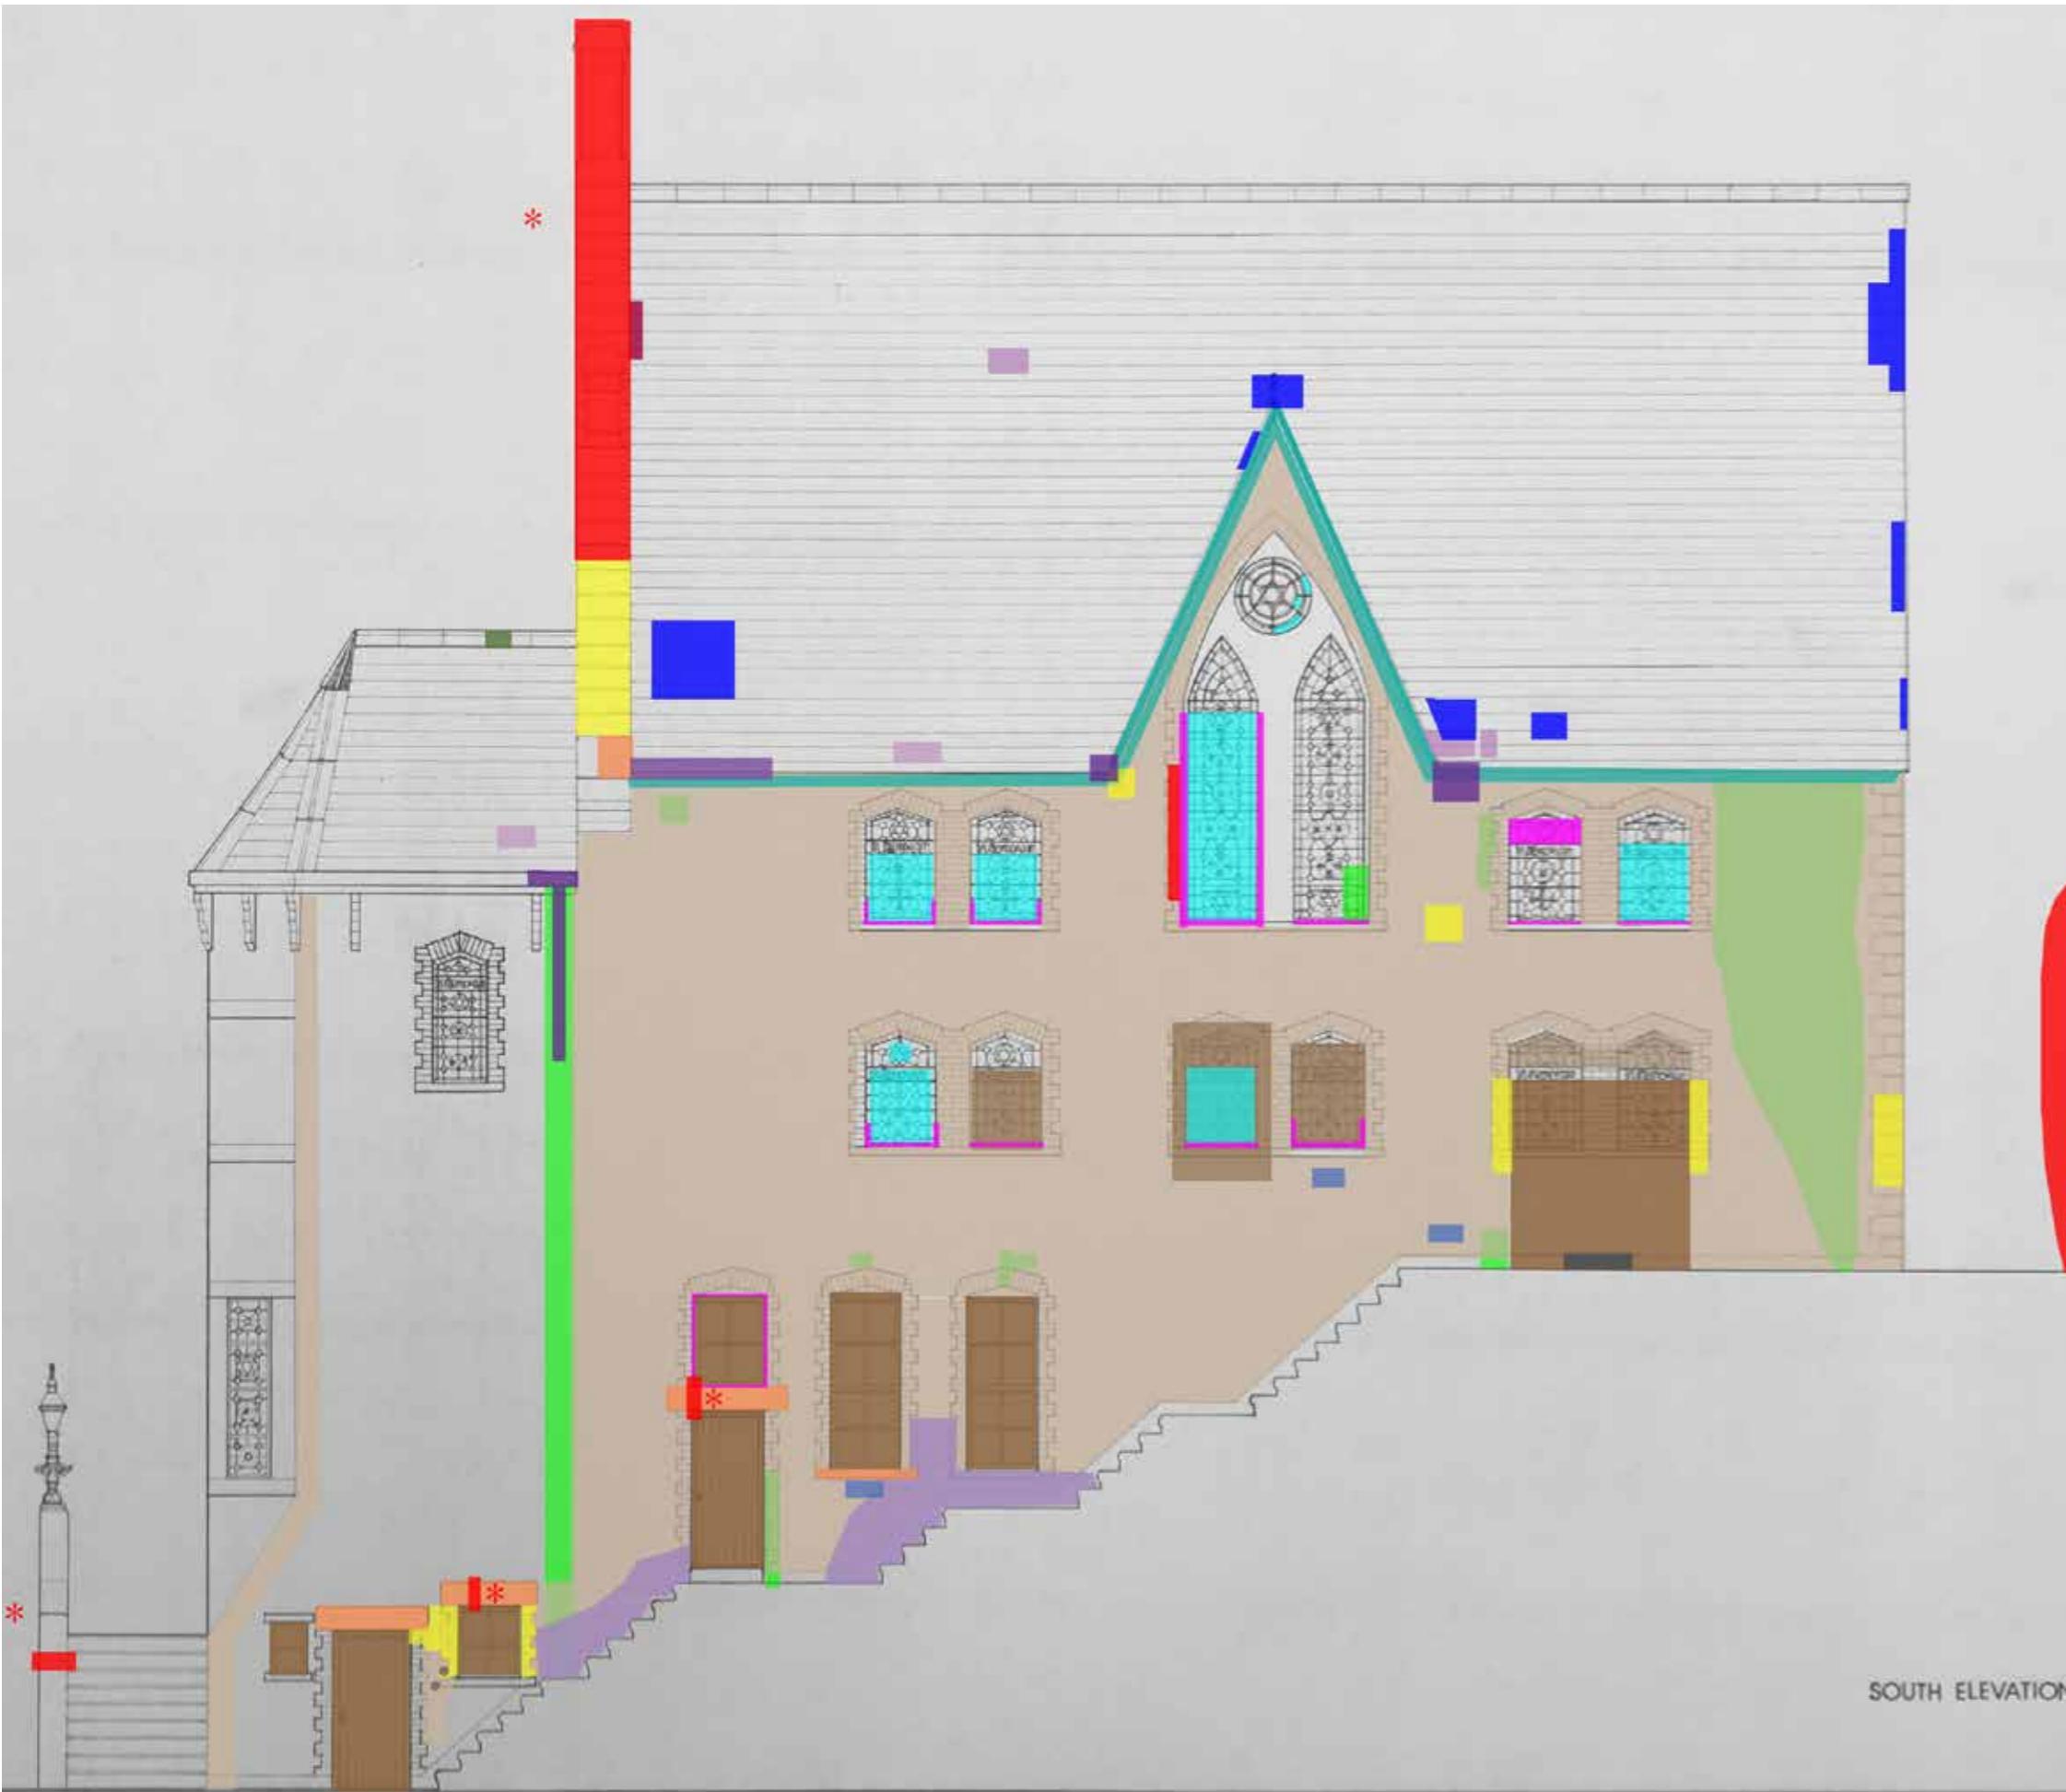
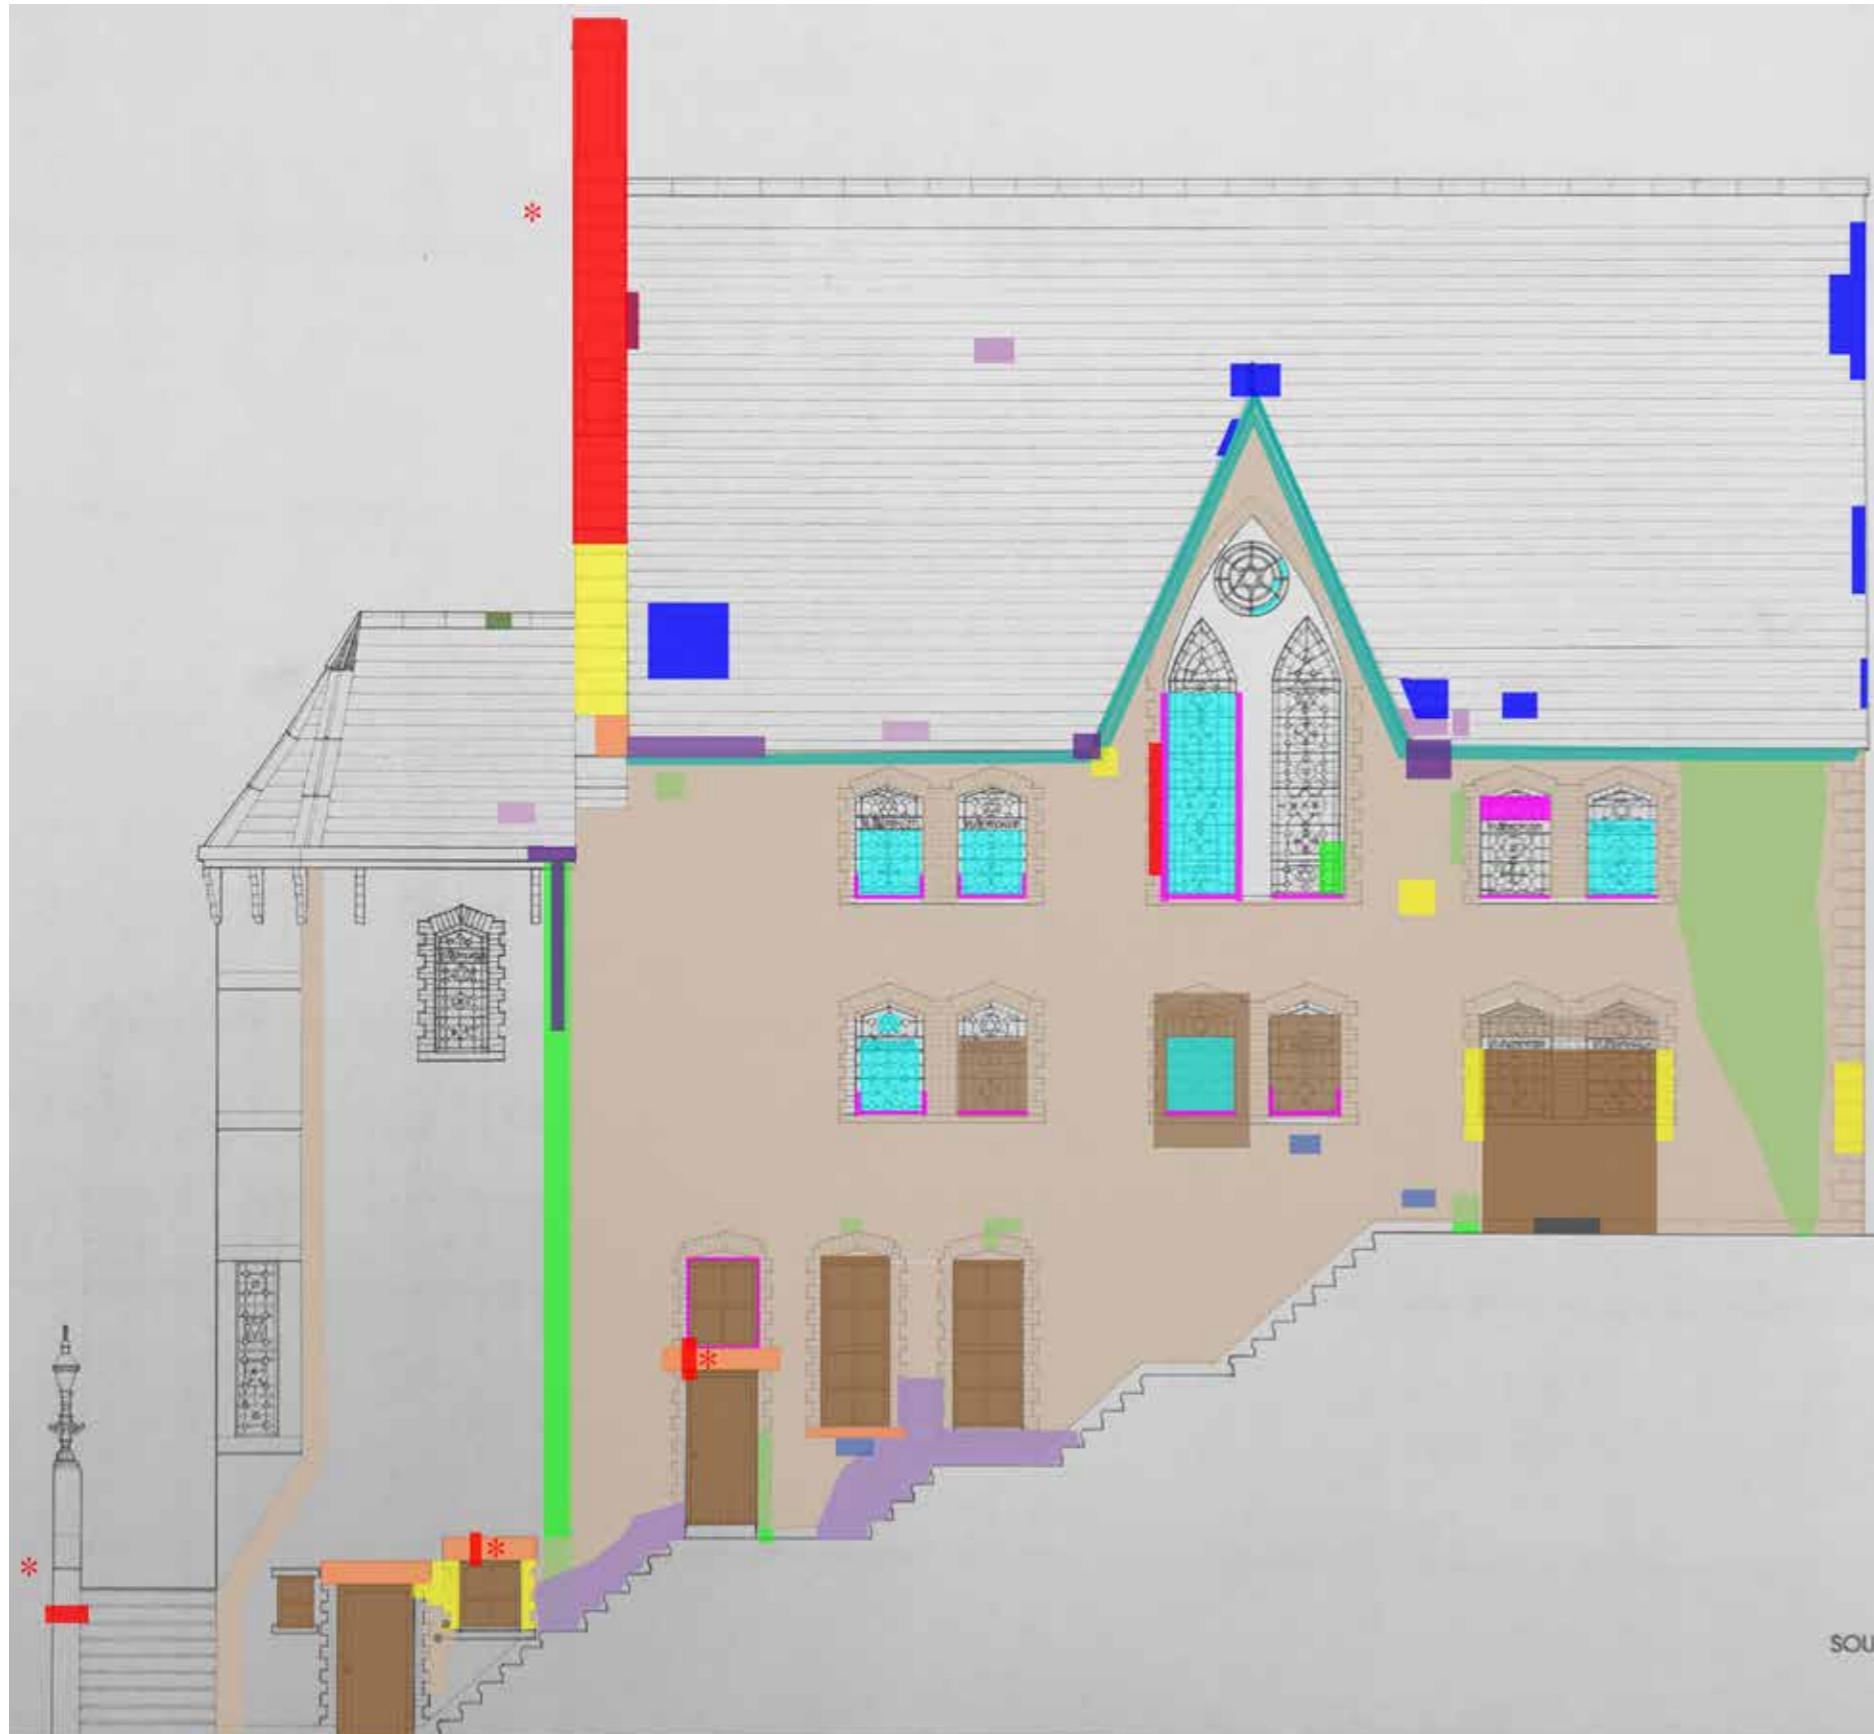
### **5.3 SIDE (SOUTH) ELEVATION**

## Drawing Identifying Areas Of Poor Condition
