# Synagogue, Merthyr Tydfil

## RECORD OF BUILDING AND CONDITION ASSESSMENT REPORT

.....  
(449)2503-GVVP-A-HIS-P00

Date: 17.03.25

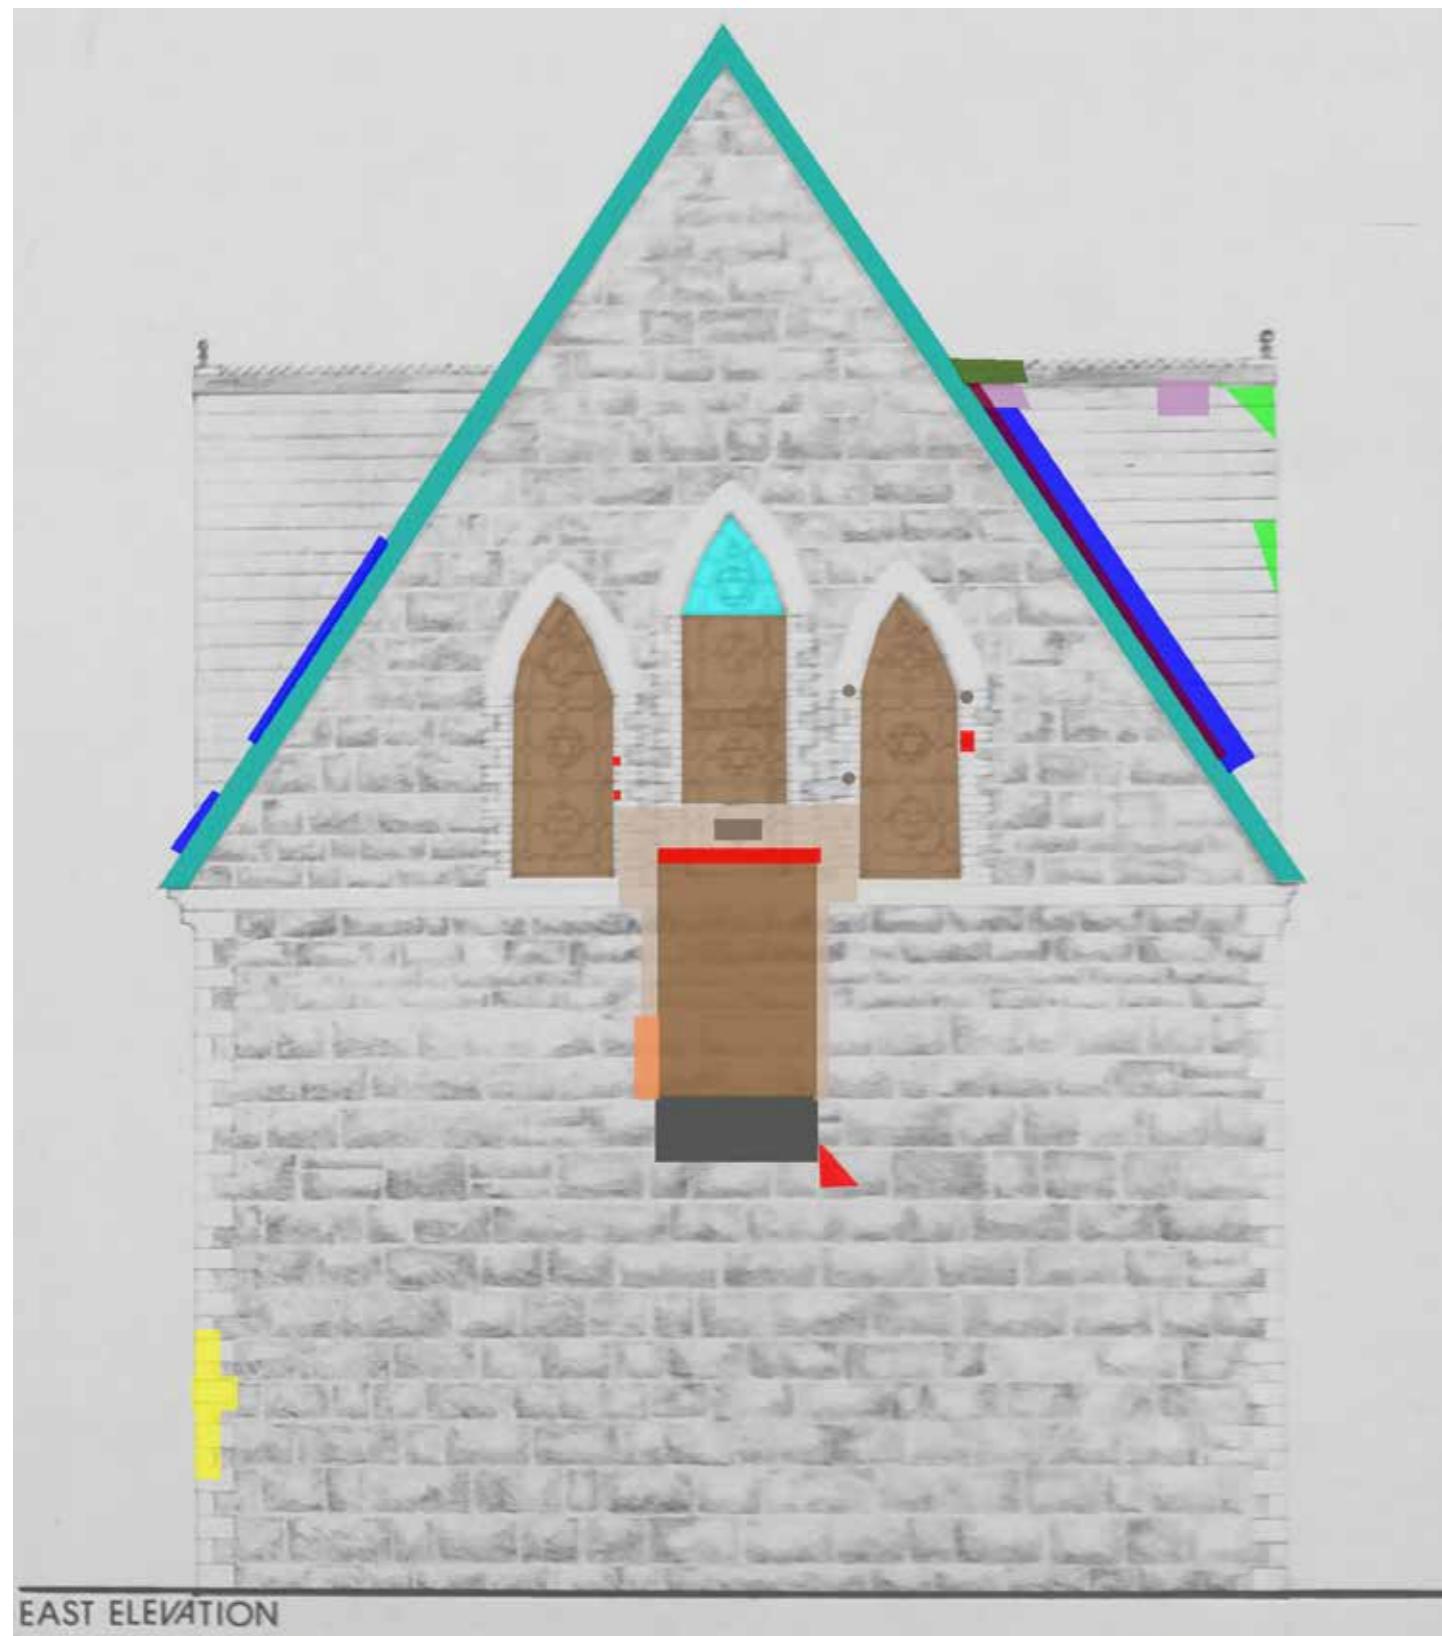
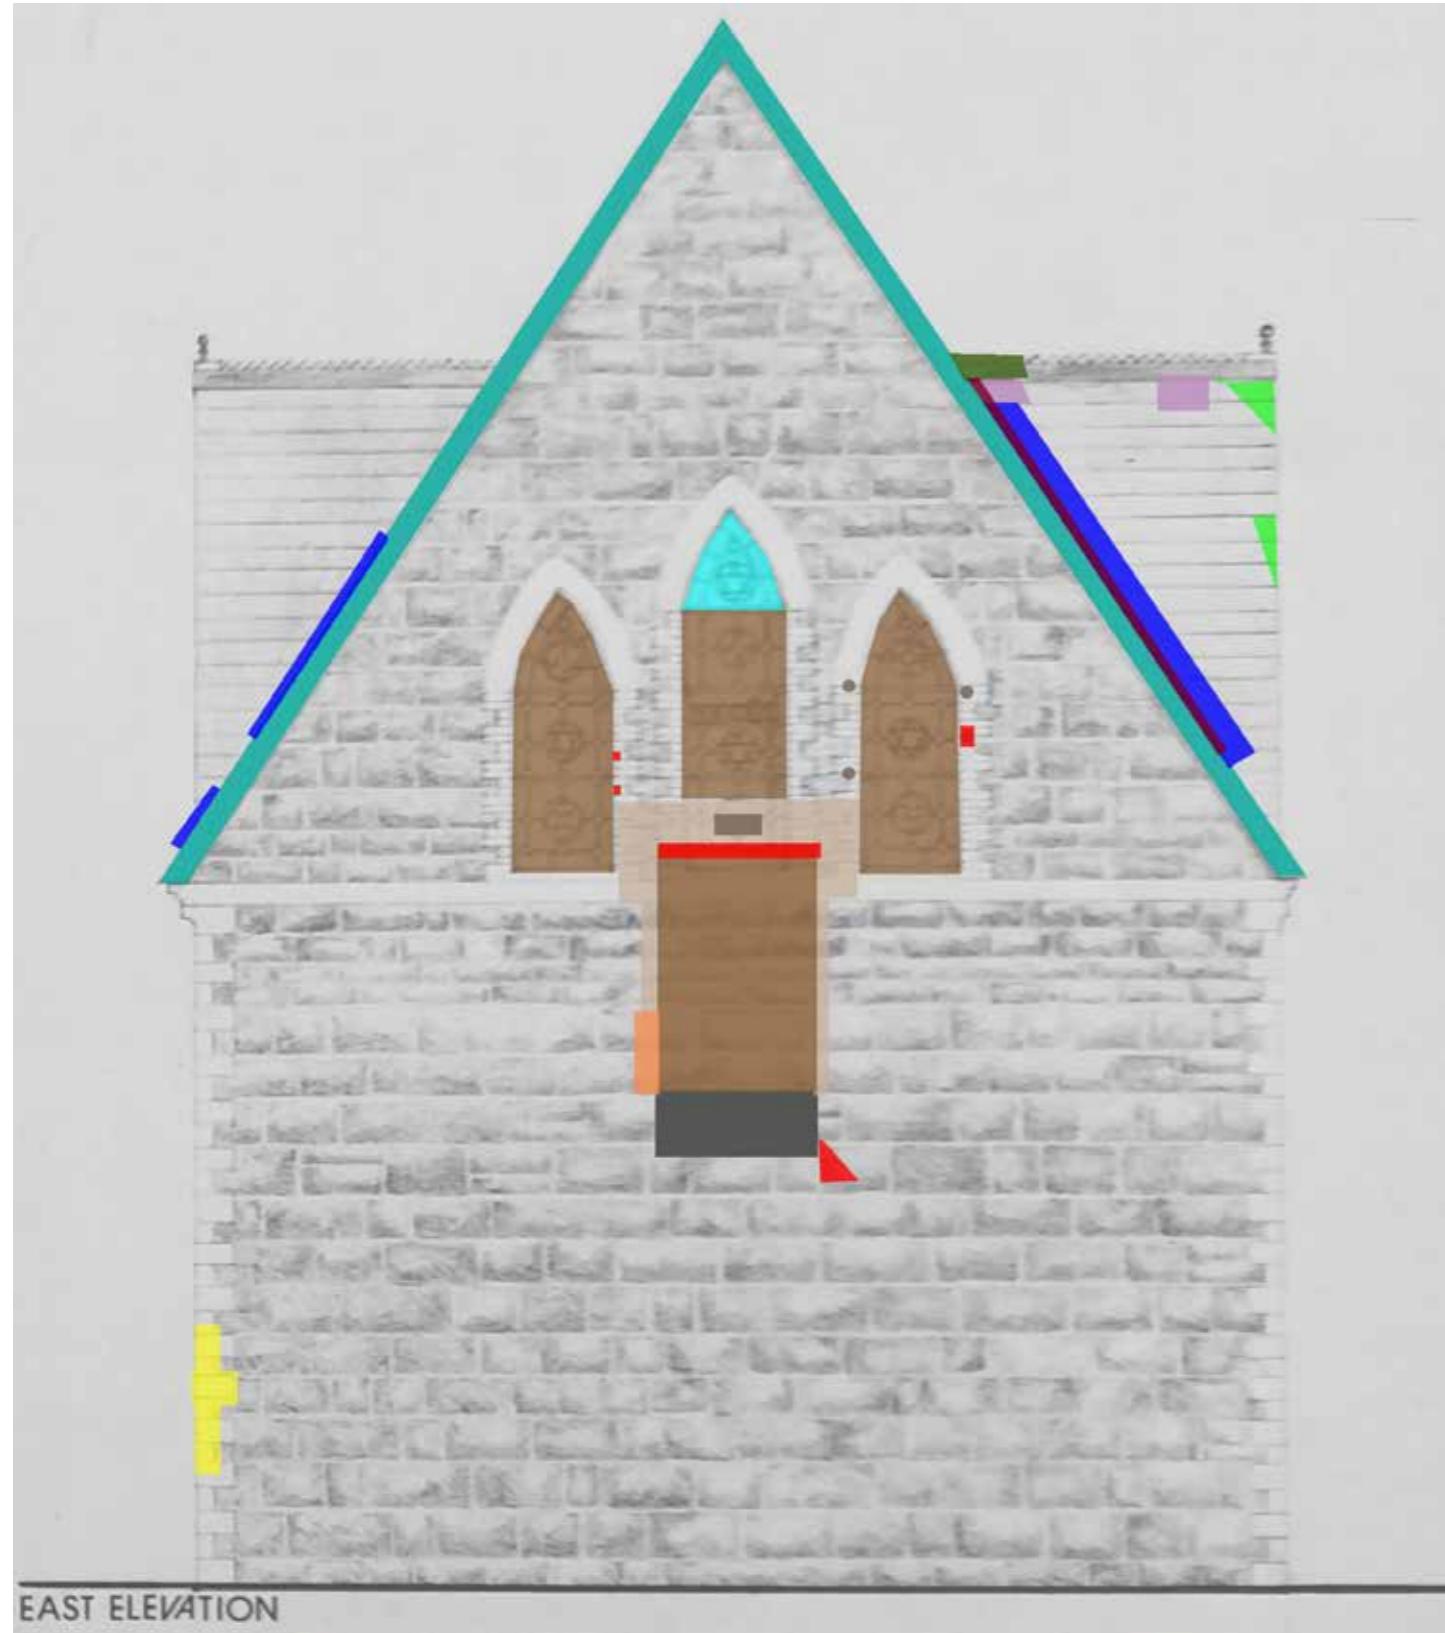
## 5.4 REAR (EAST) ELEVATION

## Drawing Identifying Areas Of Poor Condition

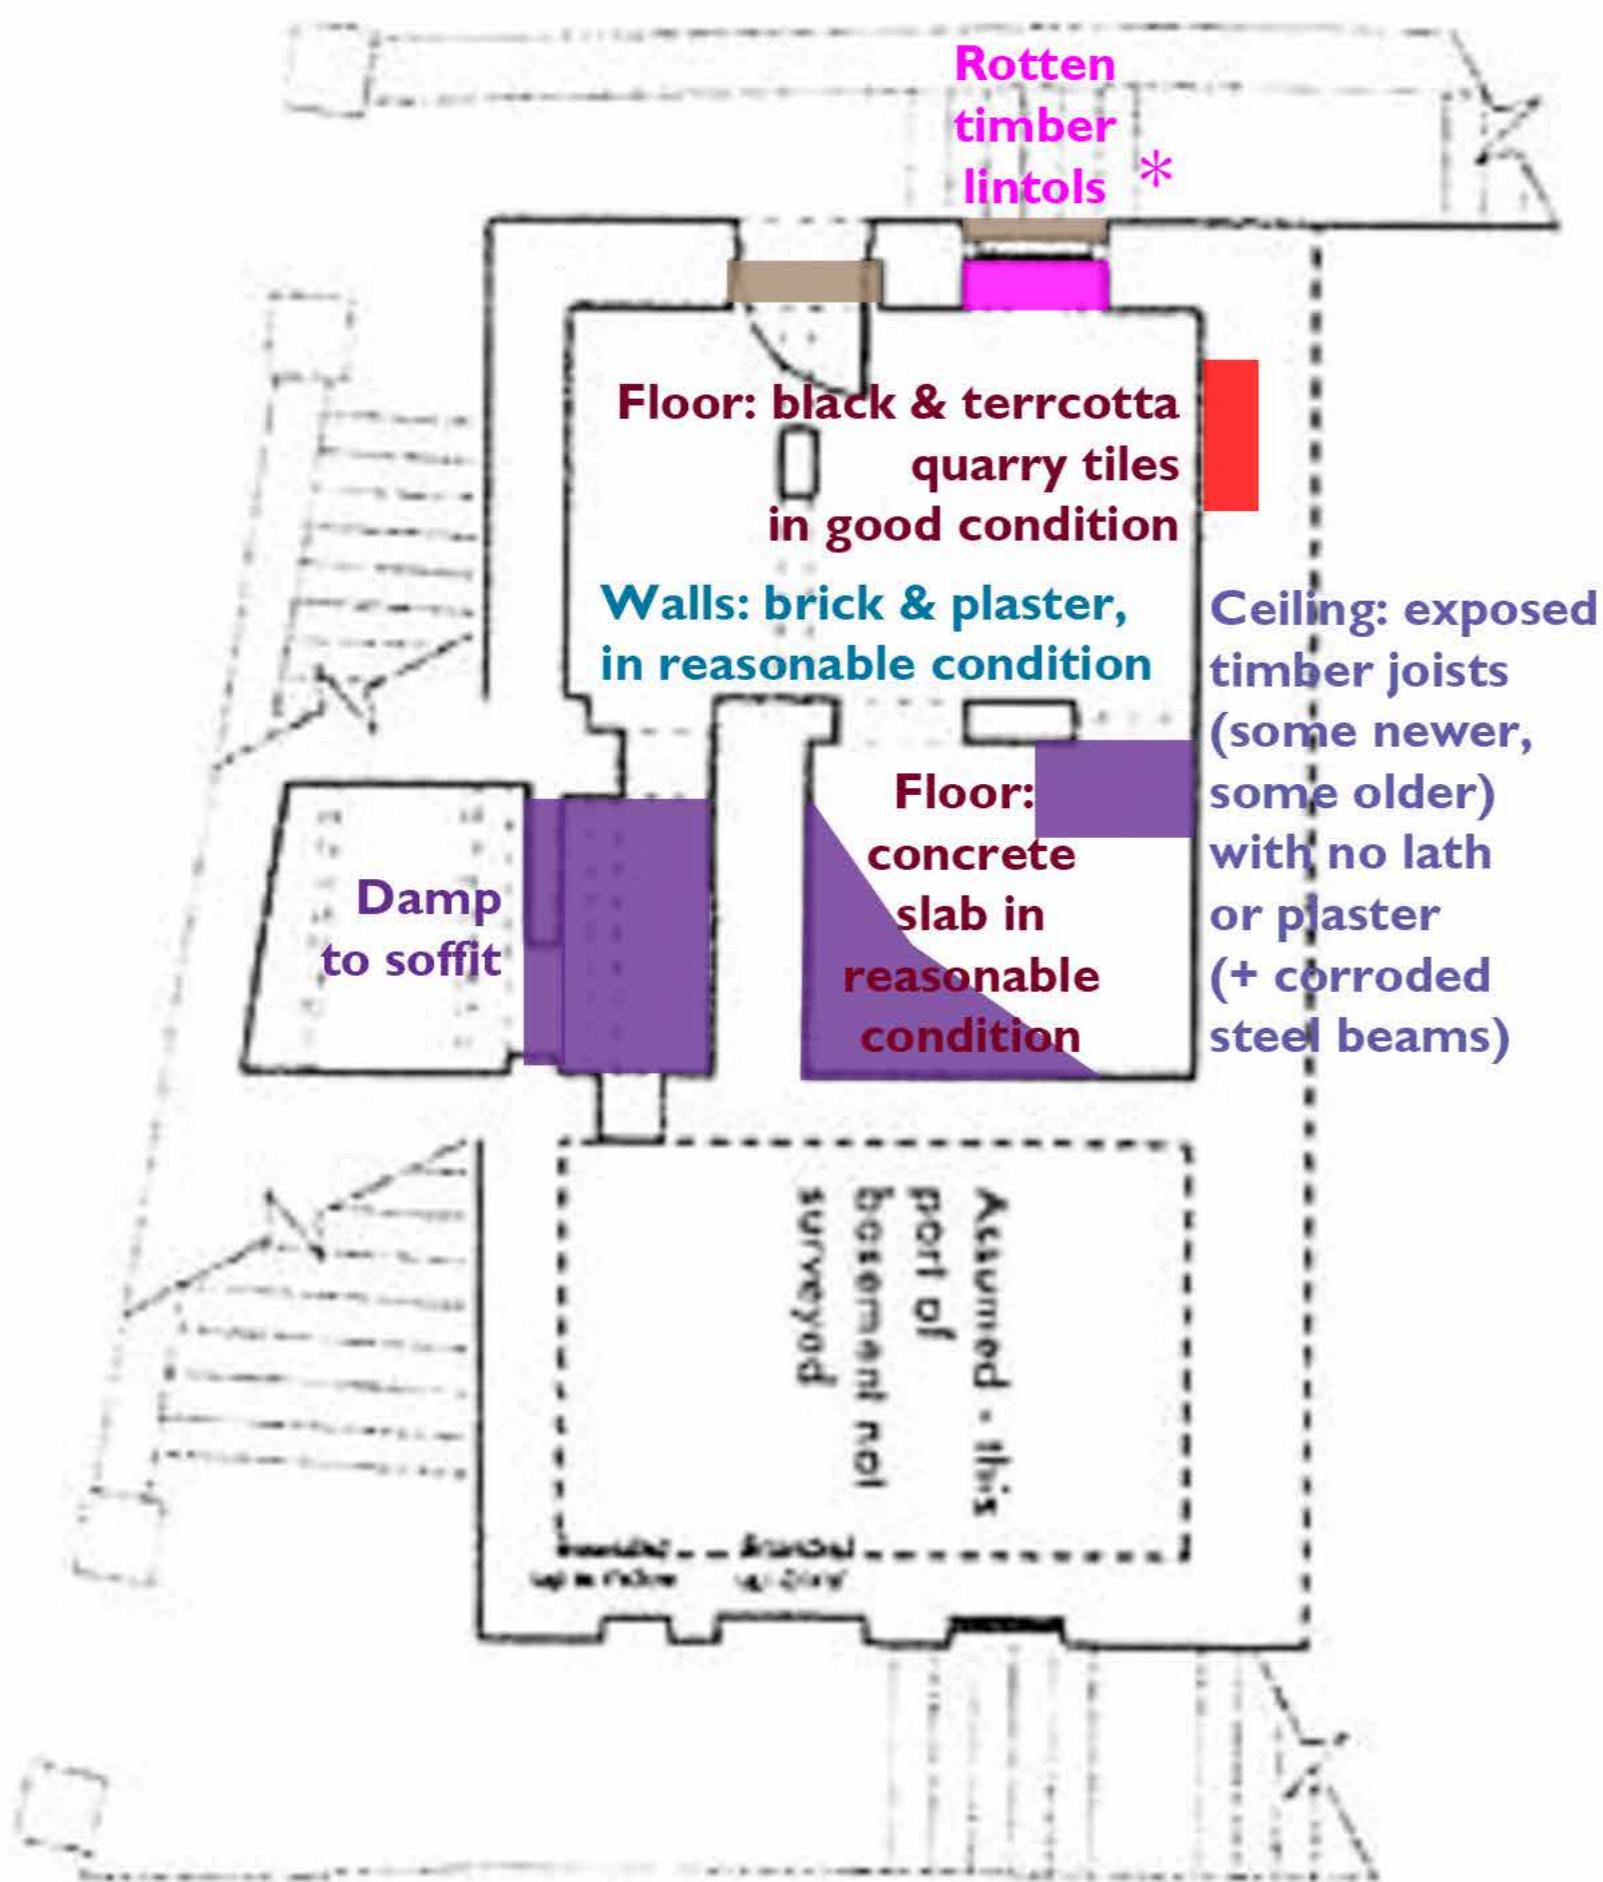
## 5.5 LOWER GROUND FLOOR

## Drawing Identifying Areas Of Poor Condition

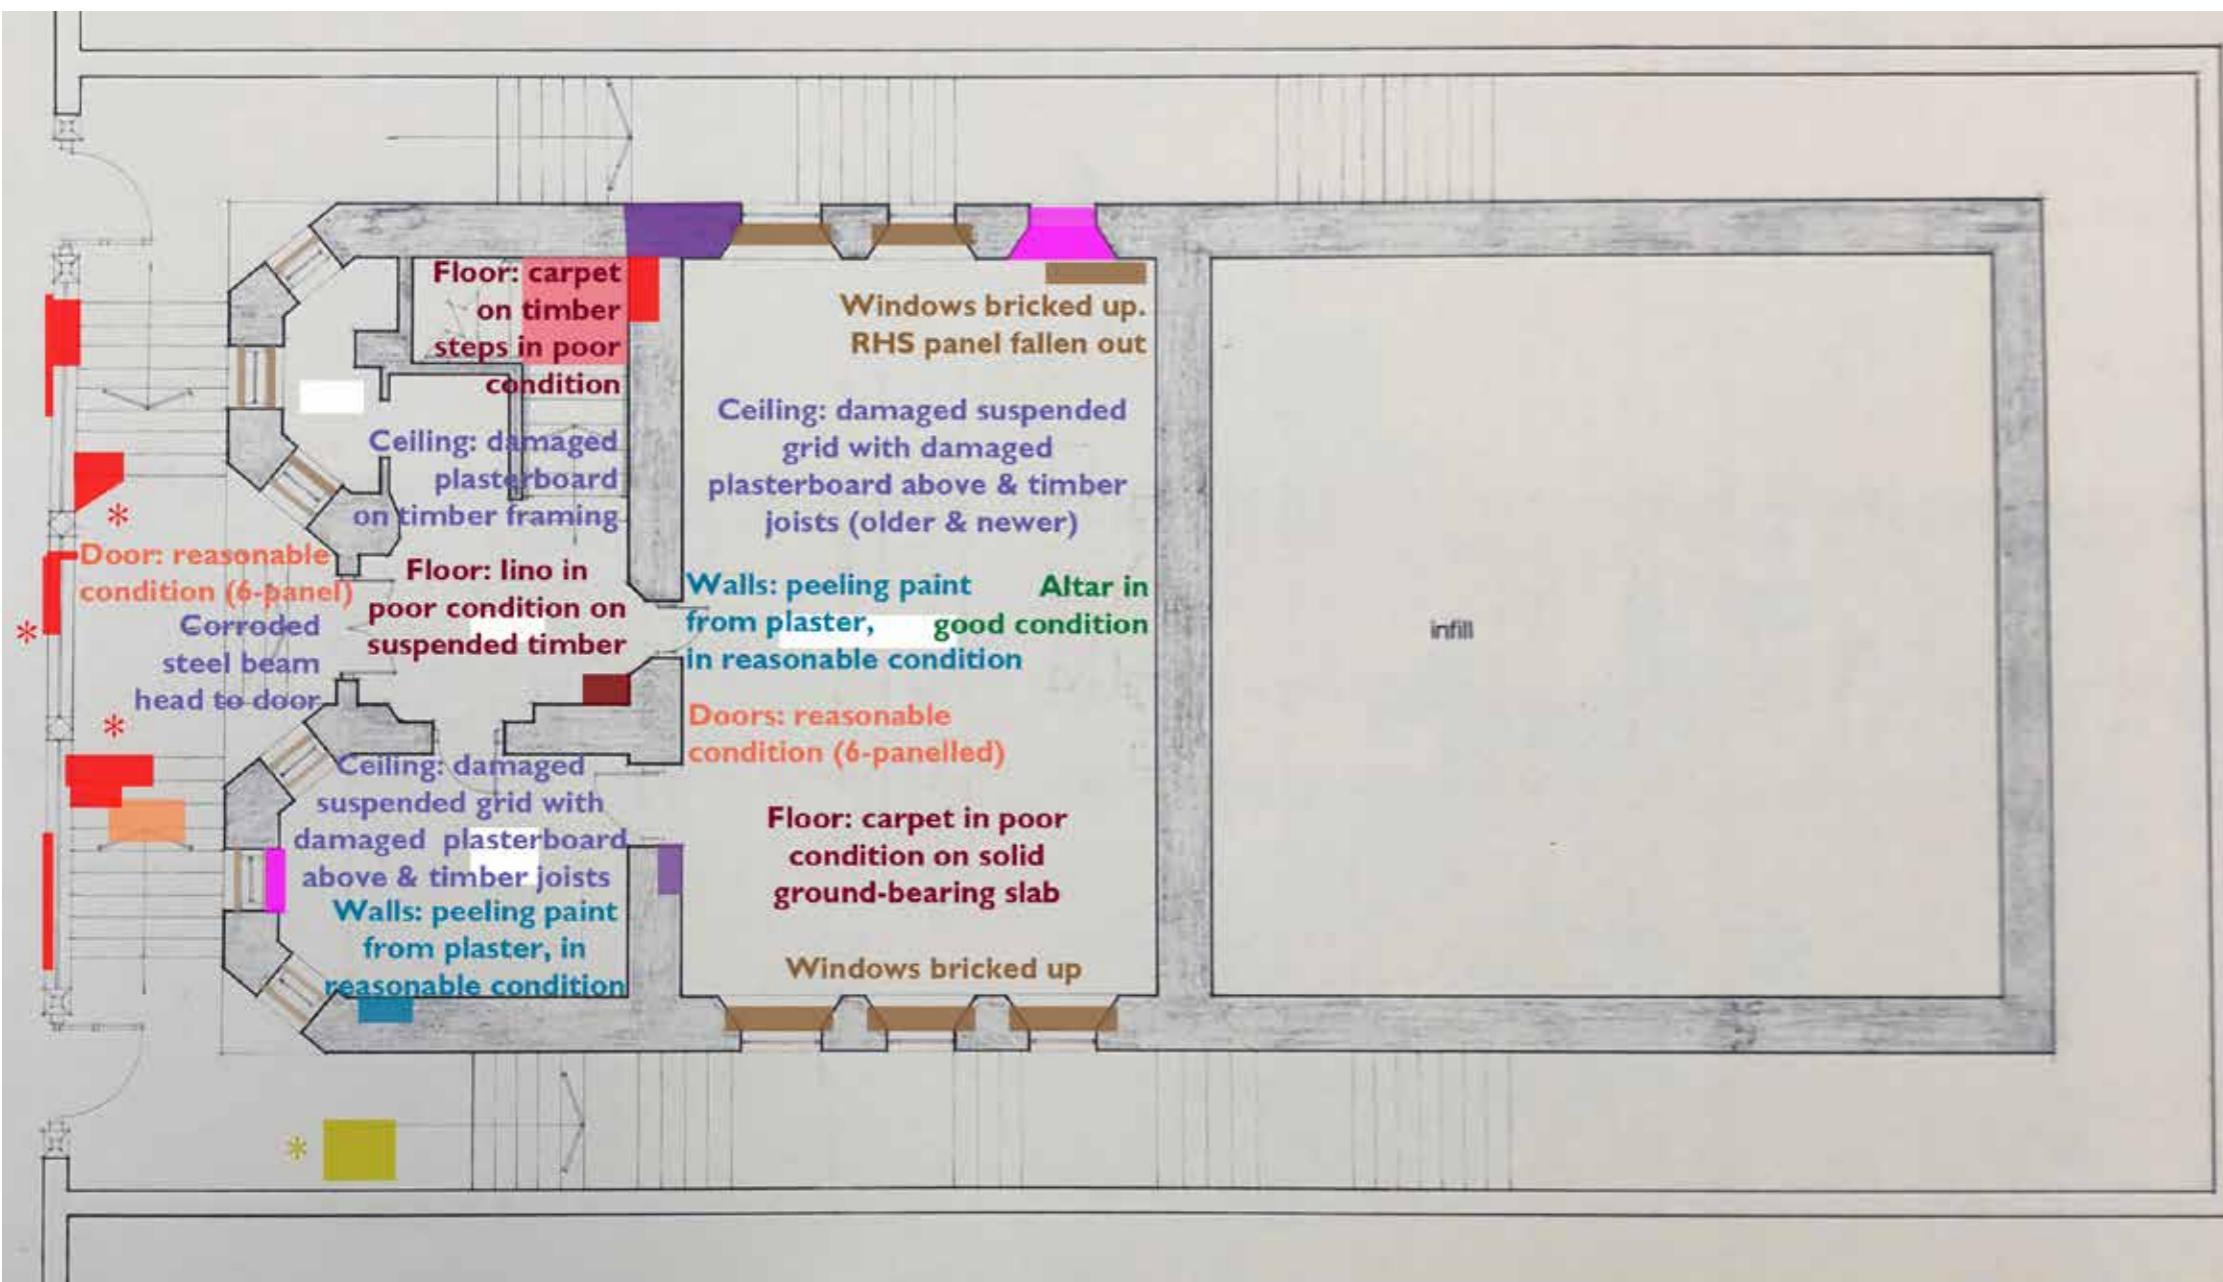
## 5.6 UPPER GROUND FLOOR PLAN

### Drawing Identifying Areas Of Poor Condition

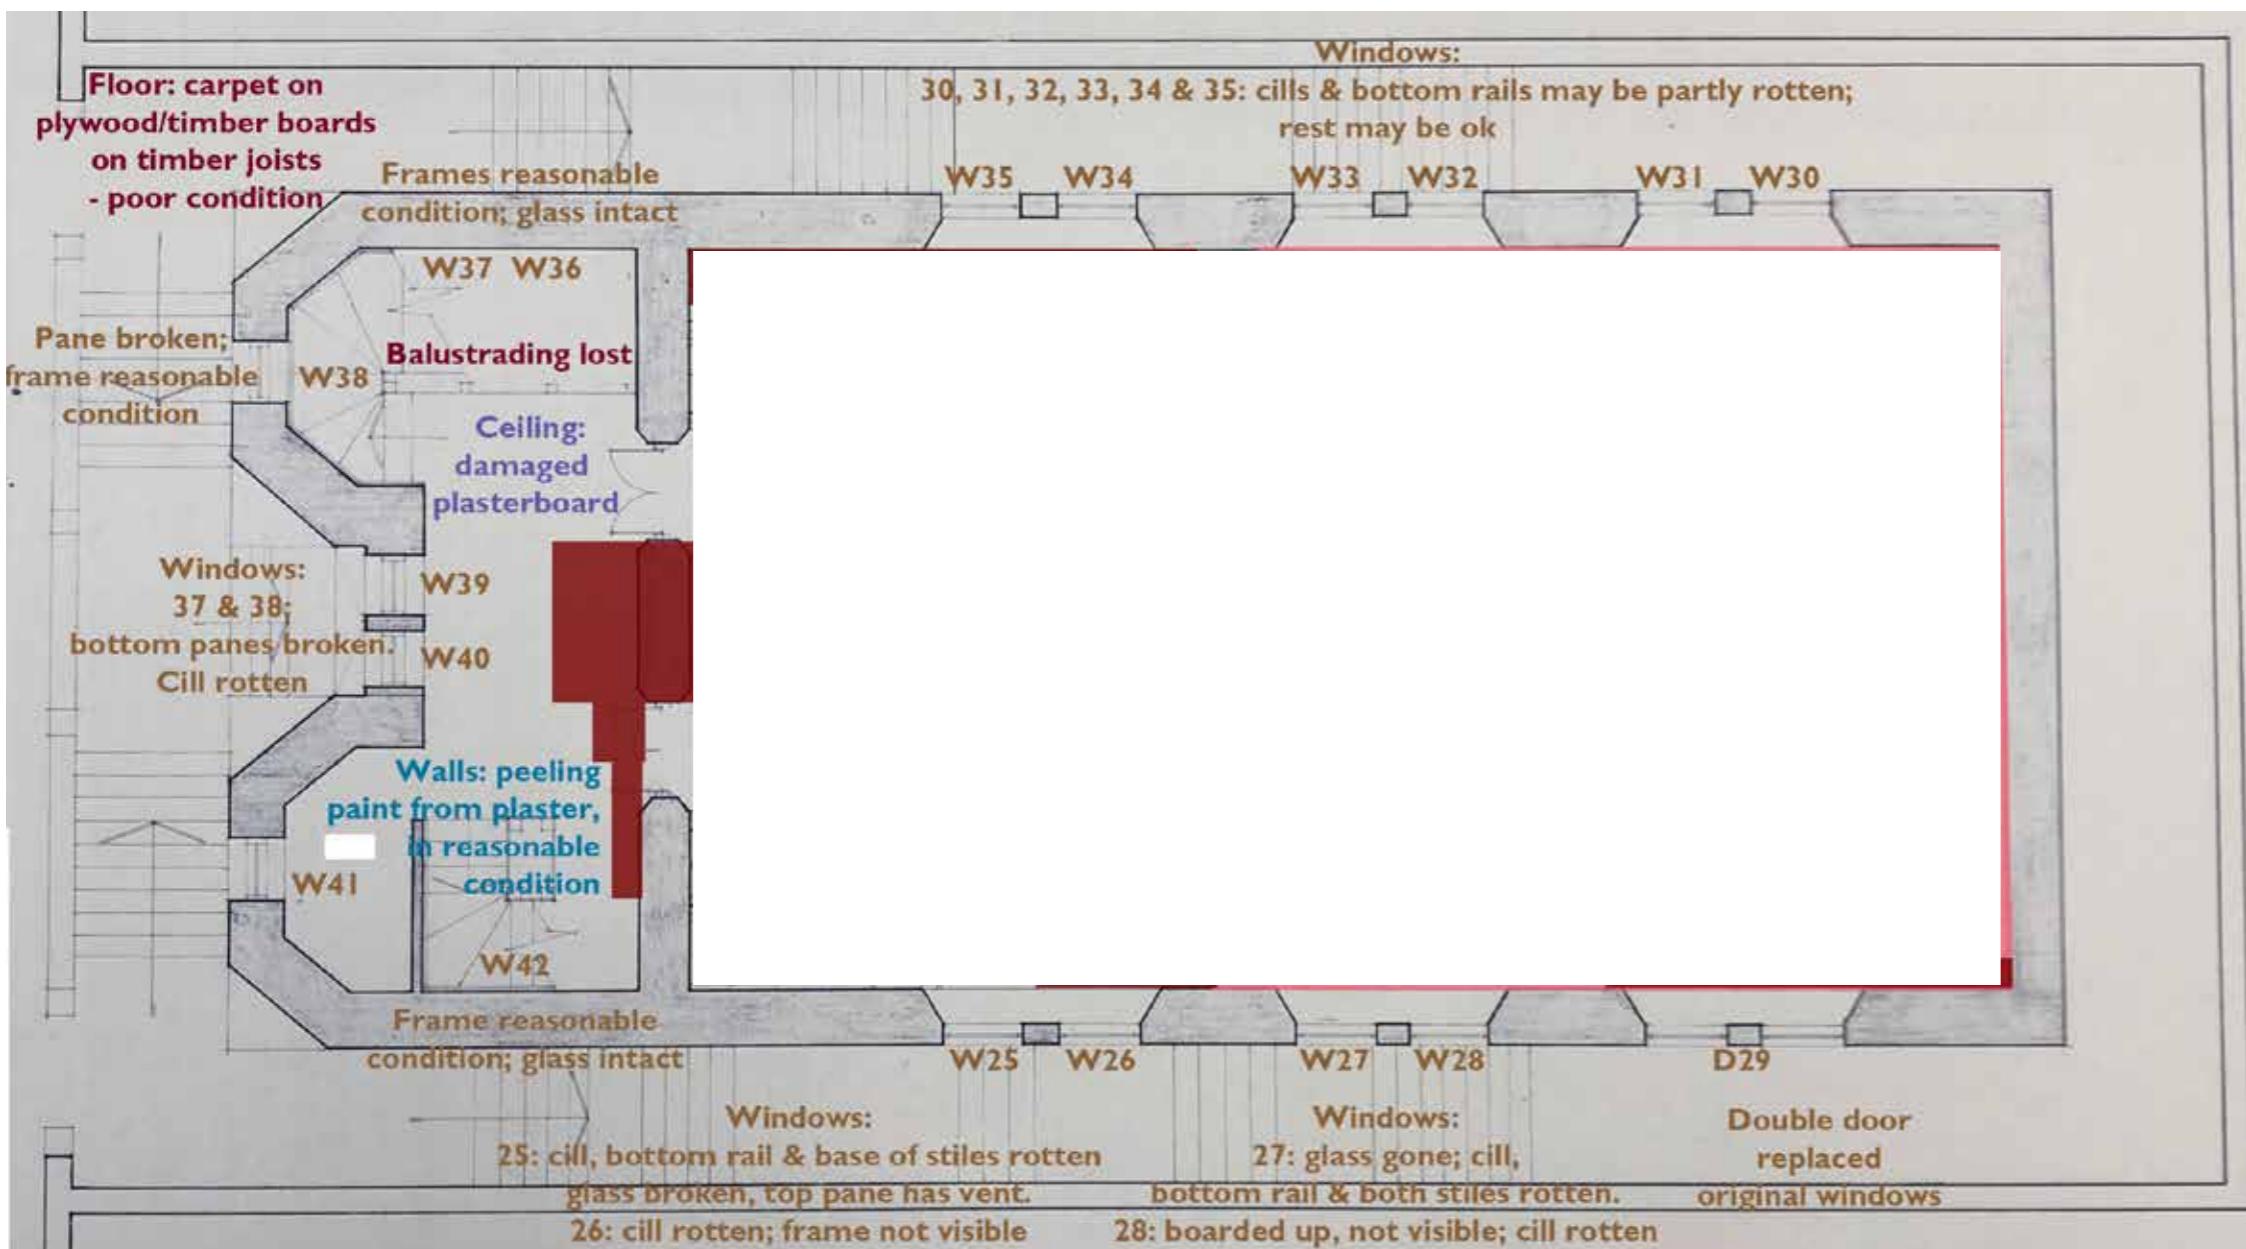
## 5.7 FIRST FLOOR PLAN (TO BE FURTHER DEVELOPED)

## Drawing Identifying Areas Of Poor Condition

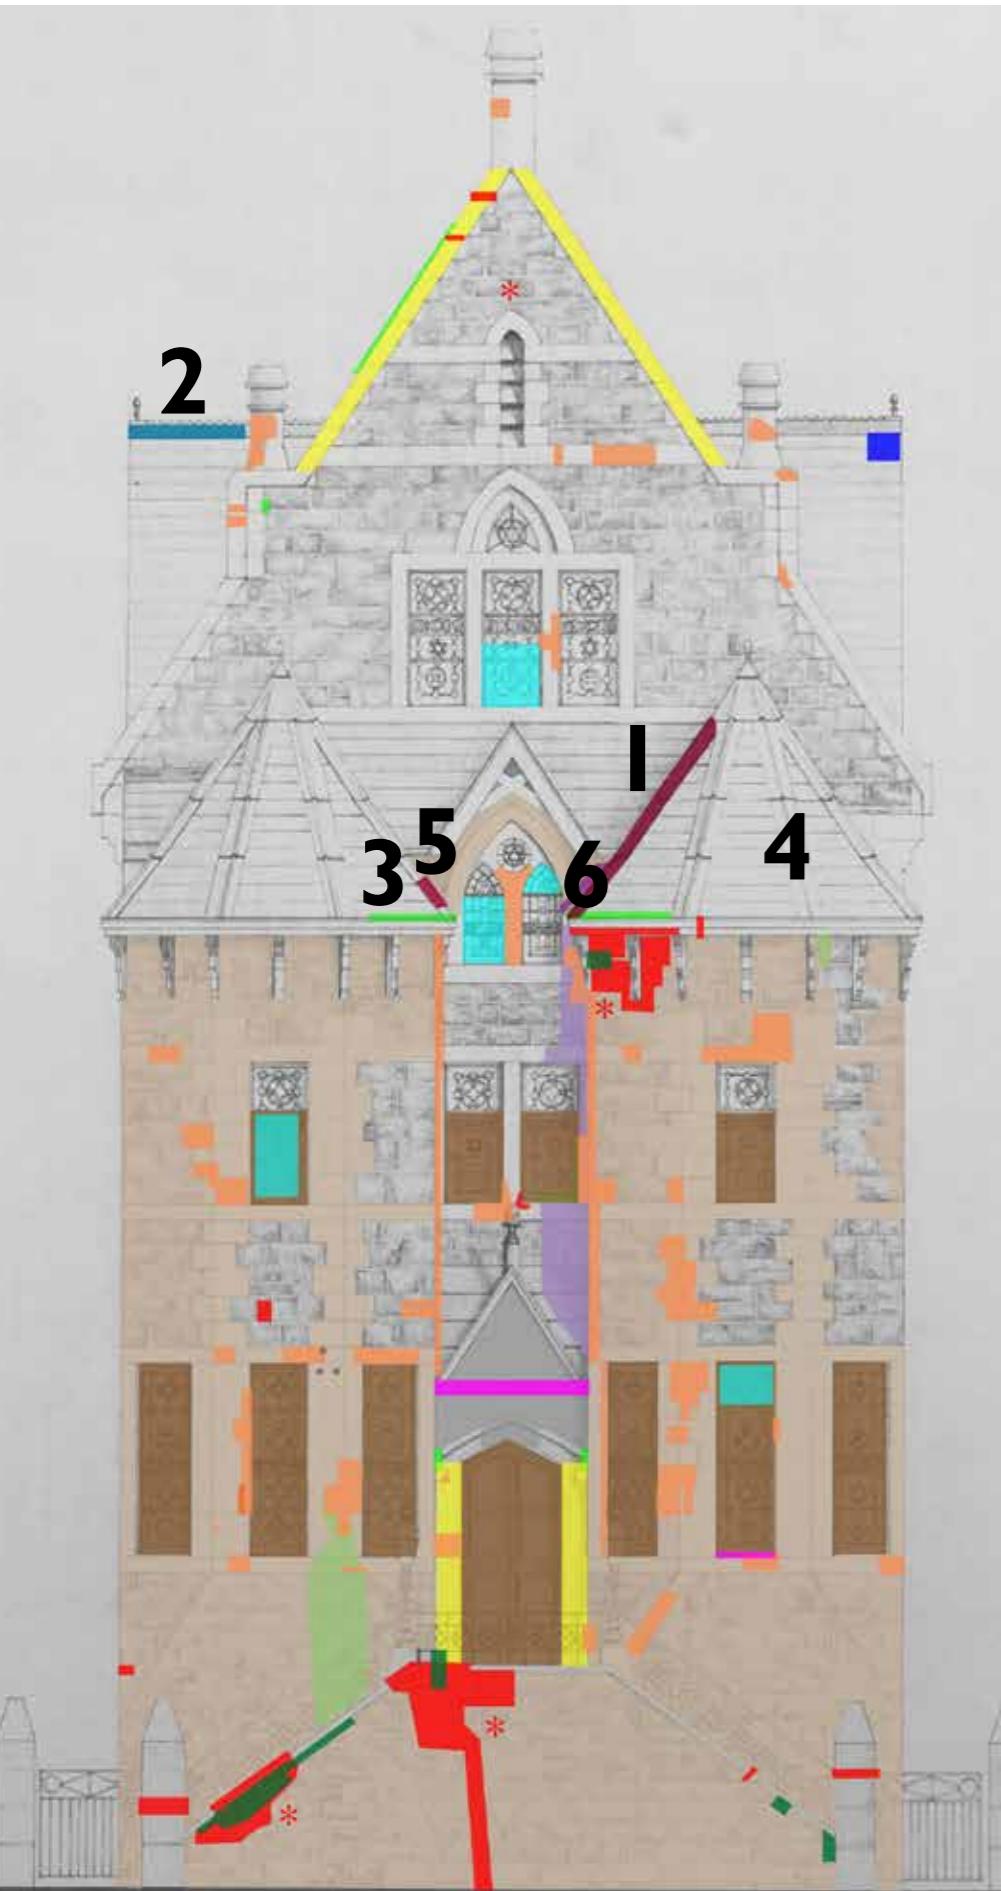
**6.1 FRONT (WEST) ELEVATION**

Examples of Condition Issues with the Roof  
(with numbers referring to photographs)

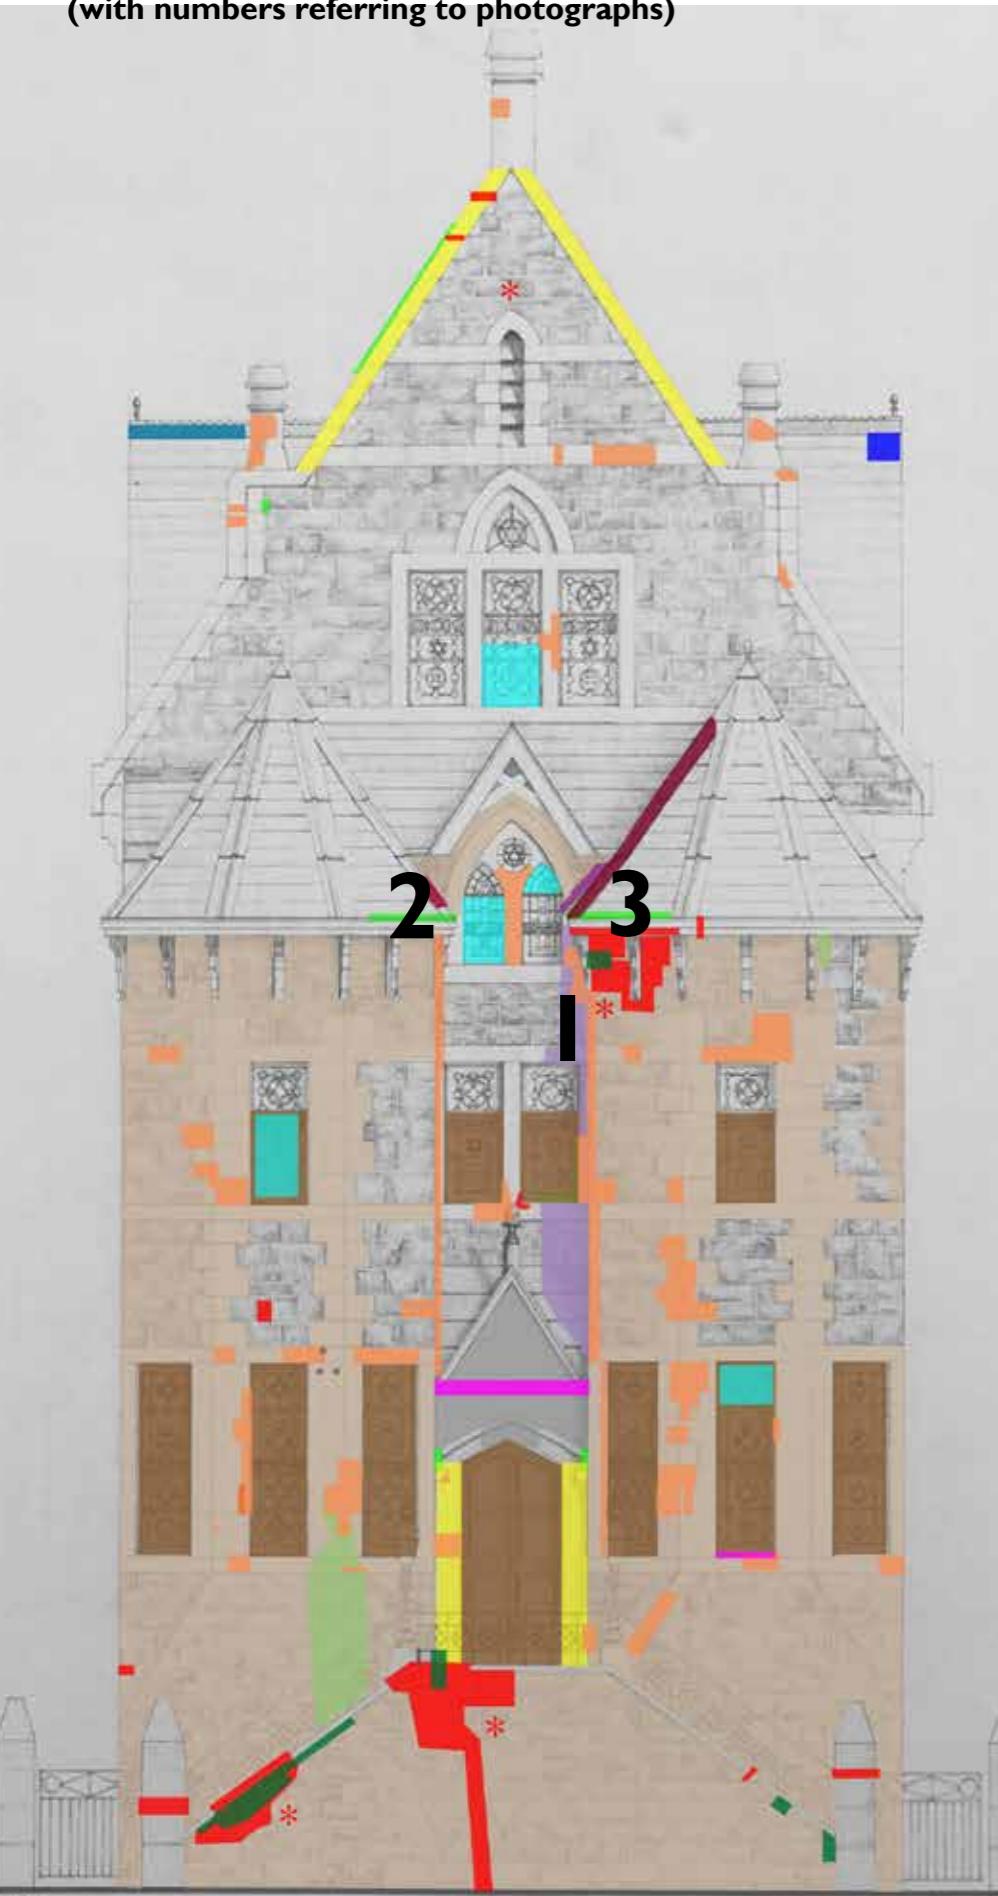
**6.1 FRONT (WEST) ELEVATION****Examples of Condition Issues****with the Rainwater Goods****(with numbers referring to photographs)**

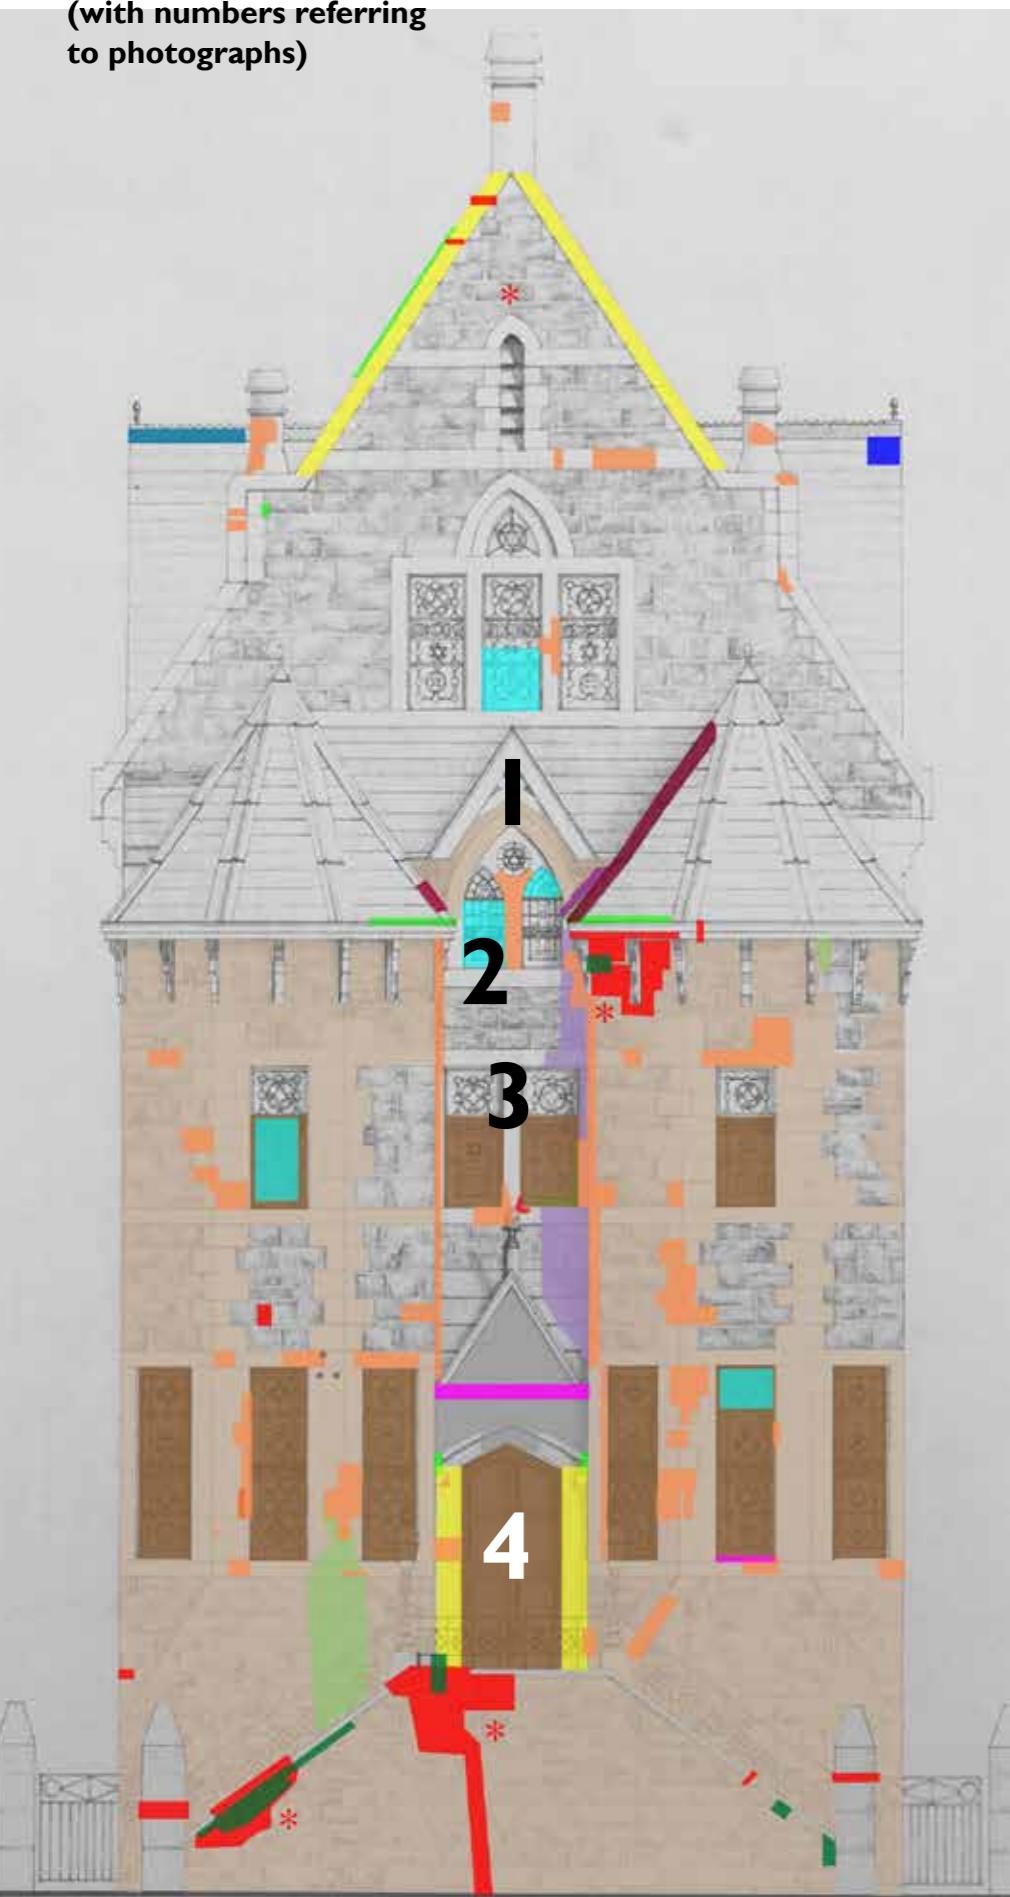
**6.1 FRONT (WEST) ELEVATION**

Examples of Condition Issues  
with the Windows & Door  
(with numbers referring  
to photographs)

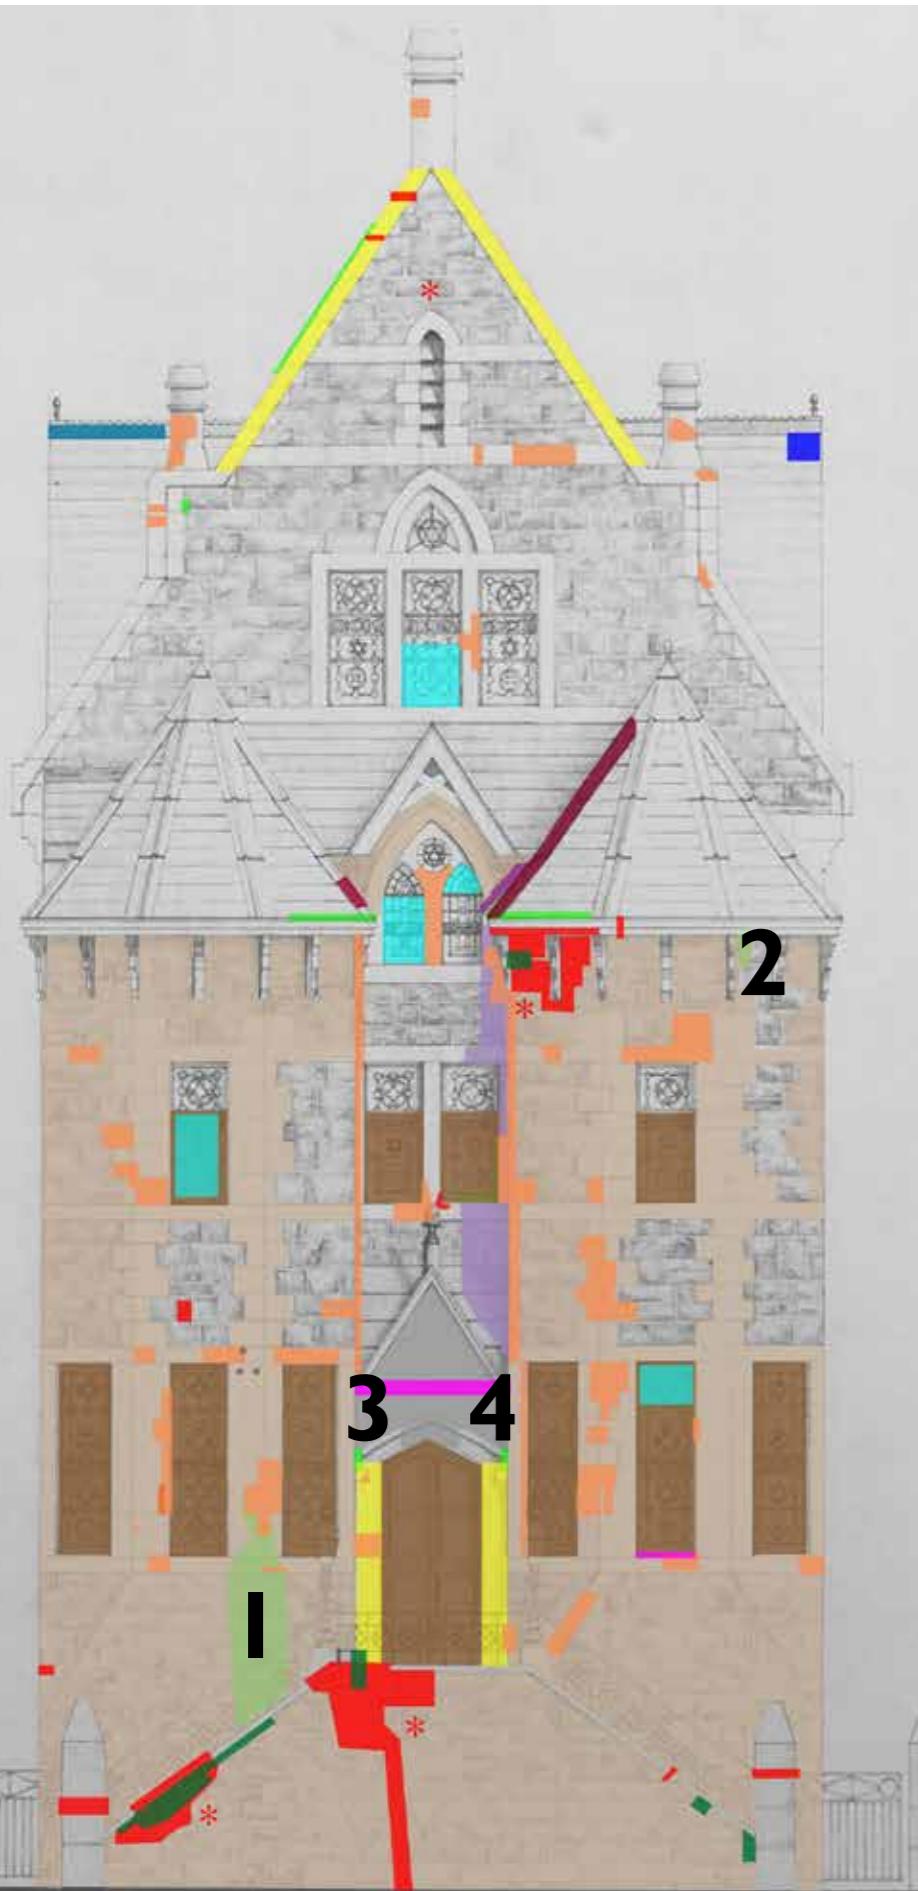
**6.1 FRONT (WEST) ELEVATION**

Examples of Condition Issues with Vegetation  
(with numbers referring to photographs)

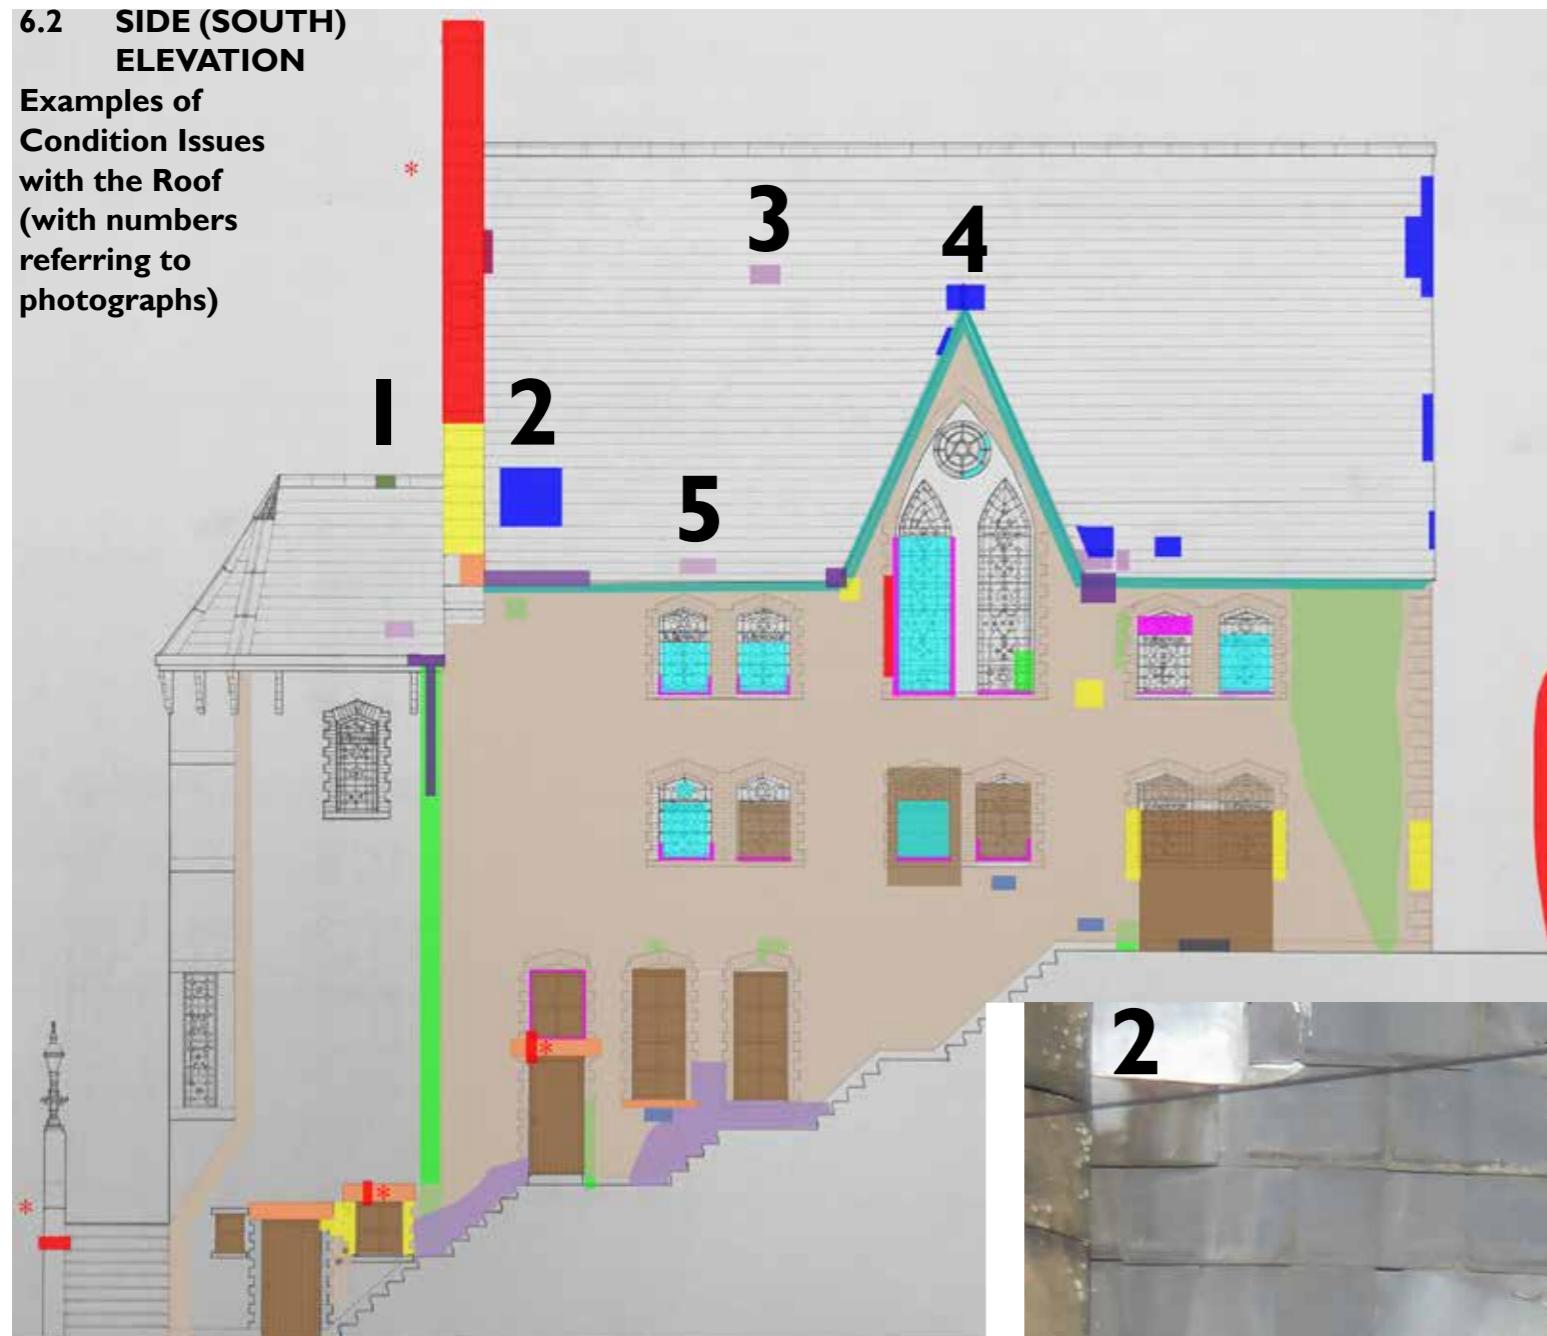
**6.2 SIDE (SOUTH) ELEVATION**

Examples of Condition Issues with the Roof (with numbers referring to photographs)
