# Synagogue, Merthyr Tydfil

## RECORD OF BUILDING AND CONDITION ASSESSMENT REPORT

.....  
(449)2503-GVVP-A-HIS-P00

Date: 17.03.25

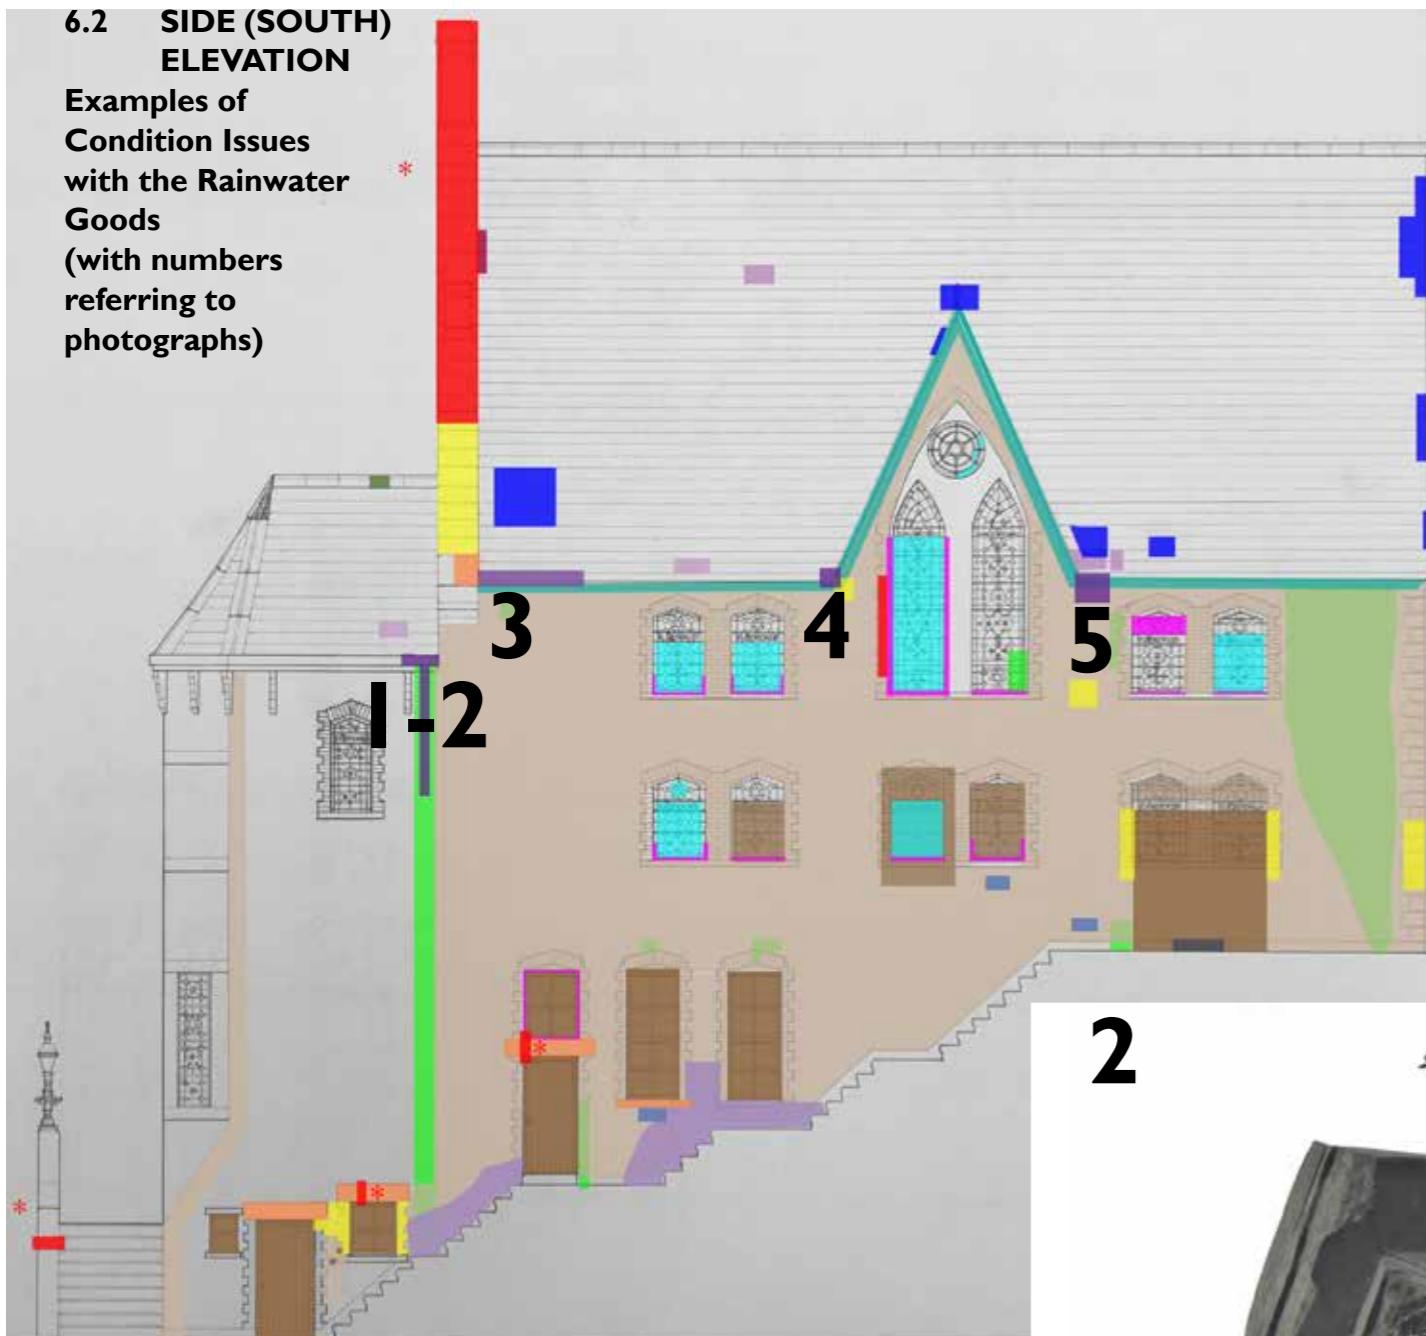
**6.2 SIDE (SOUTH) ELEVATION**

Examples of Condition Issues with the Rainwater Goods (with numbers referring to photographs)

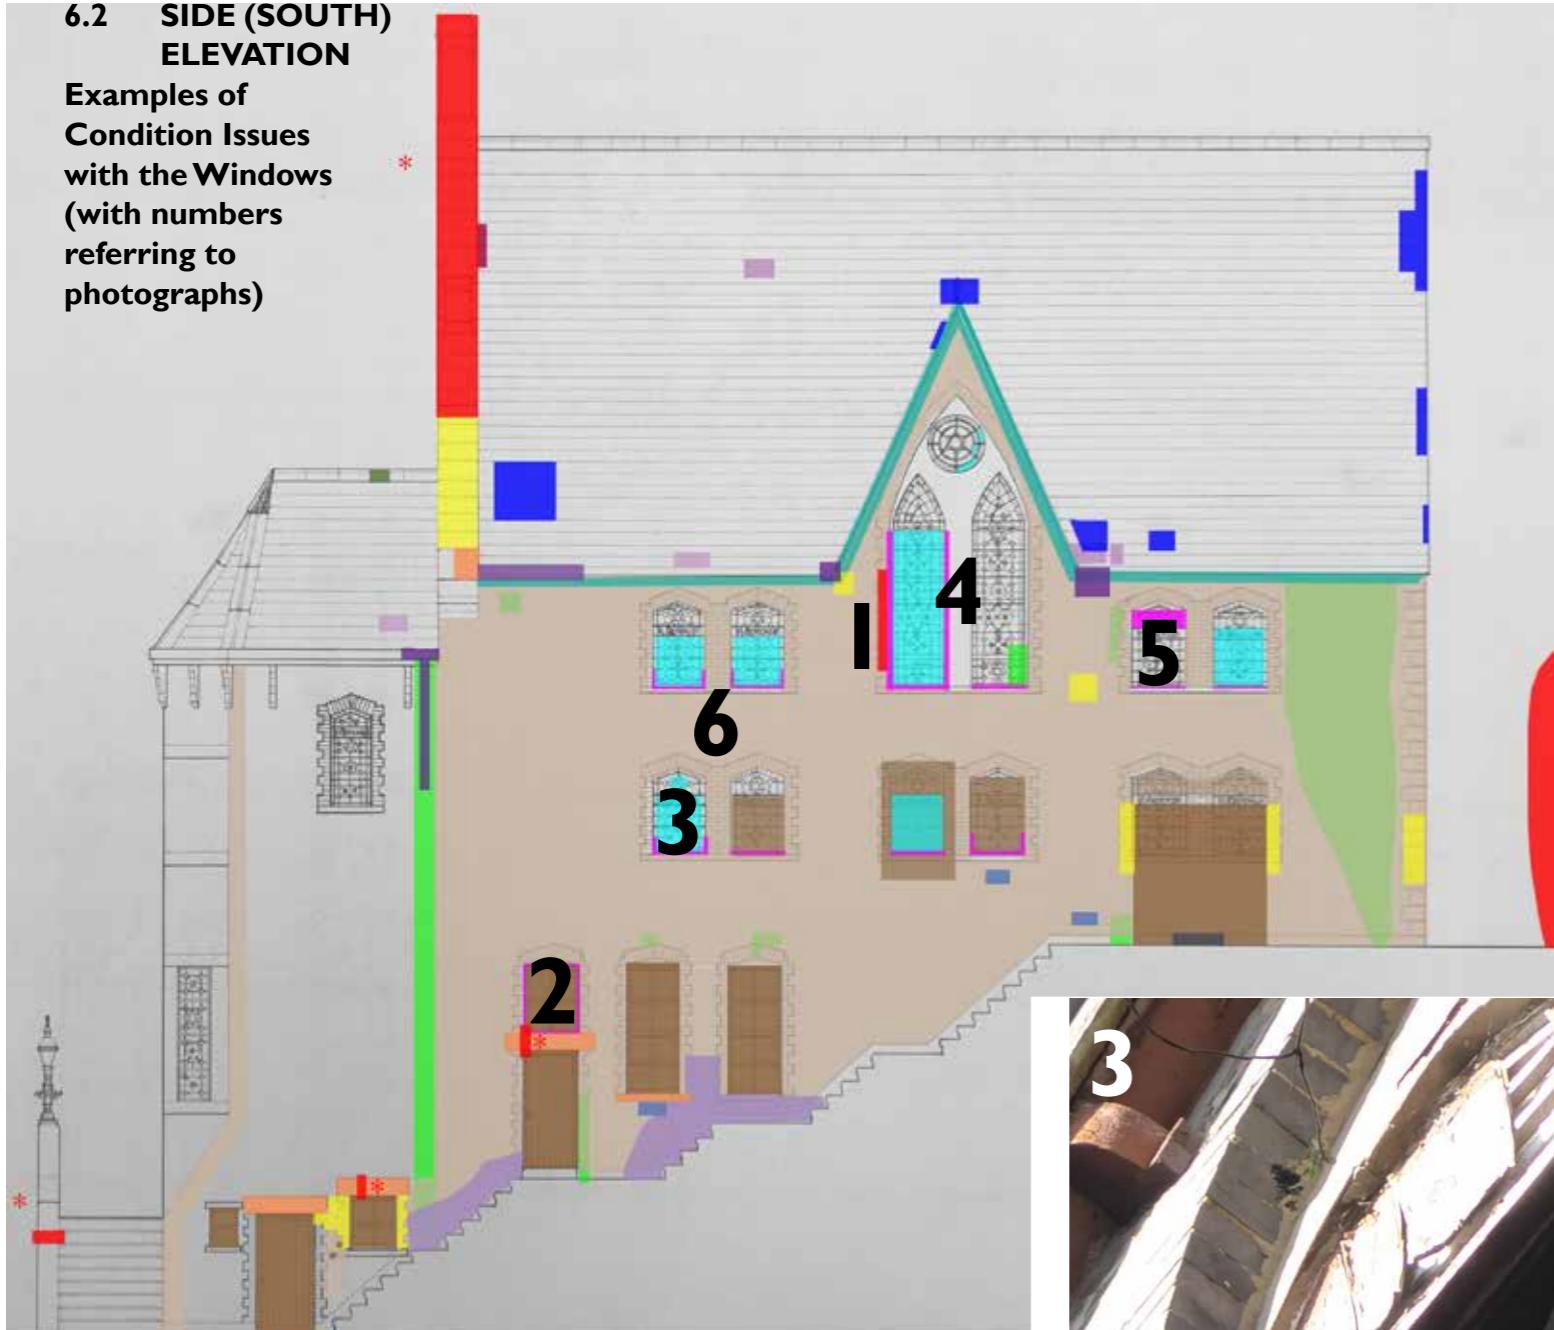
## 6.2 SIDE (SOUTH) ELEVATION

Examples of Condition Issues with the Windows (with numbers referring to photographs)

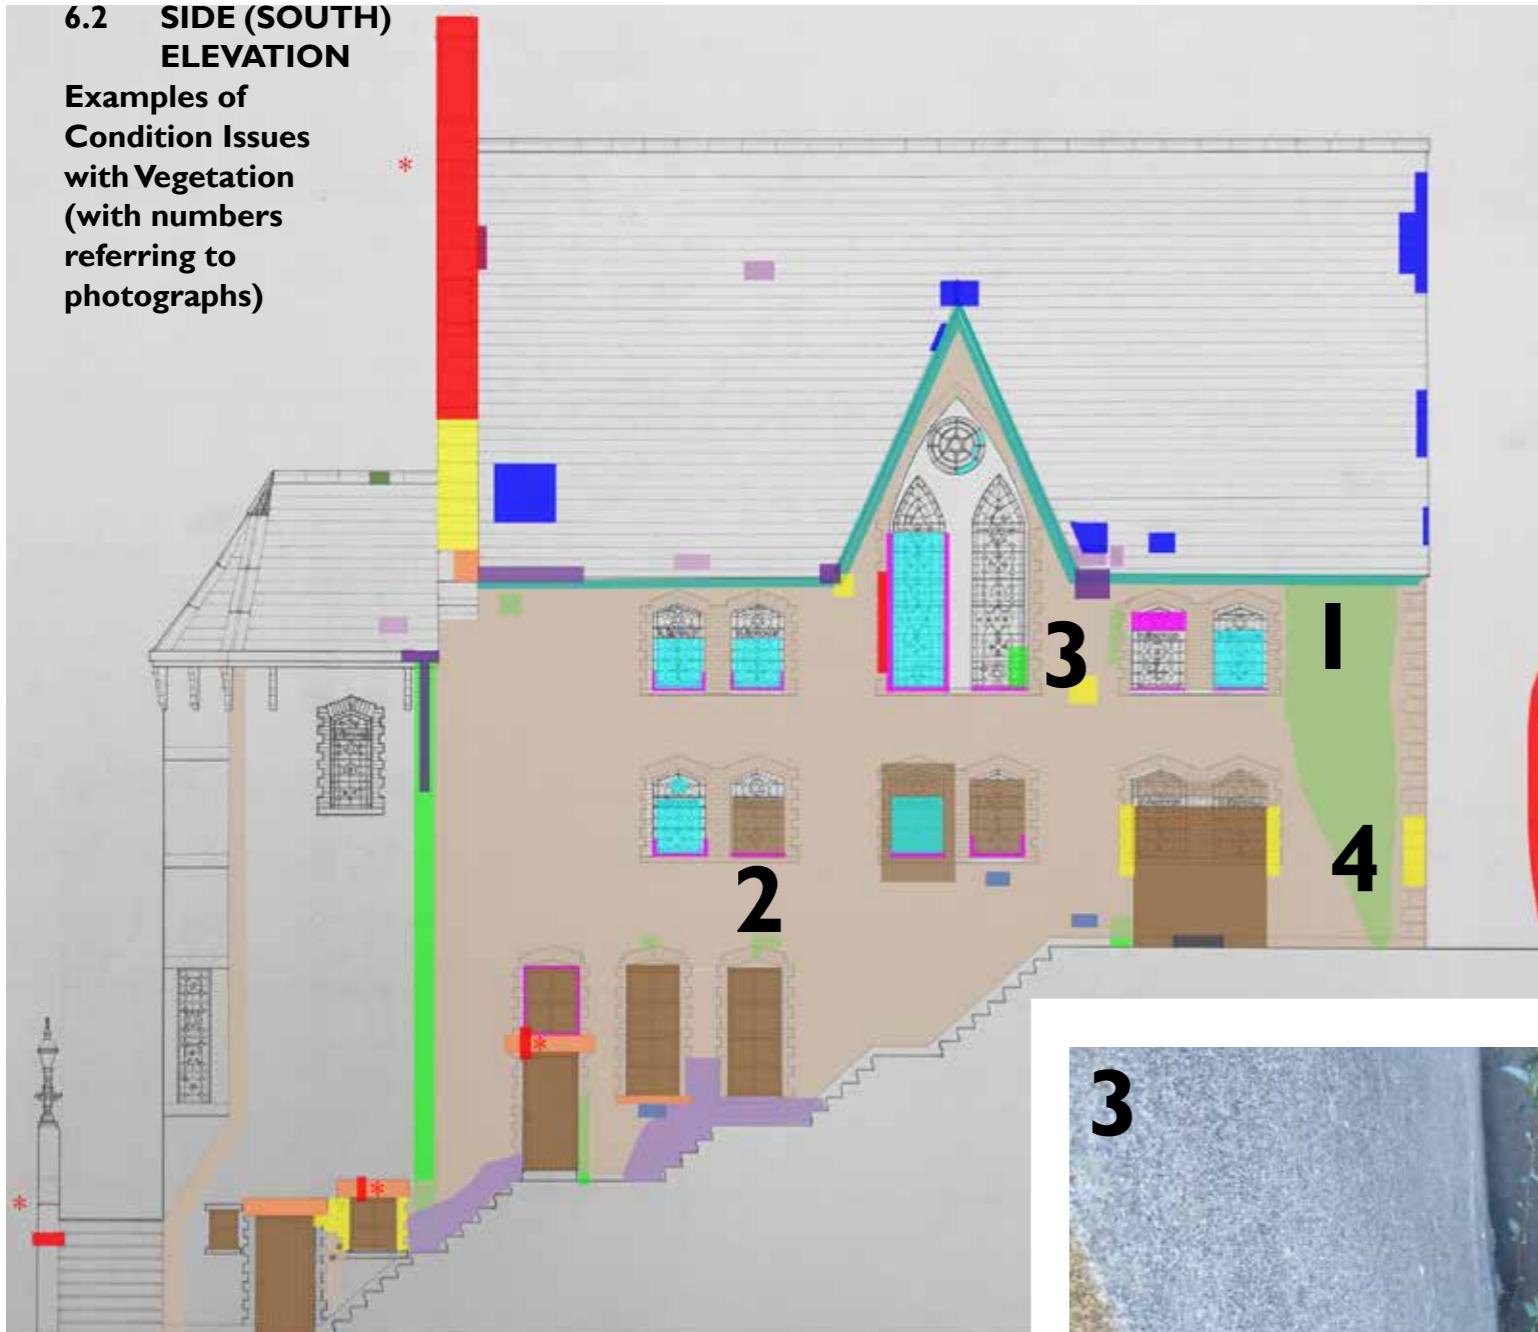
## 6.2 SIDE (SOUTH) ELEVATION

Examples of Condition Issues with Vegetation (with numbers referring to photographs)

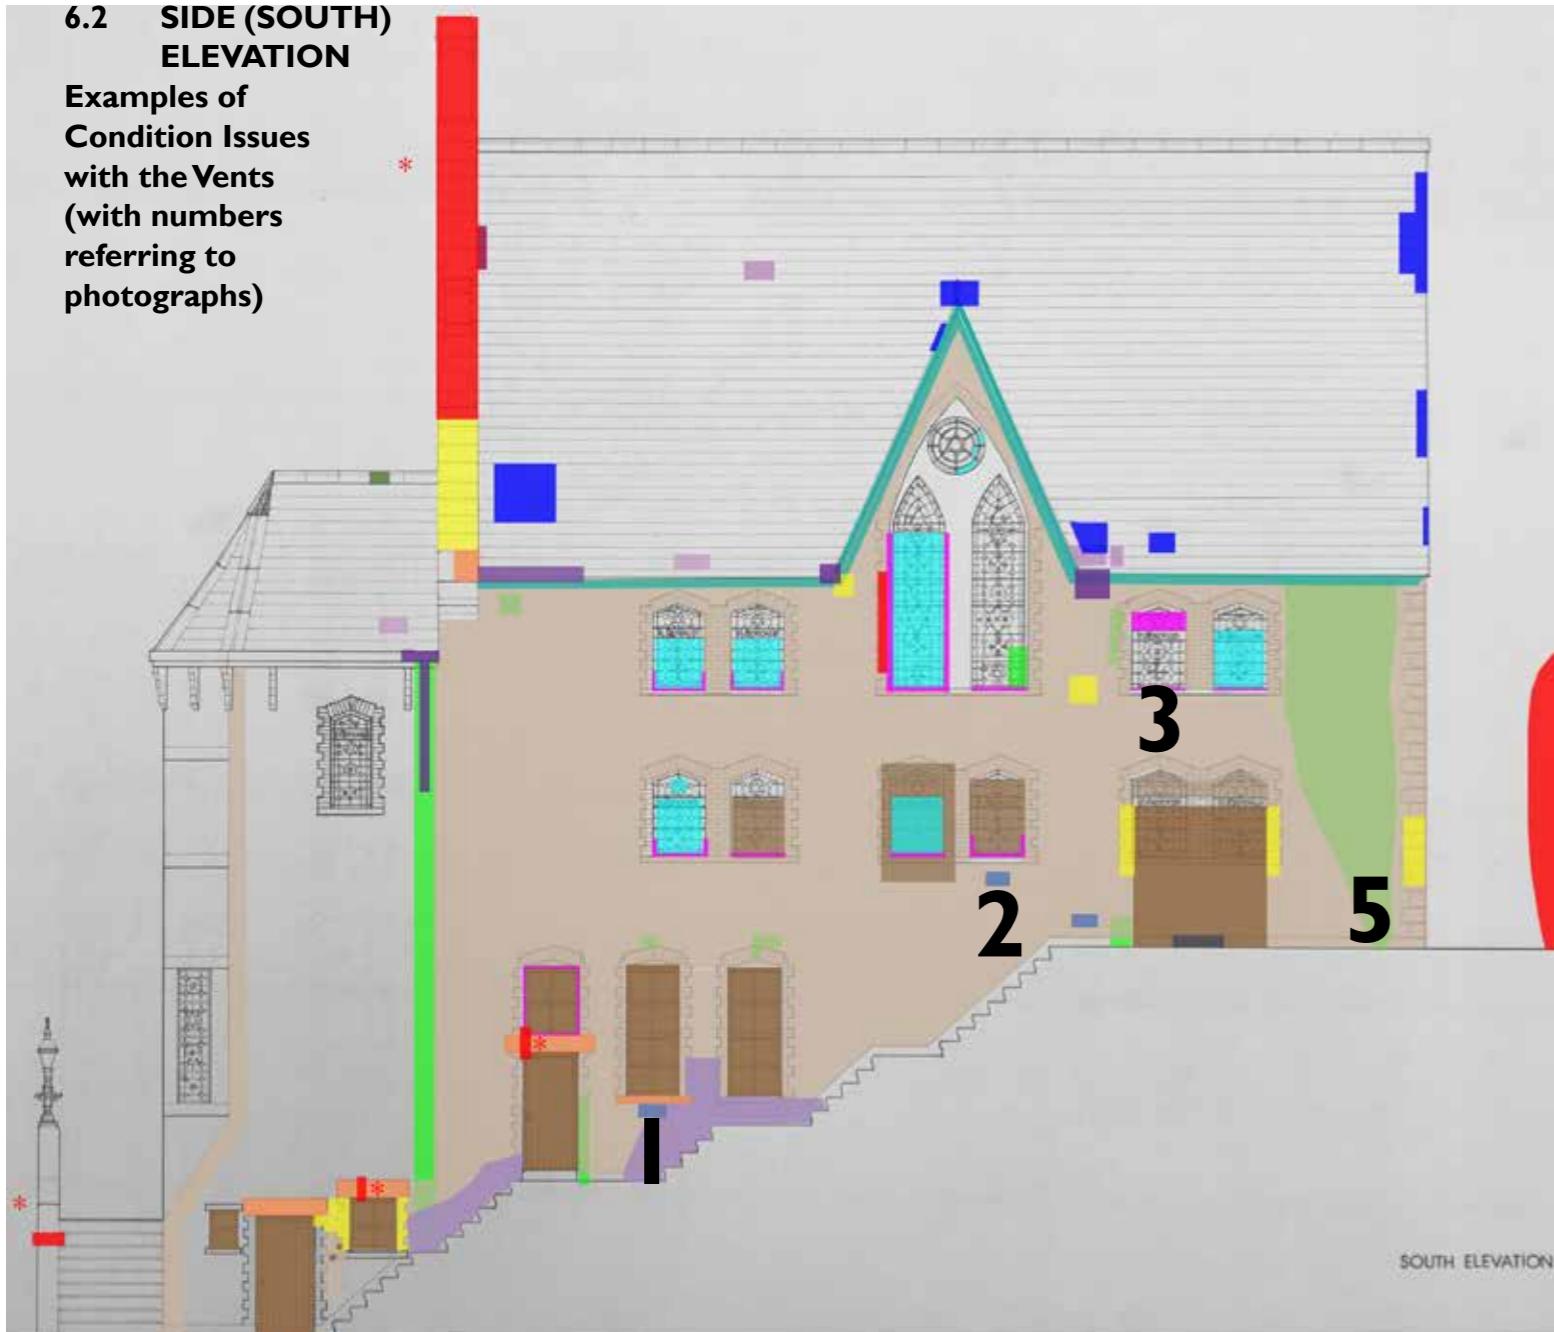
## 6.2 SIDE (SOUTH) ELEVATION

Examples of Condition Issues with the Vents (with numbers referring to photographs)

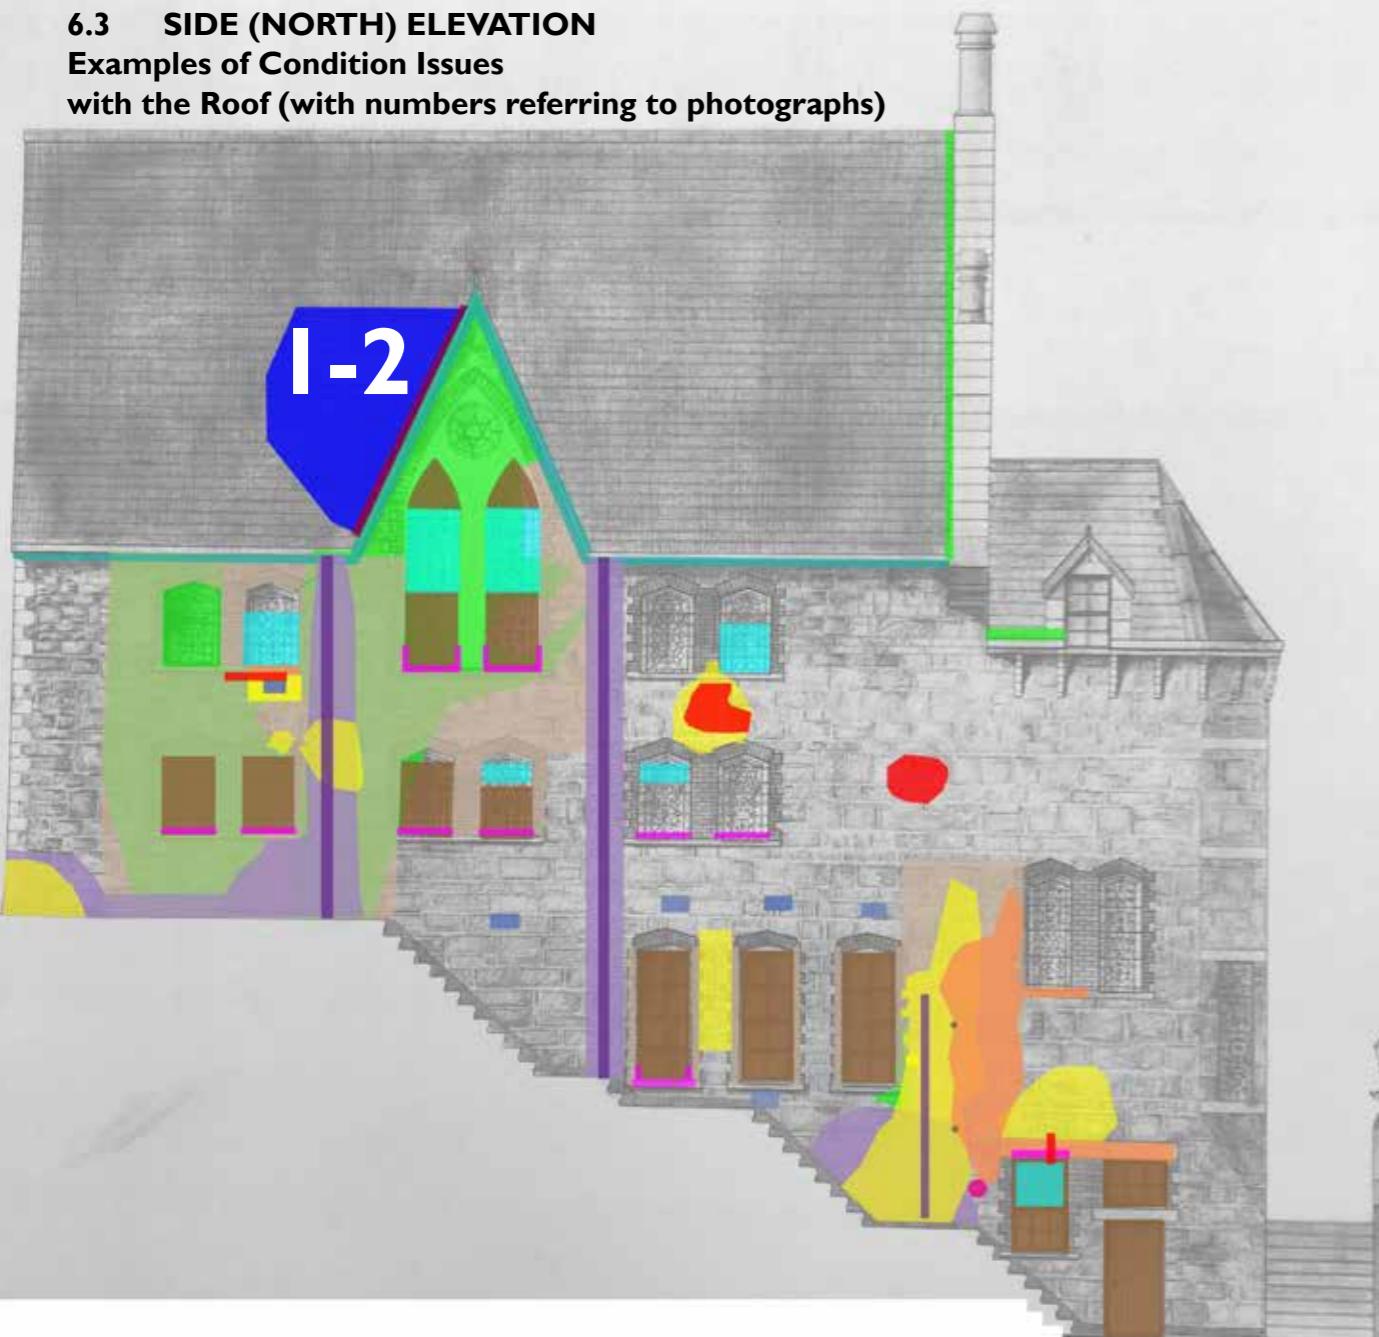
### 6.3 SIDE (NORTH) ELEVATION

#### Examples of Condition Issues

with the Roof (with numbers referring to photographs)

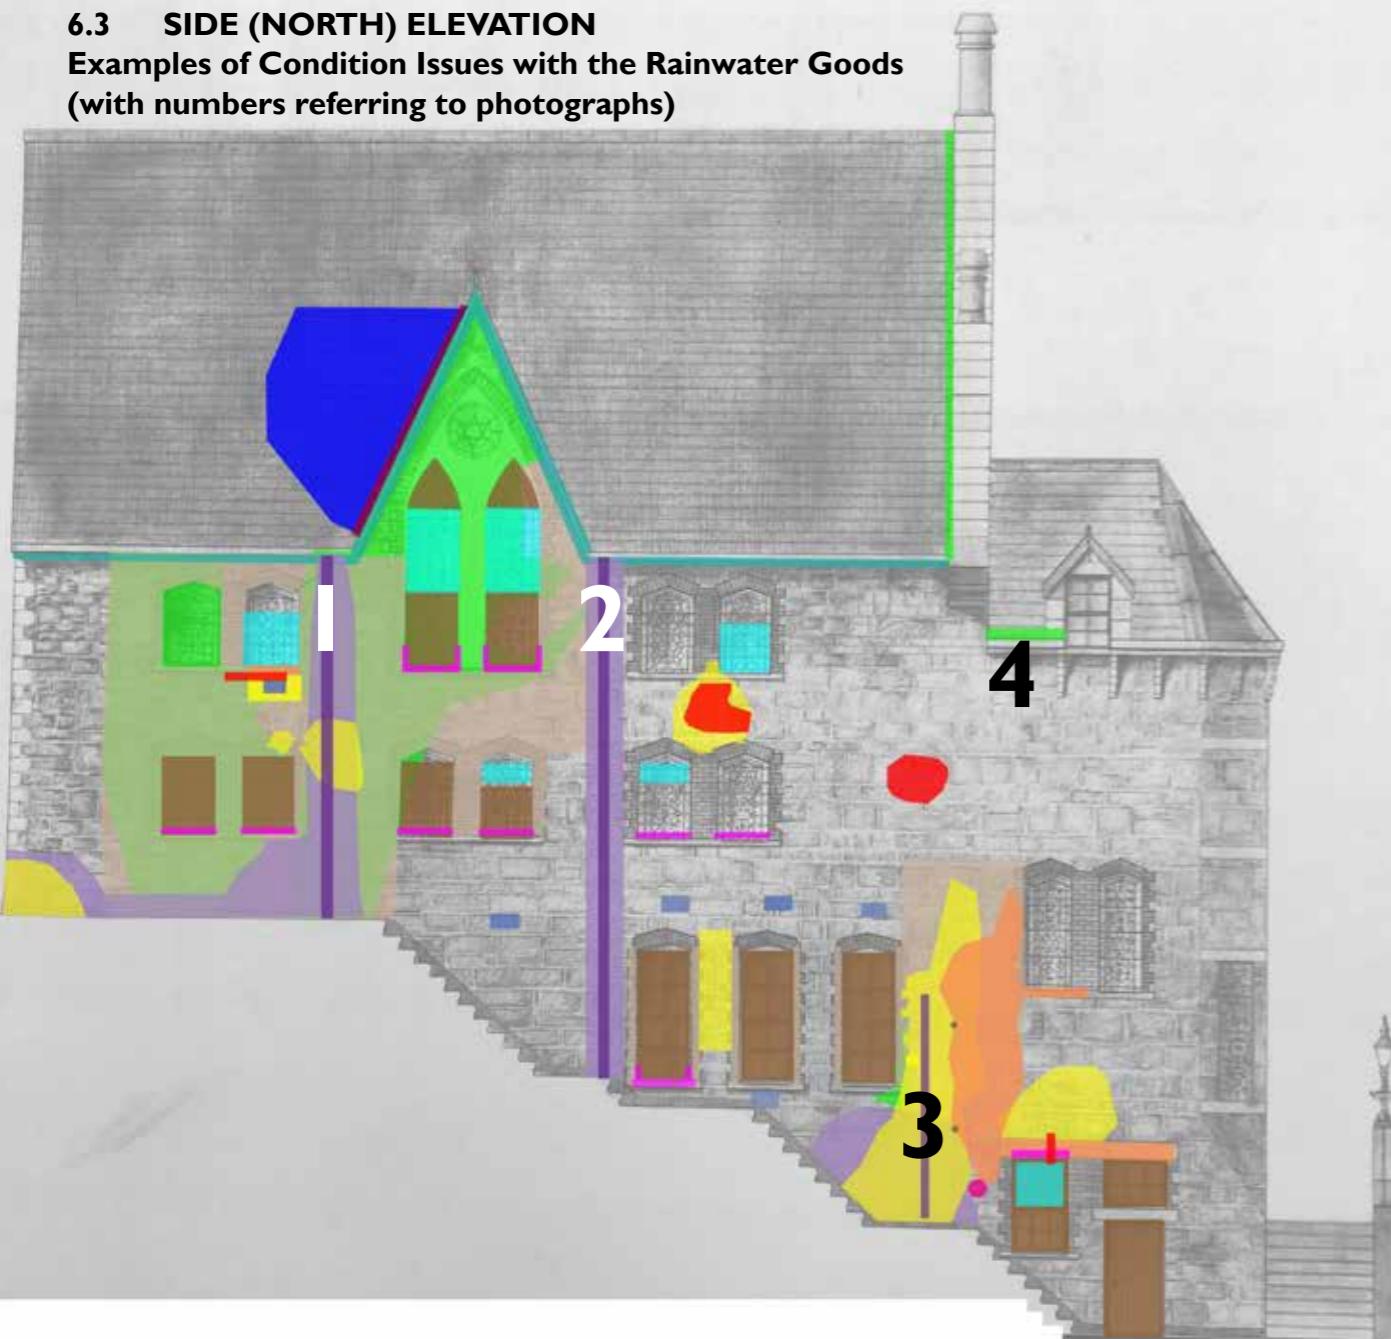
### 6.3 SIDE (NORTH) ELEVATION

Examples of Condition Issues with the Rainwater Goods  
(with numbers referring to photographs)

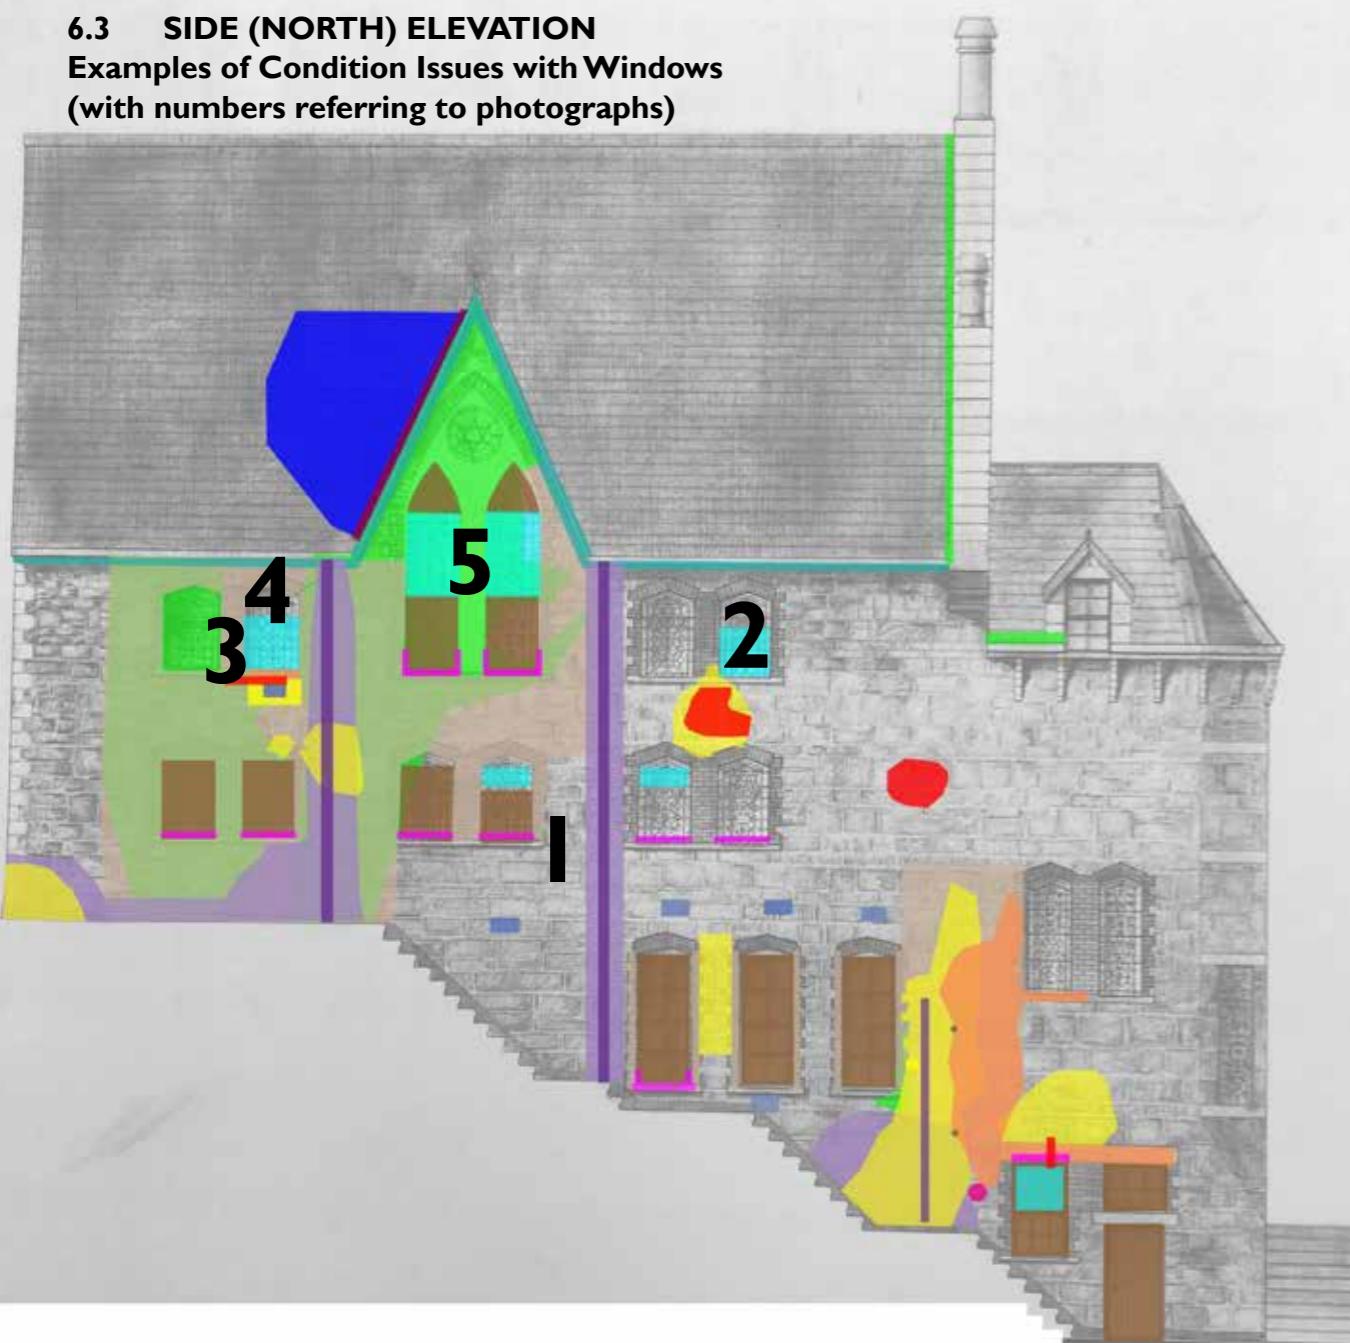
### 6.3 SIDE (NORTH) ELEVATION

Examples of Condition Issues with Windows  
(with numbers referring to photographs)

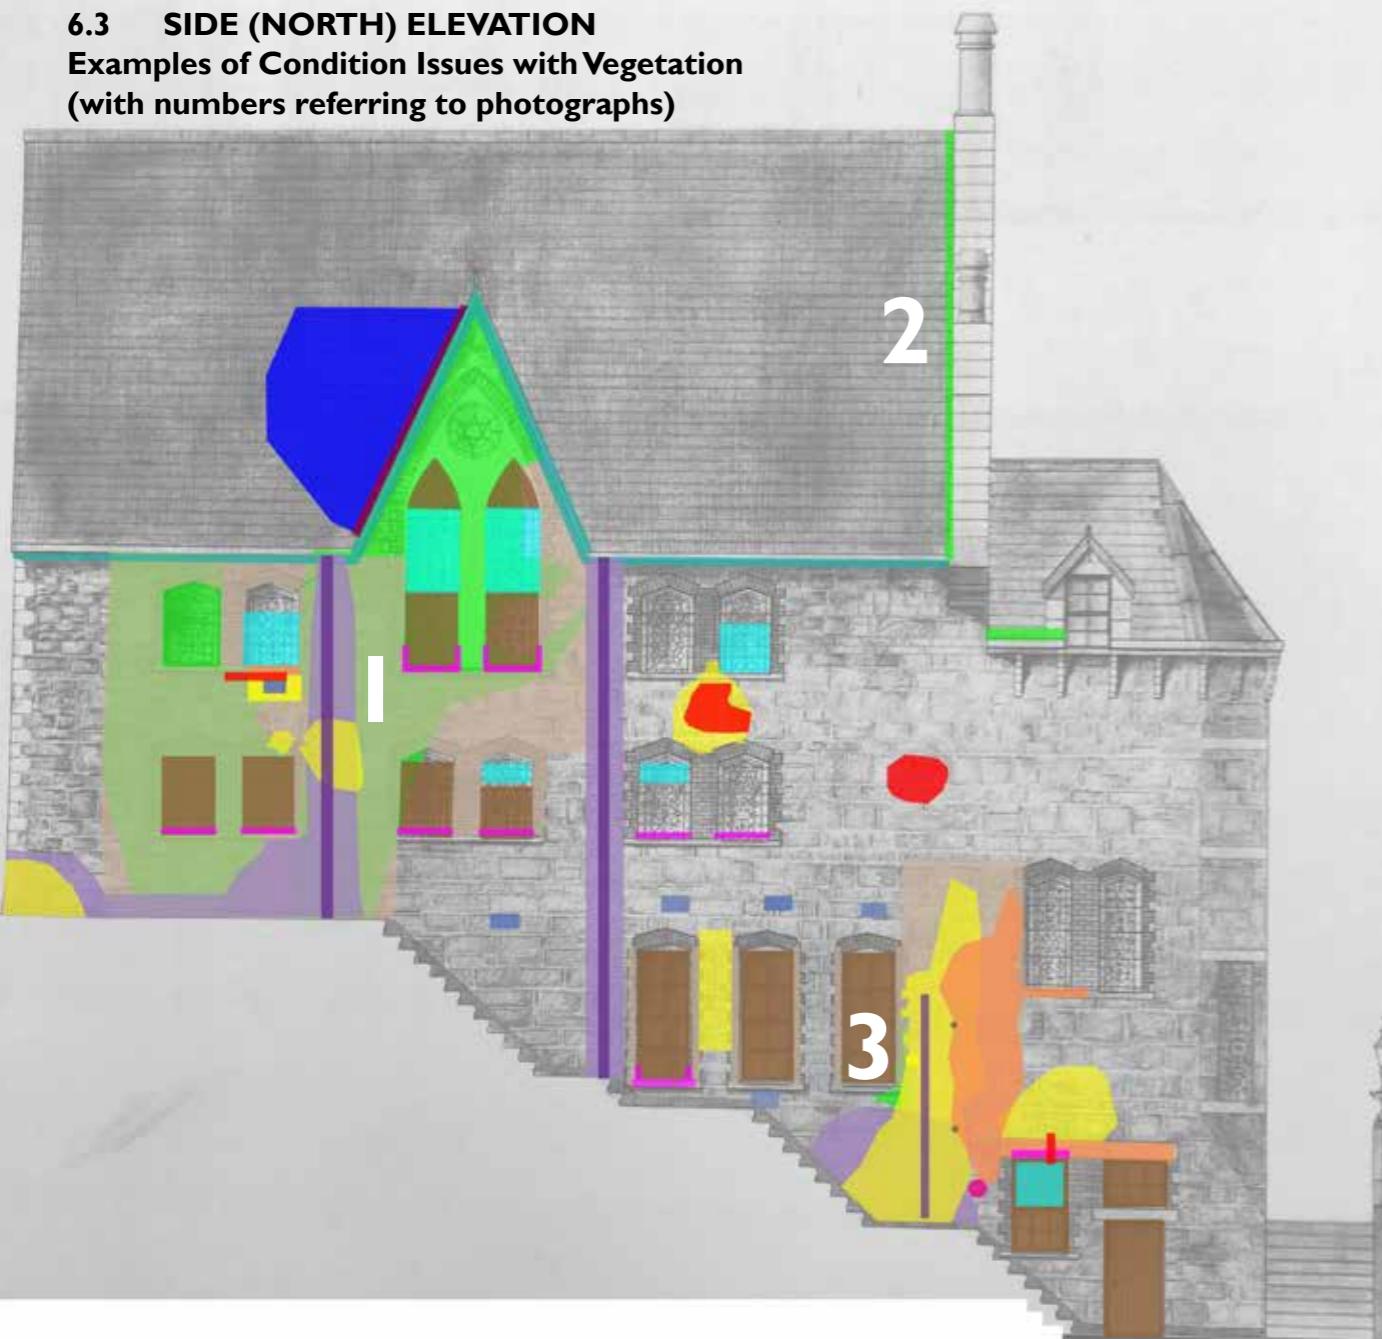
**6.3 SIDE (NORTH) ELEVATION**

Examples of Condition Issues with Vegetation  
(with numbers referring to photographs)

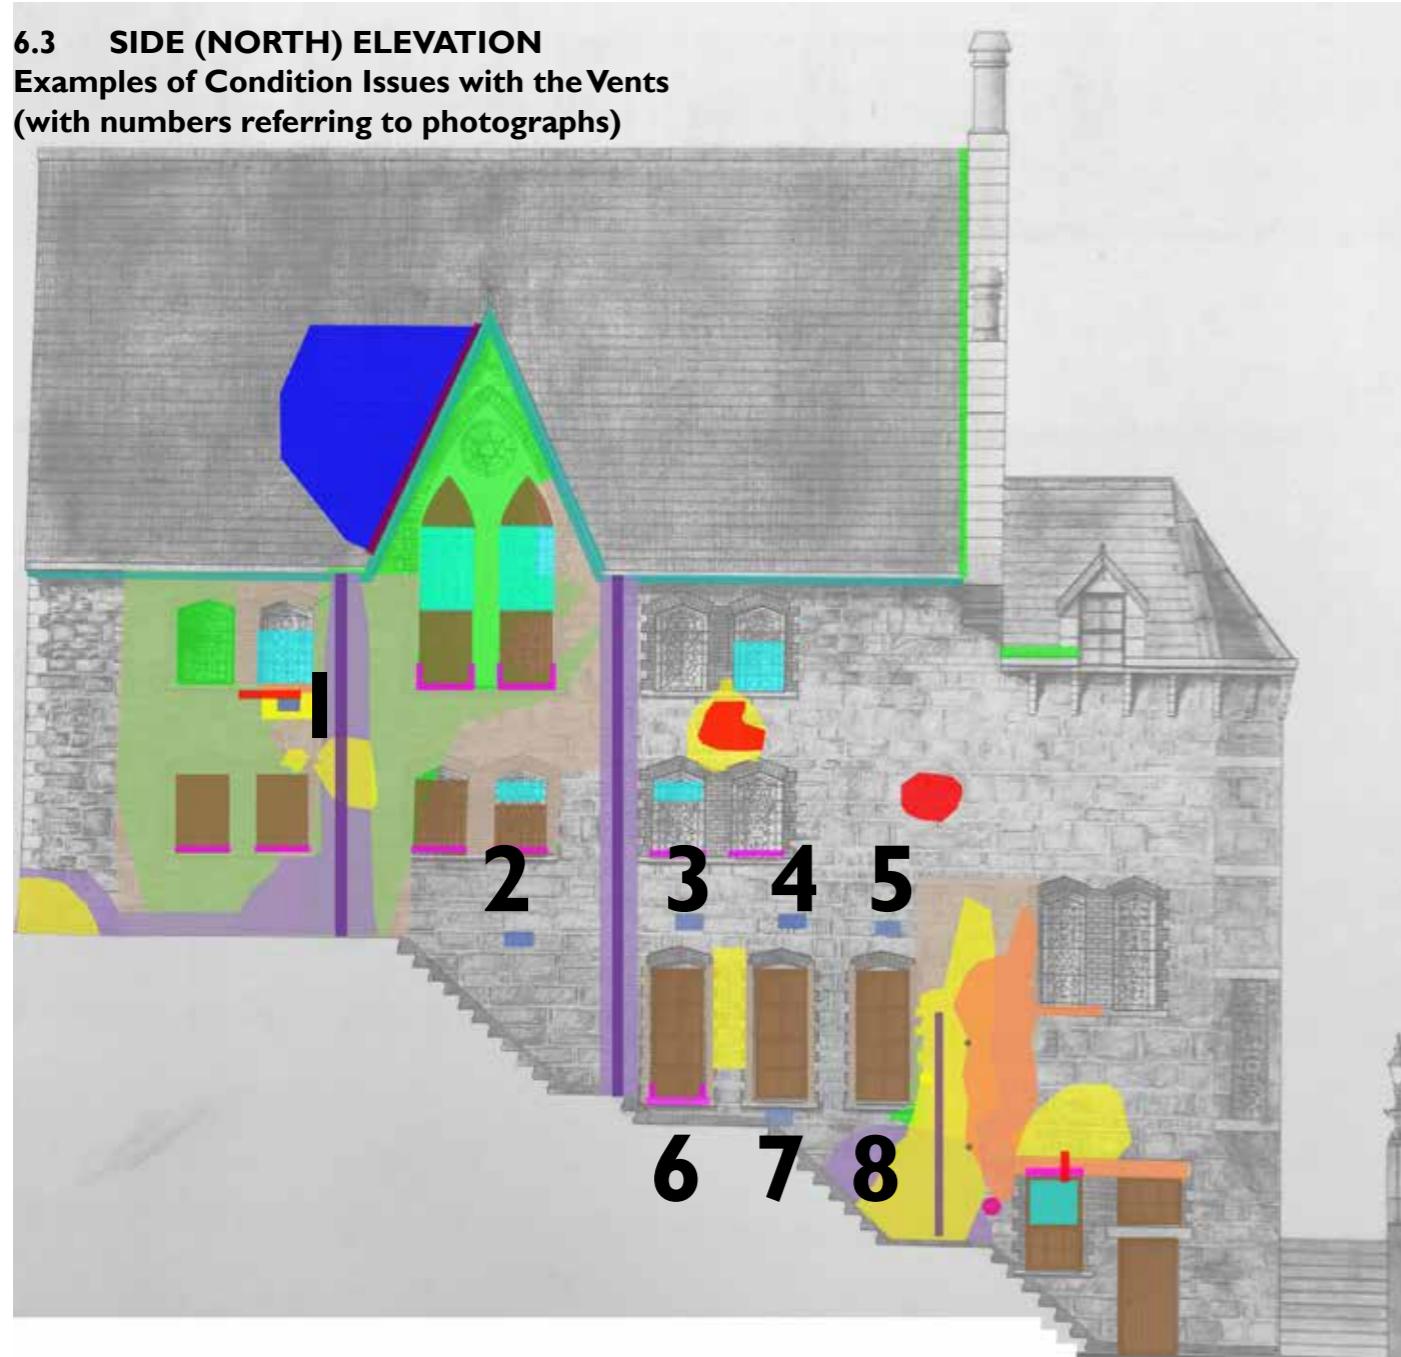
**6.3 SIDE (NORTH) ELEVATION**

Examples of Condition Issues with the Vents  
(with numbers referring to photographs)

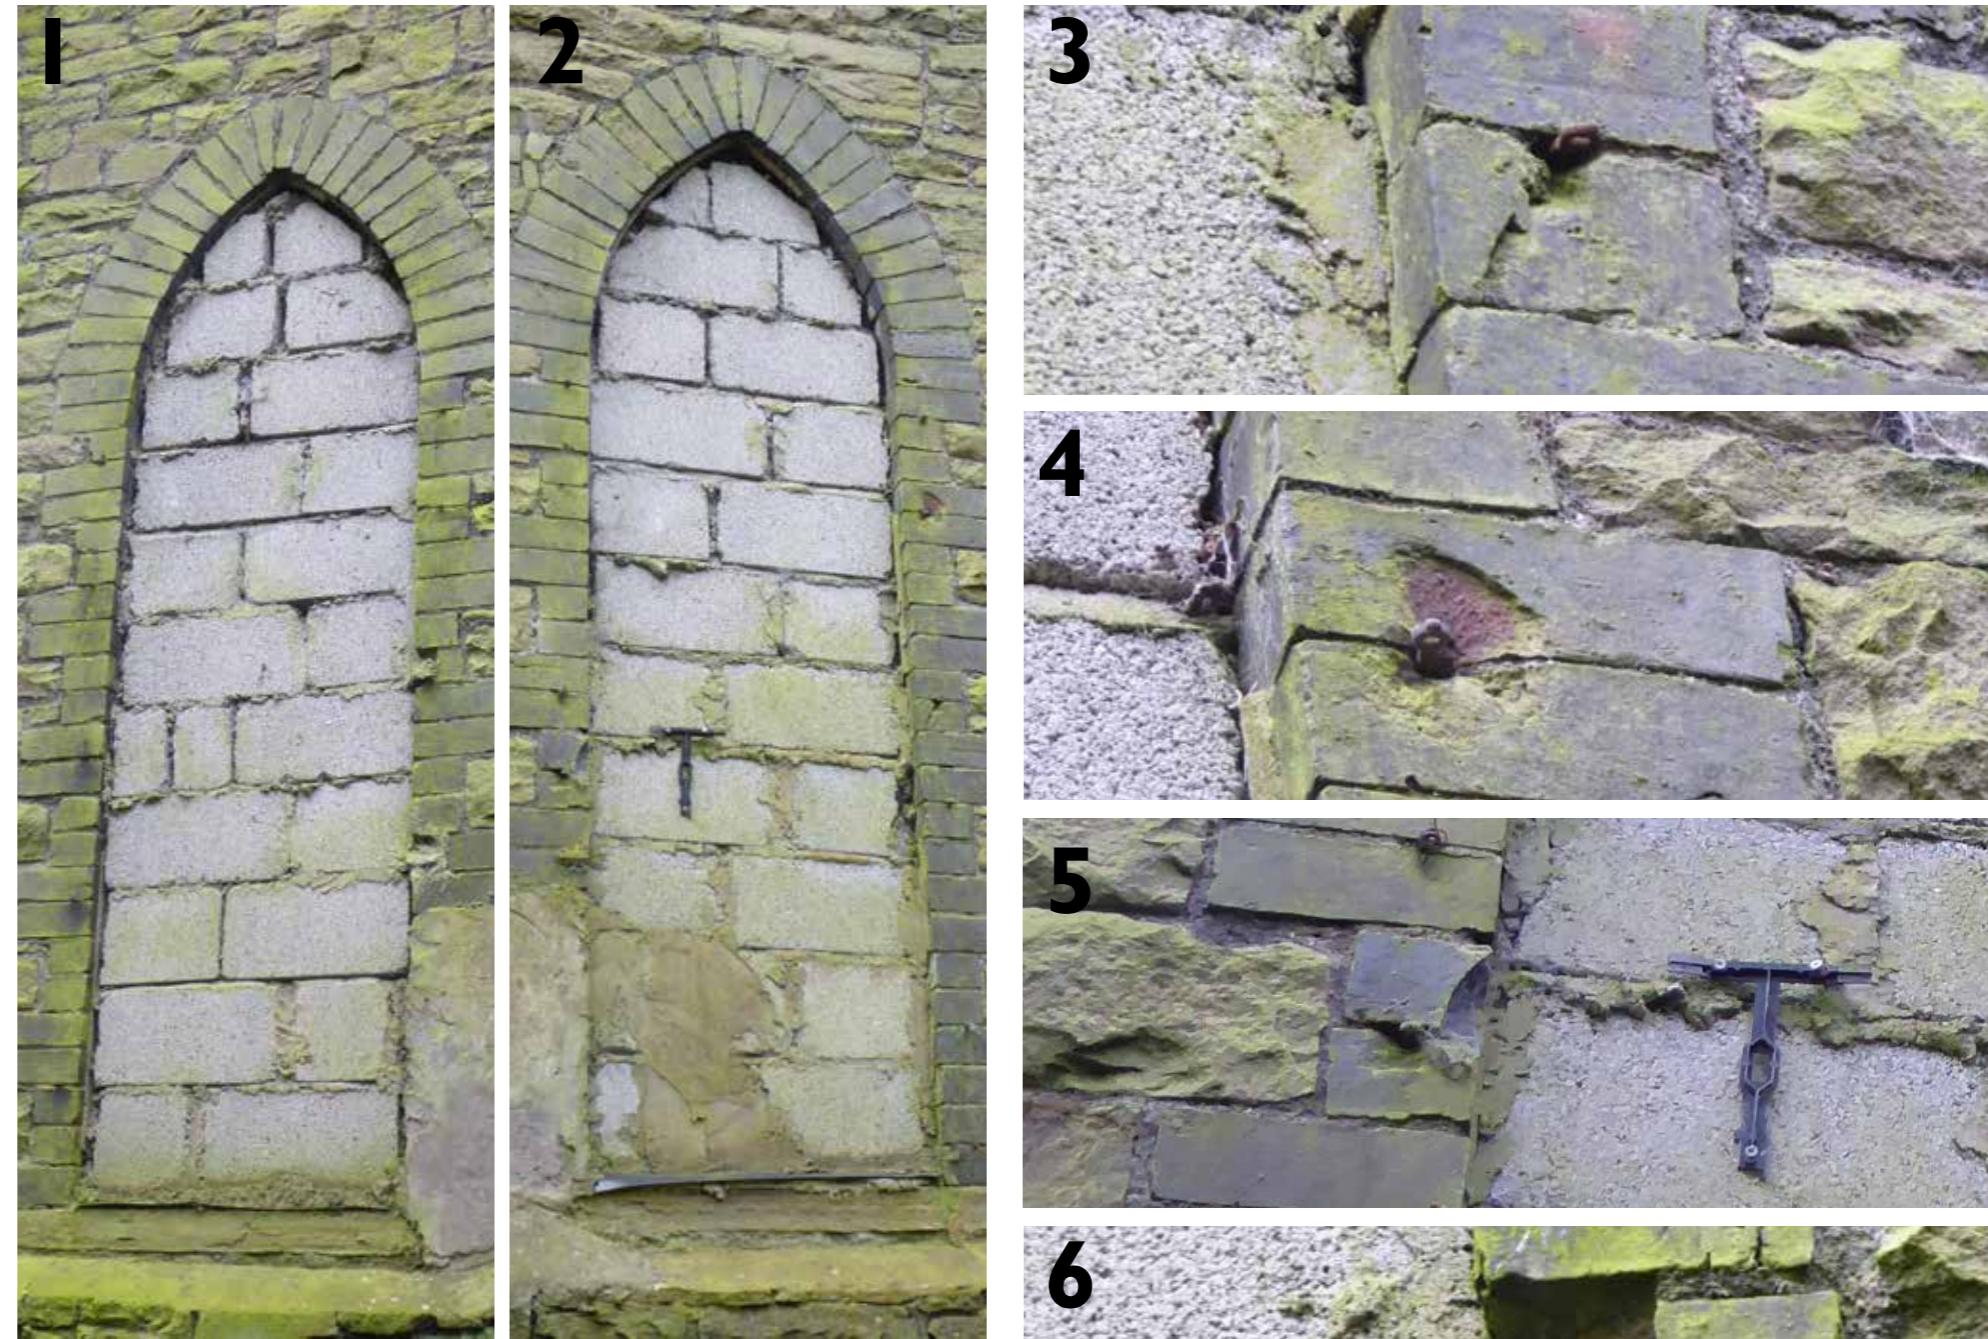
**6.4 REAR (EAST) ELEVATION**

Examples of Condition Issues  
with the Stonework  
(with numbers referring  
to photographs)
