*Report No. BC/MB/08.09.01.*

# **MINING RISK ASSESSMENT:**

**Land South of Winchfawr Park,  
Heolgerrig, Merthyr Tydfil.**

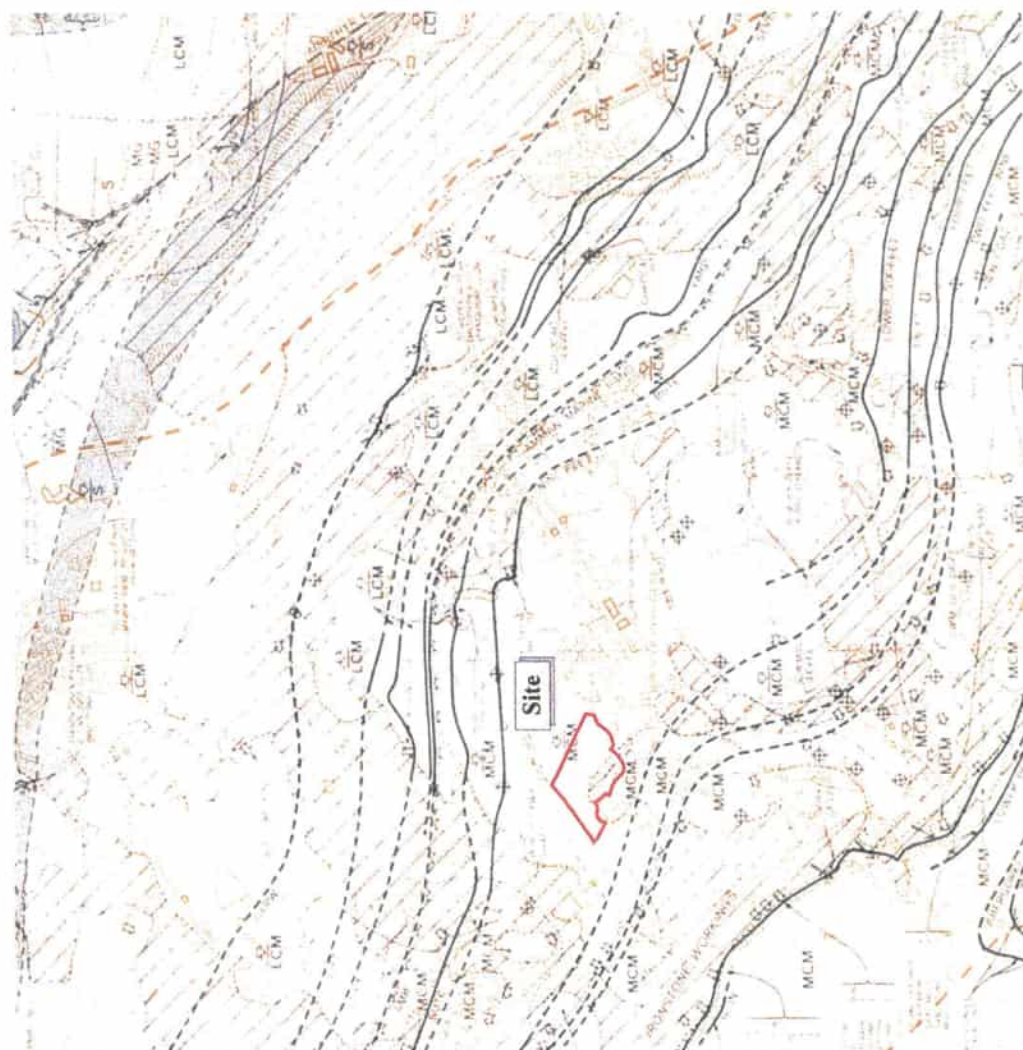
Drawing No: BC/NB/08.09.01.02.

The Site is situated near the northern margin of the South Wales Coalfield and is underlain at shallow depths by strata assigned to the Middle Coal Measures, a sub-division of the Upper Carboniferous Period. The most recently published geological sheet at 1:10,560 scale (SO 00 NW) shows the inferred positions of the outcrop of the Upper Six Feet Seam to be present approximately 50m north-east of the Site (see *Geology Plan, drawing no. BC/MB/08.09.01.02*). However, mining records indicate that the outcrop of the Seam actually passes through the Site (see *Extract from Mine Records Plan: Six Feet Seam, drawing no. BC/MB/08.09.01.04*). The published geological sheet shows the outcrop of the Nine Feet Seam to be present approximately 100m north of the Site, mining records indicate it may be a little further north than this. The average dip of the strata in the region is 1 in 13 towards the south-south-west.

The coal measures of the South Wales Coalfield have been affected by large faults. In the Heolgerrig area these large faults have a slightly sinuous trace at the surface and an average trend towards the north-west. The published geological sheet indicates that the Site is not affected by large scale faulting.

The published geological sheet also indicates that the coal measures locally are overlain with deposits of glacial boulder clay and that a lenticular area at the south-western end of the Site is occupied with made ground, likely to be colliery spoil. Ground investigation carried out on the Site by Terra Firma confirmed the presence of both soils. Published geological records indicate that the Site is not affected by landslip.

There are no features associated with the solid geology of the Site that would require any particular measures to be included in the design and construction of the foundations for the proposed dwelling. It is recommended that no further action is required in this respect.

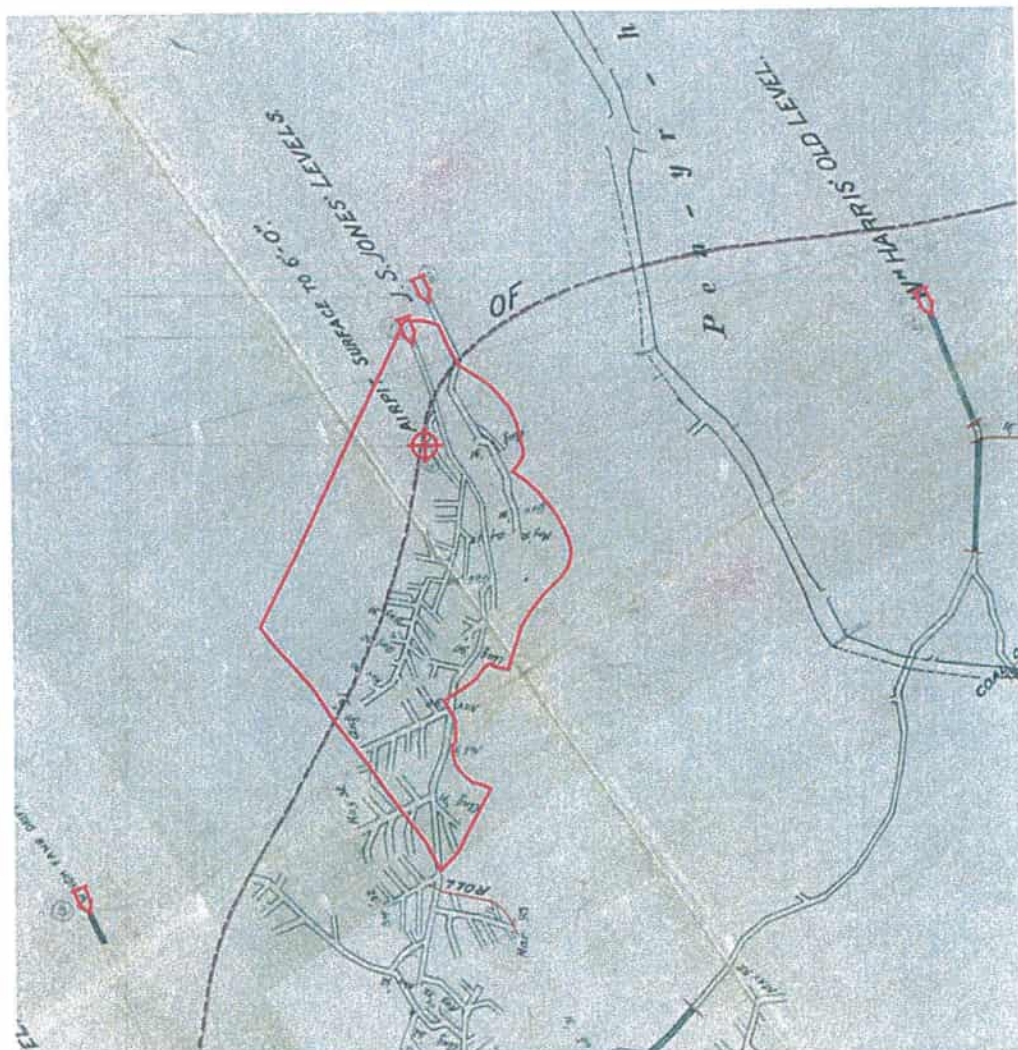
Drawing No: BC/MB/08.09.01.04.

The shallowest seam underlying the Site that is thick enough to have supported underground mining operations is the Six Feet Seam, which outcrops within the Site and underlies much of it at relatively shallow depths; it is a coal seam of variable thickness and structure that has been mined in patches across a large area of the district in underground mining operations. Mining records show that the Seam was mined fairly intensively across the southern half of the Site, the workings were prosecuted from J.S. Jones' Levels (see *Extract from Mining Records Plan: Six Feet Seam, drawing no. BC/MB/08.09.01.04*). Older and unrecorded workings may also be present close to the outcrop of the seam, where so called 'crop robbing' mining may have taken place. The mining plan shows that one of J.S. Jones' Levels (disused) was situated within the Site, at its north-eastern corner, and that a disused air pit is also present within the confines of the Site; the second of the disused J.S. Jones' Levels lies immediately outside the Site. The Site was also undermined in the Nine Feet Seam prior to 1854 (see *Extract from Mining Records Plan: Nine Feet Seam, drawing no. BC/MB/08.09.01.05*).

The area has been subject to extensive underground mining operations since at least the earliest part of the nineteenth century. The Six Feet Seam is the shallowest coal seam underlying the Site that is thick enough to have supported underground mining operations. Mining records indicate that the Seam has been intensively worked beneath the Site and exploratory boreholes drilled there have encountered old workings at very shallow depths. Mining records suggest that the seam outcrops within the Site so that a strip across the north of the Site and beyond the Seam's outcrop may be free from the risk of shallow mine workings, the Nine Feet Seam being too deep to pose a risk. However, the position of the outcrop as shown on the mine plan should be viewed as an approximate position and the presence of subsidence hollows in the north of the Site, indicating the collapsing of shallow mine workings, means that the area should be developed with caution.

Mining records indicate the presence of a disused air shaft near the north-eastern corner of the Site and also a disused mine adit in the north-eastern corner of the Site; a second disused adit lies immediately outside the north-eastern corner of the Site. The Coal Authority has no record that any of the entries has been stopped up to an acceptable engineering standard and it must be presumed, until proven to the contrary, that the two lying within the Site pose a risk to any surface development there.

Underground roadways leading from the two adit mouthings and present at very shallow depths beneath the Site are at a particularly high risk of collapse to the surface. The disused air shaft poses a risk both from the fact that there may be no safe cap on it or else by virtue of it collapsing into itself, resulting in subsidence in the area immediately around it.

There is a risk of surface subsidence across most of the Site as a result of shallow mine workings in the Six Feet Seam. There is also a risk of surface subsidence/collapse near the disused air shaft and the two adits near the north-east corner of the Site. The risk from mine gases is thought to be low.

The risk from the mining relics should variously be reduced by means of commonly used techniques including, as appropriate, drilling and grouting of shallow mine workings, capping of the shaft, excavating out and/or drilling and grouting of the adit. An exclusion zone should be designed around the disused adit lying immediately outside the north-eastern corner of the Site; no hard development should take place within the exclusion zone without a full assessment of the risk and adequate safeguards being included.

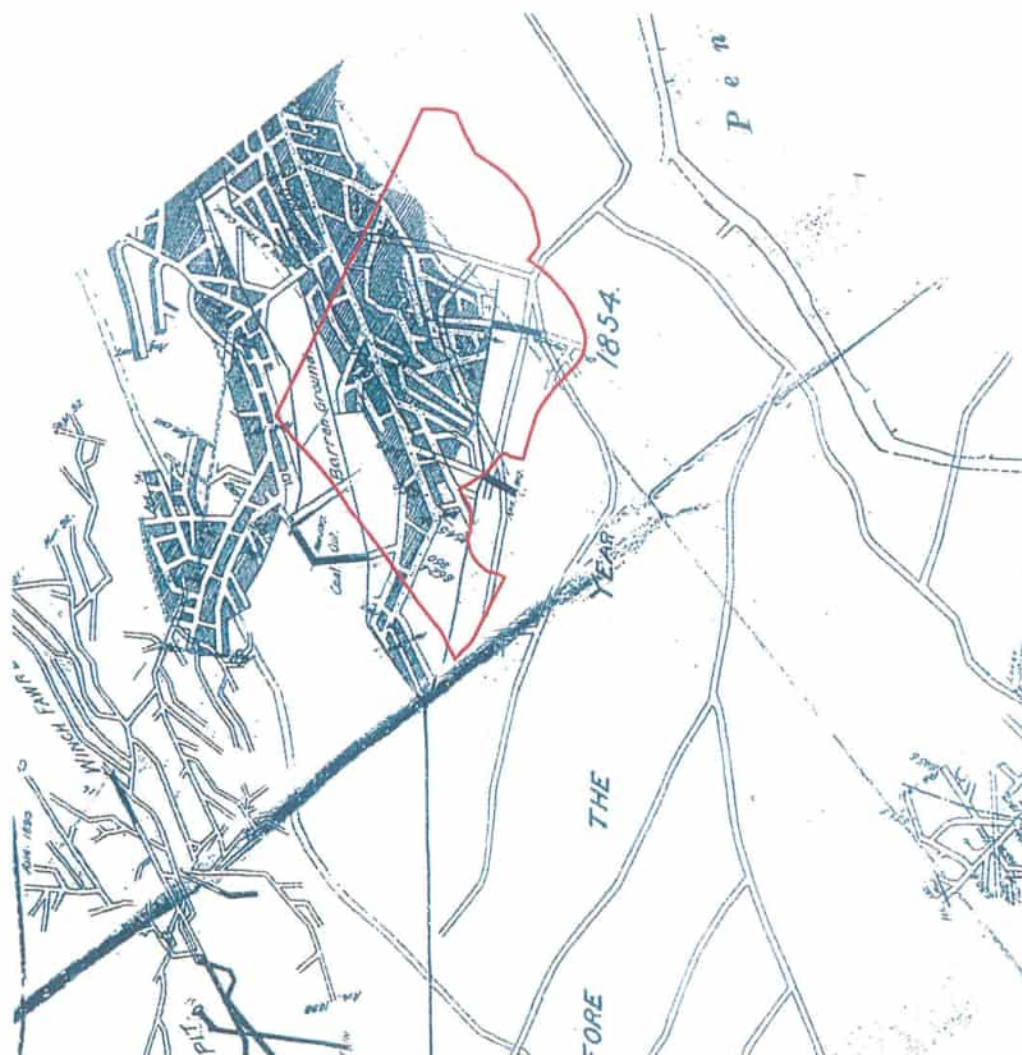
Drawing No: BC/MB/08.09.01.05.

The Nine Feet Seam is the next lowest thick coal seam in the geological sequence below the Six Feet Seam and has been extensively worked across the area. The old workings present in the Seam and underlying the Site will be at too great a depth to affect the structural integrity of the proposed dwellings. Similarly, other coal seams and ironstone veins further down in the geological sequence are all too

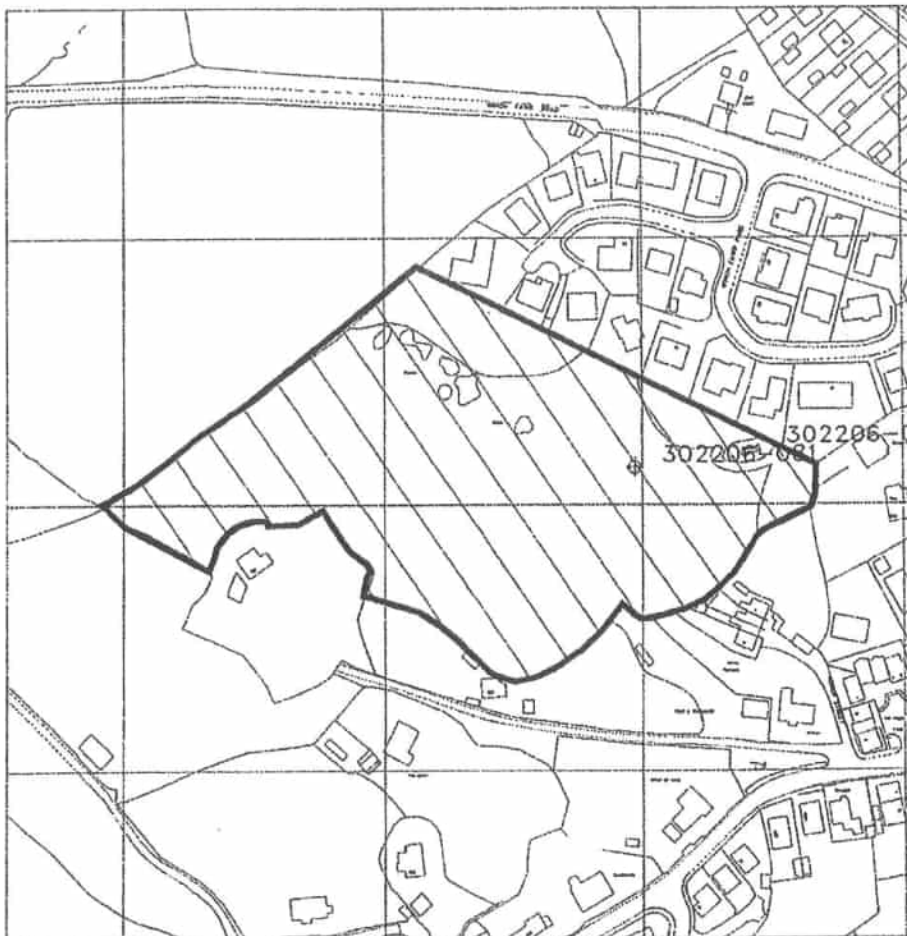
Within or within 20 metres of the property there are 2 mine entries, the approximate positions of which are shown on the attached plan. Your attention is drawn to the statements made on that plan.

We have no record of what steps, if any, have been taken to treat the mine entries.
