*Report No. BC/MB/11.20.03.*

**Coal Mining Risk Assessment:  
Land at the Sunnybank, Farm Road Heolgerrig,  
Merthyr Tydfil.**

# **Coal Mining Risk Assessment on Land at Sunnybank, Farm Road, Heolgerrig, Merthyr Tydfil.**

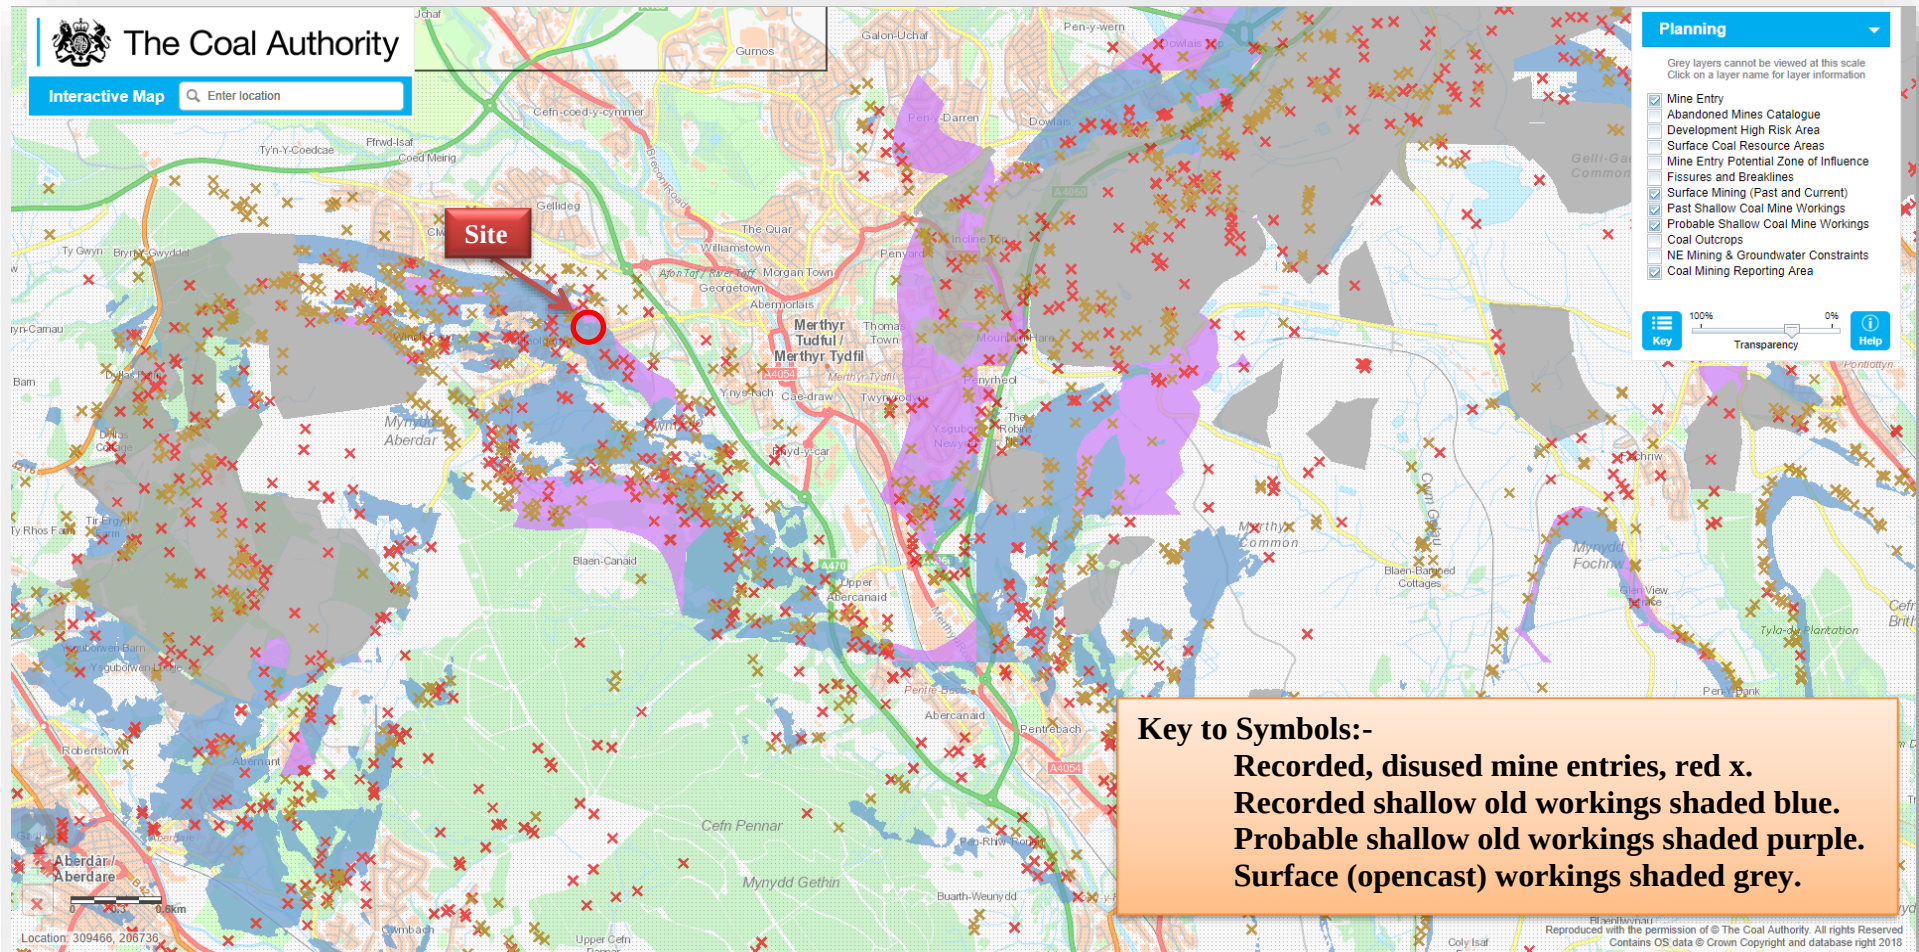
**Figure 3**  
**Print-out of The Coal Authority's Interactive Map**  
**(Accessed 17<sup>th</sup> November 2020)**

The Coal Authority's mining report and interactive map identifies the presence of shallow mine workings underlying the Site in one coal seam. Unrecorded old workings may also be present in one or more ironstone veins. It is recommended that when the location of the proposed dwelling has been finalised and approved by the LPA that exploratory boreholes are drilled in order to examine in more detail the nature and depth of any shallow mine workings that may be underlying the Site in order to inform a more detailed assessment of the risk that they pose. We envisage that commonly used techniques could be employed to mitigate the risk from any old workings that might be encountered. The borehole

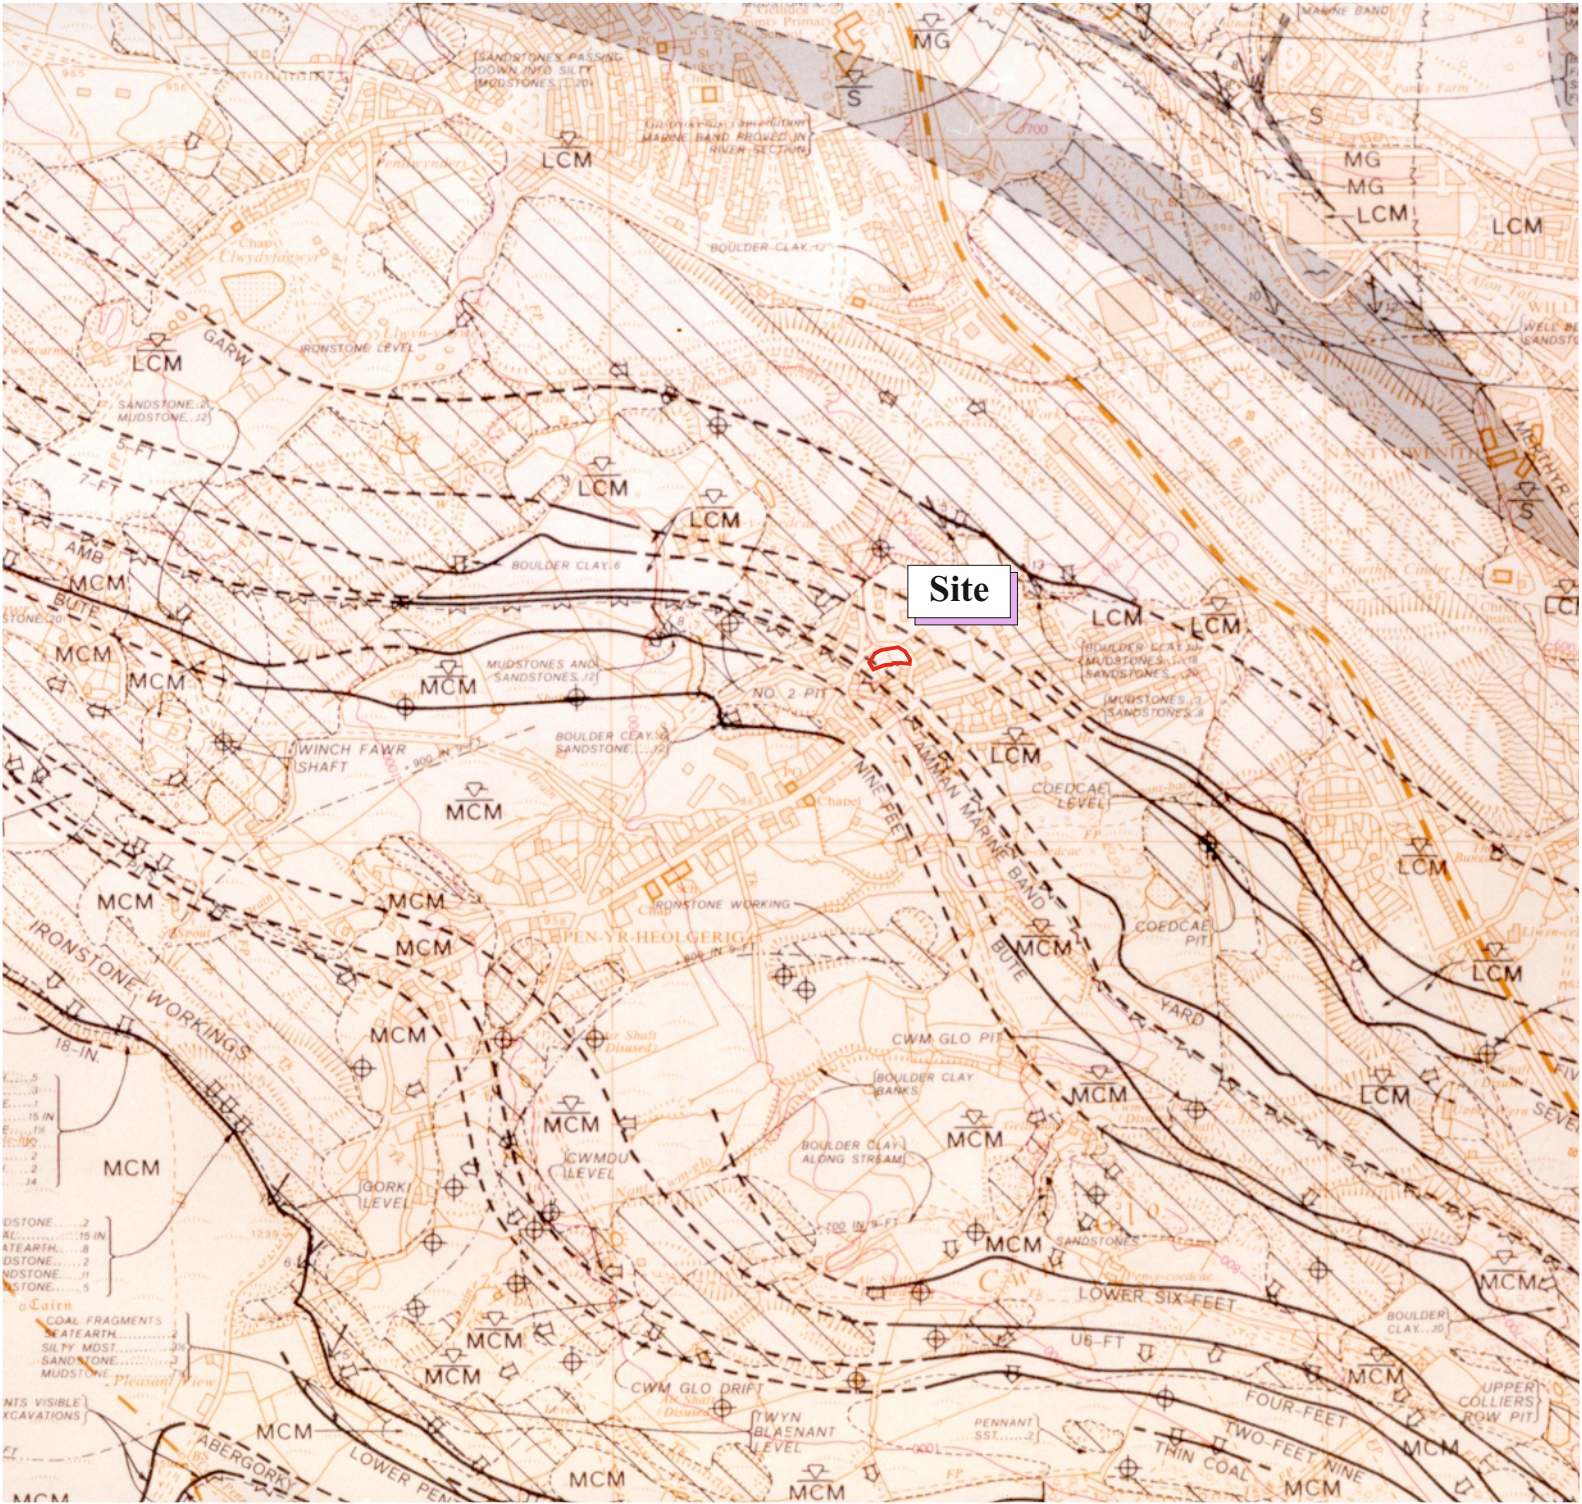
Drawing No: BC/MB/11.20.03.02.

Seams to be present approximately 30m, 70m and 90m respectively north-east of the Site (see *Geology Plan, drawing no. BC/MB/11.20.03.02*). The regional dip of the strata in the Heolgerrig area is 1 in 12 in a southerly direction so that the above group of seams underlie the Site at relatively shallow depths. There are a number of ironstone veins below the Gellideg Seam in the geological sequence, some of which are likely to be within 30m of the surface (see Figure 2, Part of the Stratigraphic Column).
