## Abercynon Feeder Pipe Bridge Replacement Arboricultural Impact Assessment V8 Report for Baker Hicks

| <b>Job Number</b> | <b>7028</b> | | |

Temple Ltd was commissioned by Baker Hicks to undertake a ground level survey of trees at the Feeder Pipe Bridge, crossing the River Taff, Abercynon, CF45 4SA and to produce an Arboricultural Impact Assessment (AIA) for the access works and renovation of the bridge. A qualitative assessment of each tree was carried out according to British Standard BS 5837:2012, Trees in Relation to Design, Demolition and Construction–Recommendations, focusing on arboricultural values (categories A1, B1, C1)<sup>1</sup>, landscape values (categories A2, B2, C2) and cultural values (A3, B3, C3)<sup>2</sup>.

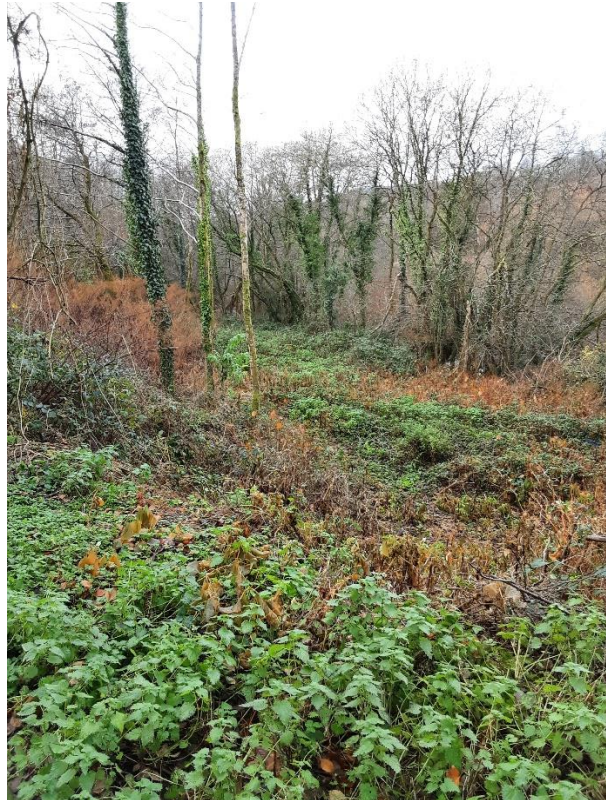
**Photograph 1**

View looking towards G4, with  
T35, T36, T37

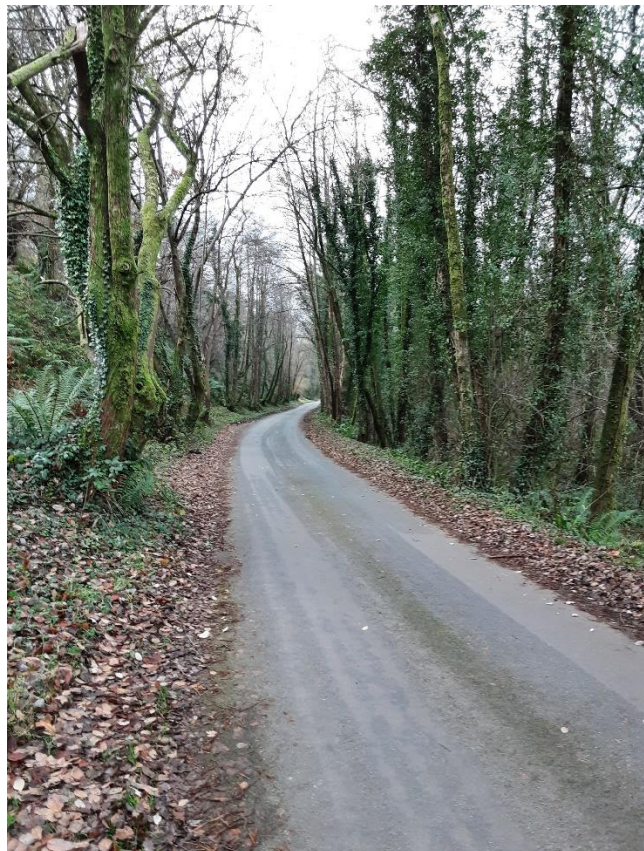
**Photograph 2**

View along road with T19 in  
the left of picture.

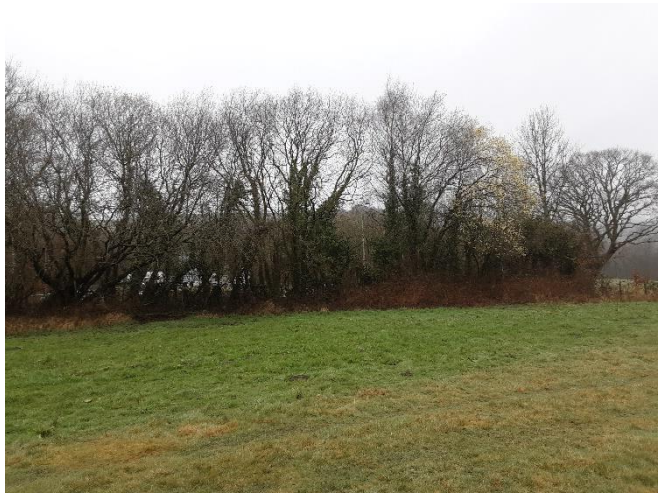
### Photograph 5

View looking towards G8.

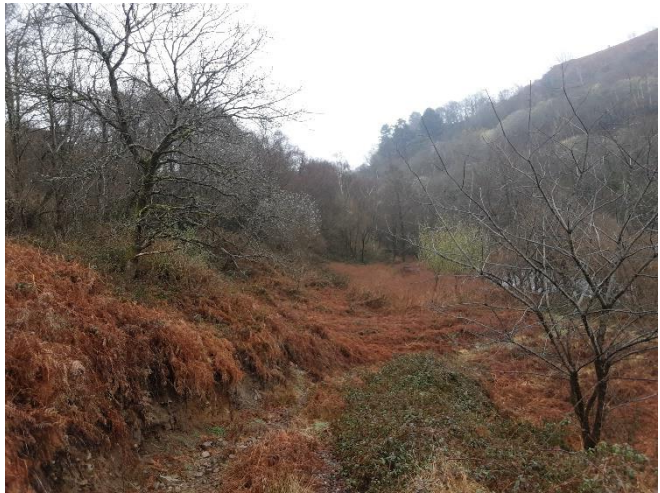
### Photograph 6

View looking down proposed access rout, T49 left T48 right.
