## Pandy Farm, Merthyr Tydfil

### Bat Report

Report Ref: 1703 / 02c

Date: 21/03/23

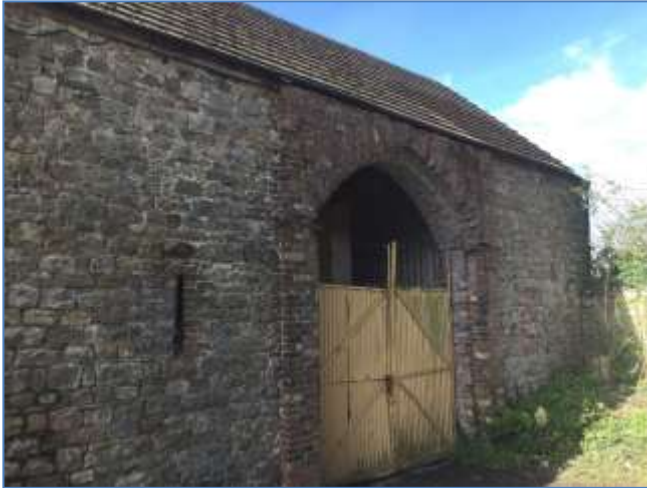
Photograph 1. Building B. The gated access on the northern elevation.

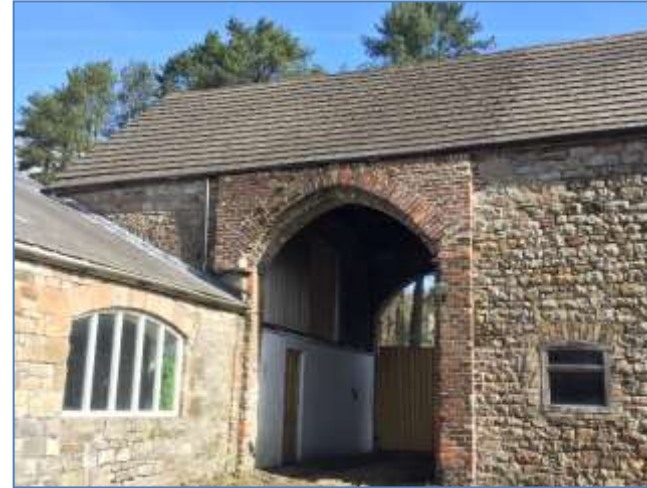
Photograph 2. Building B. The gated access on the southern elevation.

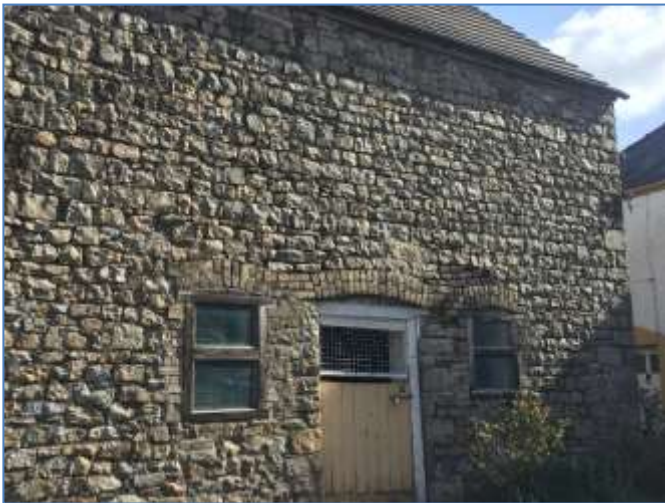
Photograph 3. Building B, eastern section. The rough stonework on the southern elevation.

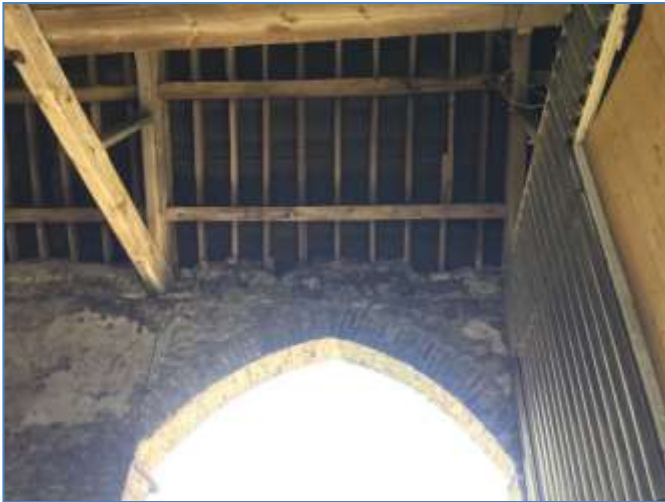
Photograph 5. Building B. The roof structure above the central gated section.

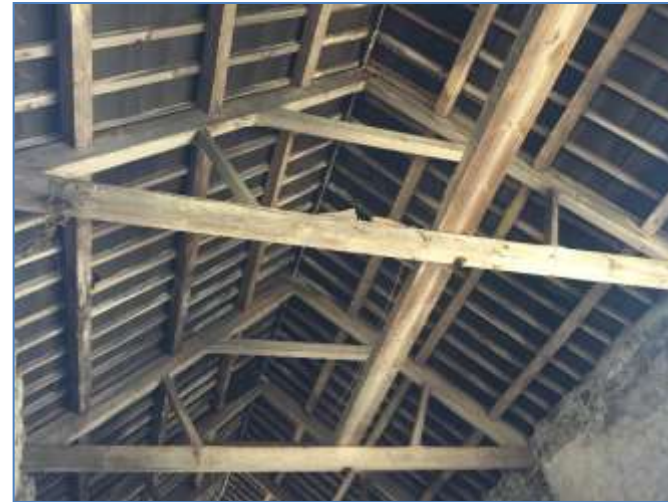
Photograph 6. Building B, eastern section. The tie and collar beam roof construction.

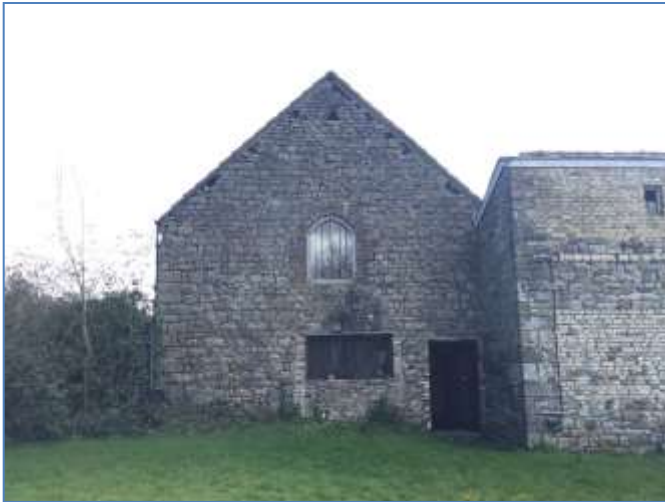
Photograph 9. Building B, western section. The western elevation (adjacent to Building C).

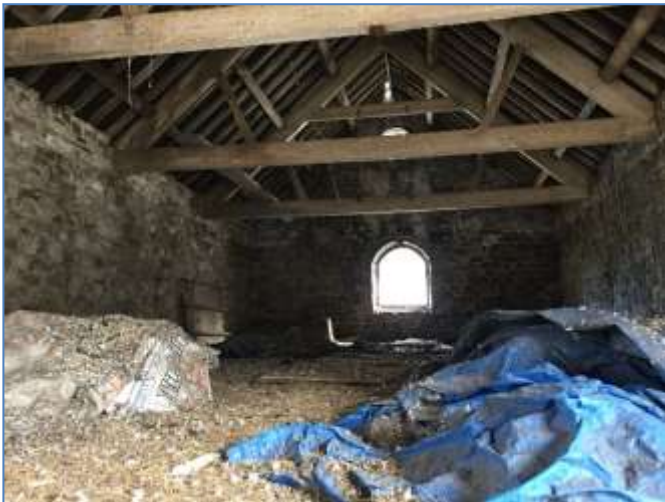
Photograph 11. Building B, western section. The first floor.

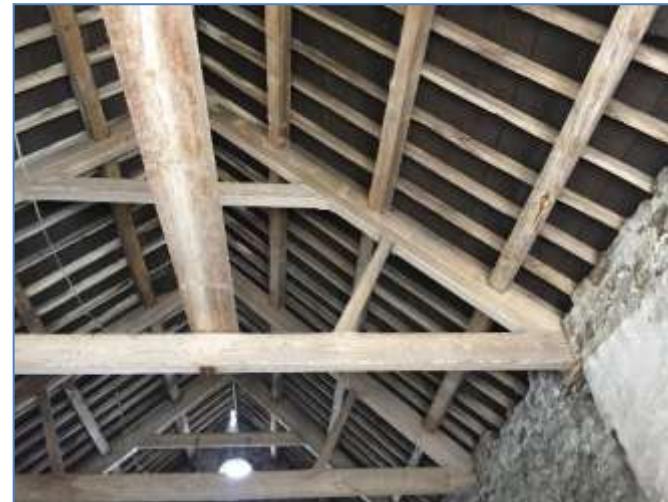
Photograph 12. Building B, western section . The tie and collar beam roof construction.

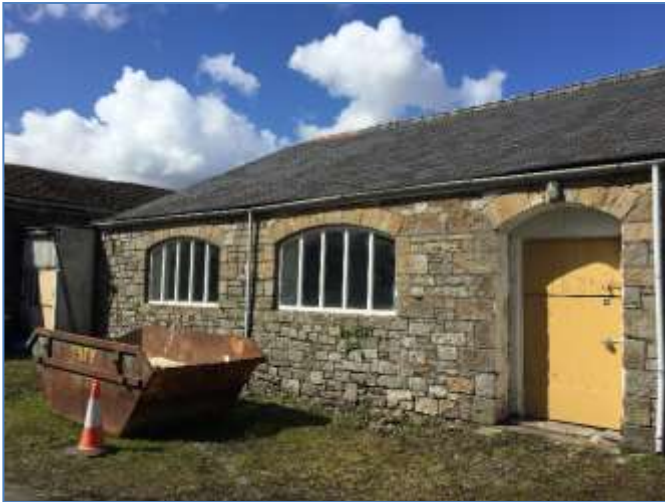
Photograph 13. Building C, southern half of the eastern elevation.

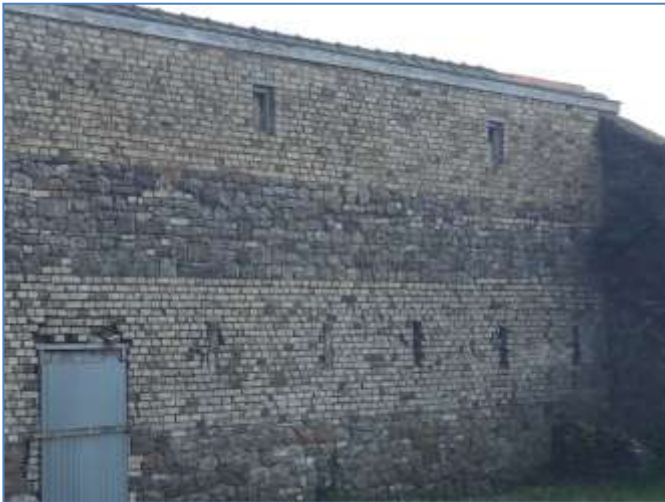
Photograph 15. Building C. The western elevation.

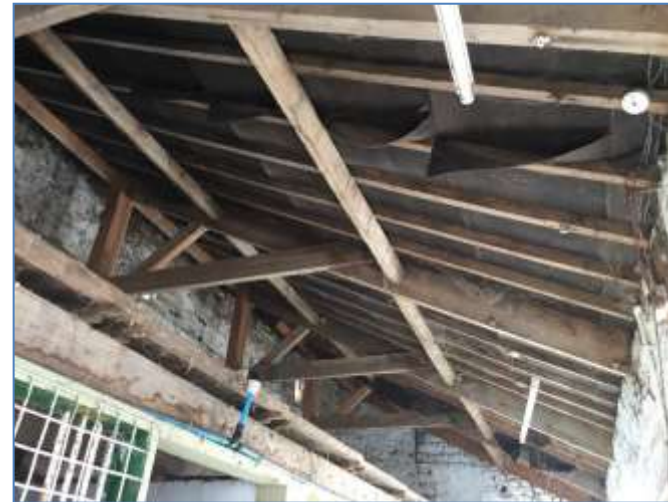
Photograph 16. Barn C. The internal roof construction and mezzanine loft.

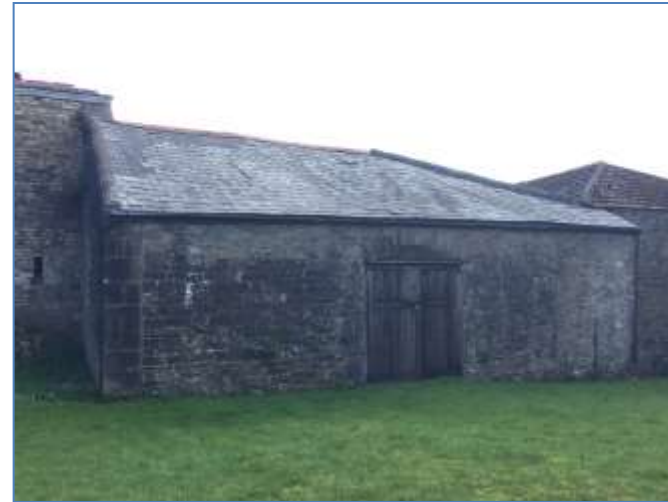
- 3.7 The workshop is a traditionally built stone building with a hipped artificial slate roof. The stonework is in good condition on the western elevation; with the north and south being formed by the adjacent buildings, and the east being the small store rooms.

Photograph 18. Building D. The western elevation.

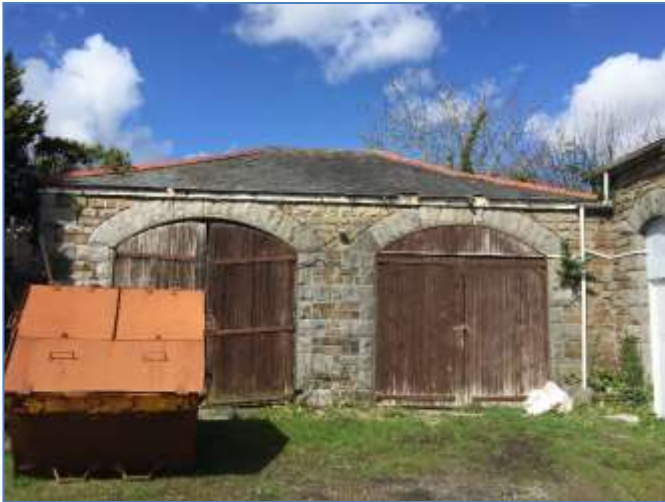
- 3.12 Building E is a single storey building of stone construction. The front, eastern, elevation is constructed of cut stone, which is well fitted and contains no obvious gaps. The other elevations

Photograph 21. Building E. The eastern elevation.

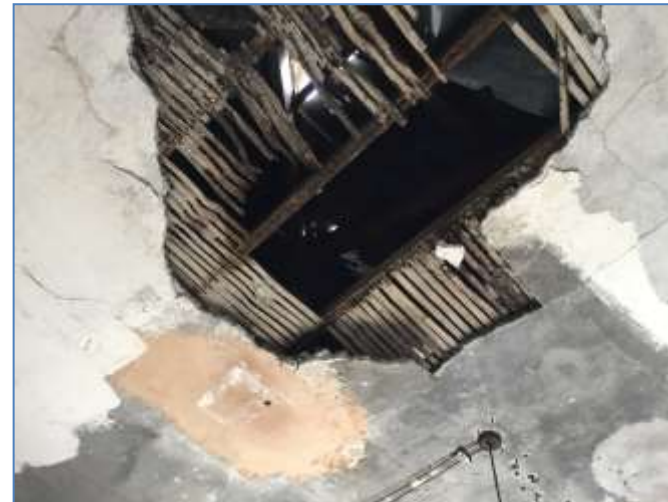
- 3.17 Internally the ground floor stonework painted throughout and in good condition.
- 3.18 There is a suspended ceiling with no access into the loft space, which will be large and over 2m in height. There is a large damaged section through which it is possible to view the underside of the roof. The loft space does not appear cluttered and it is likely to have a simple cut and pitch construction. No roofing felt was present. It was not deemed safe to use a ladder against the damaged ceiling so the loft could not be inspected for evidence of bats.

Photograph 24. Building E. Damage to the ceiling showing the unlined roof above and access through the roof.

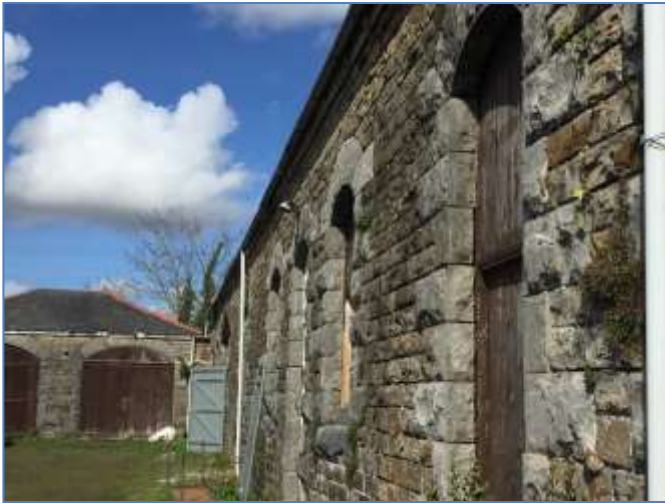
Photograph 25. Building F. The southern elevation.

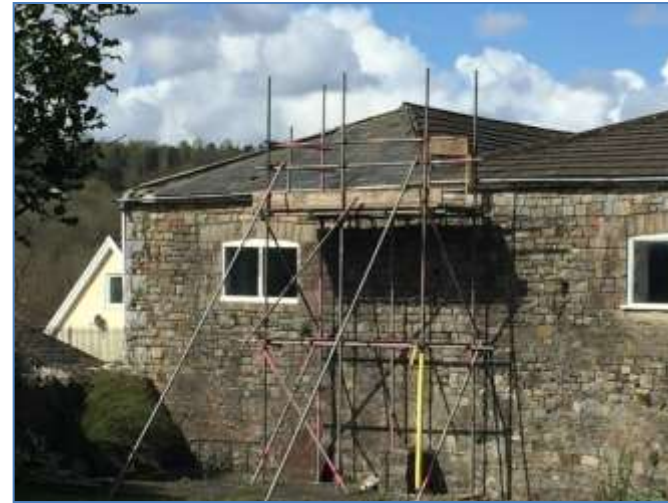
Photograph 26. Building F. The eastern elevation.

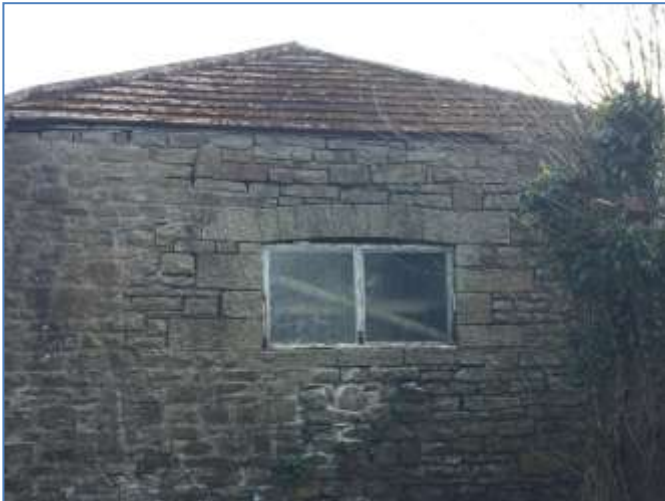
Photograph 27. Building F. The western elevation

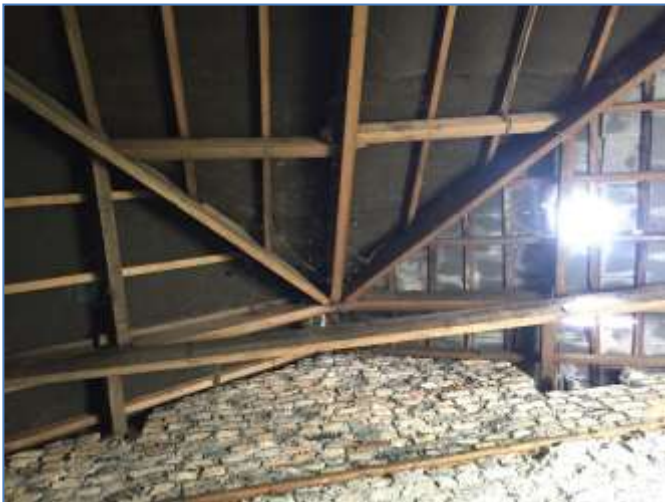
Photograph 31. Building F. Bitumen felt present on most of the western hip.

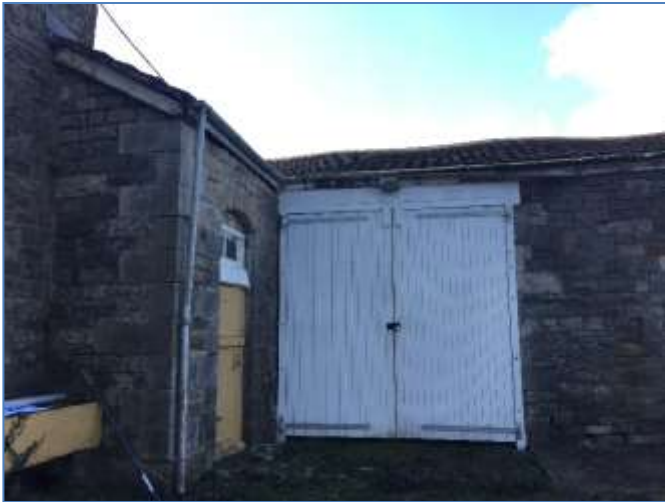
- 3.29 The roof is clad with small concrete tiles, with a concrete ridge and appears to be in good condition. There are timber fascias on the eastern and western elevations, with large gaps present beneath all.

Photograph 33. Building G. Gaps beneath fascia boards at the western corner.

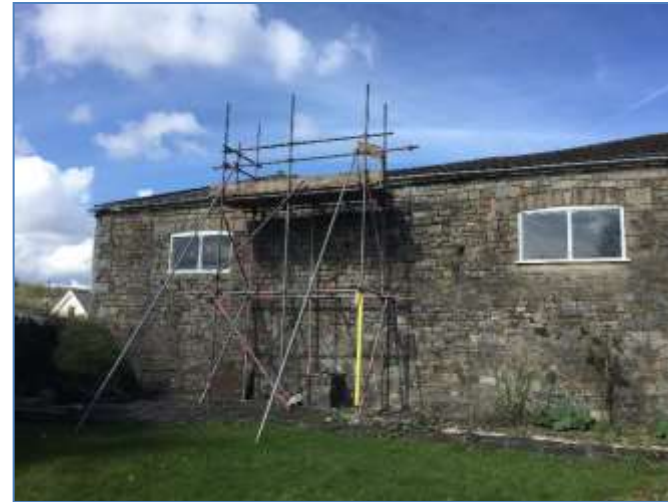
Photograph 34. Building G. The eastern elevation (right hand section of building).

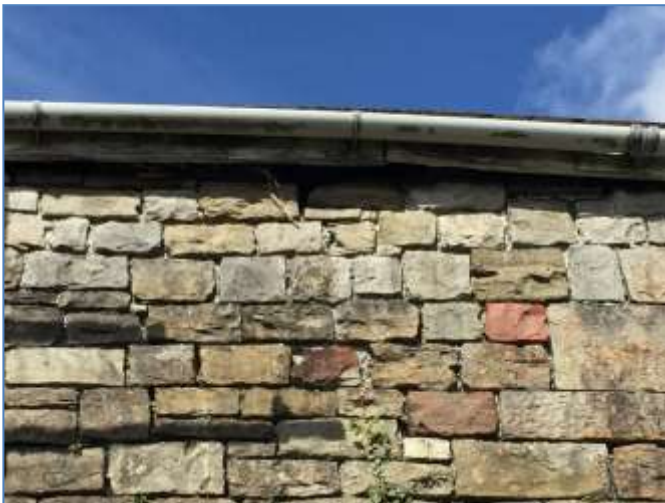
Photograph 35. Building G. Significant gaps beneath fascias on the eastern elevation.

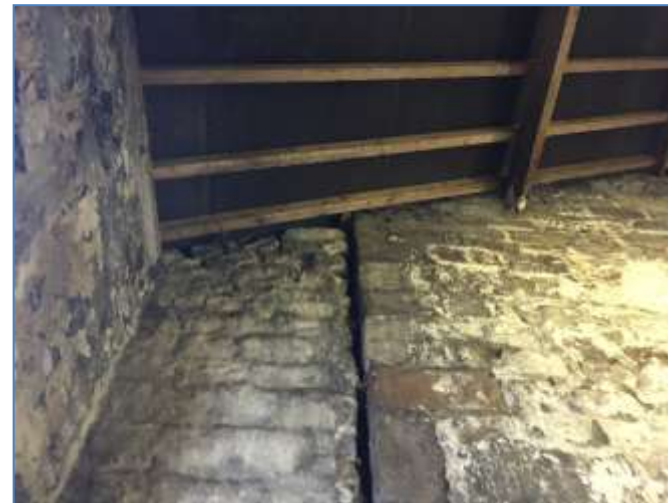
- 3.30 Internally the main workshop space is open to the roof, which is of simple cut and pitch construction. There is bitumen felt throughout which is in excellent condition, with only a few gaps present where overlapping pieces are sagging.

- 5.2 There was no increase in the number bat droppings recorded in Building G, first noted in April 2022, by October 2022. The DNA analysis confirmed the droppings as brown long-eared bat. The small number does not reflect a significant roost and is likely to be a single brown long-eared bat on a couple of occasions. It is clear that the roost is not used regularly and therefore the individual is not reliant on the internal space.

Photograph 36. Building G. A large internal crevice and the bitumen felt in good condition in close proximity to where bat droppings were recorded.

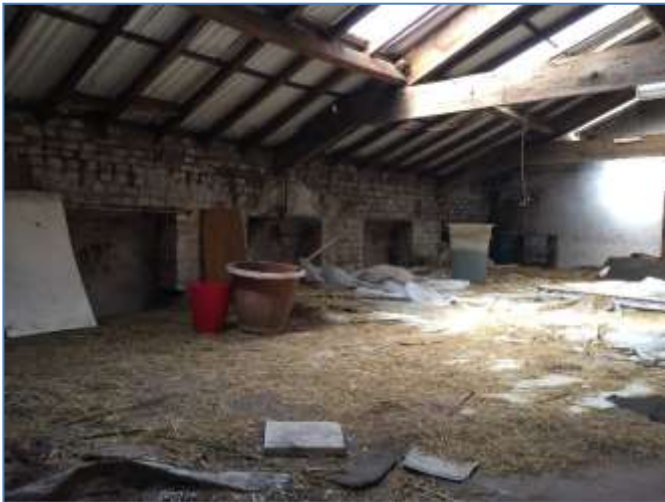
Photograph 39. Building H. The mezzanine loft level is very well lit.
