**ARDAGH METAL PACKAGING,  
ABERCANAID, MERTHYR TYDFIL**

**Coal Mining Risk Assessment**

11708/LW/16/CMRA

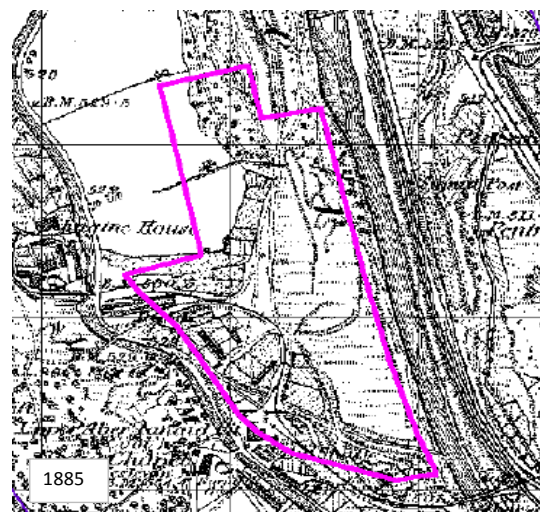
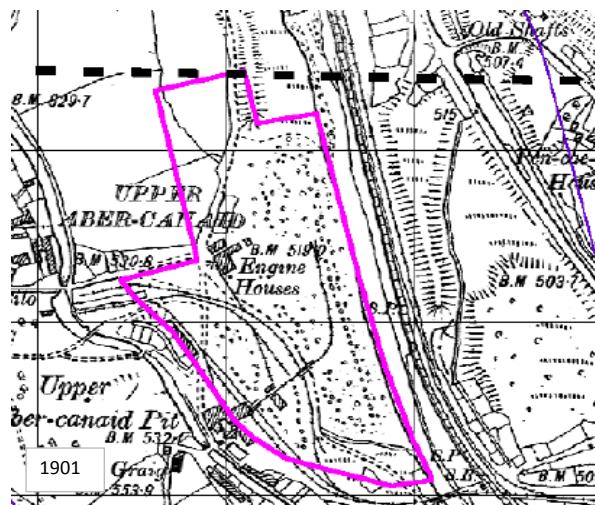
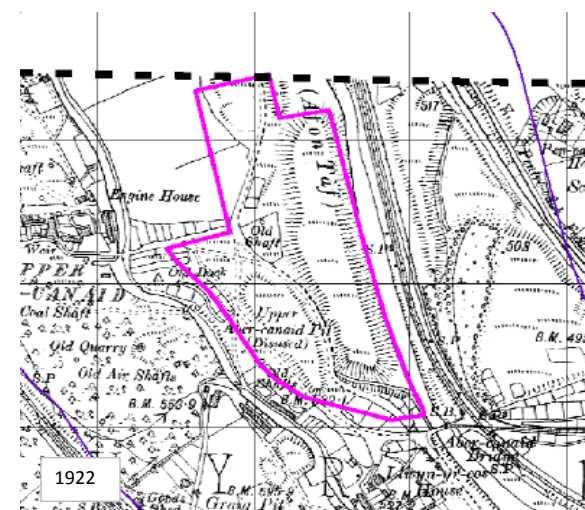
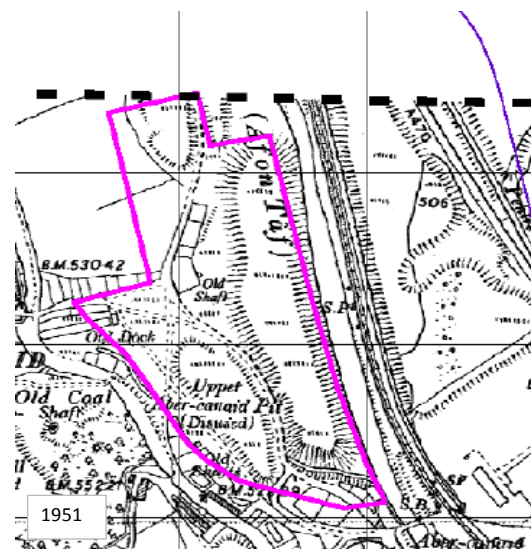
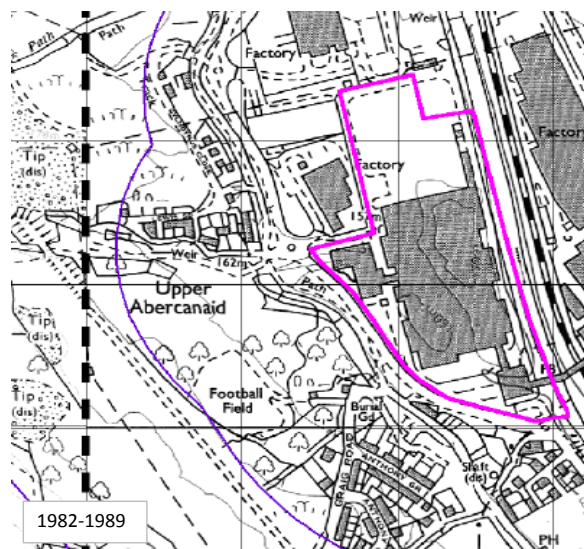
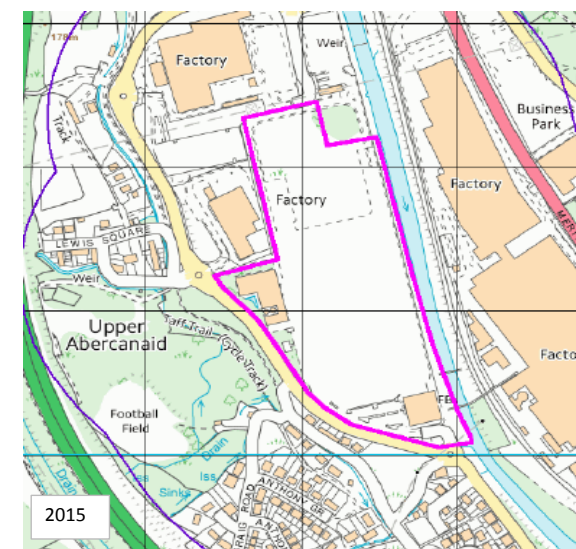
FIGURE 3: SITE HISTORY (Based on 1:10,560/10,00 scale maps)

The earliest map in our possession, dated 1884, shows the site to be predominantly covered in colliery spoil heaps. An 'Old Coal Shaft' was noted in the centre of the site.

The most southern area of the site was noted as the Upper Abercanaid Pit (Coal), with a shaft, an engine house and a boiler house all located on the south west boundary.

By 1900, the majority of the stream that intercepted the north part of the site was indicated to flow below the spoil heaps. An Engine House was located in the north west of the site in the vicinity of the 'Old Shaft' which was noted on the 1884 maps. The spoil heaps in the north and central area of the site were fed by tramlines. Abercanaid Houses had been demolished and replaced with tramlines and spoil heaps. The majority of the south easterly flowing stream in the south of the site now lay below the spoil heaps and tramlines.

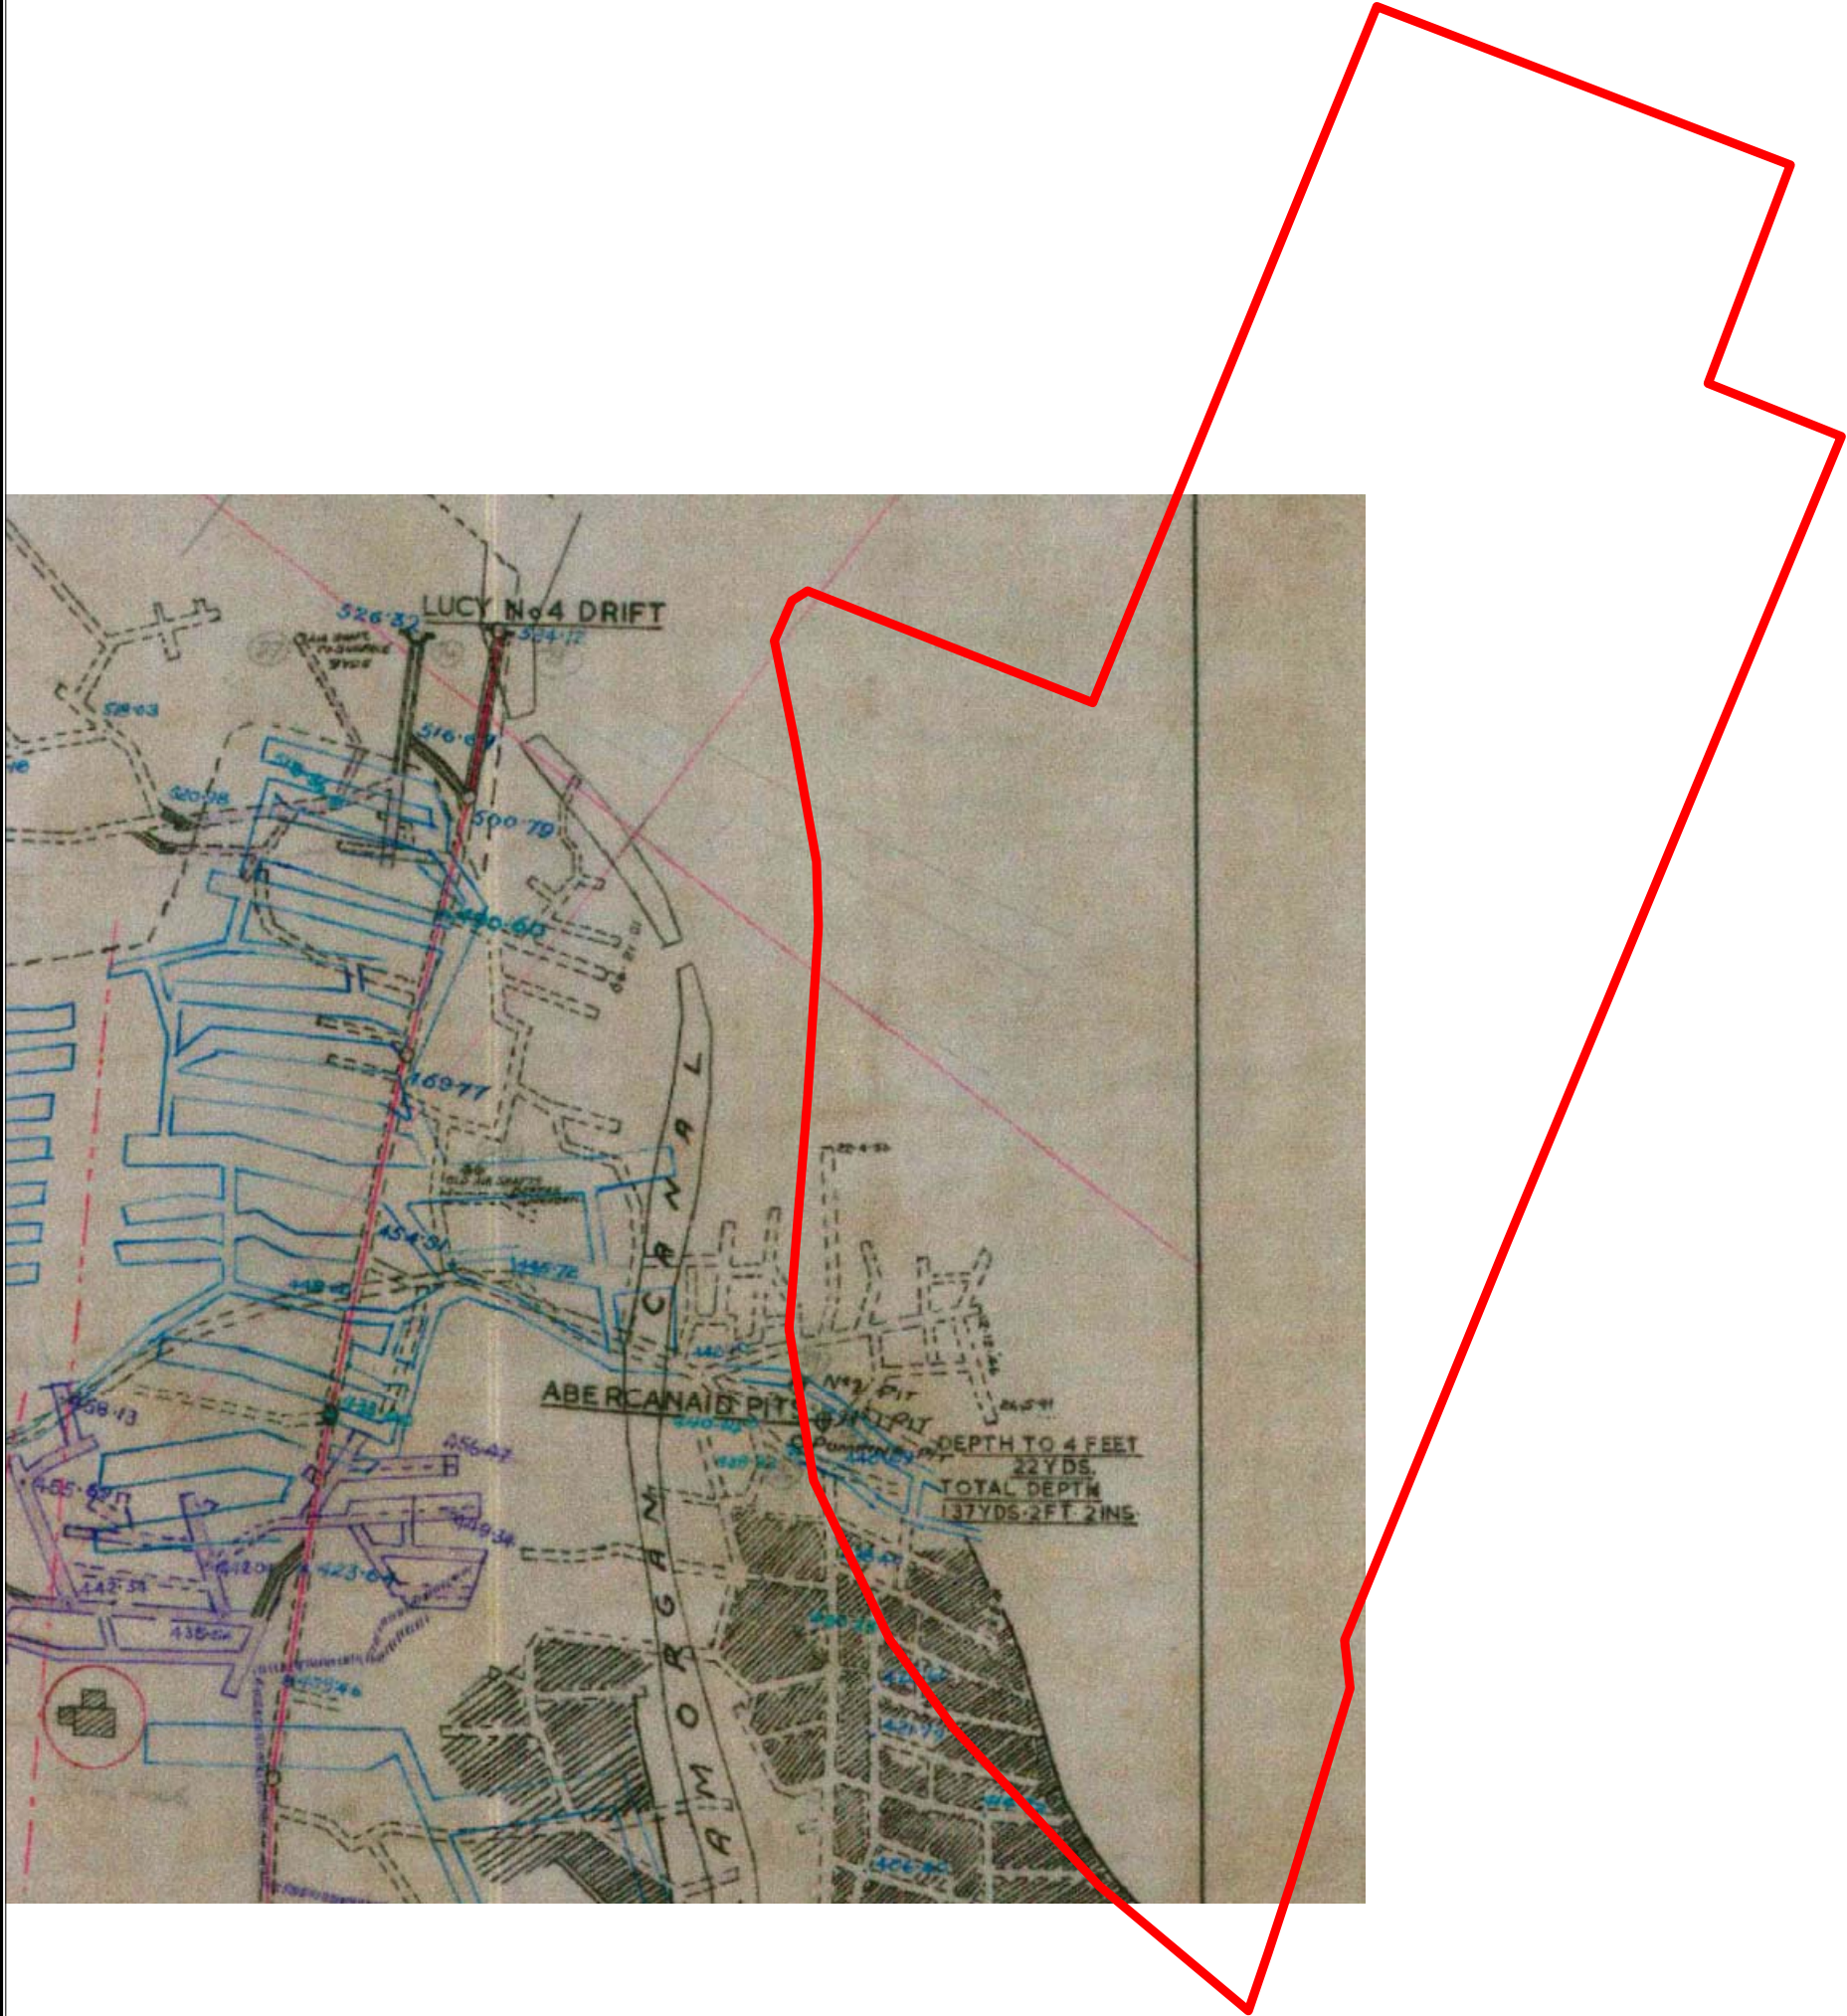
Figure 4: Abandonment Plan - Four Feet Seam

Abandonment plans obtained from the Coal Authority, indicate recorded workings in the Four Feet seam in the south of the site, the Nine Feet seam in the centre and southern areas and workings of the Seven Feet seam in the southern and central areas of the site. Extracts from these abandonment plans are presented in Figure 4, 5 and 6 respectively.

There are recorded workings in the Four Feet, Seven Feet and Nine Feet seams beneath the central and southern areas of the site at depth ranging from shallow to deep. The shallow workings are thought to be in the Four Feet seam and these present a risk of potential mining subsidence to the site.
