RHONDDA  
GEOTECHNICAL  
SERVICES

COAL MINING RISK ASSESSMENT  
MERTHYR TYDFIL C.B.C.  
DEVELOPMENT AT  
MERTHYR MOTOR AUCTIONS  
PANT ROAD  
DOWLAIS  
MERTHYR TYDFIL  
CF48 3SH  
18/01/2021

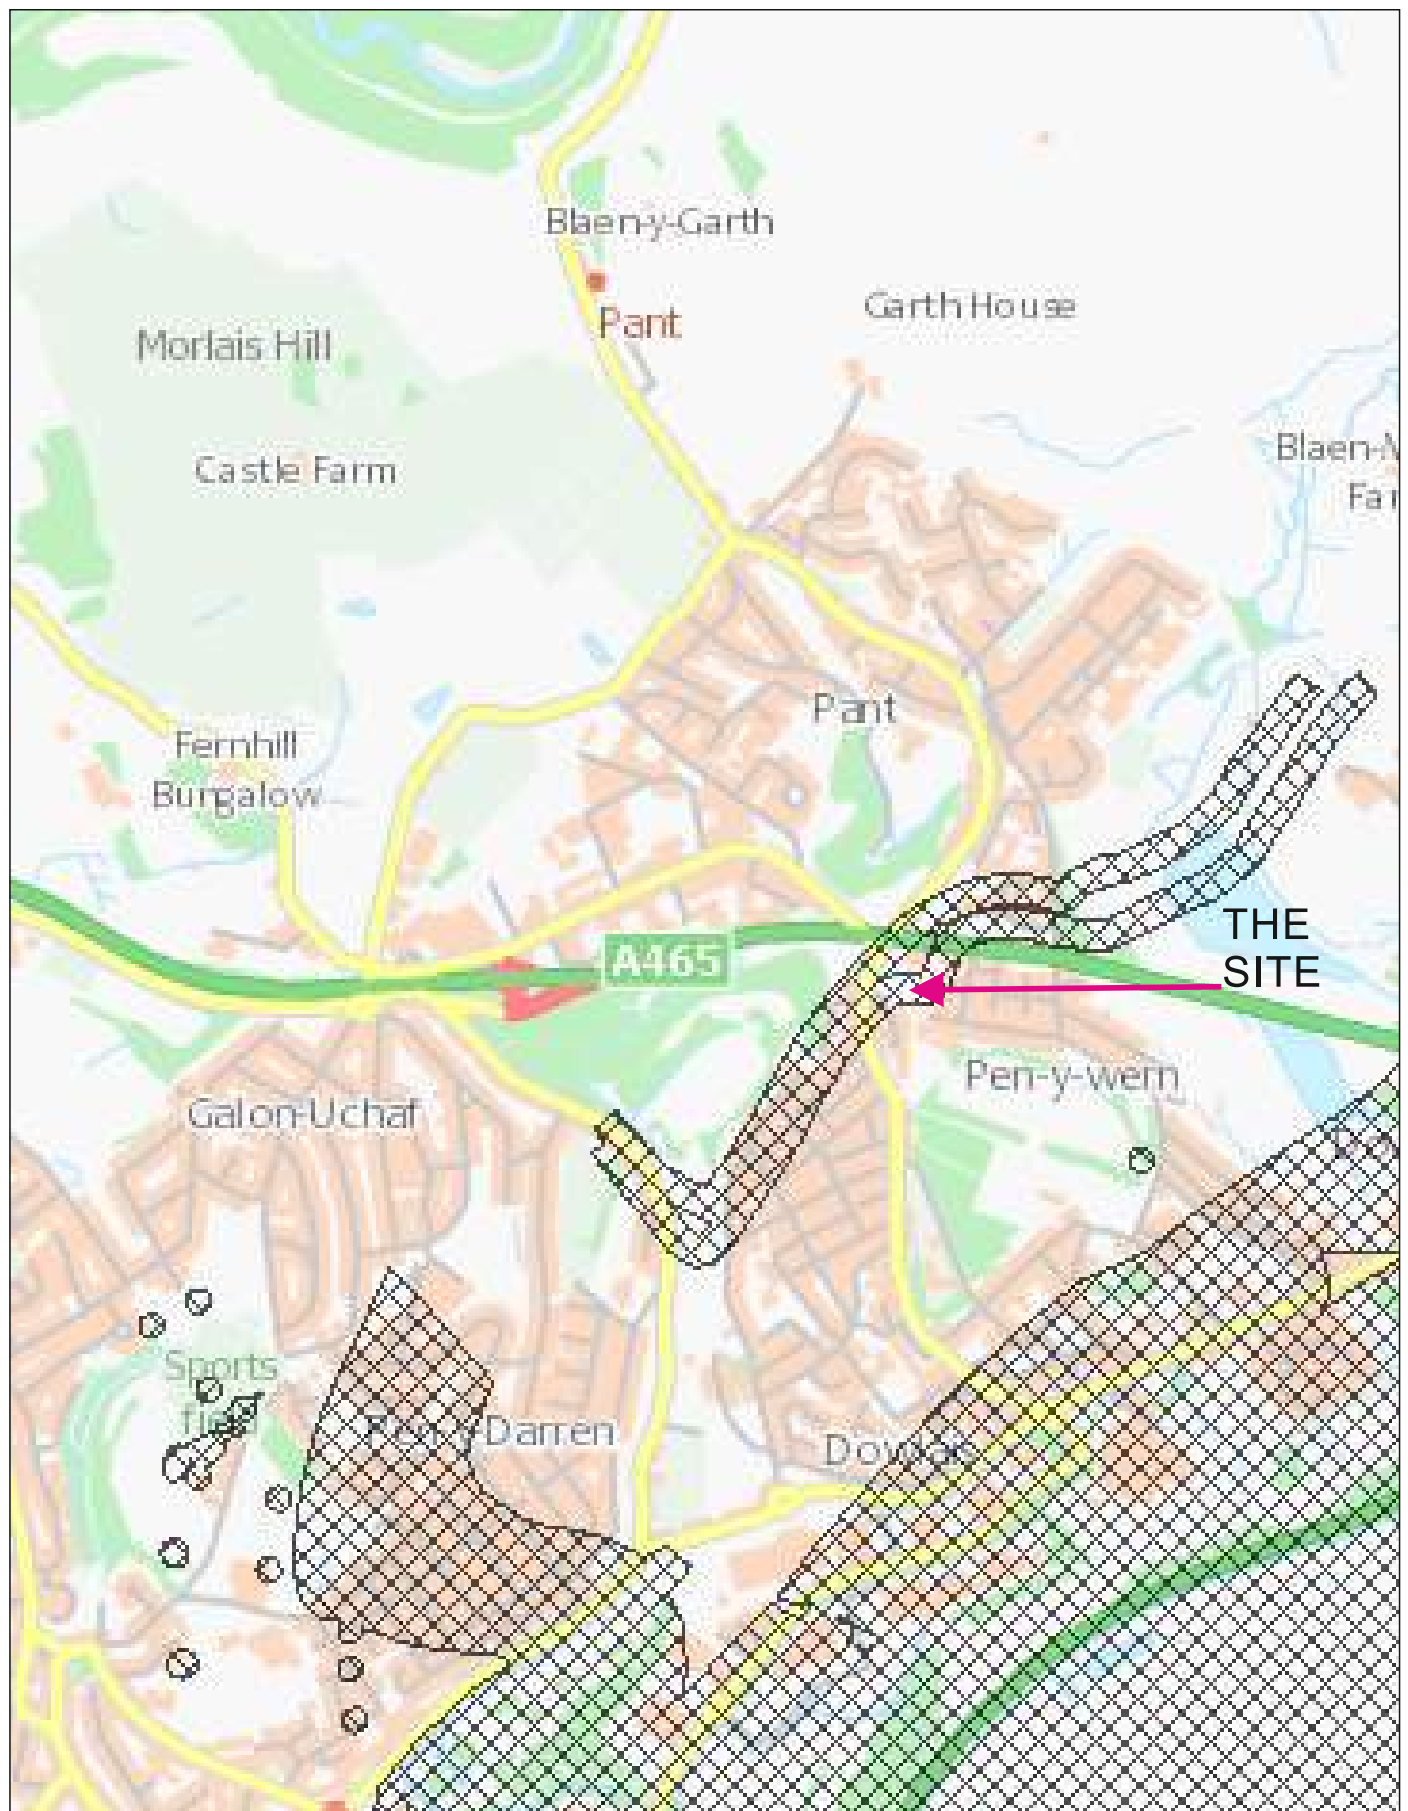
- e) A walkover survey of the site.
- 2a) The C.A. interactive viewer contains a vast amount of information from various sources particularly on the mining data window. An extract from the planning window can be seen in Figure 3. It can be seen that the site lies on a linear strip of Development High Risk. From its appearance, and the surrounding areas, this is a buffer zone above a seam outcrop. The small circular areas well to the southwest are 20m exclusion zones around mine entrances. In order to fully understand why sites have a high risk status it is informative to study the Coal Mining Data window. This window is far superior to the planning window as it is at a larger scale. There are multiple datasets which can be turned on and off. An extract from the Mining Data Window is reproduced as Figure 4 overleaf. For clarity only two sets of data are turned on in Figure 4- seam outcrops and mine entries. The brown lines running close to, or through of the site are coal seam outcrops. The seam code for both is SW0101, which means the C.A. believe both outcrops are the Garw Seam. This claim will be analysed in more detail in following sections. There is a marked contrast in Figure 4 between the area around the site and land to the south. The land well to the south is covered with multiple mine entries and tightly packed seam outcrops. In contrast, the area around the site has no mine entries and only the two previously mentioned outcrops. Figure 5 from the data window has two different datasets switched on- recorded and suspected mining. The C.A. have no records of mining anywhere northwest of Dowlais and Dowlais Top. In contrast, the entire area of Merthyr south of that line is underlain by mineworkings, either recorded or suspected.

FIGURE 3  
 COAL AUTHORITY INTERACTIVE VIEWER, PLANNING WINDOW.  
 BLACK HATCHED AREAS ARE DEVELOPMENT HIGH RISK.

The site falls into a development high risk area for one reason only. That is the supposed seam outcrop on site and the associated buffer zone above it. This zone is recorded on the interactive viewer and seen in Figures 3 and 4.

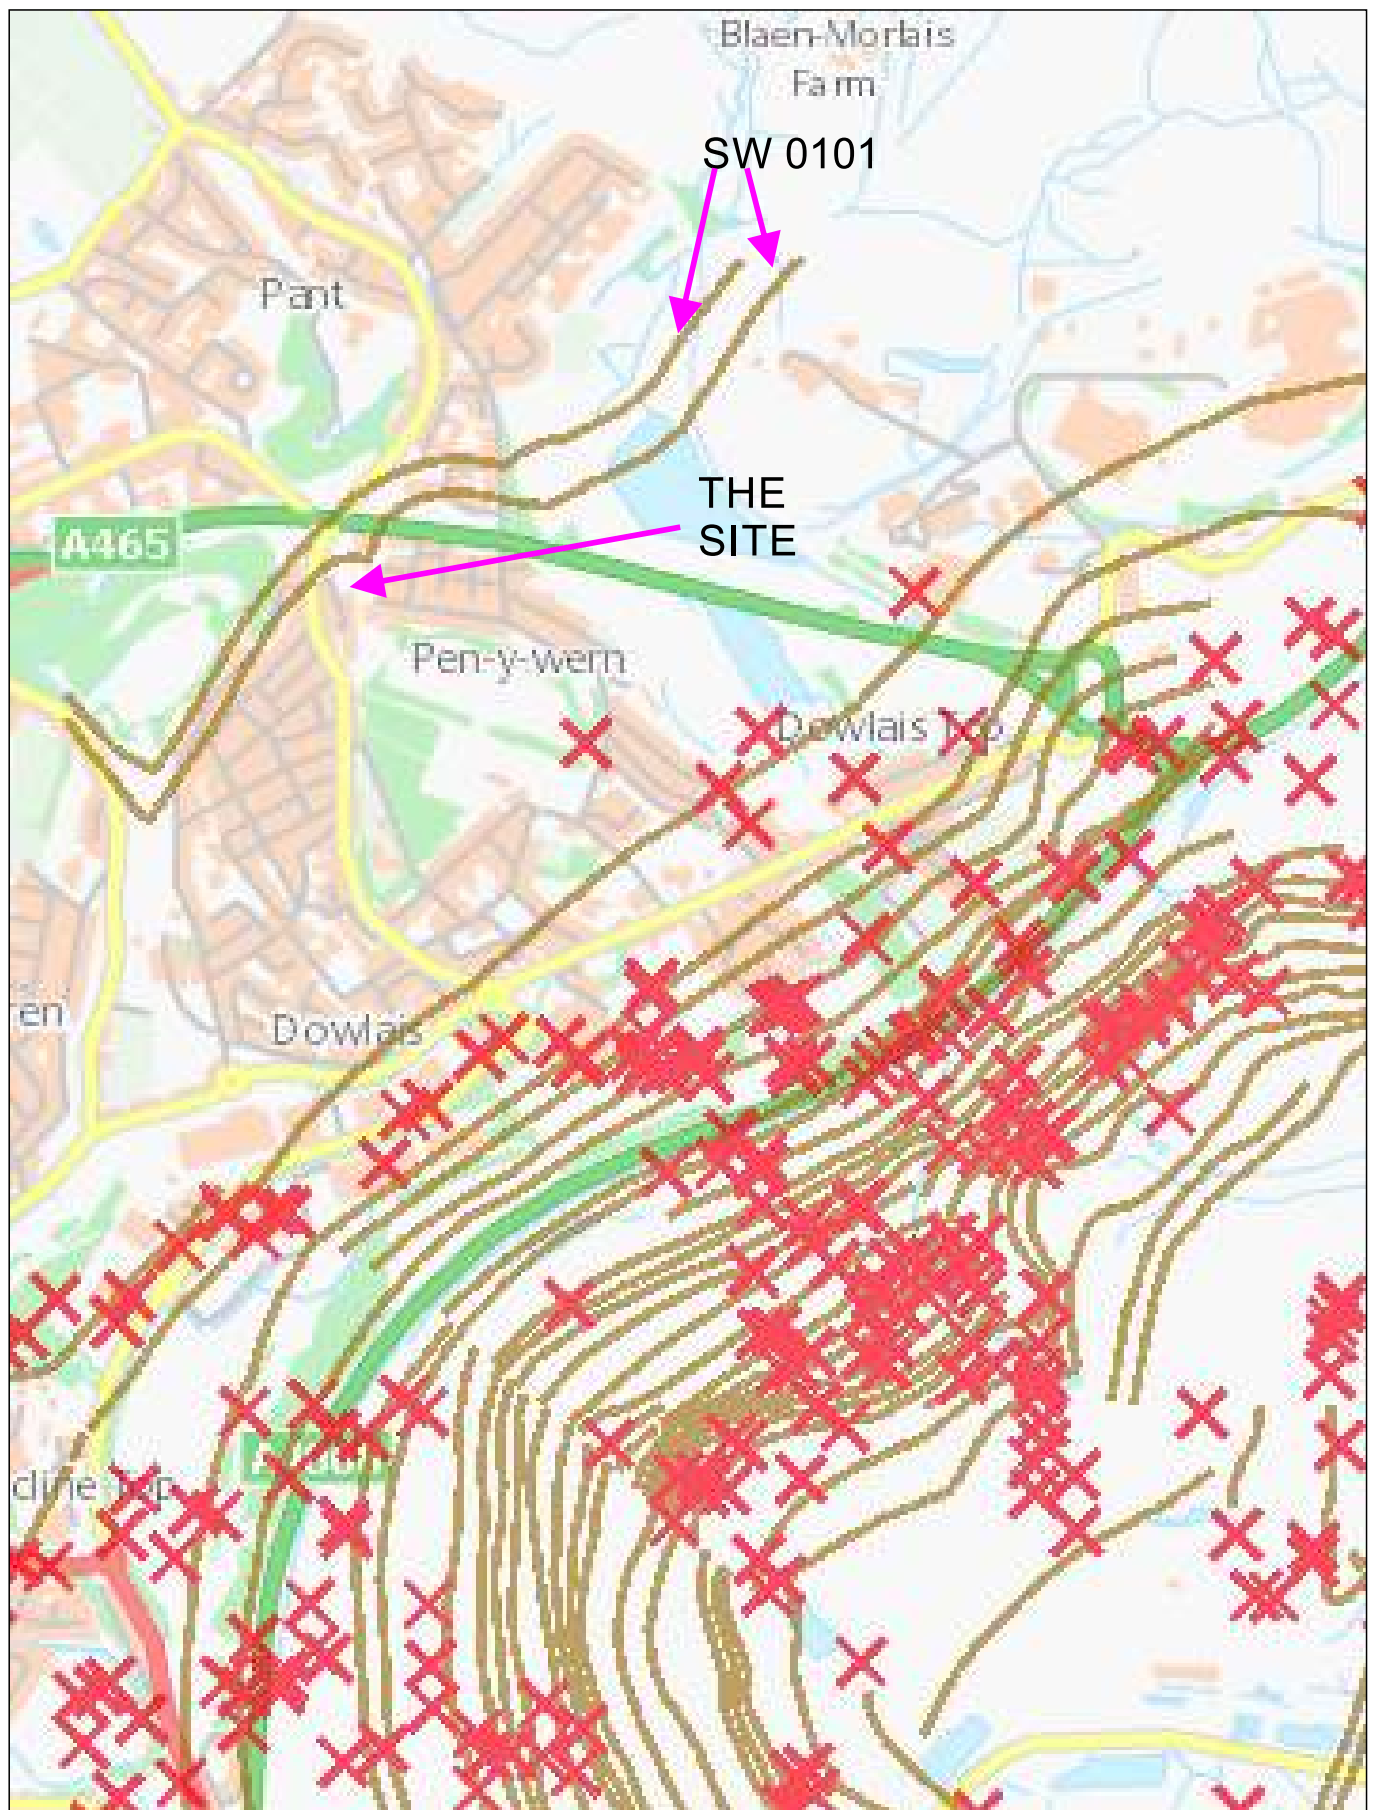
FIGURE 4  
EXTRACT OF THE C.A. VIEWER, MINING DATA WINDOW. RED  
CROSSES ARE MINE ENTRIES, BROWN LINES ARE SEAM  
OUTCROPS. THE SITE POSITION IS SHOWN.

The C.A. Data records two seam outcrops on the site and names both of them as the Garw Seam. Clearly, this is wrong for two reasons.

Firstly for a double outcrop as shown, the seam has to be repeated by one of two causes. Either the top of a very tight, recumbent fold can be removed by erosion or alternatively the seam outcrop can be repeated by a low angle thrust

fault. Both these features are relatively common on the southern rim of the main coalfield and in the Pembrokeshire Coalfield. They are unknown on the northern rim where Merthyr sits. Because there is such a large, good quality exposure on site it is straightforward to confirm that there is no trace of these complex structural features. The strata seen in the high rockface is not structurally deformed in any way, and dips gently south in a uniform way.

The second error in the C.A. Data is naming the seam as the Garw. The Garw is a workable seam in some parts of the Coalfield. Formerly known as the Cnapiog in the Merthyr Area, the Memoirs record it as 0.45m thick with some limited workings from outcrop. However, this seam does not underlie the site and actually outcrops 900m south of the site.

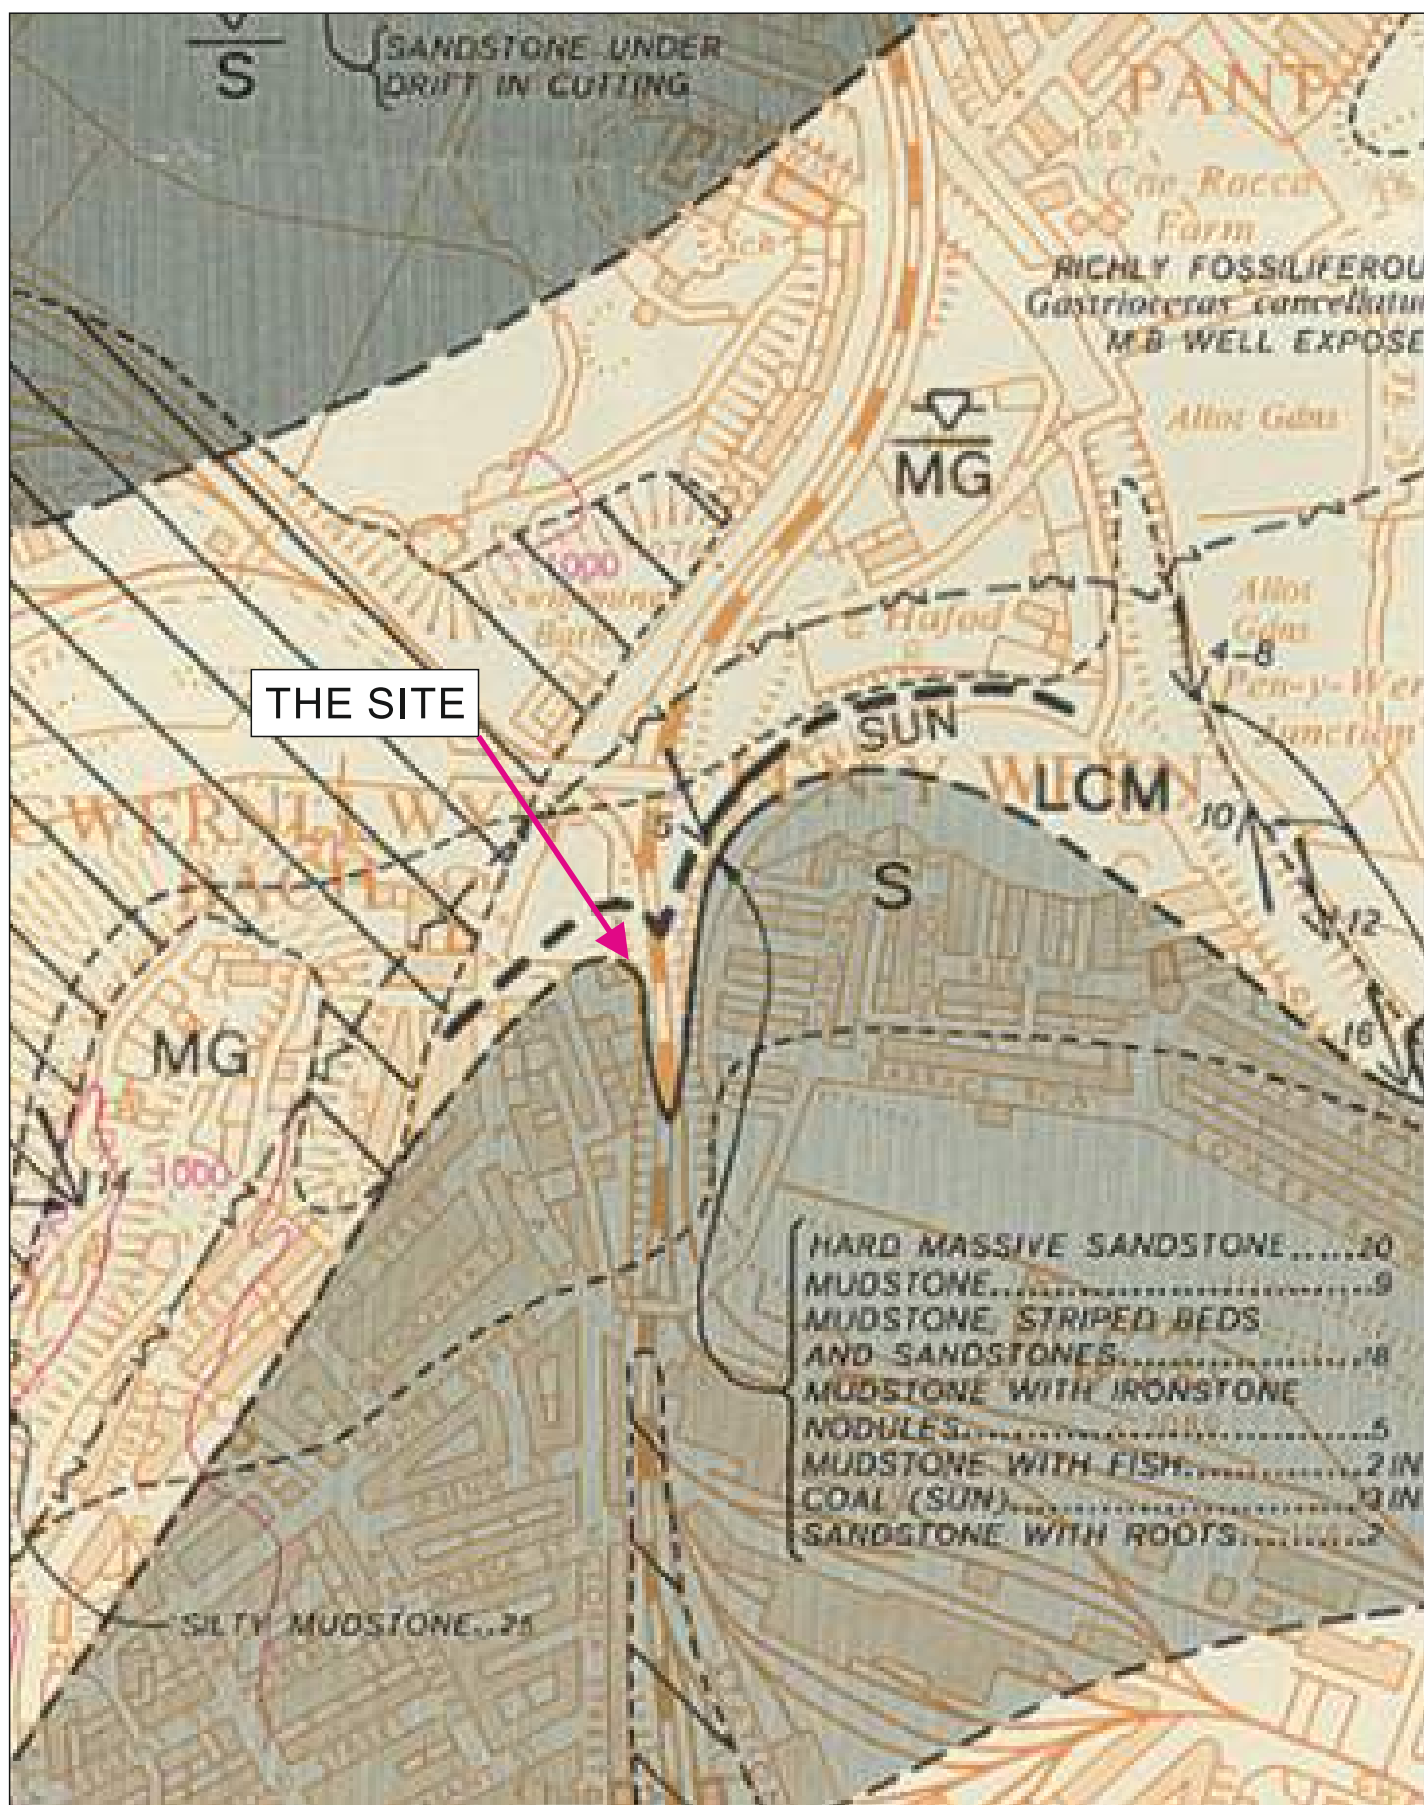
Figure 6 shows a very different picture to Figure 4. This is surprising as the primary data source for the C.A. viewer is the British Coal Rationalised Plan. This itself drew heavily on the Geological Survey with additional information from N.C.B/B.C. records. There is a single seam outcrop marked in Figure 6, and this is the Sun Seam (not the Garw). The Geological Survey have measured and recorded a section of bedrock exposure. This is near the present day main gates of the Auction Grounds and is described in the Memoirs. This section can be seen in Figure 6 and shows the Sun Seam to be 12" (0.3m) thick. This is overlain by 32' (9.75m) of mudstones, thin sandstones and ironstone nodules. Above this is the Farewell Rock. This is the grey shaded area in Figure 6. This is a strong quartzitic sandstone, so called because there were no workable coal seams below it.

Measured dips are not shown on the Interactive Viewer. These are essential in order to fully understand the Geology and apply it to a risk assessment. A dip of 5° towards the southwest is recorded in the exposure mentioned above. When combined with the topography it is clear the Sun Seam will underlie the site at a fairly shallow (<30m) depth. In Figure 7 the Garw Seam (generally considered the lowest workable coal) can be seen a considerable distance above the top of the Farewell Rock, and this places its outcrop approximately 900m south of the site, not on site as in the C.A. data.

EXTRACT OF GEOLOGICAL SURVEY SHEET SO 00NE. THE O.S. BASE MAP IS FROM 1965 AND VERY DIFFERENT TO TODAY. NOTE THE GEOLOGICAL SECTION WITHIN THE AUCTION BOUNDARY.

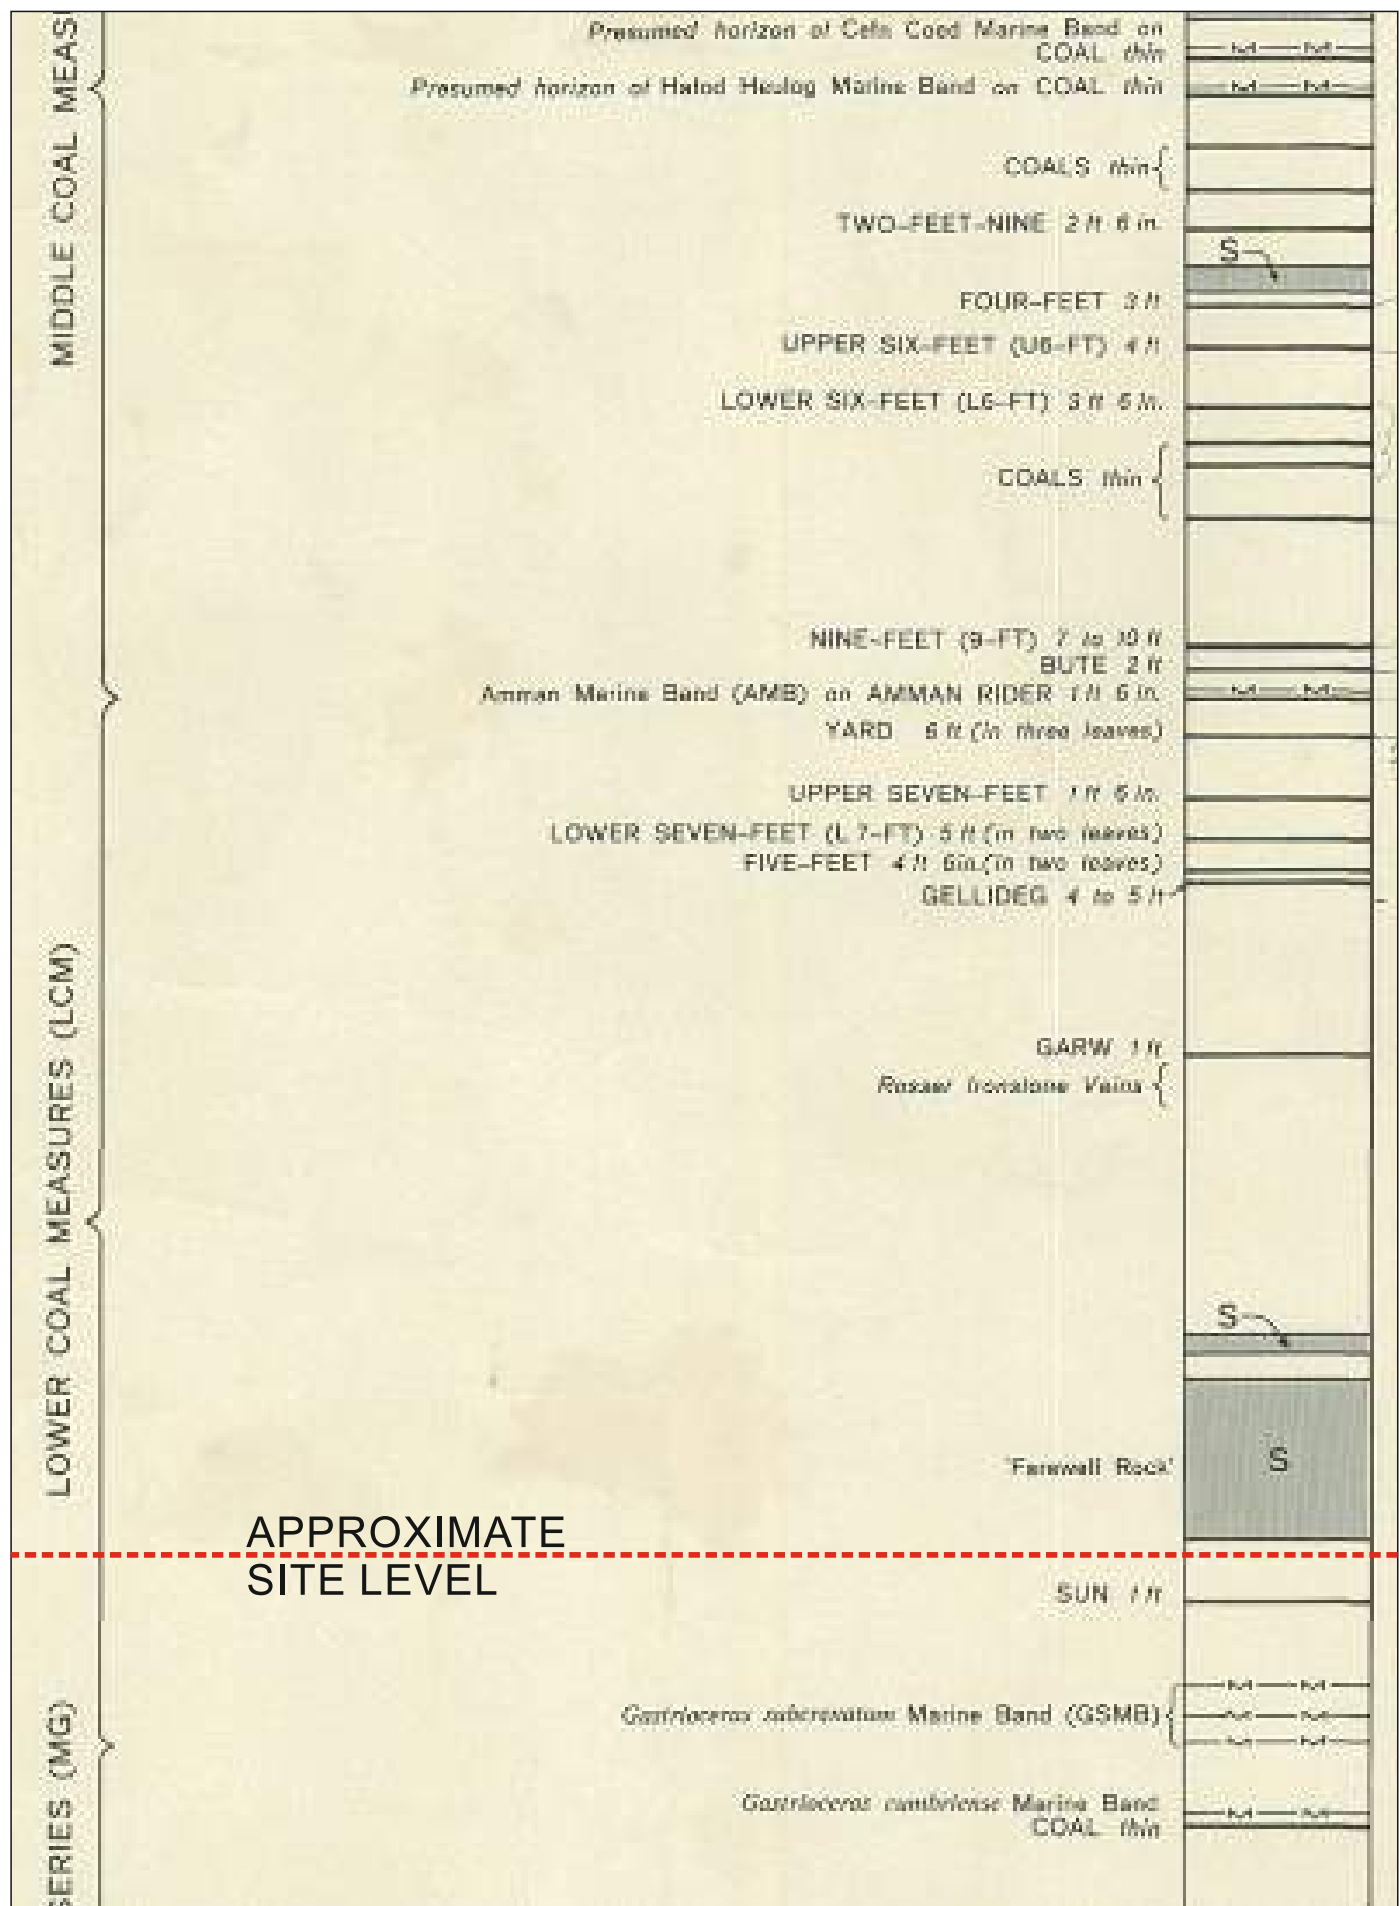
FIGURE 7  
SECTION OF THE STRATIGRAPHIC COLUMN FROM SO 00NE.  
THE APPROXIMATE SITE LEVEL IS MARKED.

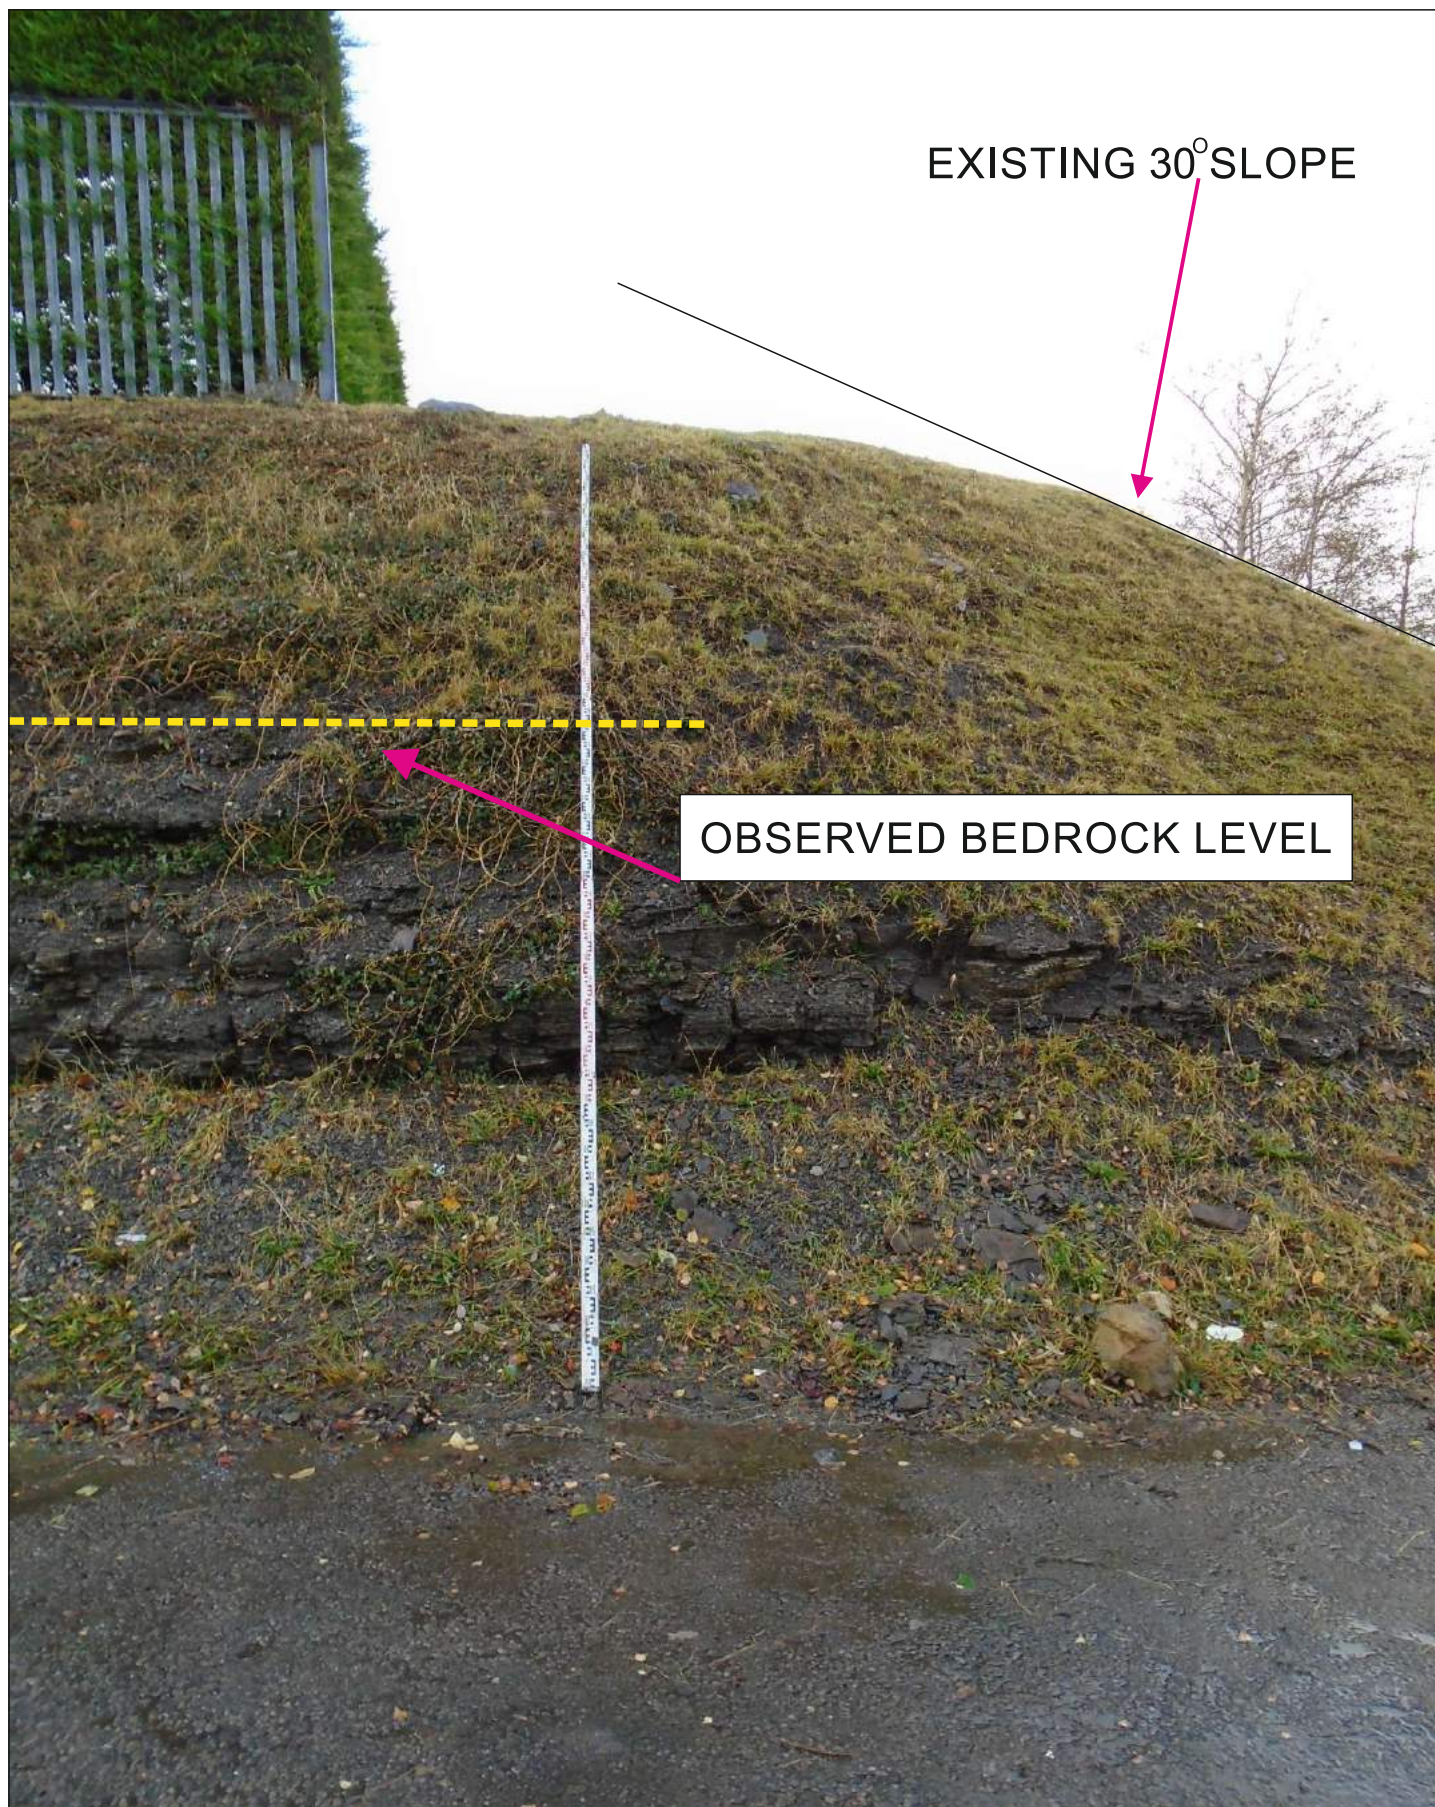
2e) a detailed inspection of the embankment was carried out on Monday 2/11/2020 in connection with the geotechnical survey mentioned in the introduction. The embankment that is to be removed is at the same level as the elevated garden of no. 43 Llewellyn Street and is separated from it by a steel palisade fence with dense conifers behind it. The houses in Llewellyn Street are at approximately the same level as the yard of the auctions, only the gardens are at a higher level. These back onto the former railway cutting mentioned in the previous section. The embankment has a flat top running away from the palisade fence and ranging from 8m-12m wide before running down to the yard level at an average slope of 30°. On the eastern flank of the embankment the underlying bedrock is exposed. This can be seen in Figure 9. The bedrock is a thinly interbedded series of Siltstones and Mudstones with Ironstone Nodule horizons. This can be seen in Figure 10. The bedrock has been cut back, presumably as part of the railway cutting. In the rockface opposite, on the other side of the yard the base of the Farewell Rock is exposed. The Geological Memoirs record 9.75m of interbedded strata between this and the Sun Seam. This is the material exposed on the side of the embankment. The Sun Seam cannot be seen in the side of the embankment. This means that it is somewhere below the level of the yard, probably at a very shallow depth. This supports the conclusions of Section 2b,c.

**FIGURE 9**  
THE SURVEY STAFF IS OPEN TO 5m BUT IS LEANING BACK. THE BEDROCK IS SEEN APPROXIMATELY 3m ABOVE THE YARD LEVEL BUT THEN APPEARS TO DROP AWAY TO THE RIGHT (NORTH).

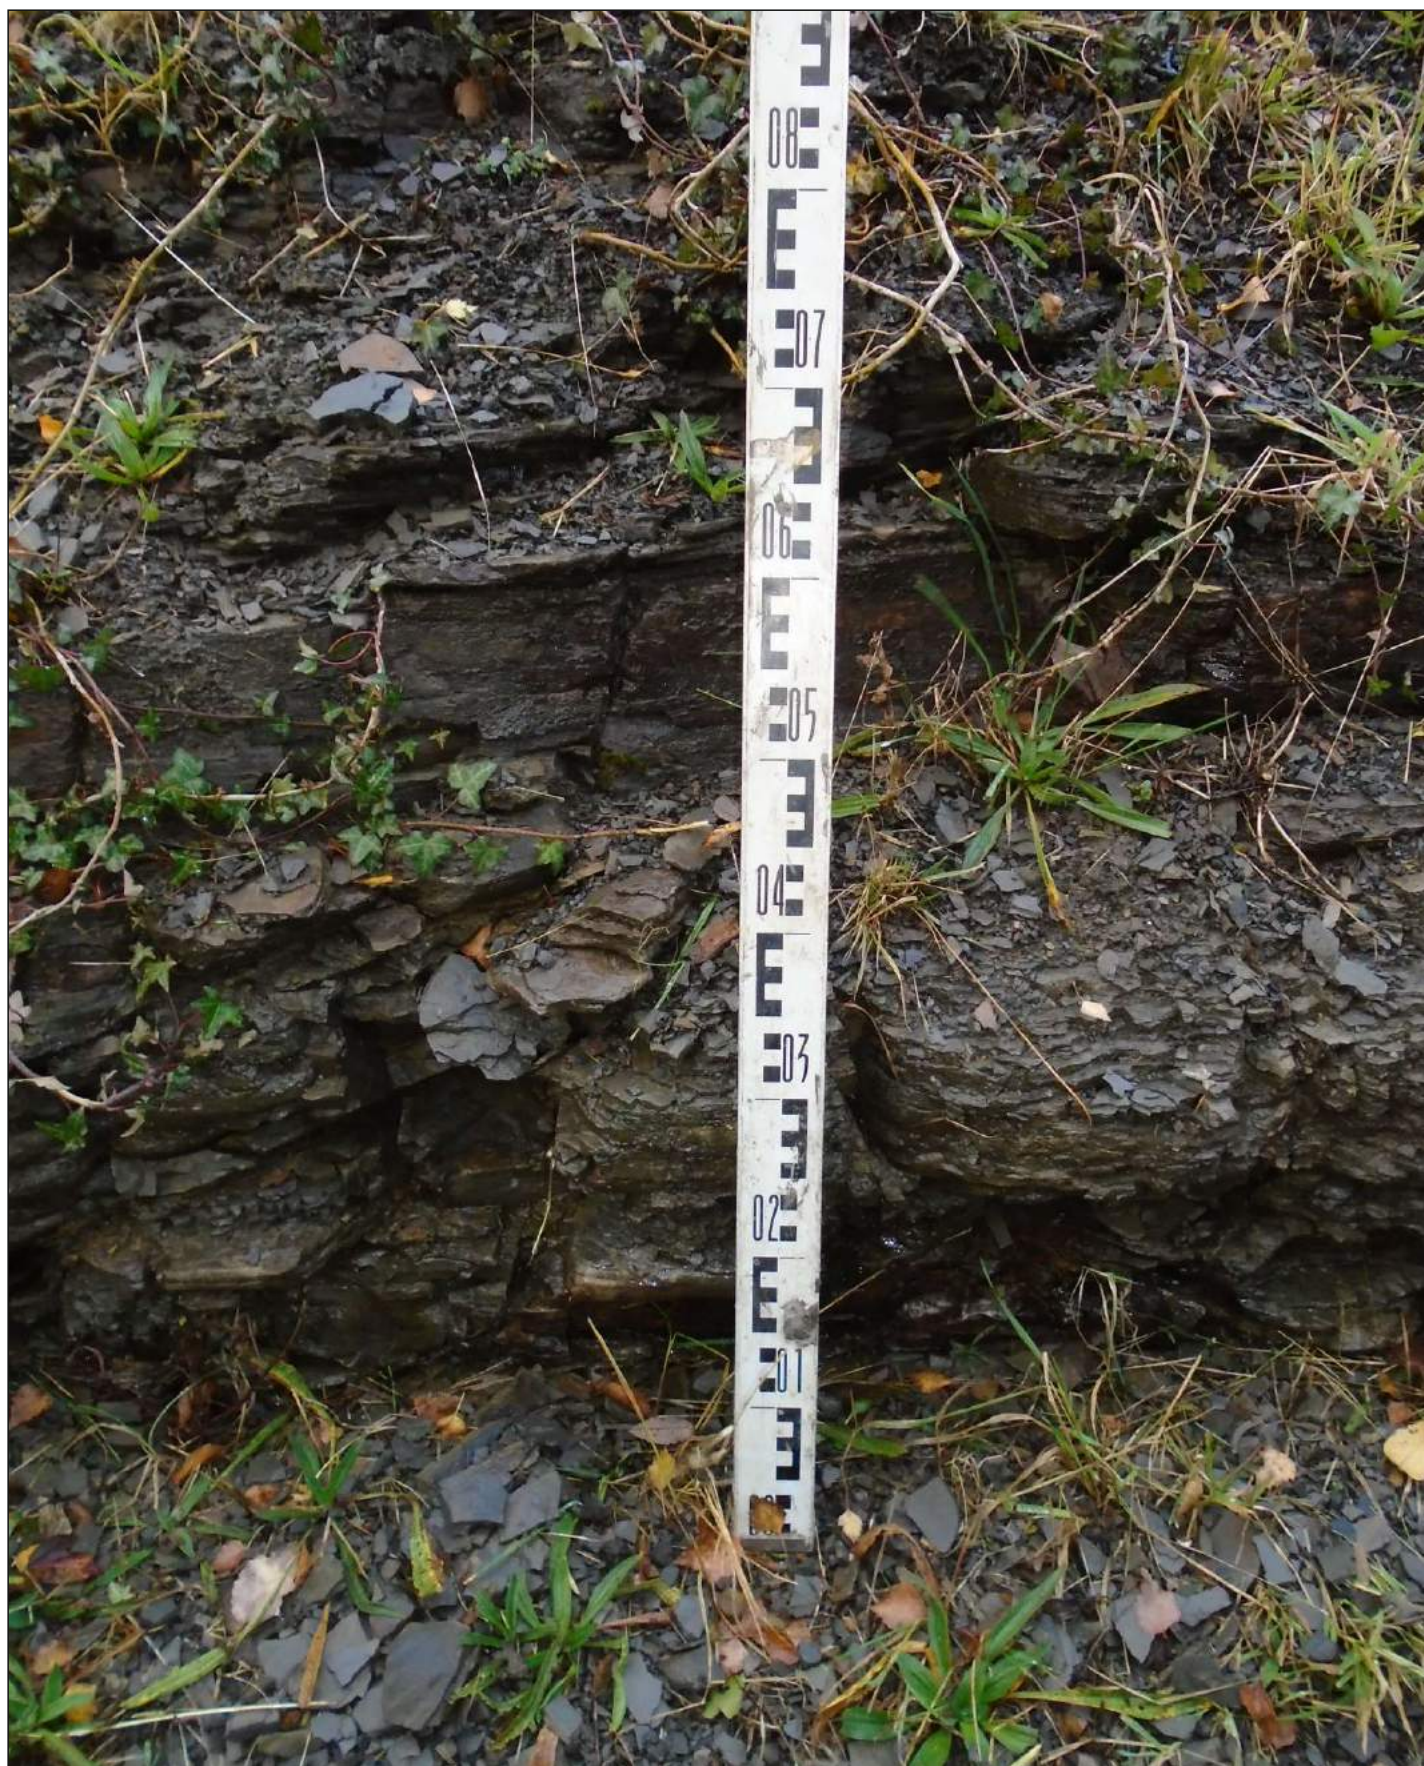
FIGURE 10  
INTERBEDDED MUDSTONE, SILTSTONE AND IRONSTONE  
NODULES EXPOSED IN THE EMBANKMENT.
