# Bike Park Wales Tree Survey Addendum 19<sup>th</sup> December 2018

1.1.1 This is an addendum to Bike Park Wales BS5837:2012 Tree Survey 07/09/18. The proposed site layout has now been developed and the original survey area has been extended.

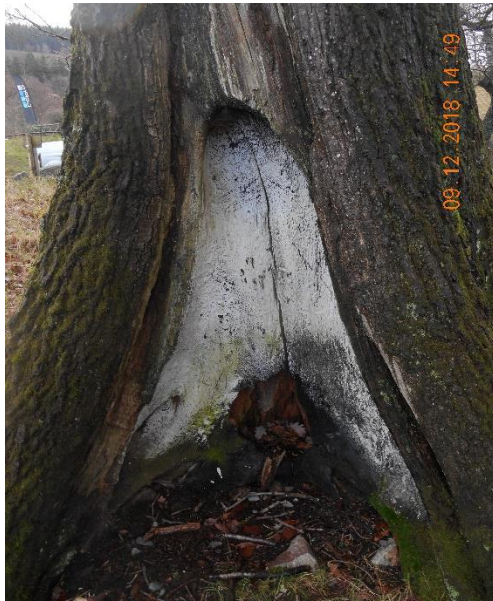
| Tree and Tag No<br>Species | | Hght<br>(m) | Stems | | Crown | | Age | RP<br>A (m²)<br>R (m) | Phys<br>Condition | Structural<br>Condition | Preliminary Recommendations | | Cat<br>ERC |
|---|--|---|---|---|---|---|---|---|---|---|---|---|---|
| Common Oak<br><i>Quercus robur</i> | | 32 | 1 | 1340 | N<br>E<br>S<br>W | 8<br>14<br>15<br>14 | 9<br>5<br>2<br>8 | M<br>A: 707<br>R: 15 | Good | C: Good<br>S: Good<br>B: Good | Monitor :: Unspecified<br>Large bark wound to 2m east side. Cavity formed at base approx 1.5m h, 1.3m w at base and 1.2m d. There appears to be brown rot at rear of cavity, no signs of fungi at the time of this inspection. Crack in wood above rotten area. Approx 1/3 of base of stem decayed. | | <b>C.2</b><br>10 to 20 yrs |

| Tree No | Species | Work Required | Priority |
|---|---|---|---|
| T231 | Oak | Monitor tree for signs of fungal fruiting bodies or decline | 6 Months |

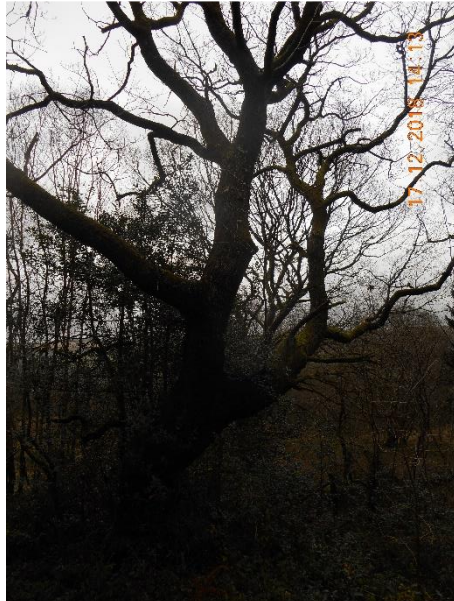
T1565 – to be removed
