*Report No. BC/MB/06.19.04.*

**Mining Risk Assessment:  
Land at 6 Criccieth Grove, Castle Park Estate,  
Merthyr Tydfil.**

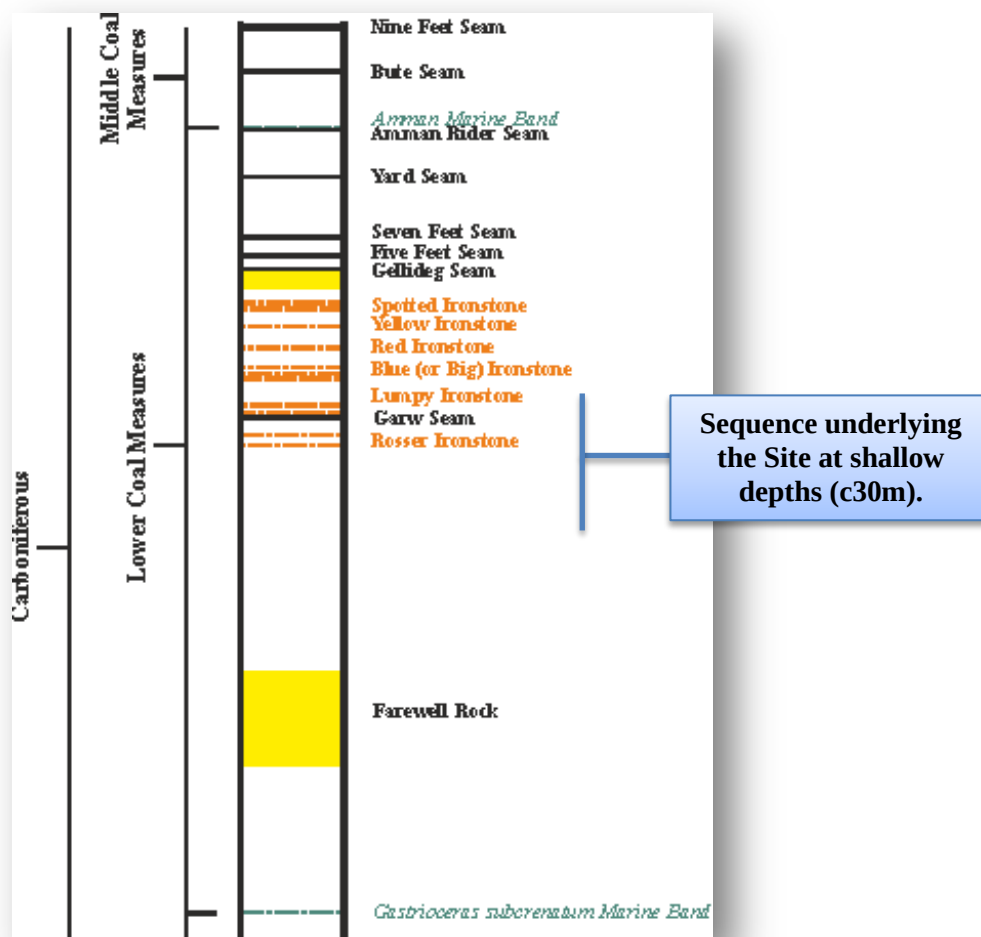
**Figure 1**  
**Part of the Stratigraphic Column.**

NE, shows the inferred position of the outcrop of the Garw Seam to be present approximately 50m south-west of the Site (see *Geology Plan, drawing no. BC/MB/06.19.04.02*). The Rosser Ironstone Veins are present below the Garw Seam in the geological sequence (see Figure 2, Part of the Stratigraphic Column). There are no coal seams below the Garw Seam that are thick enough to have supported underground mining operations. The regional dip of the coal measures in this area is 1 in 12 towards the south-west such that the Rosser Vein Ironstones underlie the Site at shallow depths.
