*Report No. BC/MB/12.13.01.*

# **Mining Risk Assessment: Land at 1 Park View House, Heolgerrig, Merthyr Tydfil.**

**Mr J. Carter Evans.**

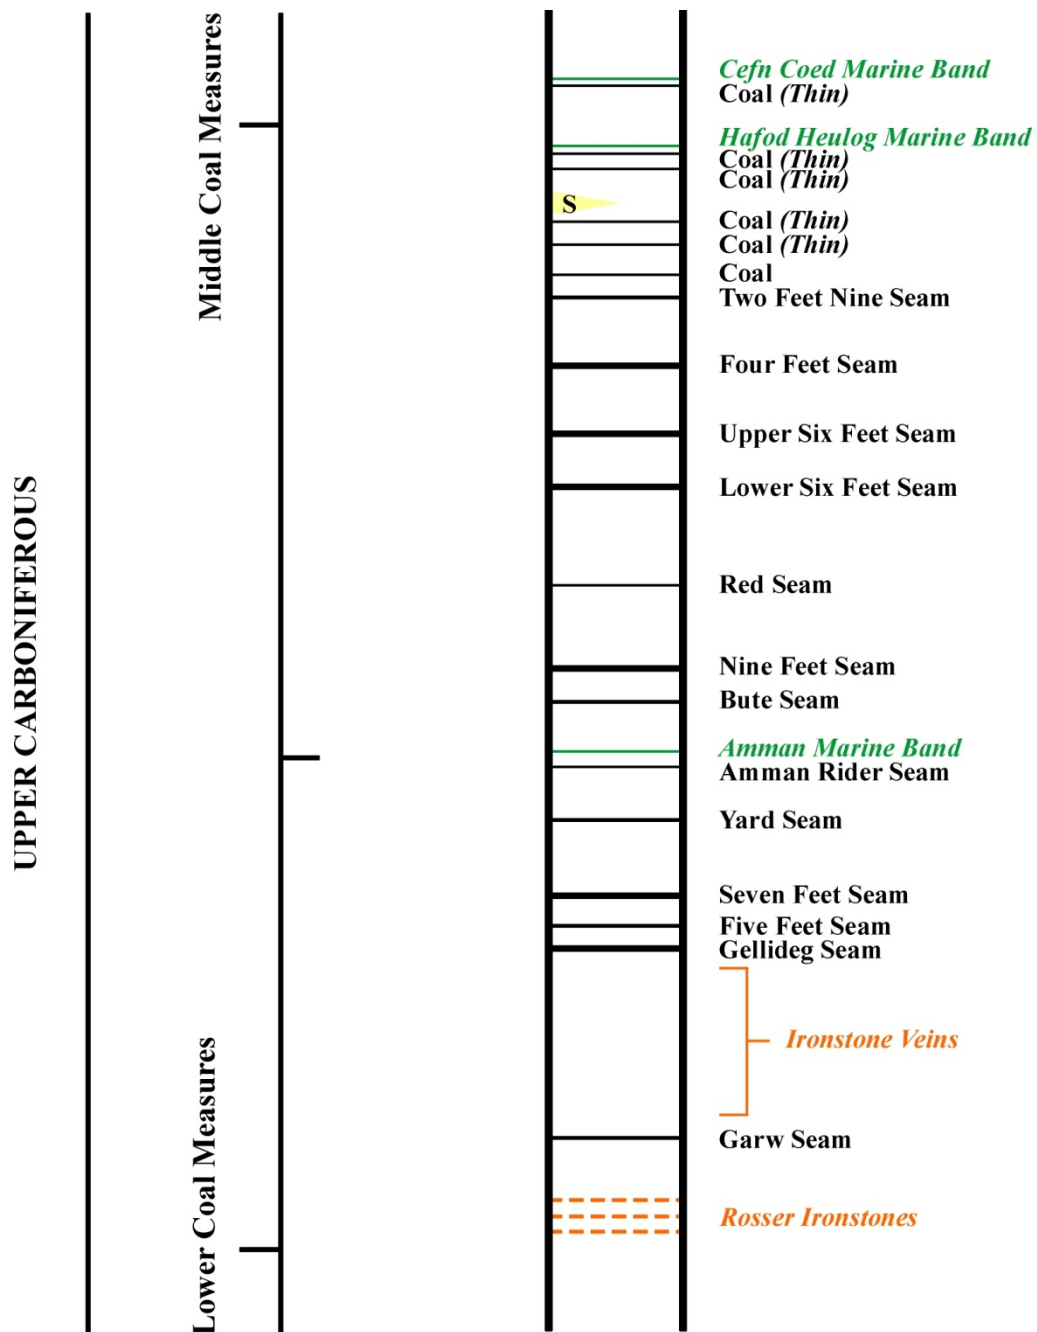
### Part of the Stratigraphic Column.

Heolgerrig and elsewhere combine to form one, thick, composite seam. Exploratory drilling immediately to the west of this Site suggests that the Six Feet Seam is represented by one, thick seam in the vicinity of the Site.

Other coal seams underlie the Site at increasing depths, the principal ones, in descending order, are the Bute, Yard, Seven Feet, Five Feet/Gellideg and the Garw Seams (see *Part of the Stratigraphic Column*, above); there are also a number of ironstone veins below the Five Feet/Gellideg Seam.

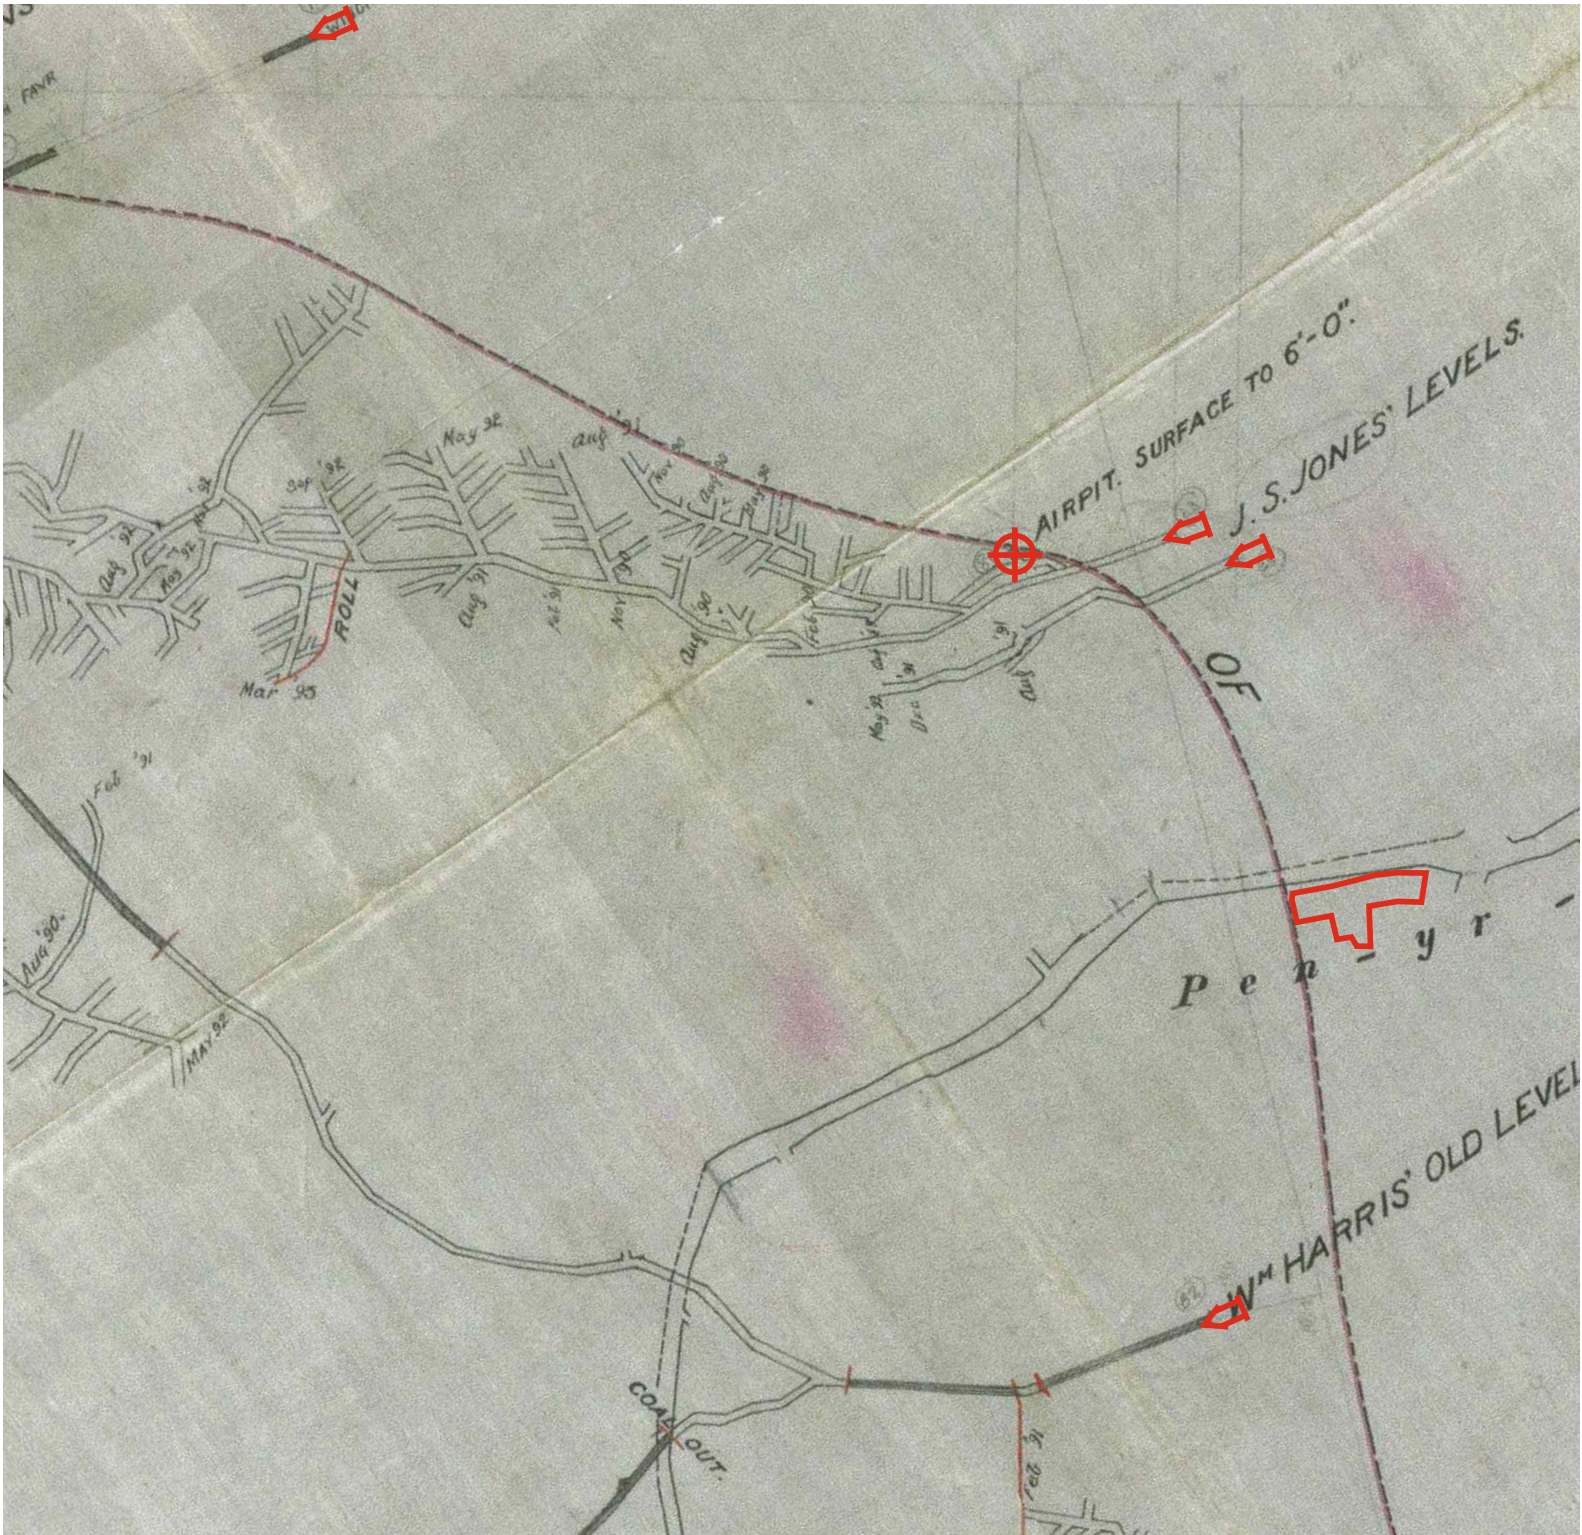
*Extract from Mine Records Plan.  
- Six Feet Seam -*

When both sets of records are taken together it is apparent that the Six Feet Seam does not underlie the Site and the Nine Feet Seam underlies the Site at relatively shallow depths. A thin coal seam, the Red Seam, is sometimes present between the above two seams, but its presence has not been confirmed in this area. Exploratory drilling carried out in the surrounding area indicates that the Upper and Lower Six Feet Seams are two separate seams in some areas of

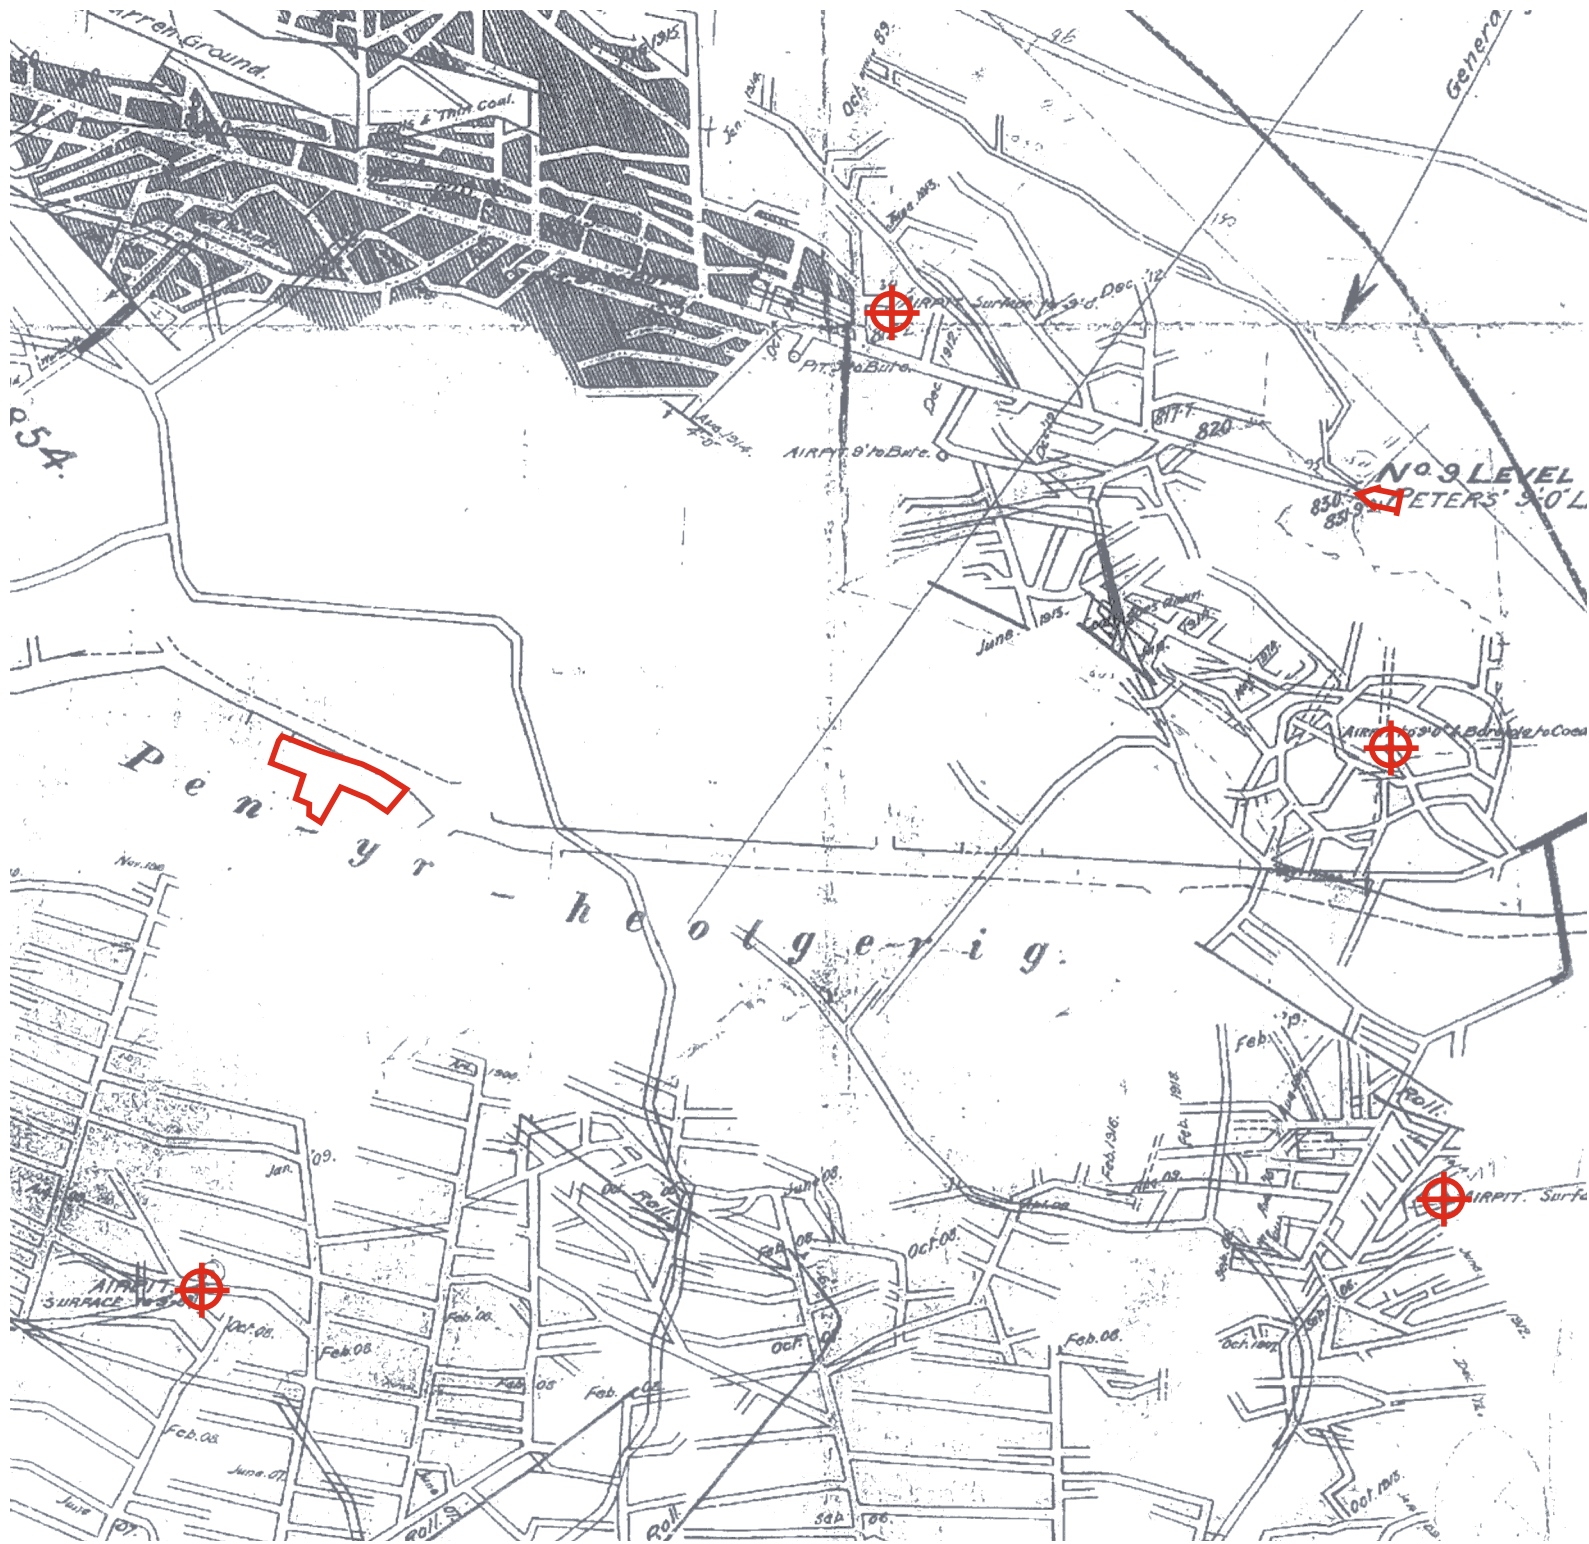
*Extract from Mine Records Plan.  
- Nine Feet Seam -*

The shallowest seam underlying the Site that is thick enough to have supported underground mining operations is the Nine Feet Seam, which underlies the Site at relatively shallow depths; it is a thick coal seam of variable thickness and structure that has been mined extensively across a large area of the district in underground mining operations. Mining records show that the Seam was mined fairly intensively both to the north and south of the Site, the

former workings were prosecuted from Peter's Nine Feet Level (see *Extract from Mining Records Plan: Nine Feet Seam, drawing no. BC/MB/03.13.02.05*). The mine plan suggests that no workings took place in this seam beneath the Site, however, the mine plan does not necessarily show all the underground workings that have taken place and the possibility of further, unrecorded workings being present beneath the Site cannot be entirely discounted. Other studies in the Heolgerrig area have identified unrecorded old workings in the Six Feet and Nine Feet Seams. Other workings are present in coal seams and ironstones lower in the geological sequence and at greater depths beneath the Site. Underground mining operations in the area ceased in the late 1930s.

If shallow old workings are found to be present the risk from those mining relics should be reduced by means of drilling and grouting.
