**Design and Access Statement**

**Proposed Replacement Windows**

5 Chapel Row, Georgetown, Merthyr Tydfil, Cf48 1BN

October 2023

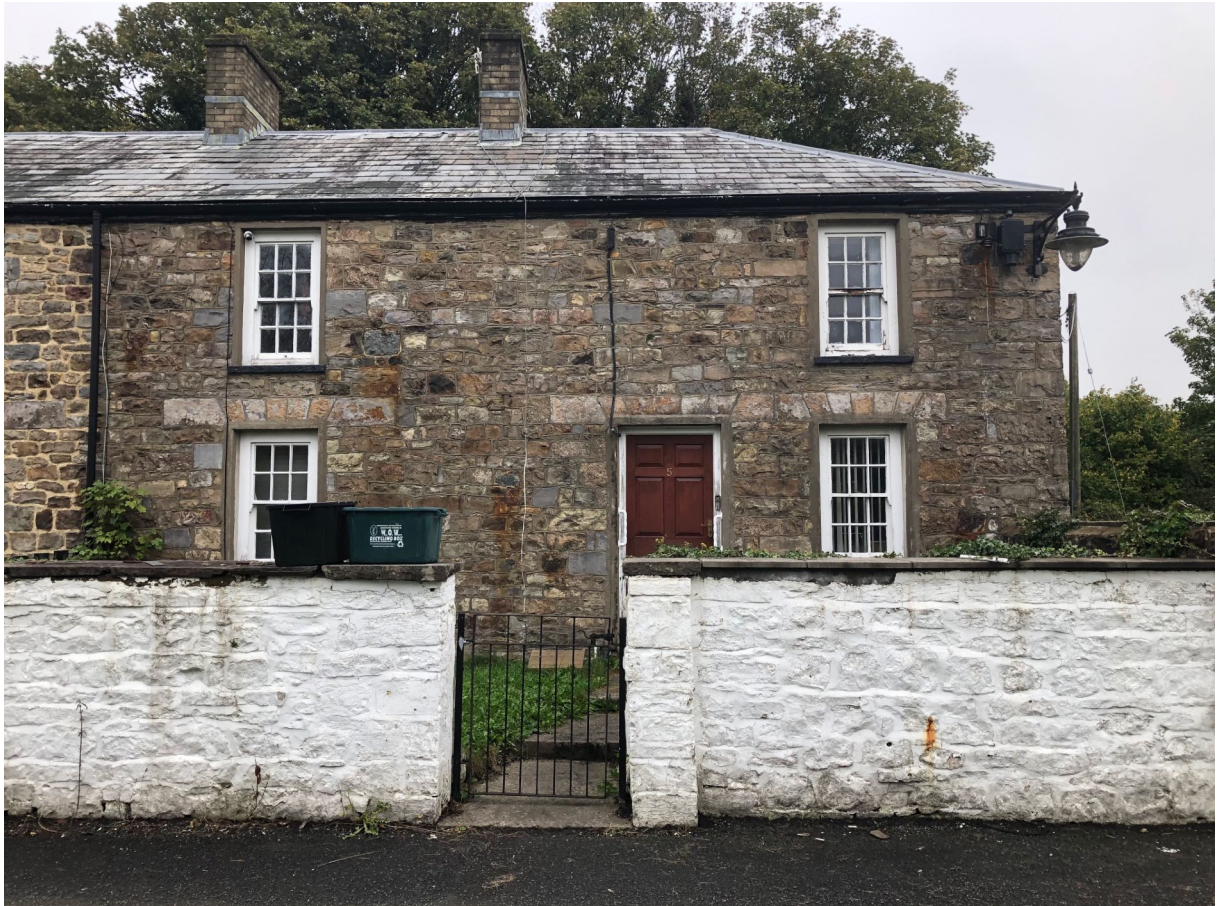
Photo 2 – front elevation

With regard to evidential value, from the exterior, the building appears to retain much of the original layout of the stone walls under a slate roof, (Photo 2) although there is a modern extension to the rear elevation with smooth-rendered walls but retaining the slate roof.

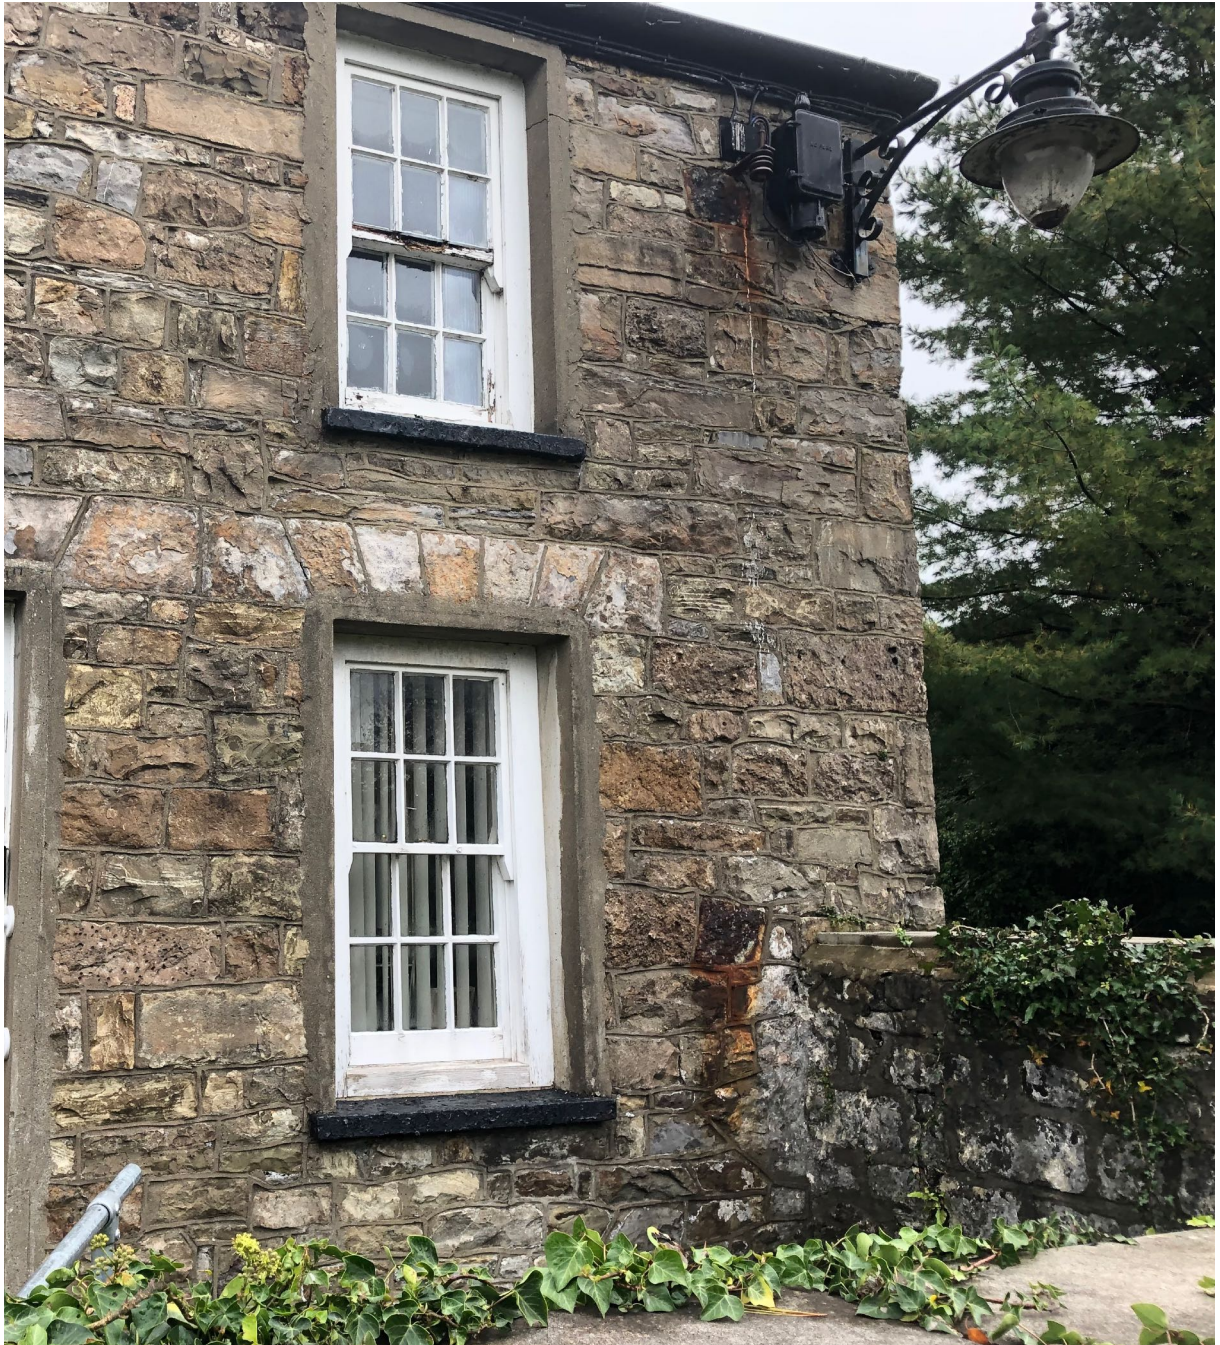
On initial inspection the windows appear in fair order. However closer examination reveals that all are suffering varying degrees of rot and have been repaired/painted over previously. See Photo 3 below – specifically the first floor window. This application seeks consent to replace the existing sash windows on a like for like basis.

Photo 3 – Windows – First floor window in poor condition
