*Report No. BC/MB/08.09.01.*

# **MINING RISK ASSESSMENT:**

**Land South of Winchfawr Park,  
Heolgerrig, Merthyr Tydfil.**

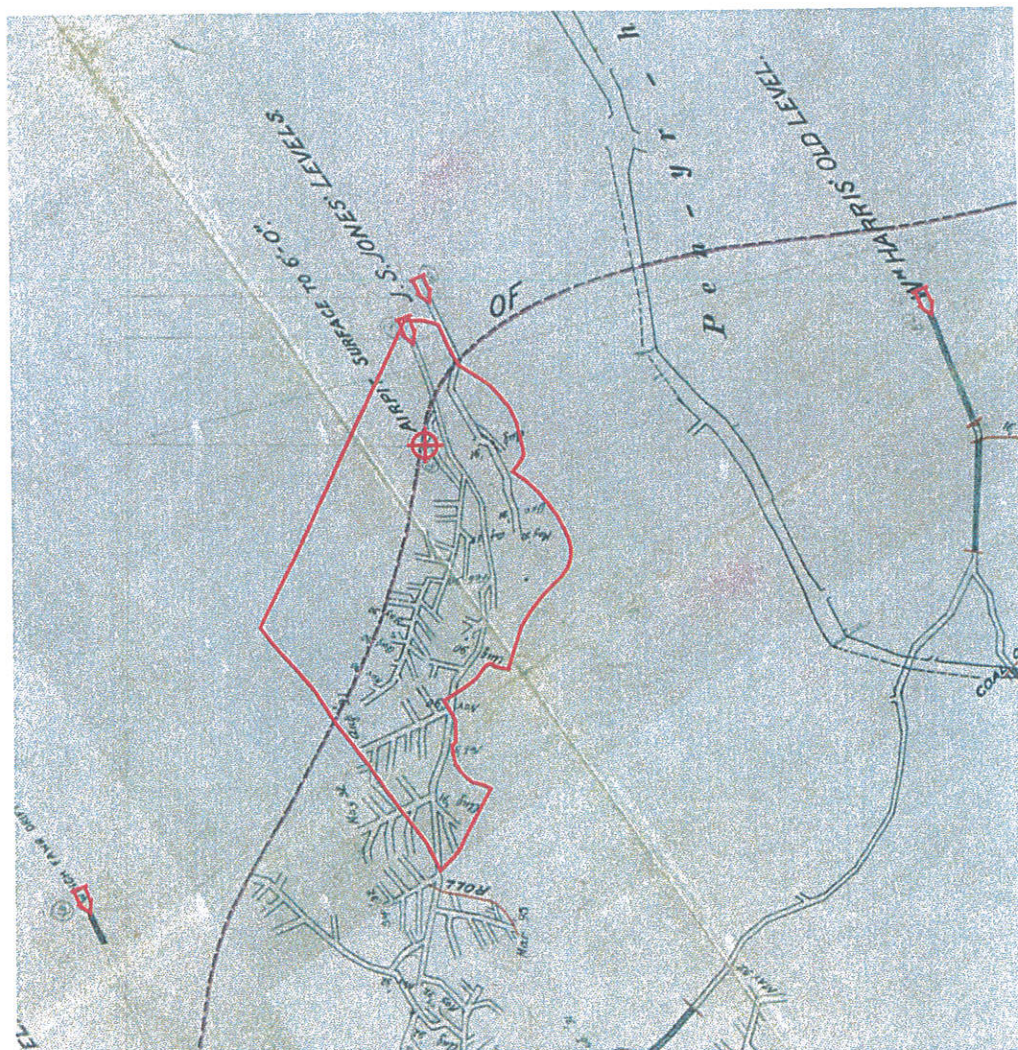
Drawing No: BC/MB/08.09.01.04.

The shallowest seam underlying the Site that is thick enough to have supported underground mining operations is the Six Feet Seam, which outcrops within the Site and underlies much of it at relatively shallow depths; it is a coal seam of variable thickness and structure that has been mined in patches across a large area of the district in underground mining operations. Mining records show that the Seam was mined fairly intensively across the southern half of the Site, the workings were prosecuted from J.S. Jones' Levels (see *Extract from Mining Records Plan: Six Feet Seam, drawing no. BC/MB/08.09.01.04*). Older and unrecorded workings may also be present close to the outcrop of the seam, where so called 'crop robbing' mining may have taken place. The mining plan shows that one of J.S. Jones' Levels (disused) was situated within the Site, at its north-eastern corner, and that a disused air pit is also present within the confines of the Site; the second of the disused J.S. Jones' Levels lies immediately outside the Site. The Site was also undermined in the Nine Feet Seam prior to 1854 (see *Extract from Mining Records Plan: Nine Feet Seam, drawing no. BC/MB/08.09.01.05*).

The area has been subject to extensive underground mining operations since at least the earliest part of the nineteenth century. The Six Feet Seam is the shallowest coal seam underlying the Site that is thick enough to have supported underground mining operations. Mining records indicate that the Seam has been intensively worked beneath the Site and exploratory boreholes drilled there have encountered old workings at very shallow depths. Mining records suggest that the seam outcrops within the Site so that a strip across the north of the Site and beyond the Seam's outcrop may be free from the risk of shallow mine workings, the Nine Feet Seam being too deep to pose a risk. However, the position of the outcrop as shown on the mine plan should be viewed as an approximate position and the presence of subsidence hollows in the north of the Site, indicating the collapsing of shallow mine workings, means that the area should be developed with caution.

Mining records indicate the presence of a disused air shaft near the north-eastern corner of the Site and also a disused mine adit in the north-eastern corner of the Site; a second disused adit lies immediately outside the north-eastern corner of the Site. The Coal Authority has no record that any of the entries has been stopped up to an acceptable engineering standard and it must be presumed, until proven to the contrary, that the two lying within the Site pose a risk to any surface development there.

Underground roadways leading from the two adit mouthings and present at very shallow depths beneath the Site are at a particularly high risk of collapse to the surface. The disused air shaft poses a risk both from the fact that there may be no safe cap on it or else by virtue of it collapsing into itself, resulting in subsidence in the area immediately around it.

The risk from the mining relics should variously be reduced by means of commonly used techniques including, as appropriate, drilling and grouting of shallow mine workings, capping of the shaft, excavating out and/or drilling and grouting of the adit. An exclusion zone should be designed around the disused adit lying immediately outside the north-eastern corner of the Site; no hard development should take place within the exclusion zone without a full assessment of the risk and adequate safeguards being included.

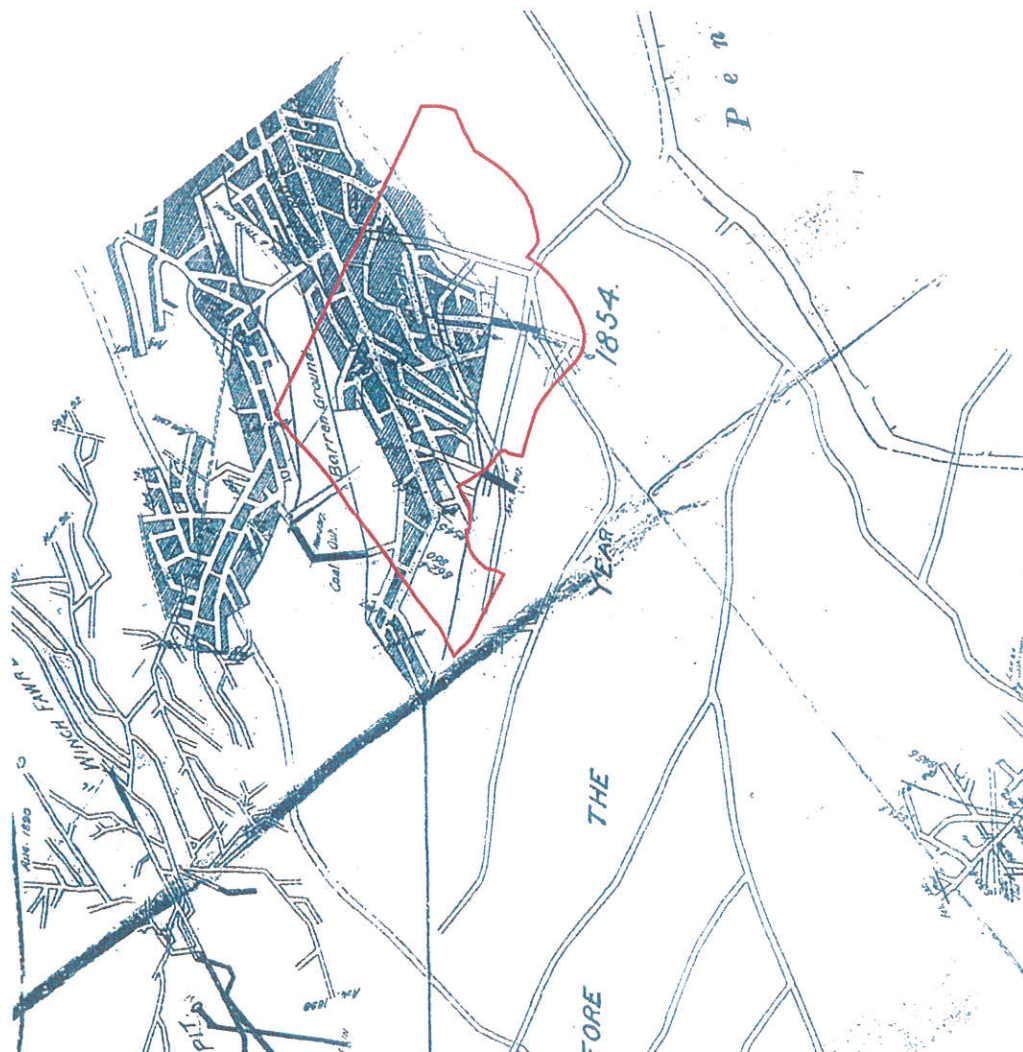
Drawing No: BC/MB/08.09.01.05.

The Nine Feet Seam is the next lowest thick coal seam in the geological sequence below the Six Feet Seam and has been extensively worked across the area. The old workings present in the Seam and underlying the Site will be at too great a depth to affect the structural integrity of the proposed dwellings. Similarly, other coal seams and ironstone veins further down in the geological sequence are all too

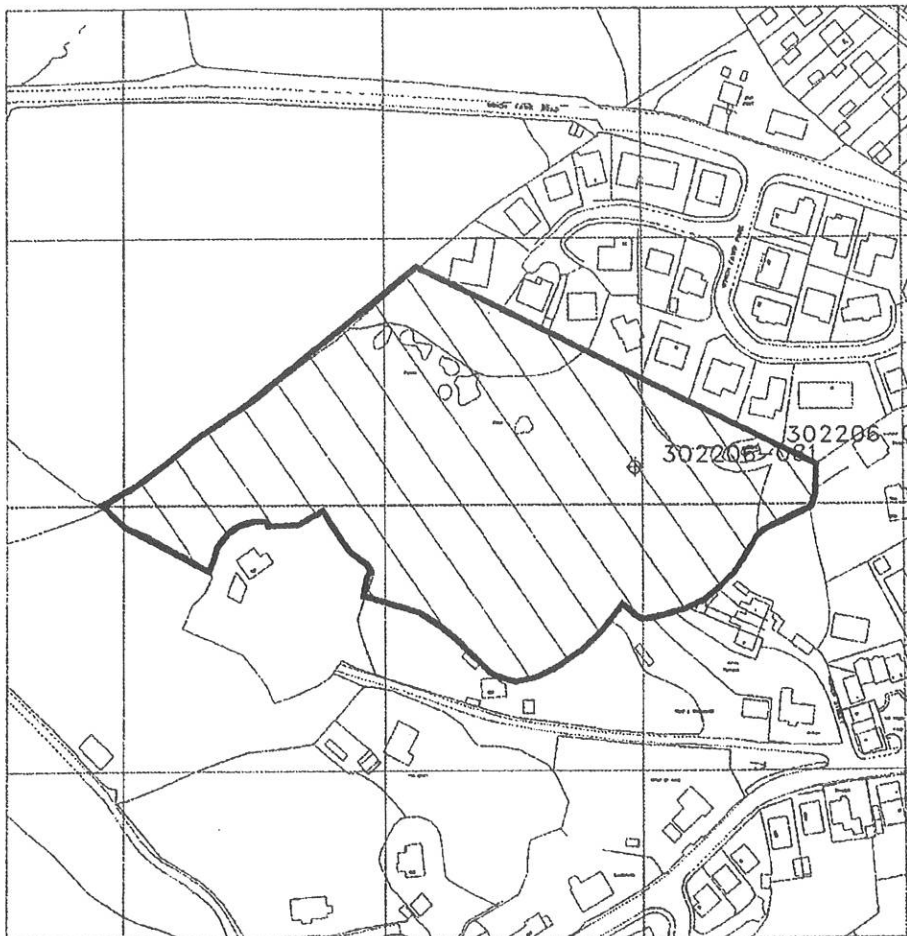
Within or within 20 metres of the property there are 2 mine entries, the approximate positions of which are shown on the attached plan. Your attention is drawn to the statements made on that plan.

We have no record of what steps, if any, have been taken to treat the mine entries.
