**Unit 7 EFI Industrial Estate,  
Merthyr Tydfil**

## **BS5837:2012 Tree Survey and Arboricultural Impact Assessment**

**March 2021**

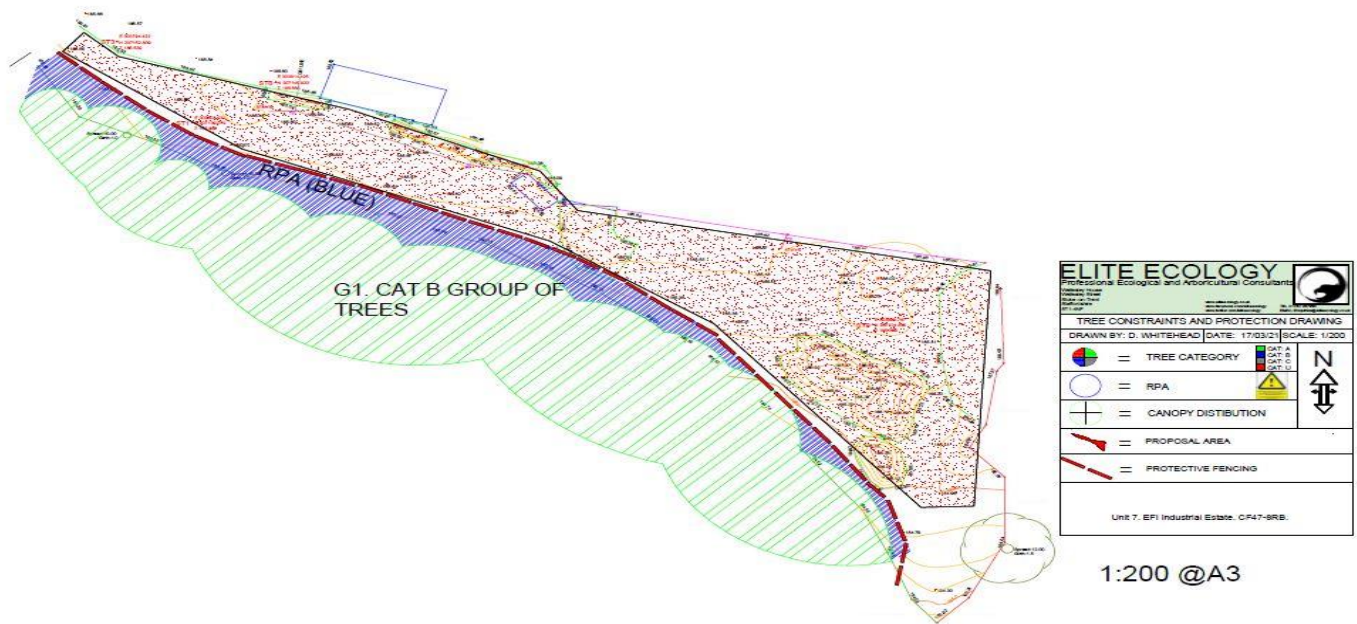
## Appendix A: Tree Constraints Plan

The average stem diameter, taken from the tree line at the riverbank top (300mm) has been used to calculate a parameter RPA of 3.6m. Should this be implemented, then the trees at the site are not thought to be at any risk. However, the lack of a clear boundary is currently allowing aggregate and surface material to be pushed over and upon the current calculated RPA which has the potential to cause detriment.

It is recommended that a permanent barrier/ fence line be erected along the line of the RPA shown in the tree constraints drawing. It is also recommended that this include a solid retaining barrier such as kerb stones or similar material to retain any surface material/ aggregate.

In summary, it is recommended that a sturdy, permanent barrier/ fence line be installed at the site along the parameter of the specified RPA as shown in the tree constraints drawing. Suitable signage should be placed within the RPA area to prevent future intrusion and disturbance.

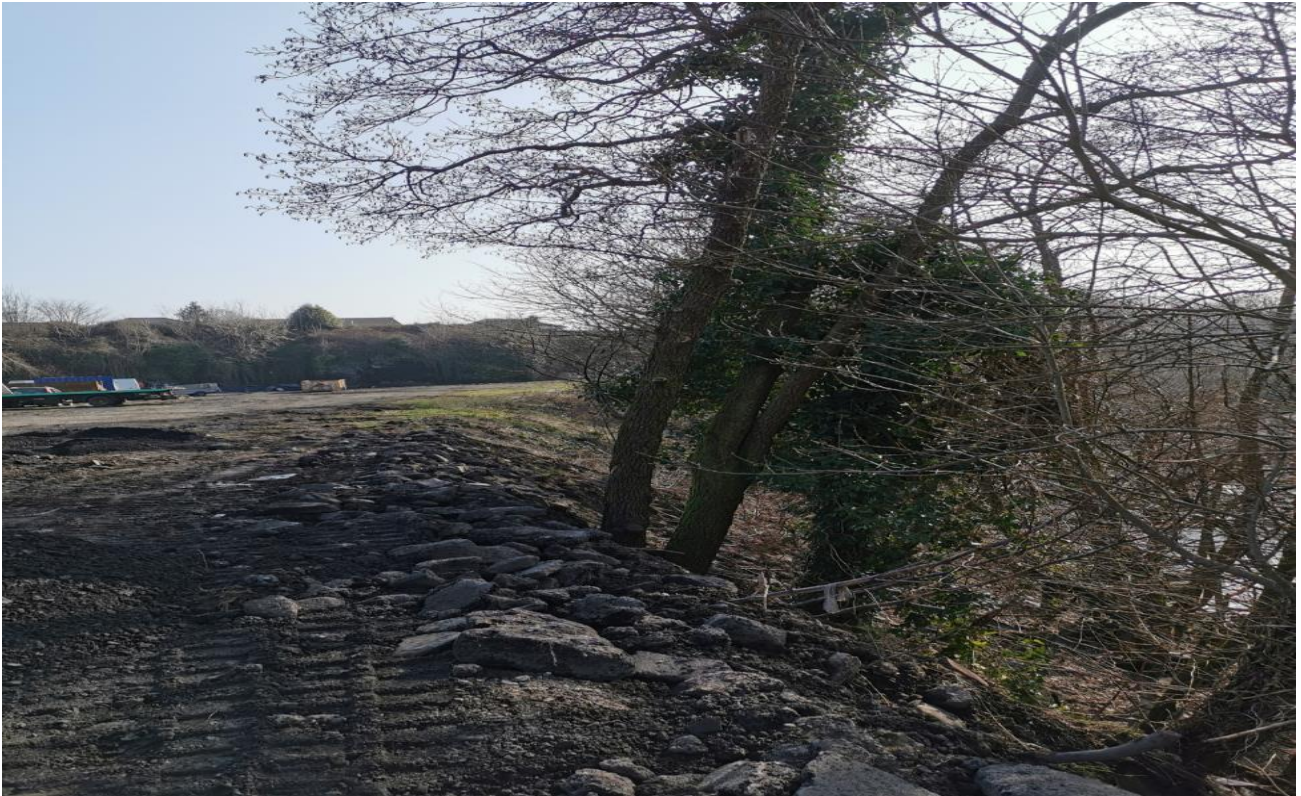
Current surface works are thought to have impacted the subject trees via overlaying and disturbing their RPA. Providing that the recommendations are followed, there is no further impacts foreseen.

**Plate 1:** Showing aggregate pushed over RPA's at the west side of the site.

It is recommended that all aggregate material currently existing within the proposed RPA is carefully removed with an excavator, using the method statement provided as guidance.

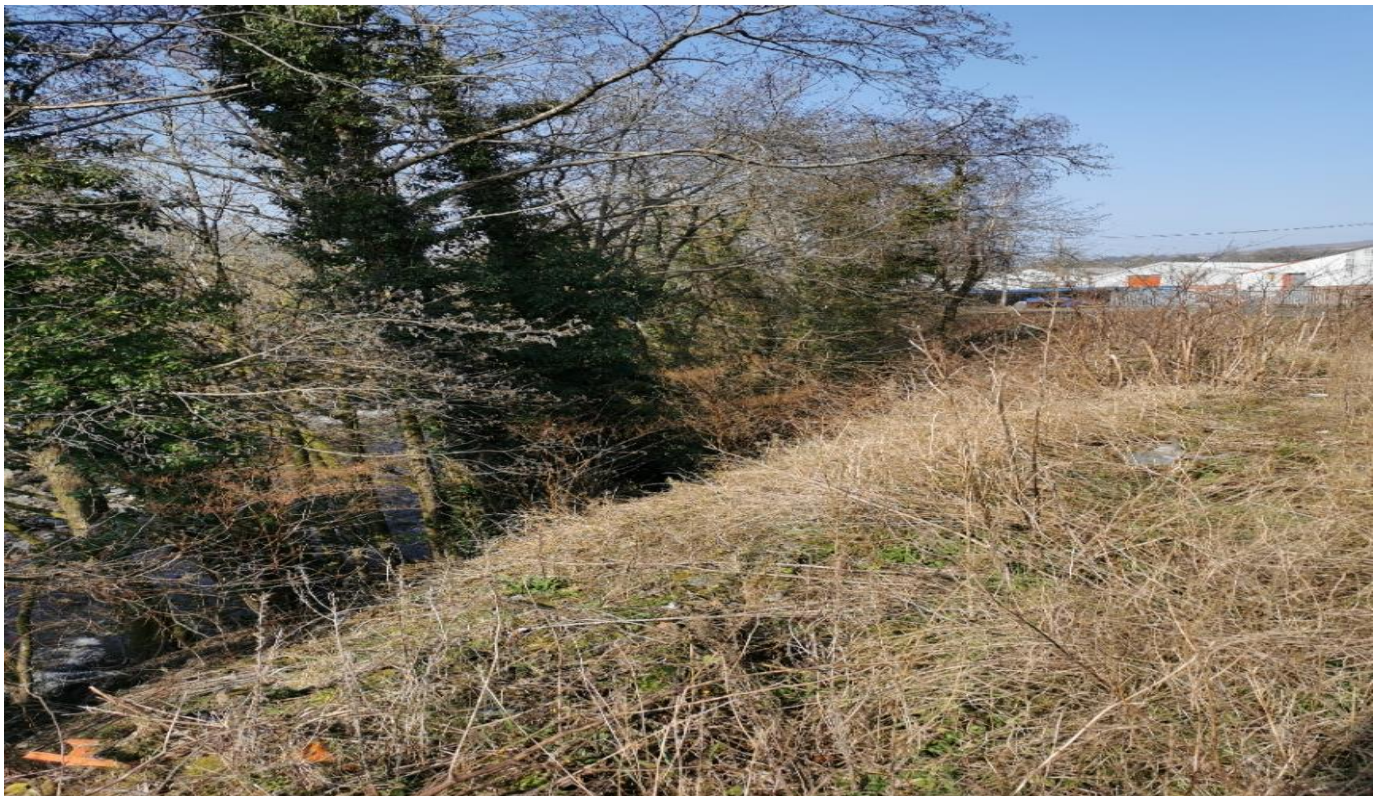
On site there was one group of trees. The general average condition for the main body of this group was found to range from **fair** to **good**, with a minority of trees being **dead** or showing decline.

**Plate 2:** Showing G1 looking west from the east side of the site.
