*Report No. BC/MB/06.19.03.*

# **Site Investigation Report on Land at Gethin House, Abercanaid**

# **Site Investigation Report: Land Adjacent to Gethin House, Abercanaid, Merthyr Tydfil.**

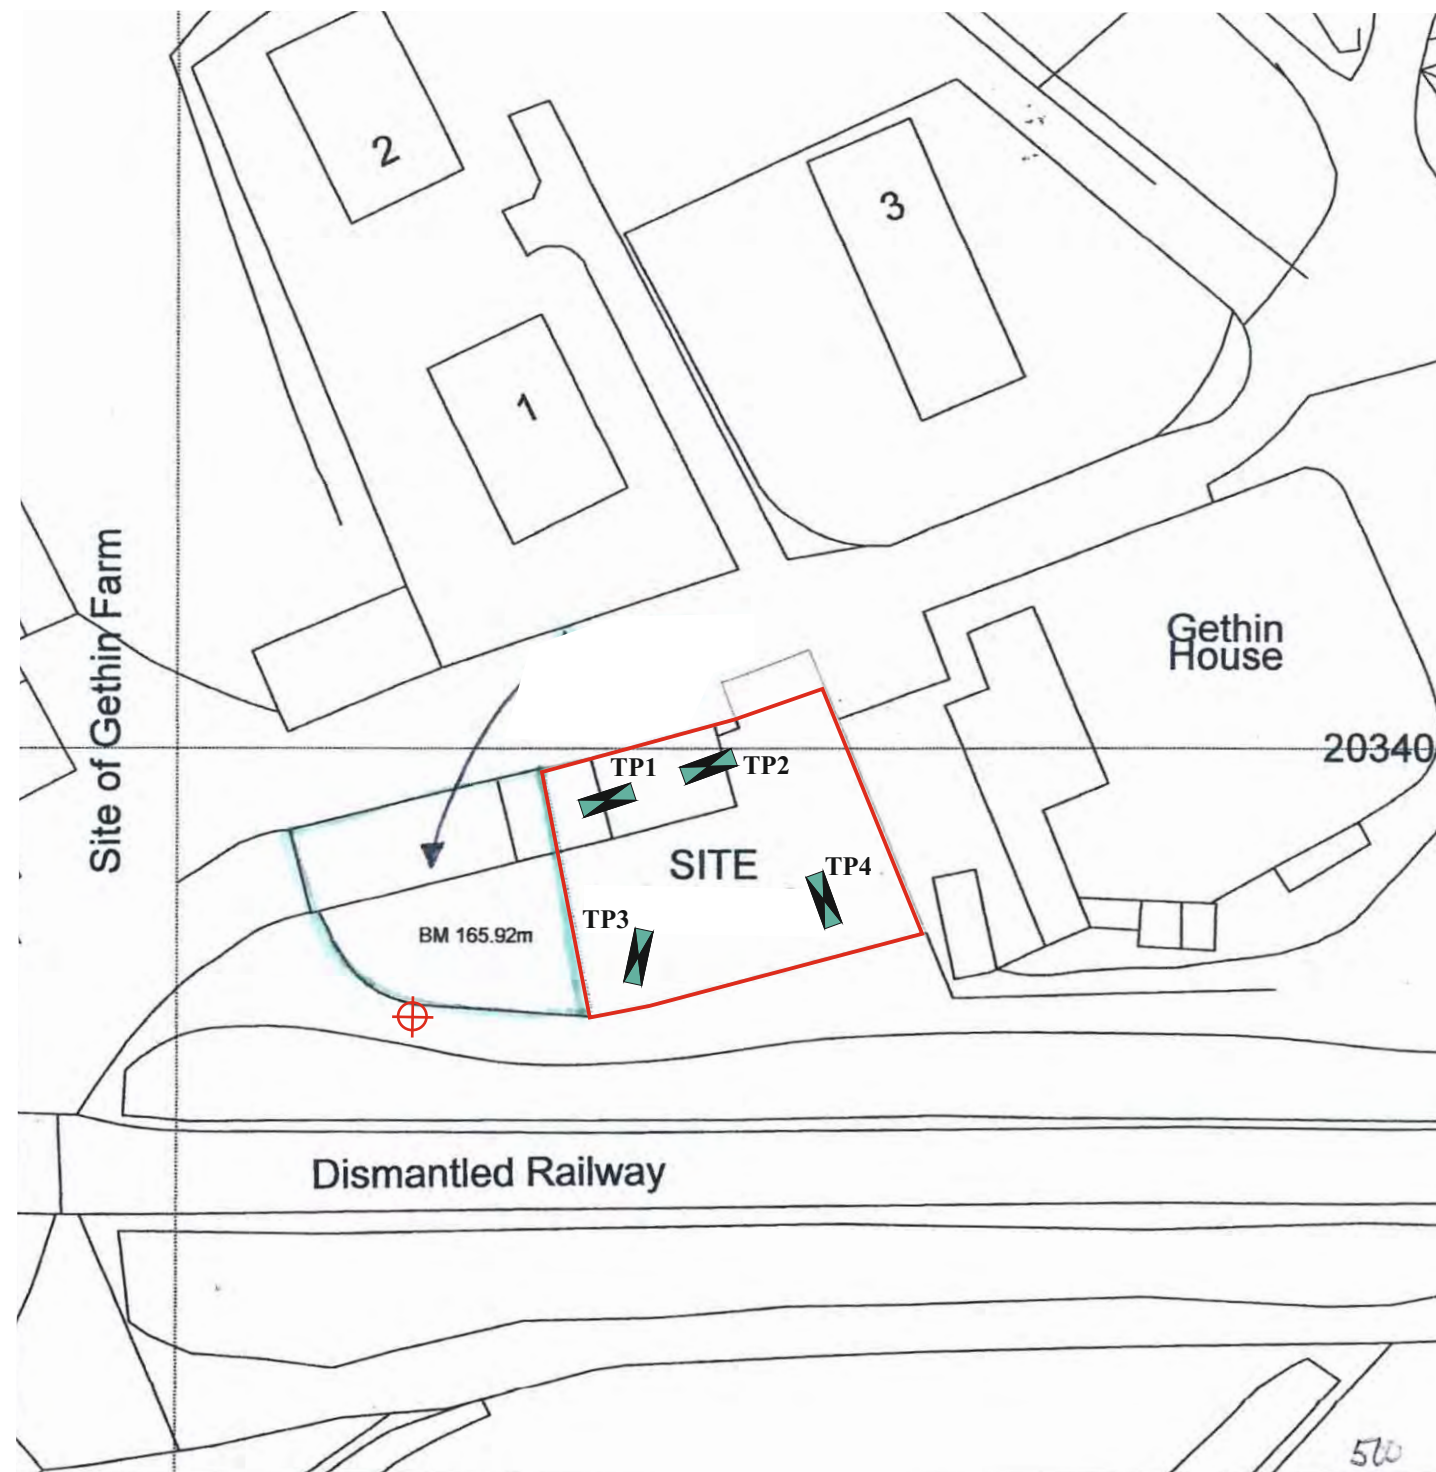
Drawing No: BC/MB/06.19.03.05.

The only mining issue affecting the development is the presence of a disused mine shaft approximately 11m west of the Site. Fixing the position of old mining features to current surface features can be prone to a degree of imprecision. The indicated position of the shaft is on third party land with the result that it cannot be investigated using intrusive methods. The risk that the shaft is closer to the Site than is indicated cannot be ruled out. Consequently, the risk that the hypothetical collapse zone around the shaft intrudes onto the Site cannot be ruled out. To provide protection against a collapse of the shaft it is recommended that the proposed dwelling is constructed on a raft foundation. To ensure that the shaft is not located on the Site it is recommended that shallow trenches are excavated on the western half of the Site.

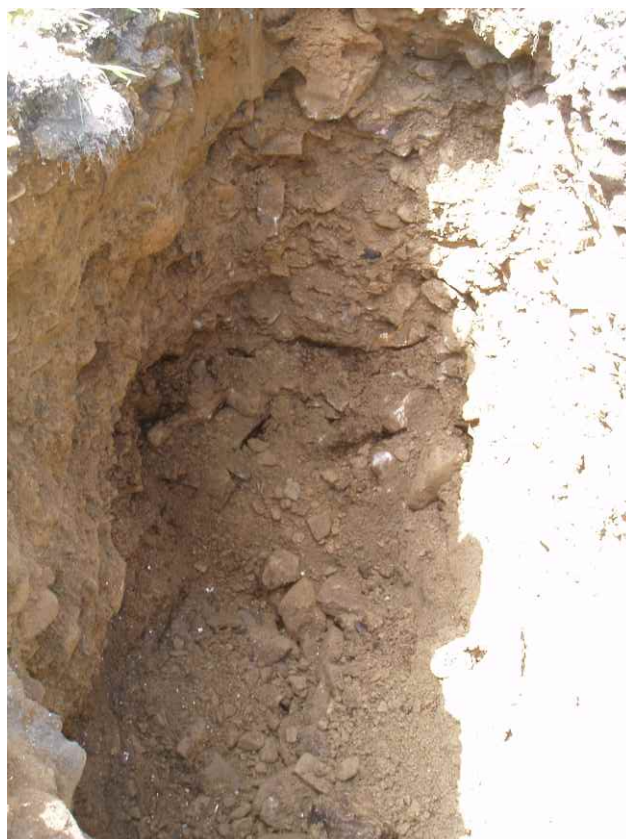
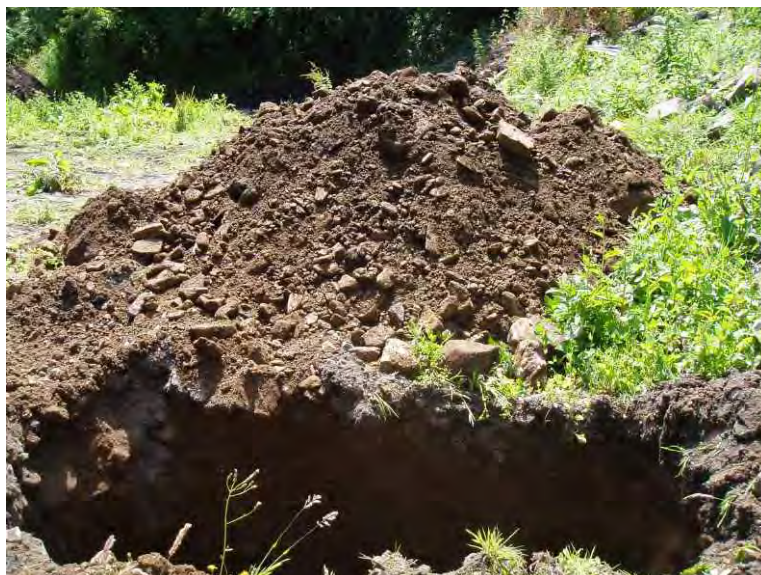
## Photo Plate 1, Trial Pit 4

| Depth | Description | Legend | Backfill/<br>Installations | | | |
|---|---|---|---|--|--|--|
| 0.40m | <b>MADE GROUND:</b> Compact, black slightly clayey sandy gravel of fine and medium angular mudstone. Coal sand. Some fragments of broken glass. | | 0.40m | | | |
