# BAT SURVEY REPORT

## HOOVER SITE, MERTHYR TYDFIL

<b>Project Number</b>	K001	
<b>Title</b>	Bat Survey Report	
<b>Document Number</b>	K001- Bat Report-V1.2	
<b>Client</b>	Walters	
<b>Issue Date</b>	29/09/2025	
<b>Prepared by:</b>	David Price - Consulting Ecologist 29/09/2025

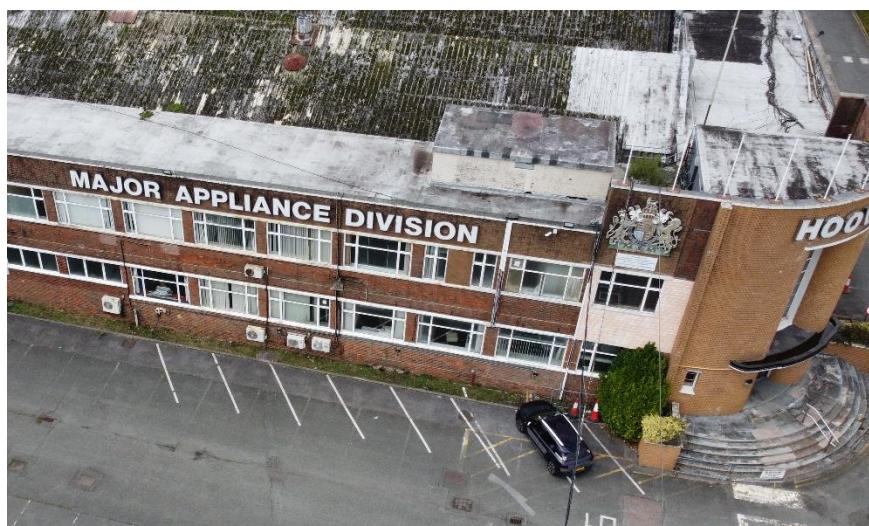
Building 1, is an art deco style brick fronted, flat roofed, office building that backs onto a corrugated steel warehouse with transparent plastic and glass panels. Though it's the same building, for the purpose of this report we're reefing to the office section as 1a, and the warehouse section as 1b.

*Photo 1: Overview of building 1.*

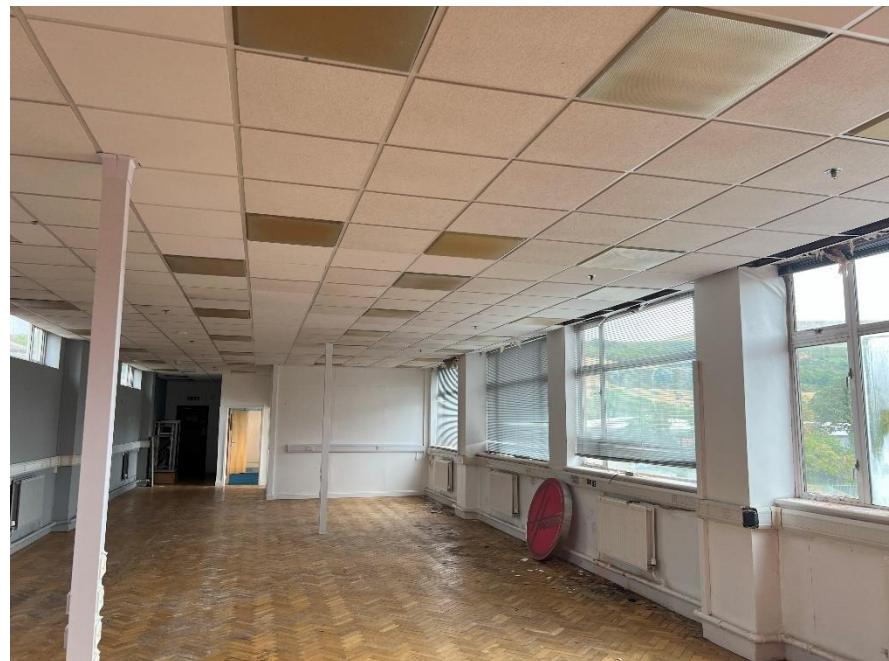
Internally the offices of building 1a are in poor condition with damp throughout. There is a suspended ceiling that offers negligible opportunities for crevice dwelling bats. The building has been empty for some time and a thick layer of dust is visible showing the building hasn't been cleaned. No evidence of bats was found within the office.

*Photo 2: Example of the typical office space within building 1a.*

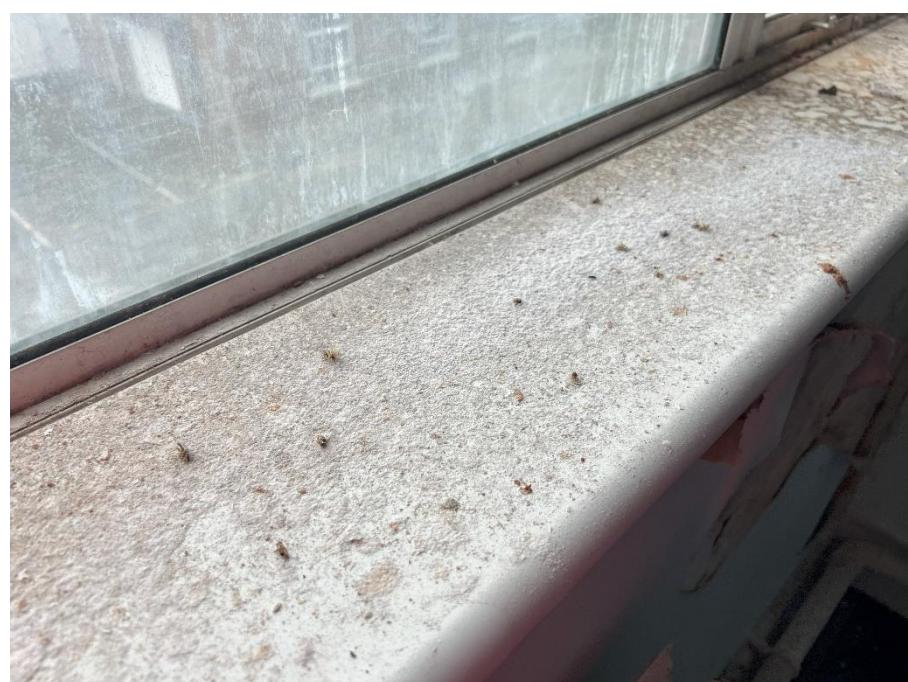
*Photo 3: Uncleaned window cills with no bat evidence.*

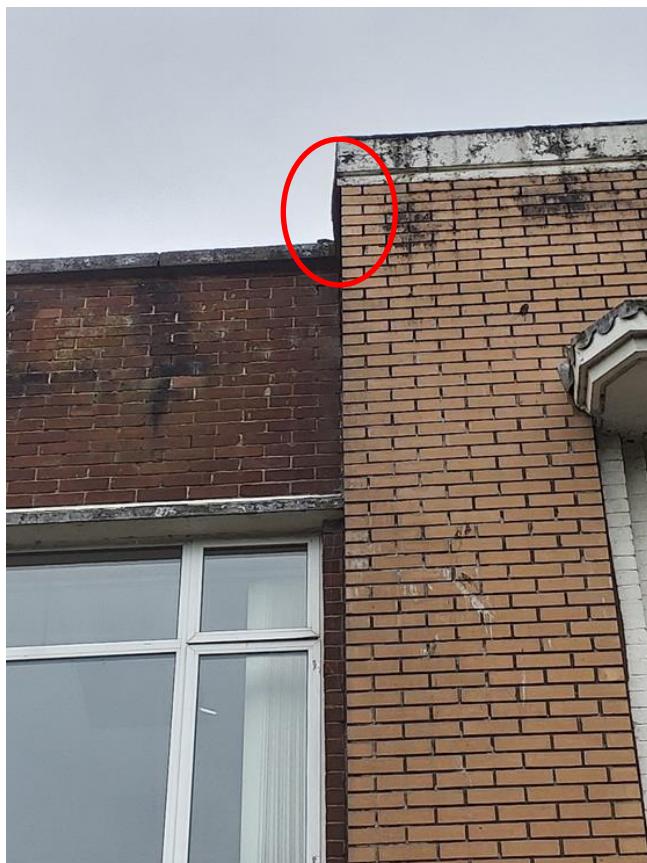
3.6 Externally the brickwork for building 1a is in relatively good condition. There were multiple areas where the roofing material had lifted to create gaps that could be utilised by crevice dwelling bats. Some small gaps were present within the brick work but likely not large enough to provide potential for roosting bats. The building is part of an area well used at night, as result it is heavily flood lit reducing its suitability for bats. Considering the size of the building and the number of possible PRFs, the building has been classified as having moderate bat potential.

*Photo 4: Lifting in roof felt*

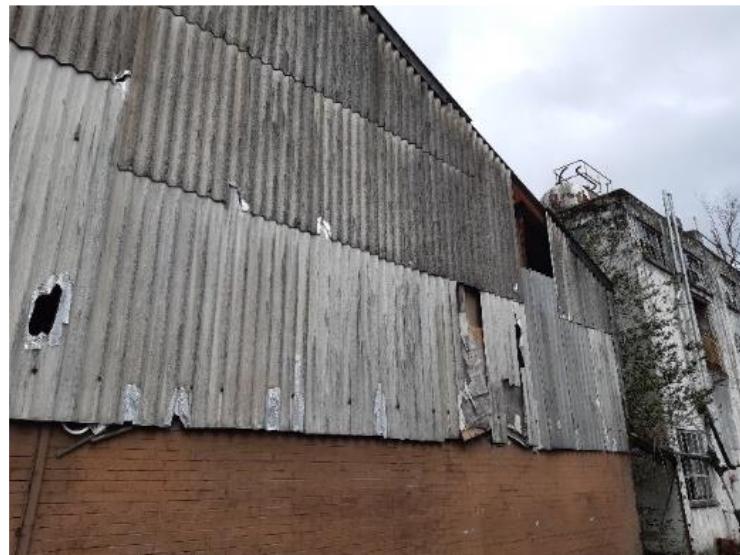
3.7 Building 1b's exterior cladding has multiple gaps and damaged or missing panels throughout. There are also small brick and breezeblock storage building on the western aspect. These building are in a poor state of repair with damaged roof, broken windows and access throughout. The building is part of an area well used at night, as result it is heavily flood lit reducing its suitability for bats. The buildings are also lit internally at night.

*Photo 5: Example of damaged boarding*

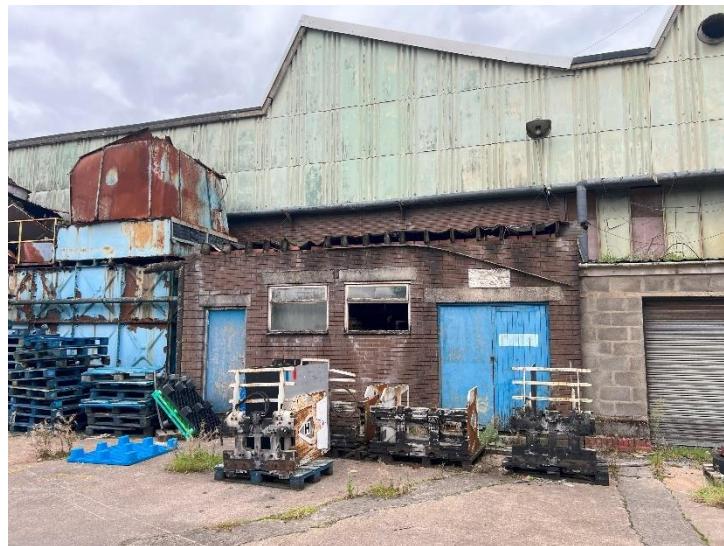
*Photo 6: Example of the brick structures adjacent to the building and further examples of the steel boarding.*

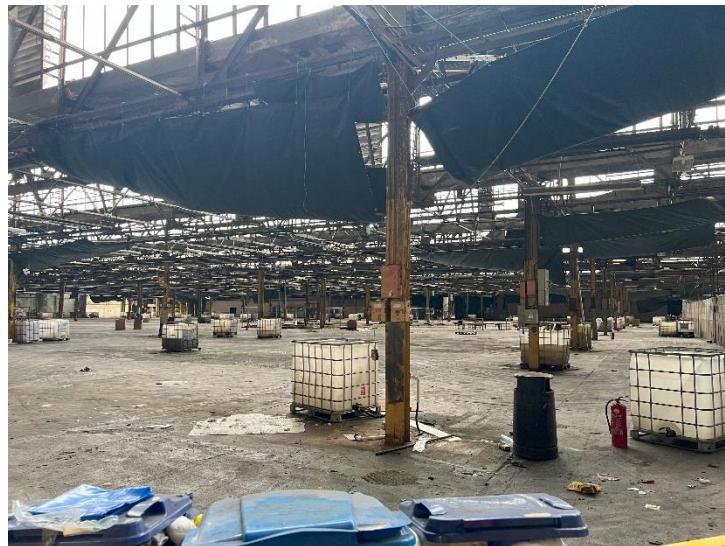
Internally building 1b; the warehouse is large, open, light with water ingress throughout. The internal microclimate of the building would vary greatly, and many of the structures are damp. The brick buildings are simple storage sheds and have negligible internal roosting opportunities for crevice-dwelling bats, they also have water and light ingress and would have an unstable internal microclimate. No evidence of bats was found within any of the structures. Despite internal and external artificial lighting, the building is classified as having moderate bat potential due to its size and number of possible PRFs.

*Photo 7: Overview of the buildings internal structure.*

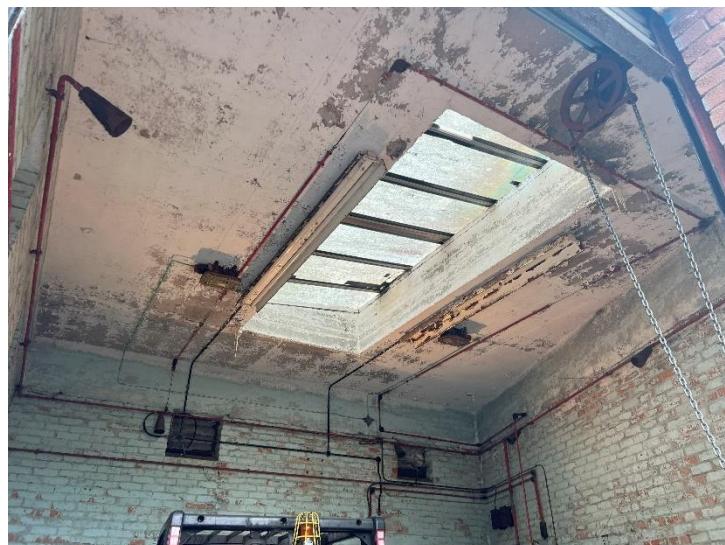
*Photo 8: An example of the internal structure of one of the small storage rooms adjacent to the main building.*

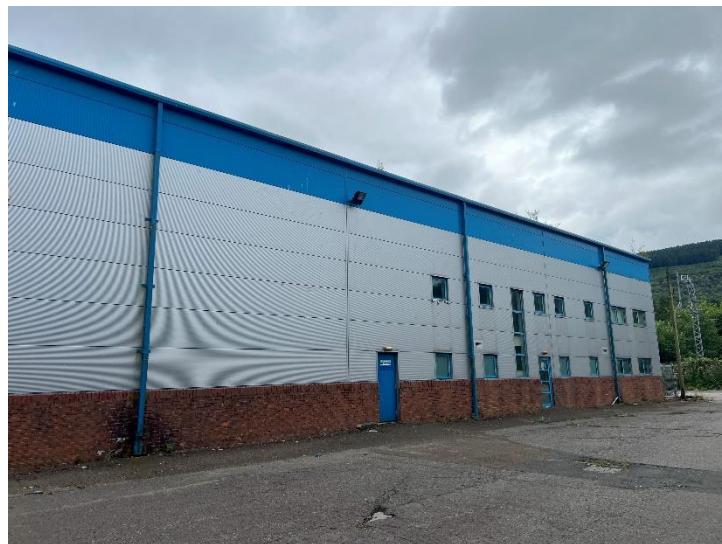
Building 2 is a modern steel warehouse. The building is in good order with no visible access points or crevices. Internally there were no visible PRFs for crevice-dwelling bats, and no evidence of bats was found within the building. The building is part of a well-used area that is heavily flood lit at night, reducing its suitability for bats. Considering the size of the building its possible some PRFs may be present but not

*Photo 9:* overview of the external structure of building 2

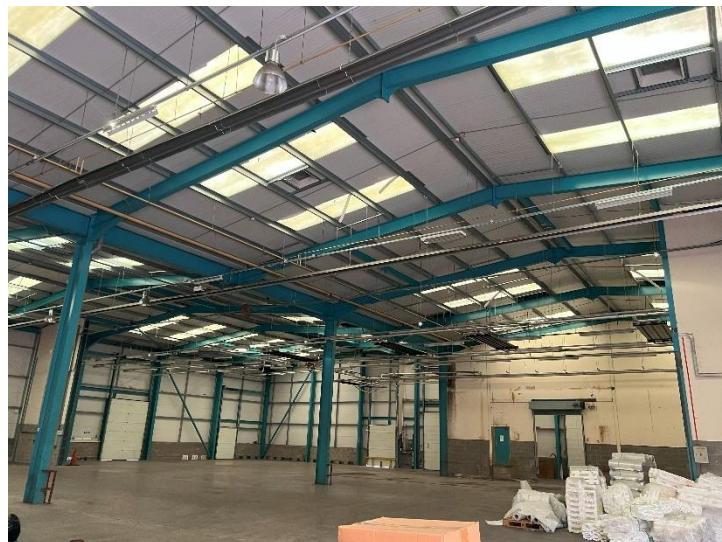
*Photo 10:* Overview of the internal structure of building 2.

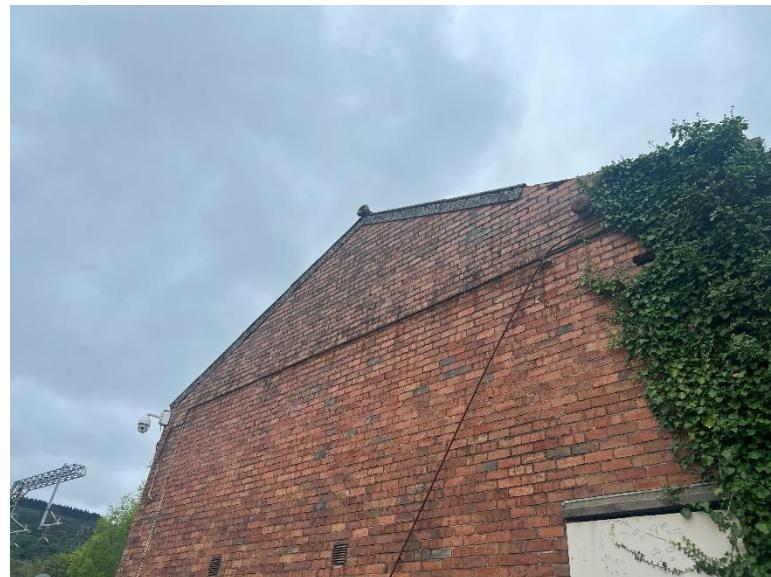
Building 3 is a brick and corrugated asbestos workshop. The building has been permanently sealed due to asbestos contamination, as a result an internal inspection wasn't undertaken. There is significant damage to the roof and some of the windows are broken allowing access into the building. There are windows all along the roof and along the top of the walls. Consequently, the building receives ample natural light during the

*Photo 11:* Damage to the barge boards allowing possible access for bats

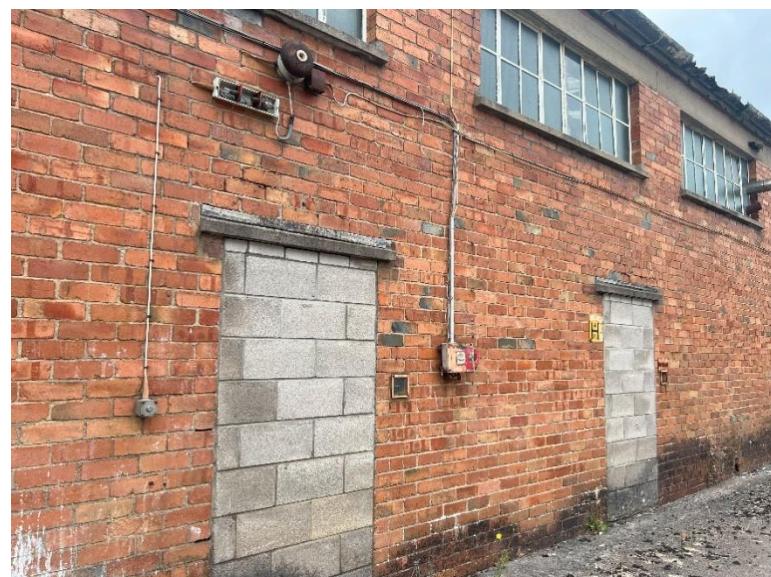
*Photo 12:* Shows how the building g has been closed for H&S reasons. The windows show the light levels from the roof lighting.

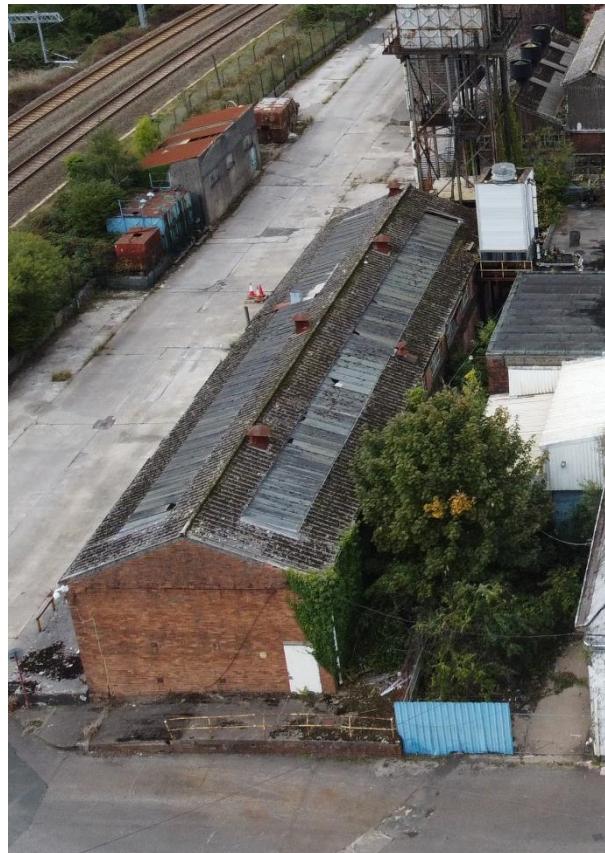
*Photo 13:* overview of building 3.

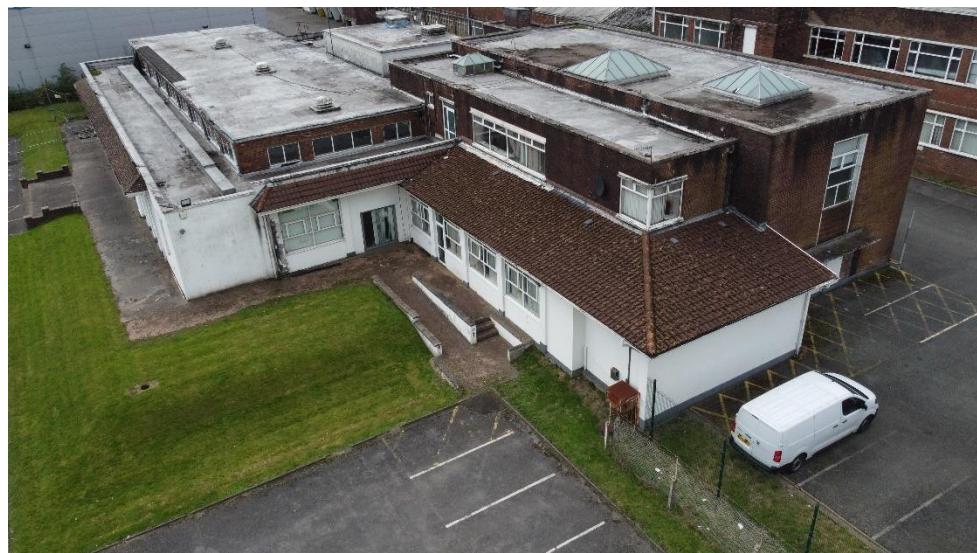
Building 4 is a two storey, flat roofed office building. The southern and eastern elevations of the building feature small sections of lean-to pitched roofing above the ground floor. The lead flashing where the roof meets the exterior wall offers the potential for crevice dwelling bats. The roofs appear in good order with no visible signs of damage. There was no access available into the loft space of the small, pitched roofs. There is a crack in the wall on the western aspect of the building. The crack has negligible potential for roosting bats. Internally the offices are in moderate condition with evidence of damp. There is a suspended ceiling that offers negligible opportunities for crevice dwelling bats. The building has been empty for some time and a thick layer of dust is visible showing the building hasn't been cleaned. No evidence of bats was found within the offices. As a thorough internal inspection of the loft spaces couldn't be undertaken, as a precaution the building has been classified as having high bat potential.

*Photo 14: Overview of building 4*

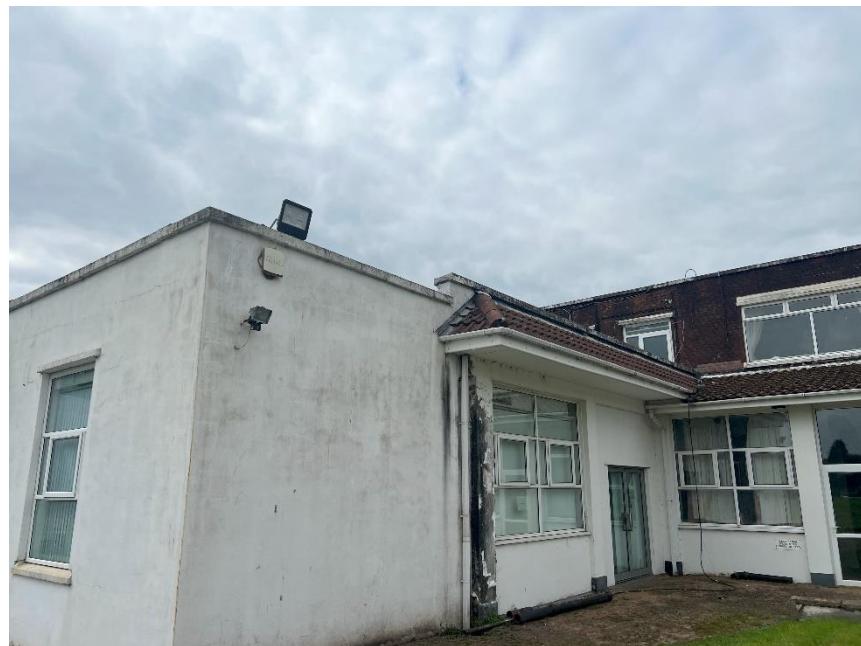
*Photo 15: The flat roof is generally in good order with negligible PRFs, the small, pitched roof has lead flashing all around offering roosting opportunities.*

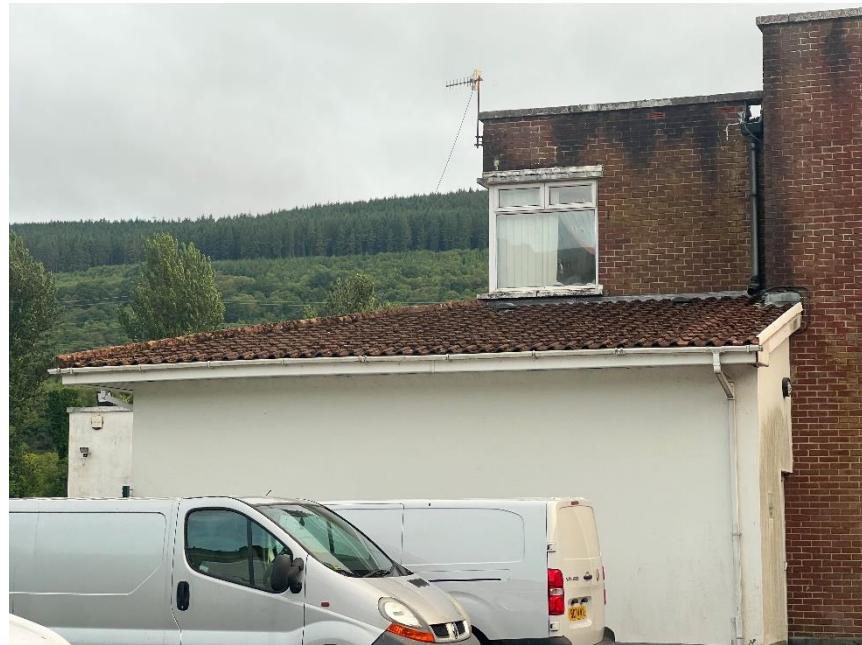
*Photo 16:* Minor damage to the small roof.

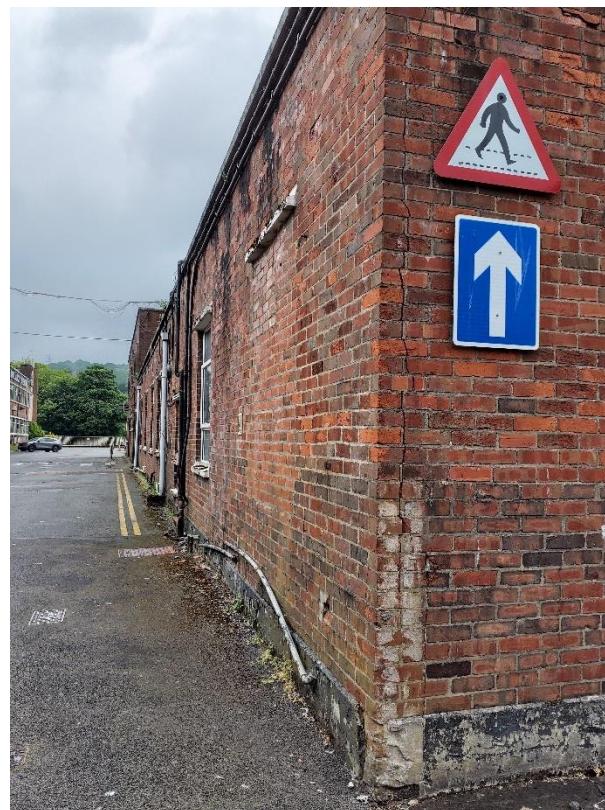
*Photo 17:* A crack in the wall, and inspection with an endoscope shows the crack has negligible potential for bats. An inspection was also made behind any signage; no evidence of bats was found.

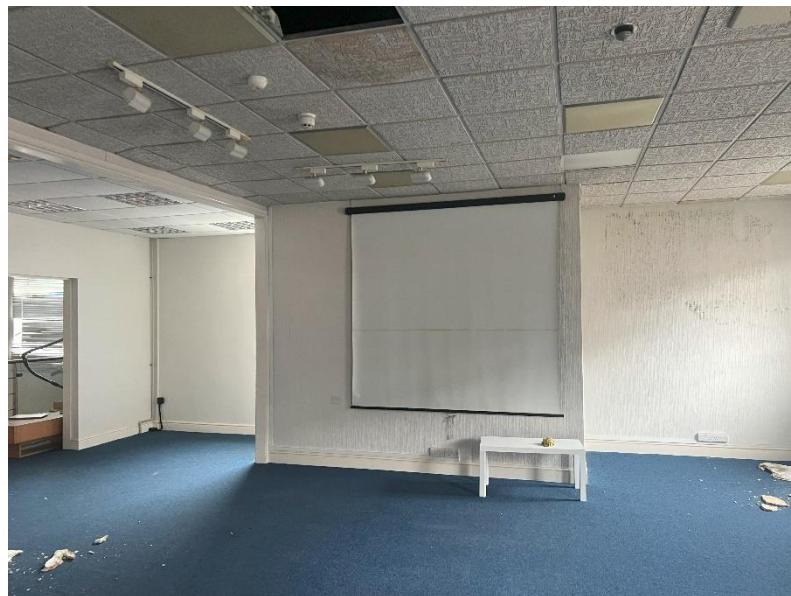
*Photo 18:* Overview of the internal structure of the building, there is evidence of damp in the walls.

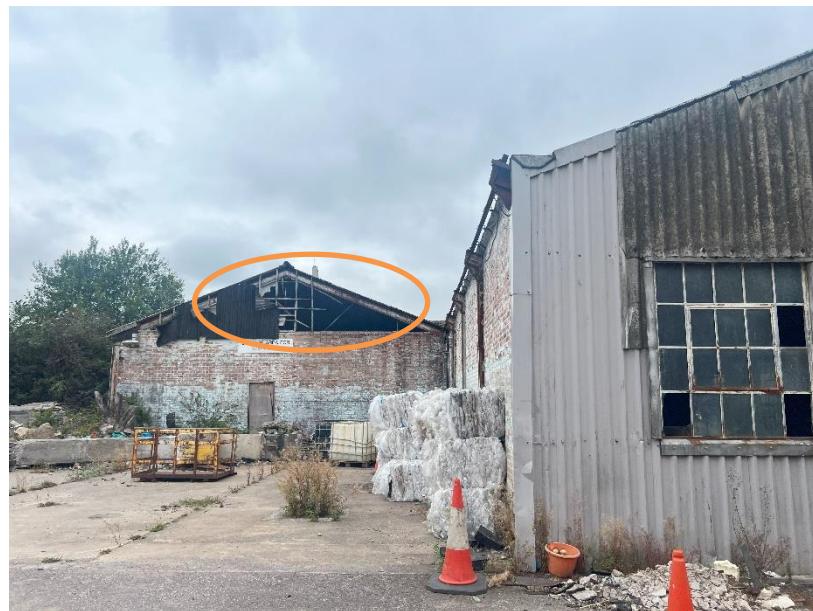
Building 5 is a brick and corrugated metal building adjacent to the western site boundary. The building has been significantly damaged with large open gables, and damaged windows throughout. The building has asbestos contamination, and an internal inspection wasn't possible. The internal microclimate of the building would vary greatly, and the brickwork is likely damp. The building is part of an area well used at night, as result it is heavily flood lit reducing its suitability for bats. There are areas of the building that couldn't be seen externally and its possible this section may be dark at night and have more stable microclimate, as a precaution this building has been classified as having high bat potential.

*Photo 19:* overview of building 5, the large open gable has been highlighted, and some broken windows are clearly visible.

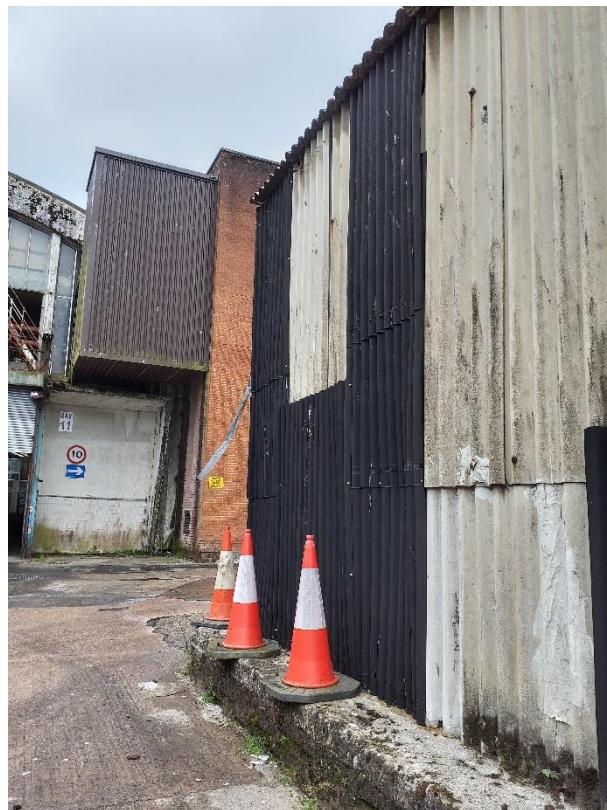
*Photo 20:* Example of the patched repair to building. There are gaps around many of the panels.

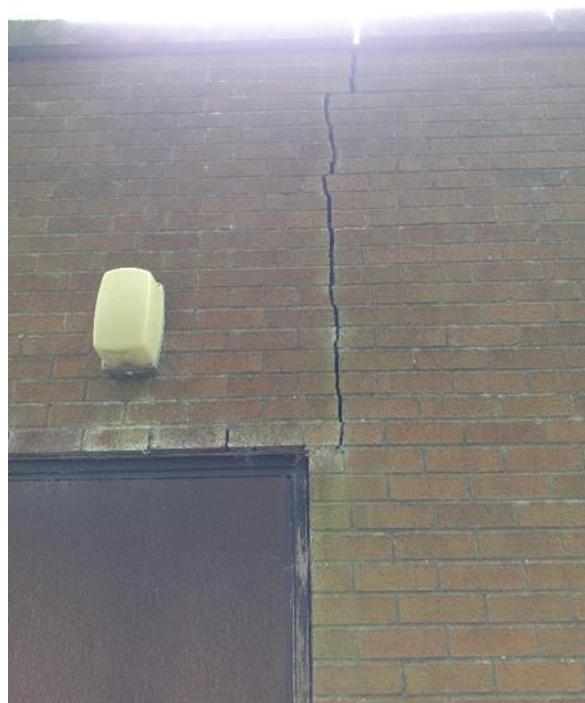
The old water pumping station building 6 was a brick building with a felt roof. The building had cracks within the brickwork which may provide potential for roosting bats. The crack did not allow access into the building. A thorough examination of the crack was made using an endoscope and a thermal imaging camera.

The crack didn't extend further than is visible, there were negligible opportunities for crevice dwelling bats, and no evidence of bats was found. The crack is open from the top so it would allow water into the space further limiting any roosting opportunities. After a thorough inspection the crack is considered to offer negligible opportunities for bats.

*Photo 21: The crack in the exterior brickwork, open at the top.*

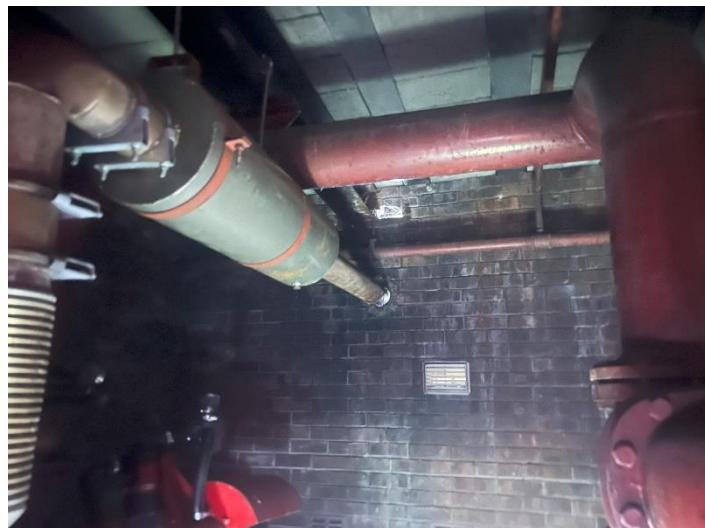
*Photo: 22.* The black internal bricks in contrast to the brown external bricks above are the result of a light coating of oil, making the internal environment of this building unsuitable for bats.

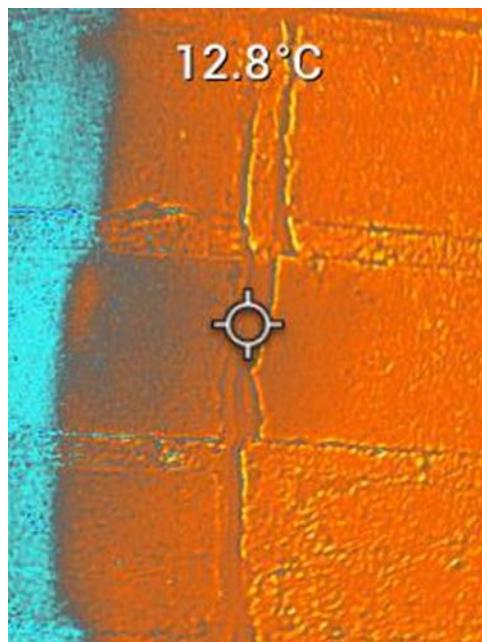
*Photo: 23.* A thermal imaging photo from the onsite inspection.

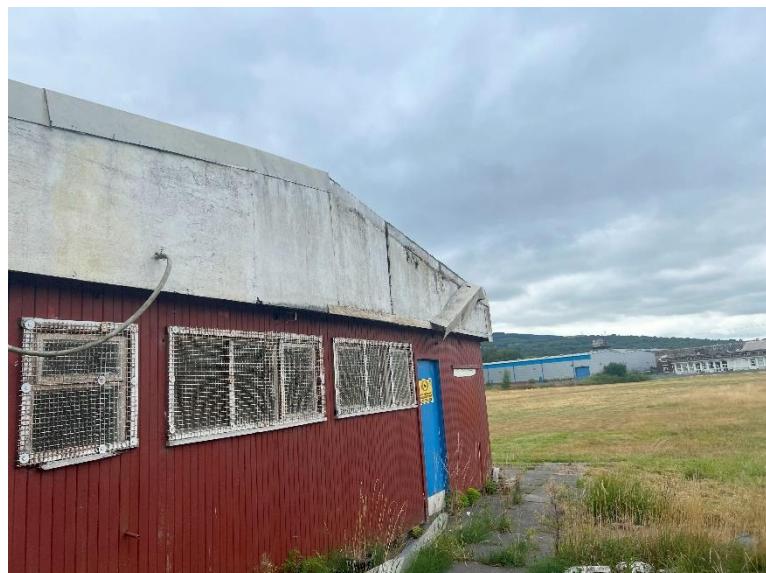
Building 7 is a cricket pavilion to the south of the site. The building is positioned out of the industrial estate adjacent to areas of unilluminated trees and grassland. The building is comprised of wooden boards and a possibly plastic roof. The wood was rotten in many areas creating gaps

*Photo 24:* Shows a lift along the roofing material, offering transitional roosting opportunities for small numbers of bats.

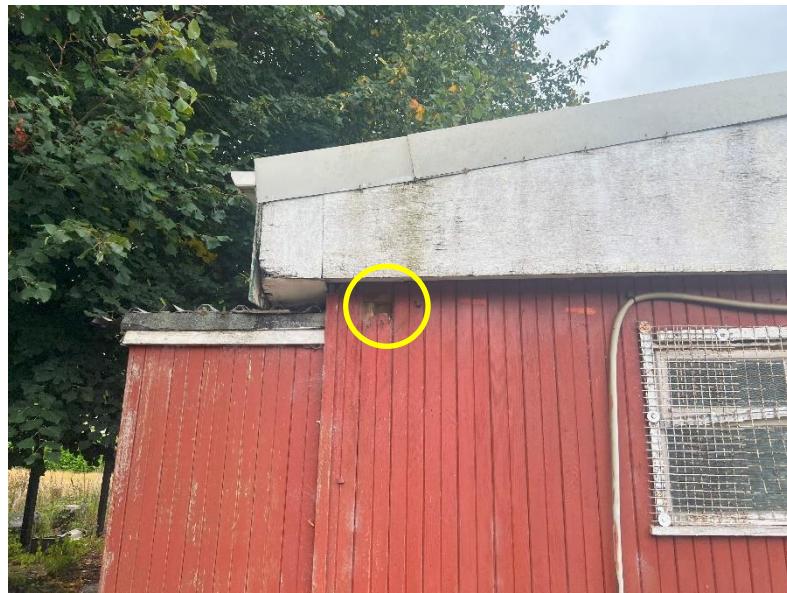
*Photo 25:* Shows a hole in the exterior cladding that could allow bats too access possible roosting locations.

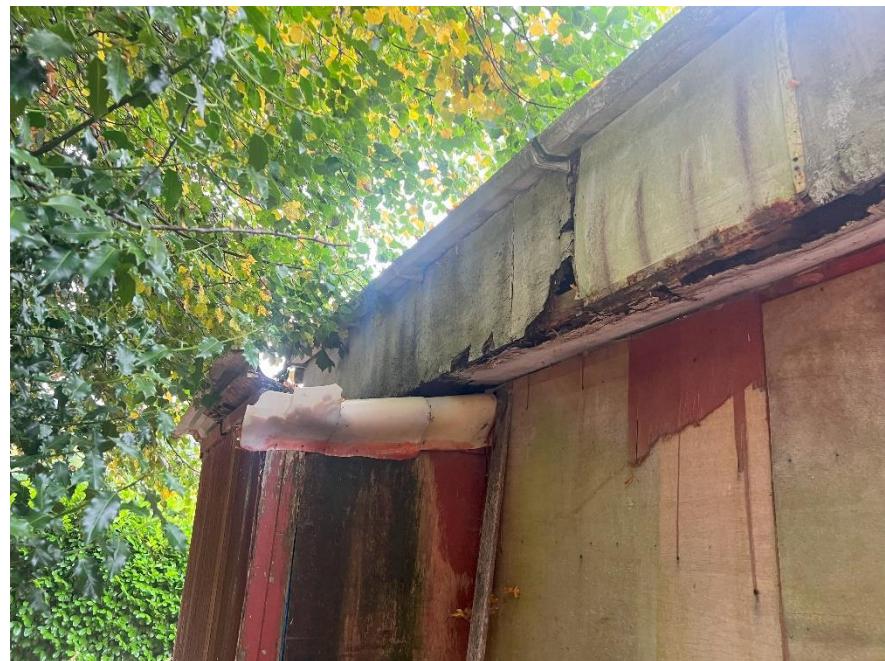
*Photo 26:* There is extensive damage to soffit boxes. Access is available for bats however it's likely the internal space is damp with little long term roosting potential.

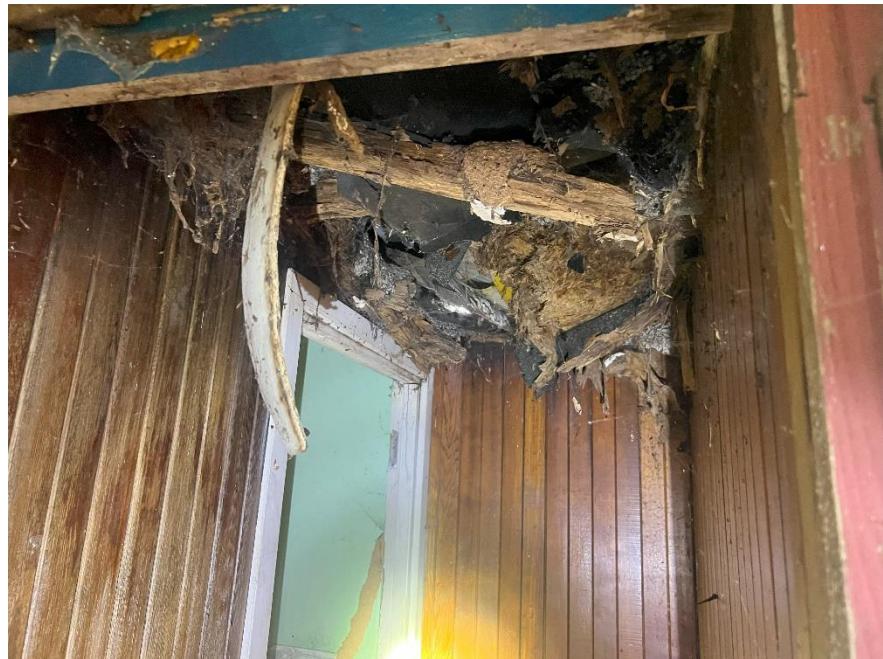
*Photo 27:* Example of the rot and damp within the roof.

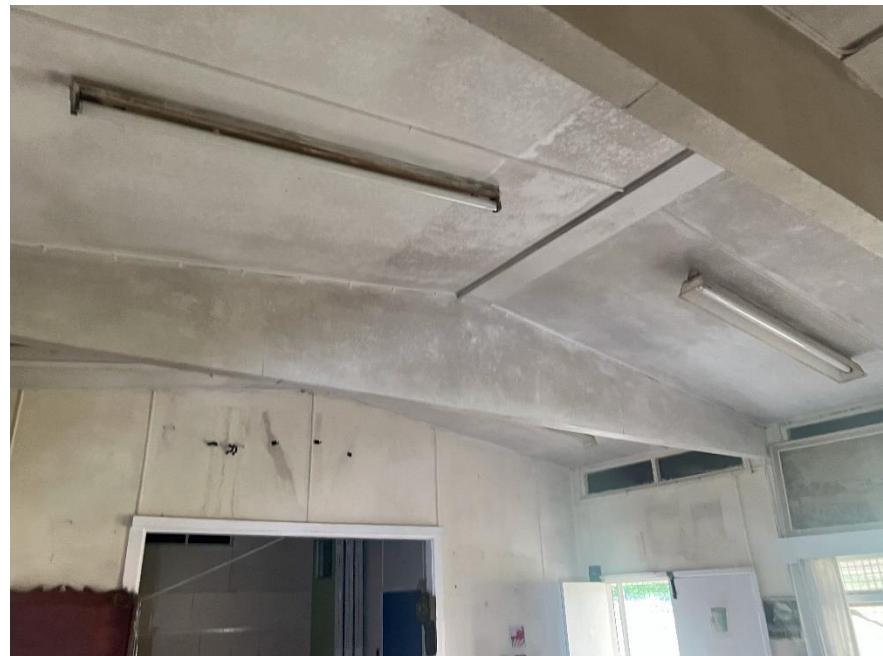
*Photo 28:* The ceiling vaulted, the insulation between the ceiling and the roof reduces the buildings suitability for bats.

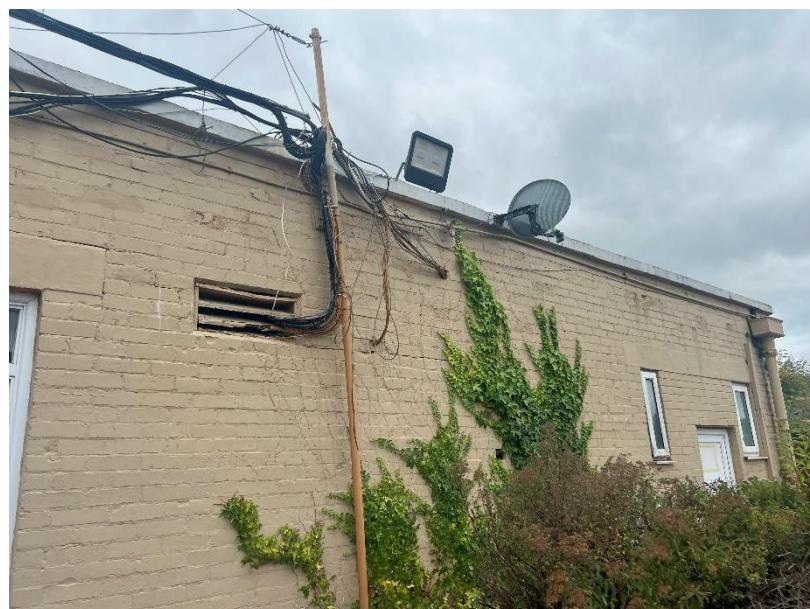
building is part of an area well used at night, as result it is heavily flood lit reducing its suitability for bats. On the western aspect of the building there is a ventilation block that allows cables to pass into a storage area. This ventilation block would allow bats to access the storage shed; however the internal structure offers few suitable roosting opportunities for bats and there is signs of damp throughout. No evidence of bats was found. Considering the possible access into the storage area, the building has been classified as having low potential for bats.

*Photo 29: ventilation block on the western aspect of building 8*

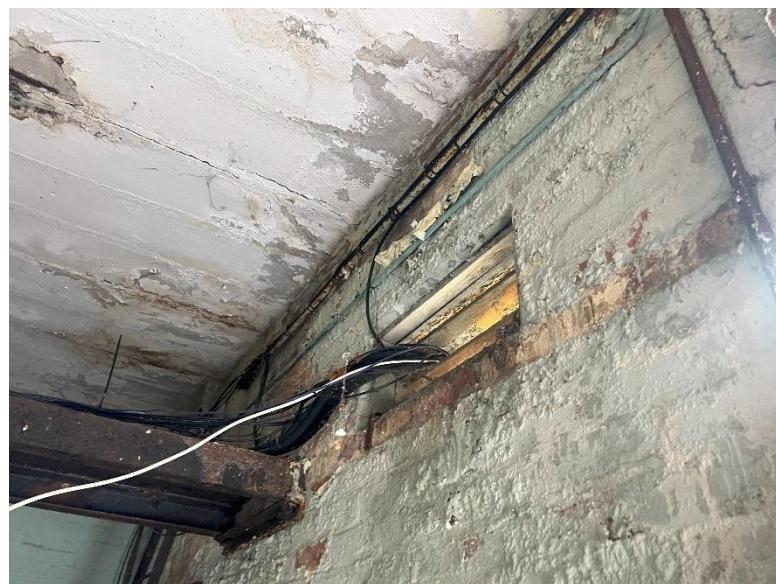
*Photo 30: internal structure of building 8*

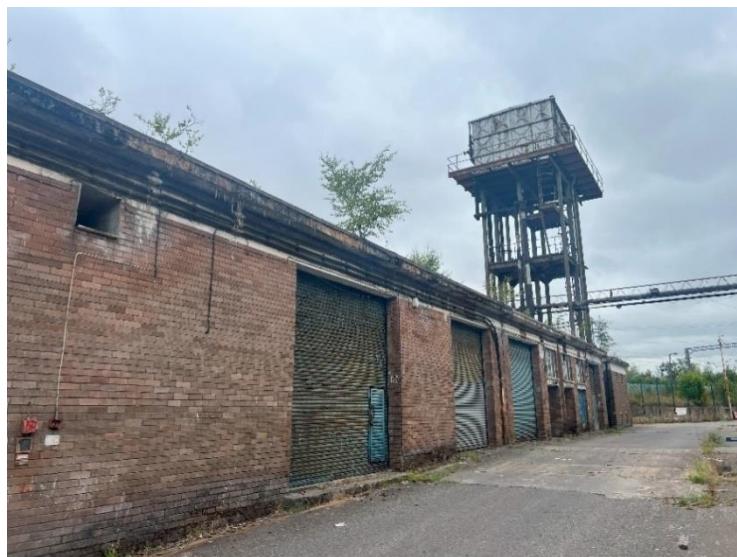
Building 9 is a series of single storey, flat roofed garage and storage buildings with a water tower. The buildings have large openings where ventilation blocks once were. Though access was available into the building, internally there were no visible PRFs for crevice-dwelling bats, and no evidence of bats was found within the building. The building is part of a well-used area that is heavily flood lit at night, reducing its suitability for bats. Though the building is artificially lit externally, considering the access points, the building has been classified as having moderate bat potential.

*Photo 31:* Overview of structure, missing ventilation bricks are clearly visible allowing unobstructed access into the building.

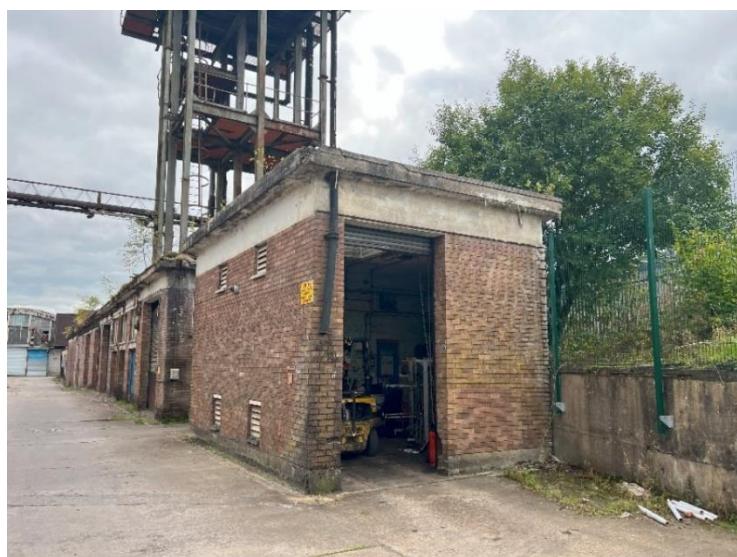
*Photo 32:* view from northern aspect, ventilation blocks are clearly visible.

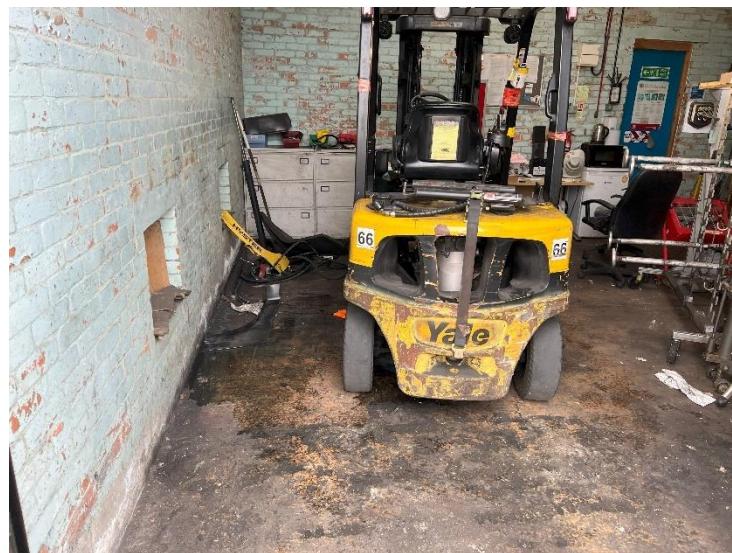
*Photo 33:* Internally the buildings are brick walled with no visible PRFs, the walls are damp, and no evidence of bats was found.

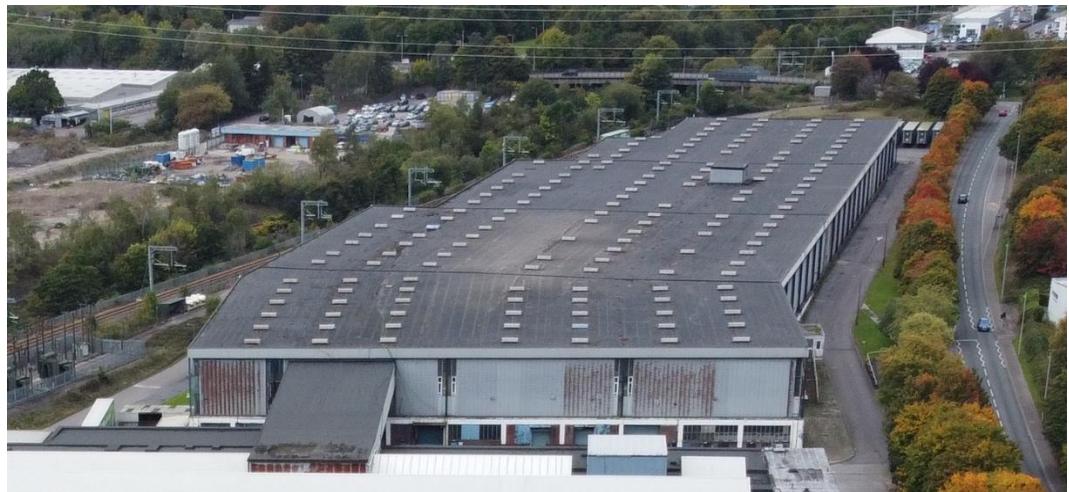
Building 11 is a large warehouse constructed of brick and breezeblock with metal panelling. The roof is corrugated steel with skylights. Internally some of the brick windows that have been bricked up and broken creating a space for bats to roost. A tough inspection with an endoscope revealed no evidence of bats. There are voids in the metal cladding that offer potential roosting opportunities for bats.

*Photo 34:* Overview of building 11.

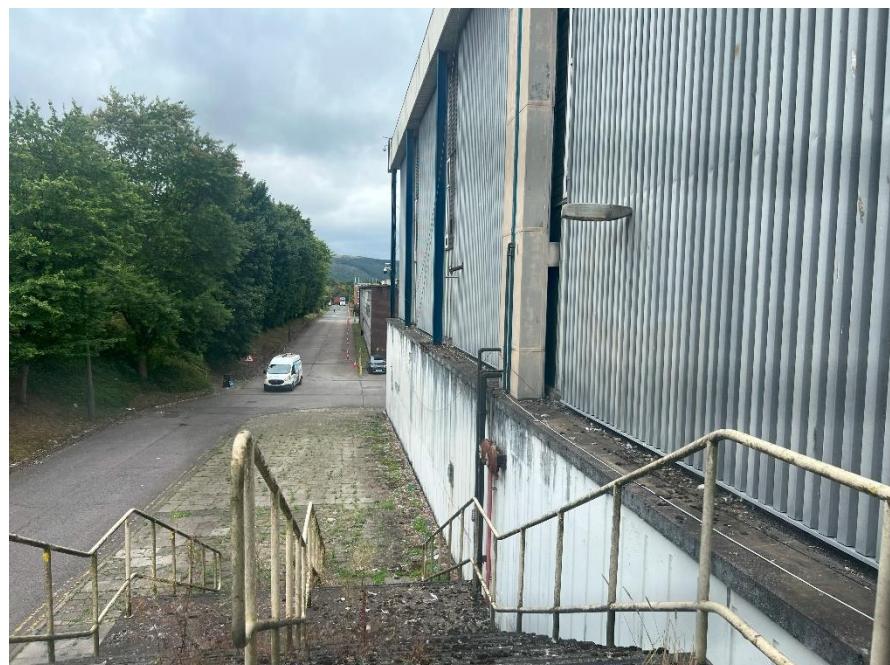
*Photo 35:* The external panelling is not flush to the wall and access is available throughout.

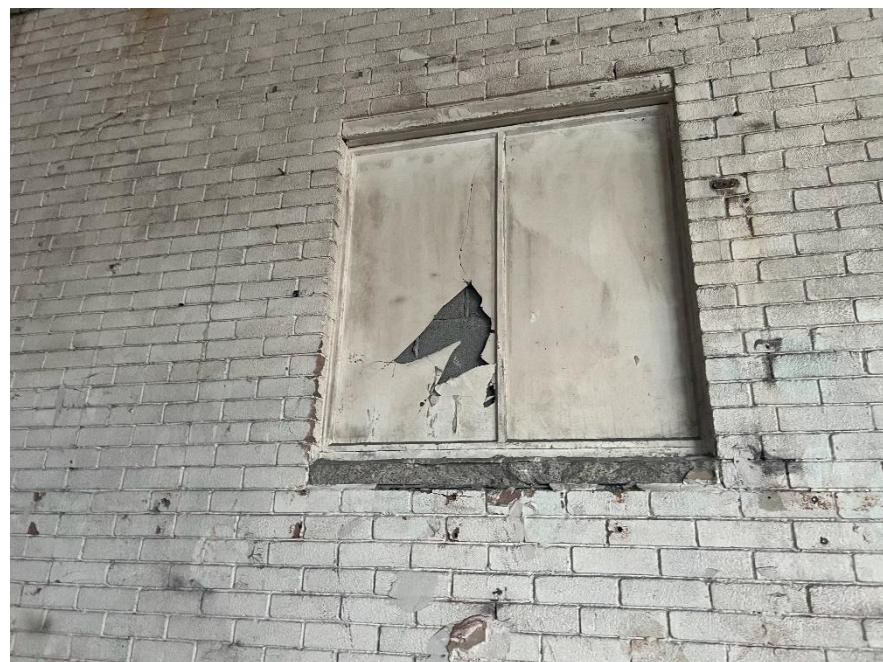
*Photo 36: broken window PRFs with building.*

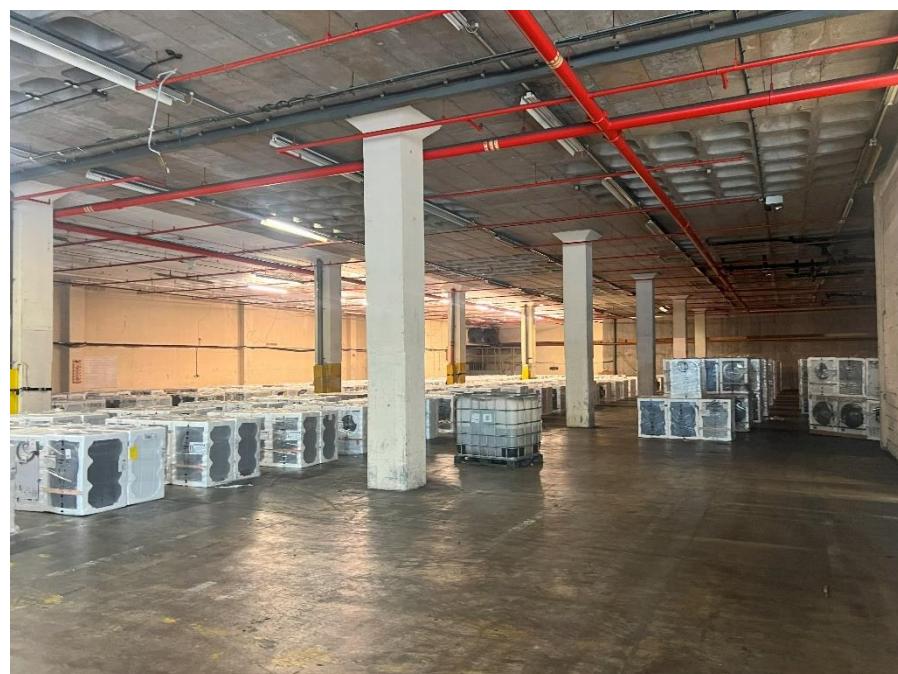
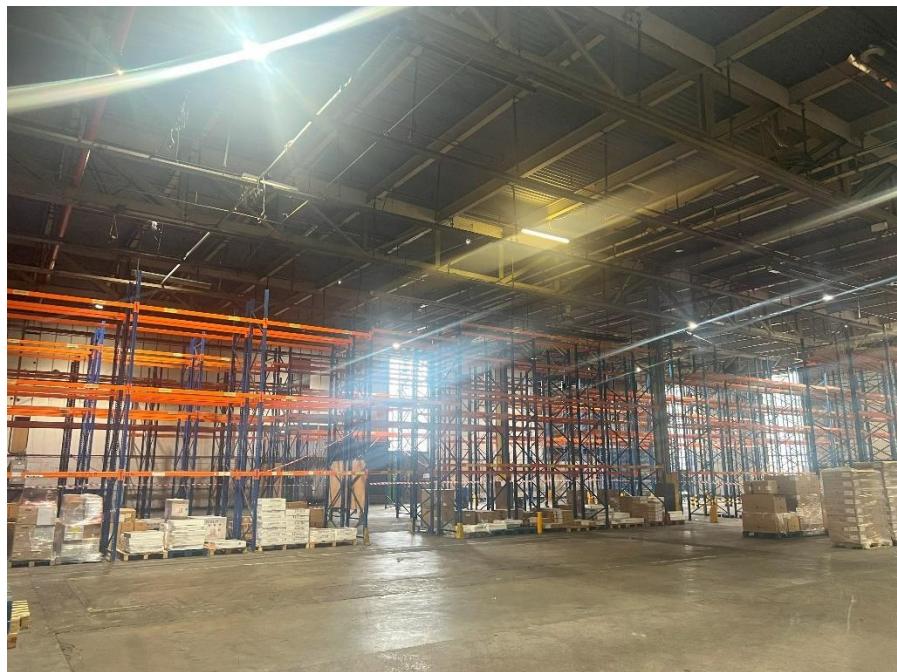
The buildings are currently in use, with internal lighting on 24hrs a day and strong floodlights at night. No evidence of bats was found within any of the structures. Considering the size of the building and the number of possible PRFs, the building has been classified as having moderate bat potential.

*Photo 37 and 38: Warehouse is active with internal lighting 24hrs a day.*
